CAMERON SPECIAL EDUCATION CENTER

FACILITY ASSESSMENT REPORT

HAMILTON + AITKEN ARCHITECTS
525 Brannan Street Suite 400
San Francisco, CA 94107

12/27/2014

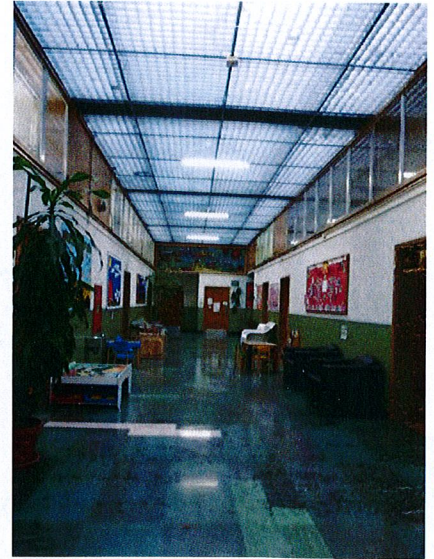
The original windows appear to be in good shape with hardware and glazing intact. Most of the existing windows are operable, although the upper and lower vents operate independently, requiring more effort. A few windows, possibly 4 windows, are missing latches. Since the existing windows are single glazed, it may be desirable to replace the windows to improve comfort, energy, and acoustic performance to reduce outside noise.

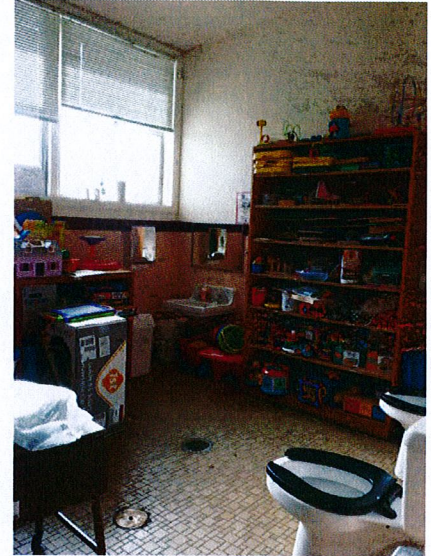
The original plywood cabinets are intact and well used. With refurbishing hardware and refinishing the wood, they could remain useful for the next sixty years. The storage needs are tremendous, and the built-in casework alone is inadequate to meet current needs. Even the staff toilet rooms are being used for storage.

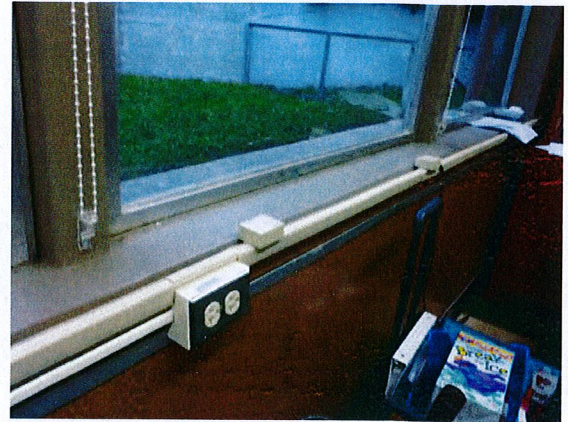
The main building is served by an underground 400Amp/120/240V service that originates from a utility pole on Lawrence Street and comes up in a riser within the combined M/E/P room on the South side of the building. There are two panels within the room, one lighting panel L-1 is a 200A panel that has all circuit banks filled and the other panel P-1 served power throughout the building. Both panel circuit banks are nearly full and do not appear to have much expansion capabilities. Based on the current uses, the loads are likely more than sufficient capacity but this is a 1950s electrical system and will likely not have the capacity to add service to a new support building on either existing panel. A new larger service should be brought in from the street with capacity to serve whatever support building needs develop during the conceptual design process.

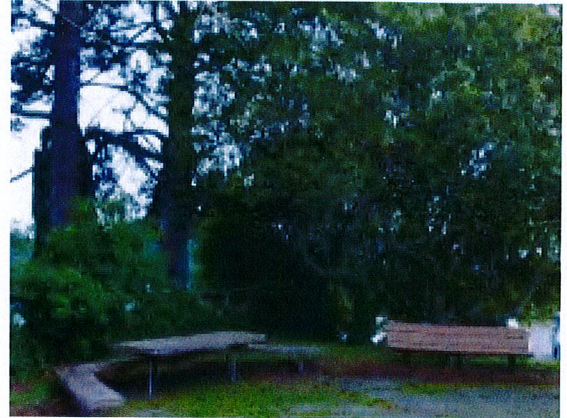
The back of the site is unobserved, blocked by the mid-site planting and the garage building. Staff does not use the parking up here because it feels disconnected from the school. It is not fenced and is not secure.

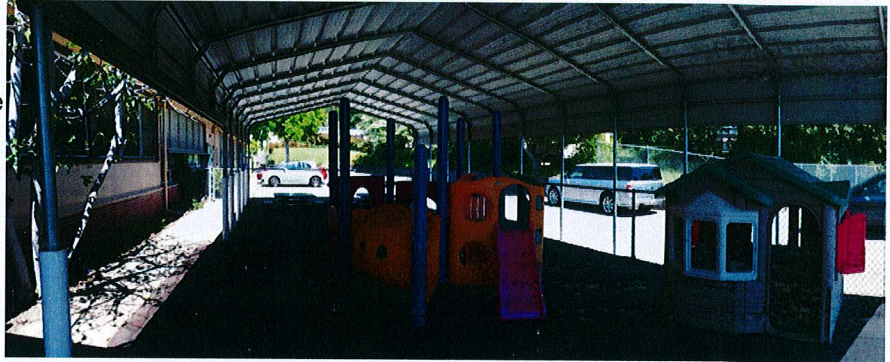
Currently, there is only one defined play space. The shade structure does not meet DSA standards for a shade structure, but it seems to be in good condition. The play elements are a mix of moveable elements and a few built-in items. Proper safety zone clearances appear to be just barely met for each of the play elements; however, given the flexibility of the elements, safety zones can easily be limited and cause potential harm to students if elements are placed too close to one another.

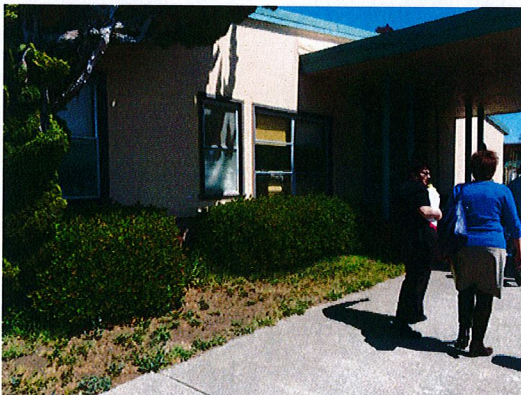
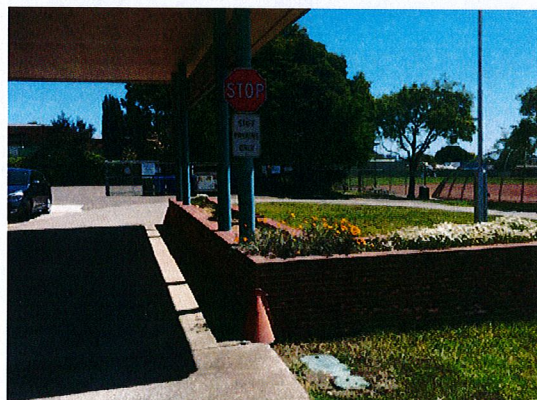
Most of the planting around the site is old, outdated, and is a mix of medium and high water use plants. There is a vast amount of lawn which requires lots of fertilizer, water, and personnel time to maintain

properly. There are several Liquidambar styraciflua trees around the property which produce seed pods which can be quite hazardous. It is recommended that the planting and irrigation be updated to a newer palette that is climate appropriate, low water use, and low maintenance. Lawn should only be used in select locations where classes will gather for group activities.

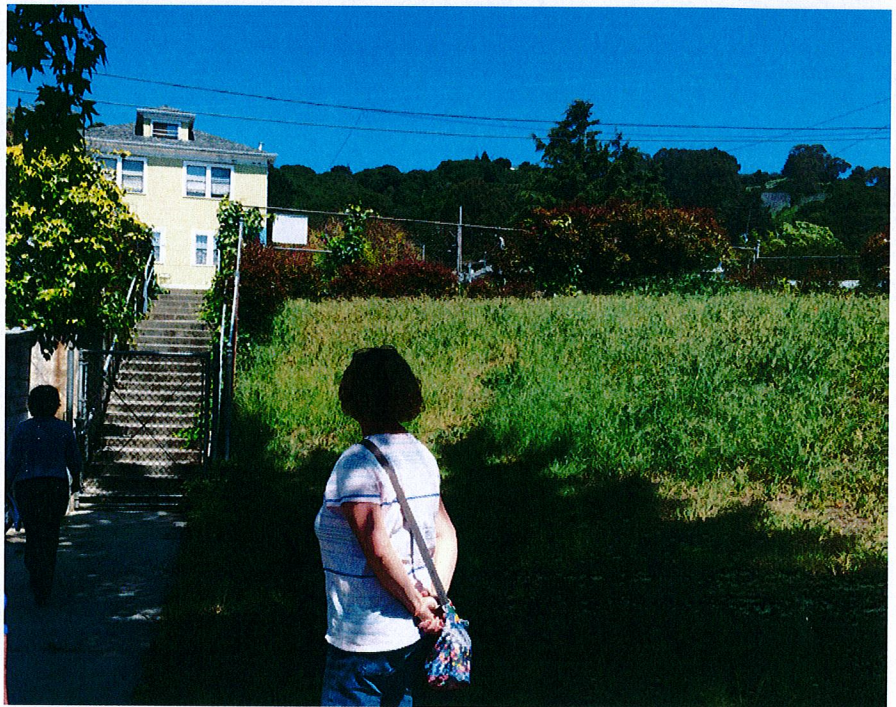
The stairs are in decent condition, but the handrails no longer meet code. As well, there is no alternate accessible entrance from Lawrence Street. The view corridor for the stairs is limited causing concern if the stairs are to be used as a main entry point. It is recommended that the view corridor be opened up by trimming the surrounding planting. As well, the adjacent slope is under utilized as it is too steep for playing, is planted with wild grasses and is unmaintained. This slope could easily be transformed into an amphitheater or seating area for group activities or waiting parents and siblings.
