STRUCTURAL EVALUATION OF
CHARLES ADAMS MIDDLE SCHOOL
WEST CONTRA COSTA UNIFIED SCHOOL DISTRICT
(WCCUSD)

October 17, 2002

DASSE Design Project No. 01B300X2

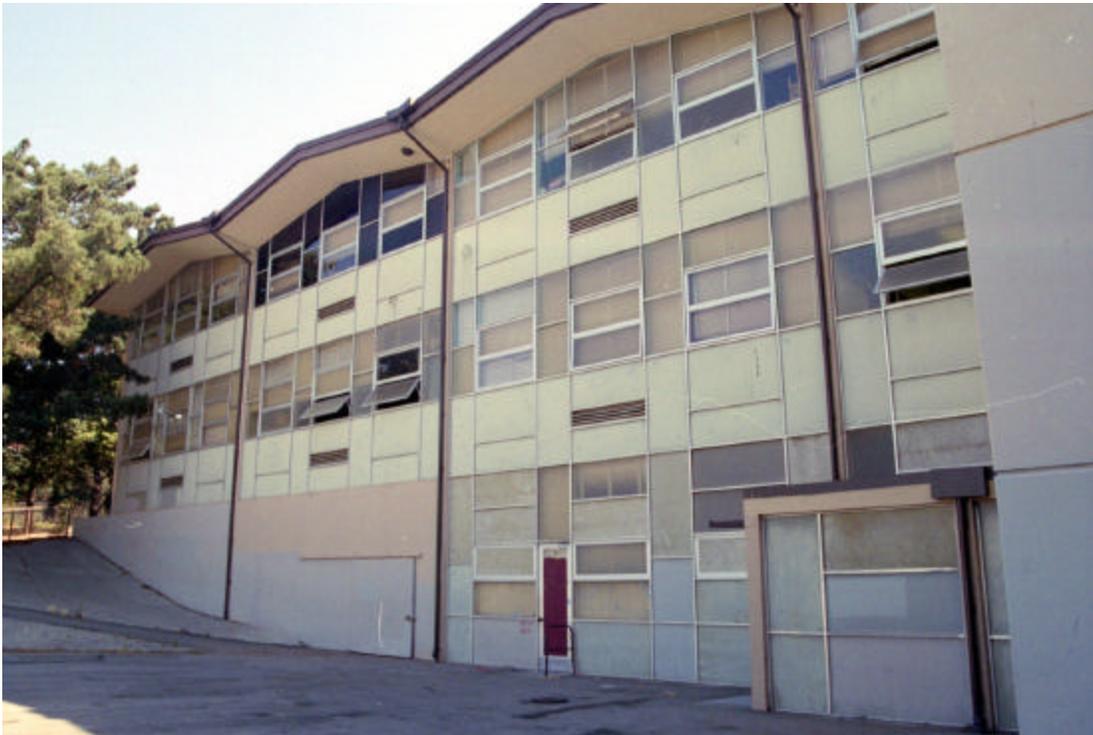
FIGURE 2: ACADEMIC BUILDING, WEST ELEVATION

The Academic building is constructed on a sloping site, where it is 2-story in front and 3-story in the rear. The east and west exterior walls have no lateral shear resisting elements (Figures 2, 3, 4, and 5). They are composed of glass, laminated panels, and windows. In the longitudinal (North-South) direction, the shear forces are resisted by a stud wall sheathed with plywood. There were several major cracks in the plaster observed at the wall lintels and this could be an indication of excessive drift the building experienced during previous earthquakes. Moreover, all the joints between this stud wall and the cross concrete walls show wide cracks in the plaster as a sign of lack of attachment between the stud walls and the concrete walls (Figures 16 and 17). Having only one shear wall in one direction would force the diaphragm to resist lateral forces in torsion. This results in overstressing it and leads to large drift.

2.	Provide new Chevron bracing in 2 bays in the east wall and in 3 bays in the west wall for the 2 nd and 3 rd levels of the Academic building.	1.1	1,2, 3, & 4

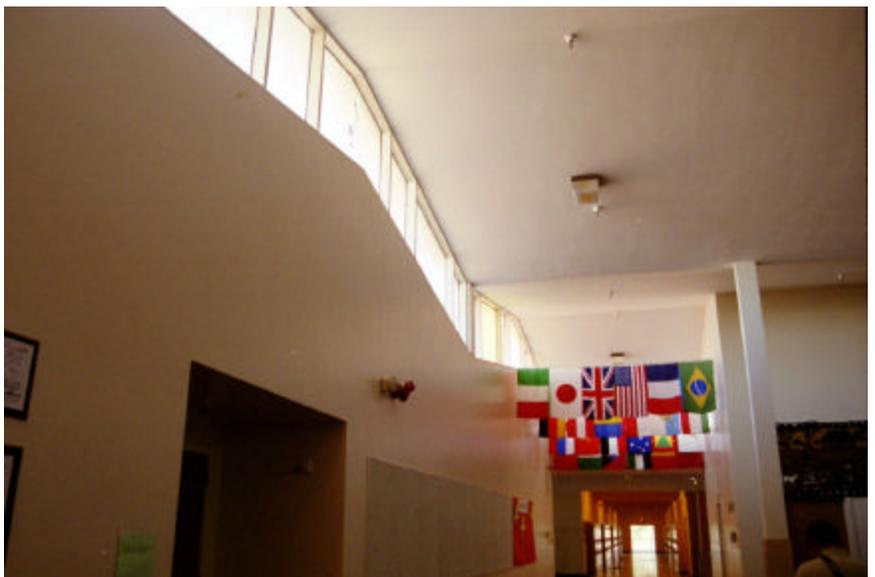
FIGURE 7: ACADEMIC BUILDING, LIBRARY CLEAR STORY

In the longitudinal (North-South) lateral direction, the library roof is supported by concrete wall on one side and the other side is a Clerestory (Figure 7), for which the diaphragm is subjected to torsion. The rest of the roof is supported by a stud wall sheathed with plywood on grid line 7. The central area (at the offices) is supported by two stud shear walls which discontinue at the 2nd floor. The 3rd floor is supported by the stud shear wall on grid line 7 except that the center area (at the offices) is supported also by stud shear wall on grid line 8.8 which discontinues at the 1st floor. The 2nd floor is supported by the foundation on one side and by the three concrete walls on grid lines 10 and 11. The 3rd floor diaphragm has to transfer the shear from the two discontinued stud shear walls at the library to the wall below due to plan offset. The 2nd floor diaphragm has to transfer the shear from the two discontinued stud shear wall at grid line 8.8 the wall below due to plan offset. This is a potential deficiency that could lead to a life safety hazard.

3.	In the Academic building, the transverse (east-west) direction shear walls are overstressed in shear at the 3 rd and 2 nd levels.
4.	In the Academic building, at the Clerestory, excessive story drift is expected at the glass window.

4.	Provide a new Chevron bracing in the library window at the Clerestory.	1.9	5
5.	Provide adequate anchorage at the concrete walls on grid lines I and O at the roof, at the wall on grid line 3 at the roof and the 3 rd floor, and for the walls on grid lines 10 and 11 at the 2 nd floor. Provide cross ties for the diaphragms in those areas at the straight sheathing splice.	1.5	N/A

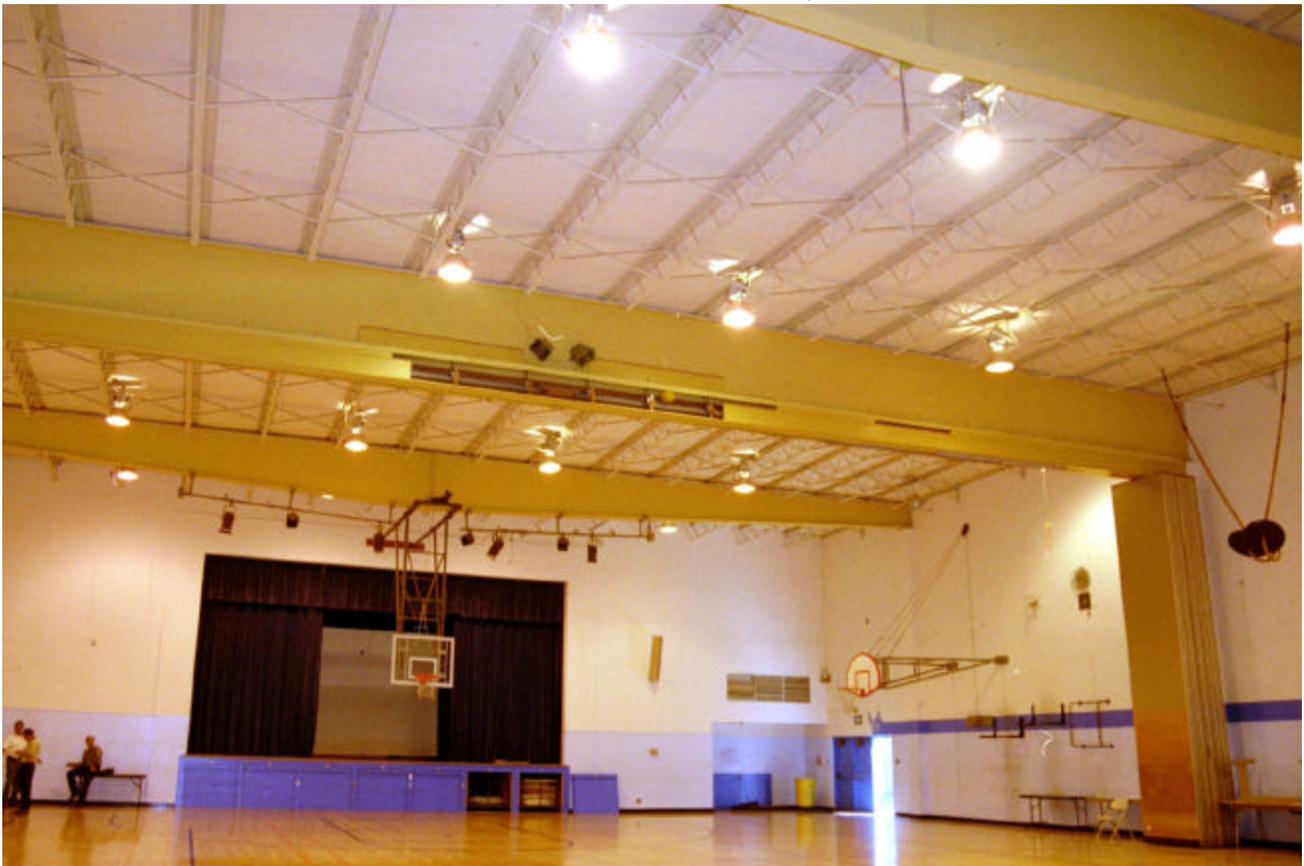
FIGURE 9: GYMNASIUM BUILDING

The one story Gymnasium building is constructed on a level lot. It has steel girders spanning 86' supported on concrete pilasters and supporting steel joists (Figure 9). The exterior cast-in-place concrete walls on four sides appear to be in good condition (Figure 8). A small wall separation was observed between the interior stage stud wall and the exterior concrete wall where some roof leak damage was also observed. The steel joists were design-built type, therefore, not all details appeared in the drawings, such as the bridging.

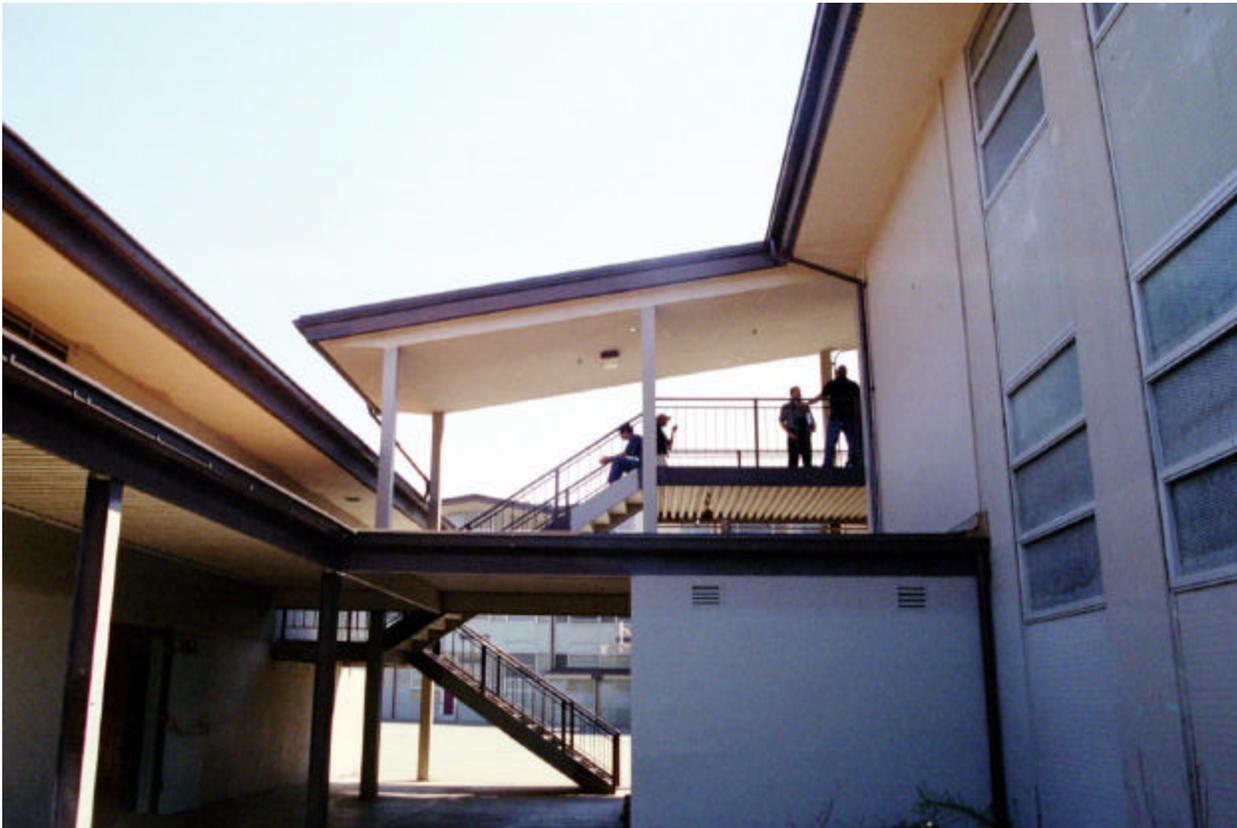
The General Arts building lateral system is wood shear wall with plywood sheathing. The roof is supported with shear walls on 4 sides, but a large portion of the north and south walls has openings. The 2nd floor is supported transversely with 3 walls and longitudinally with 2 walls. The west wall has many openings (Figures 12 and 13).

FIGURE 12: STAIRS BETWEEN MUSIC BUILDING (LEFT) AND GENERAL ARTS BUILDING (RIGHT)

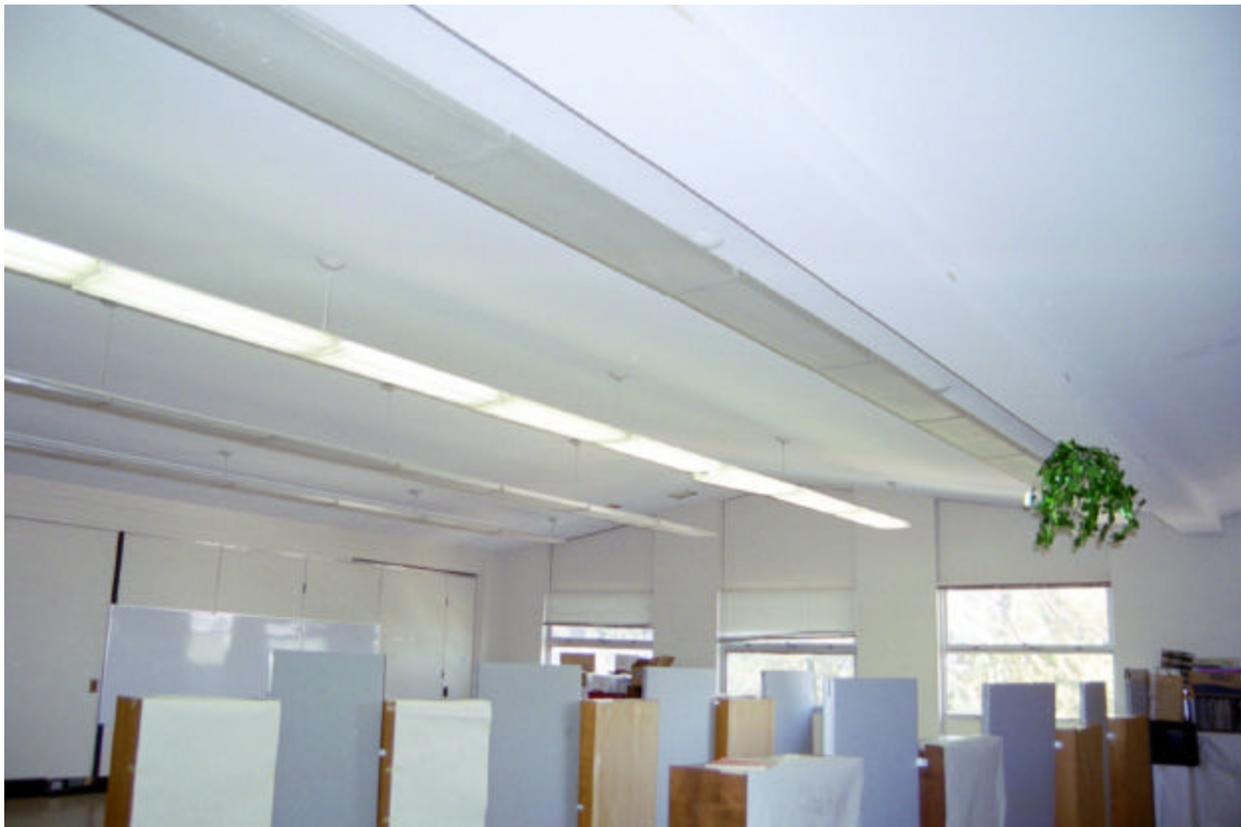
FIGURE 13: GENERAL ARTS BUILDING, WEST WALL, 2ND FLOOR

7.	Provide plywood sheathing on the inside of the west wall for the 1 st level.	1.5	6
8.	Provide plywood sheathing on the two partition walls near J and O and tie these partitions adequately to top and bottom sheathing. Eliminate one window in the south and in the north walls. Add a layer of plywood sheathing to the shear wall on grid line L.	1.5	6 & 7

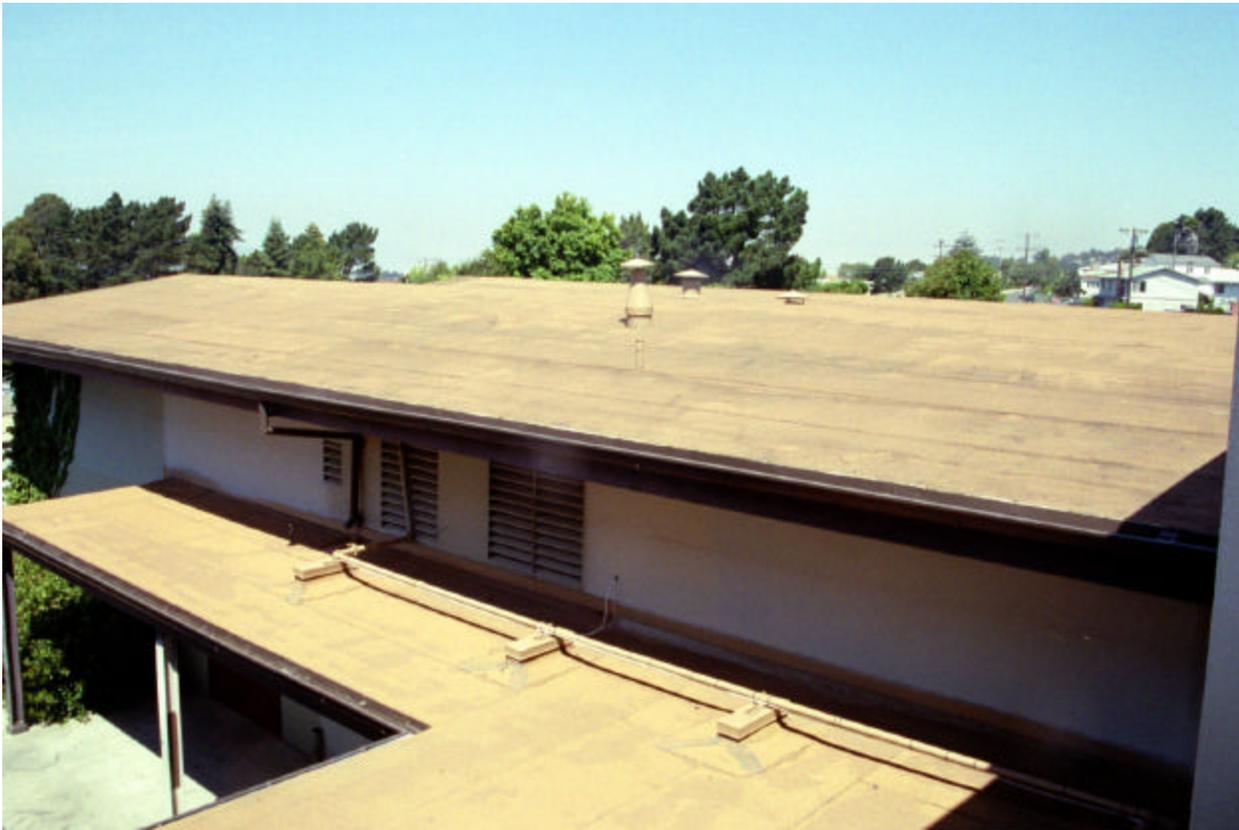
FIGURE 14: MUSIC BUILDING, SOUTH WALL

The Music building lateral system is bearing concrete shear walls. All concrete walls are 8" thick and approximately 17' high (Figures 14 and 15). The wood mezzanine is laterally supported in one direction with wood shear walls and in the other direction with the building concrete walls.

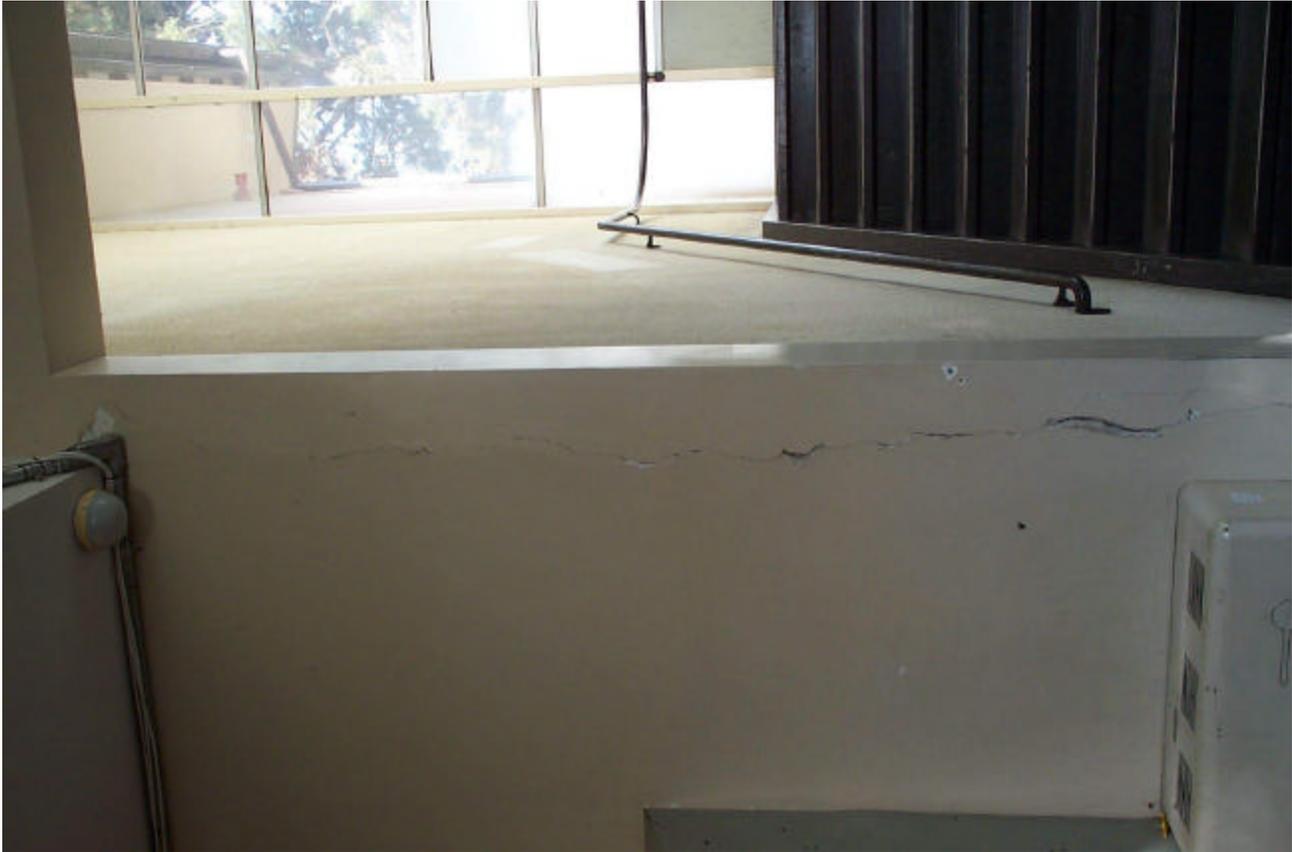
FIGURE 16: ACADEMIC BUILDING, END CONCRETE/STUD WALL SEPARATION

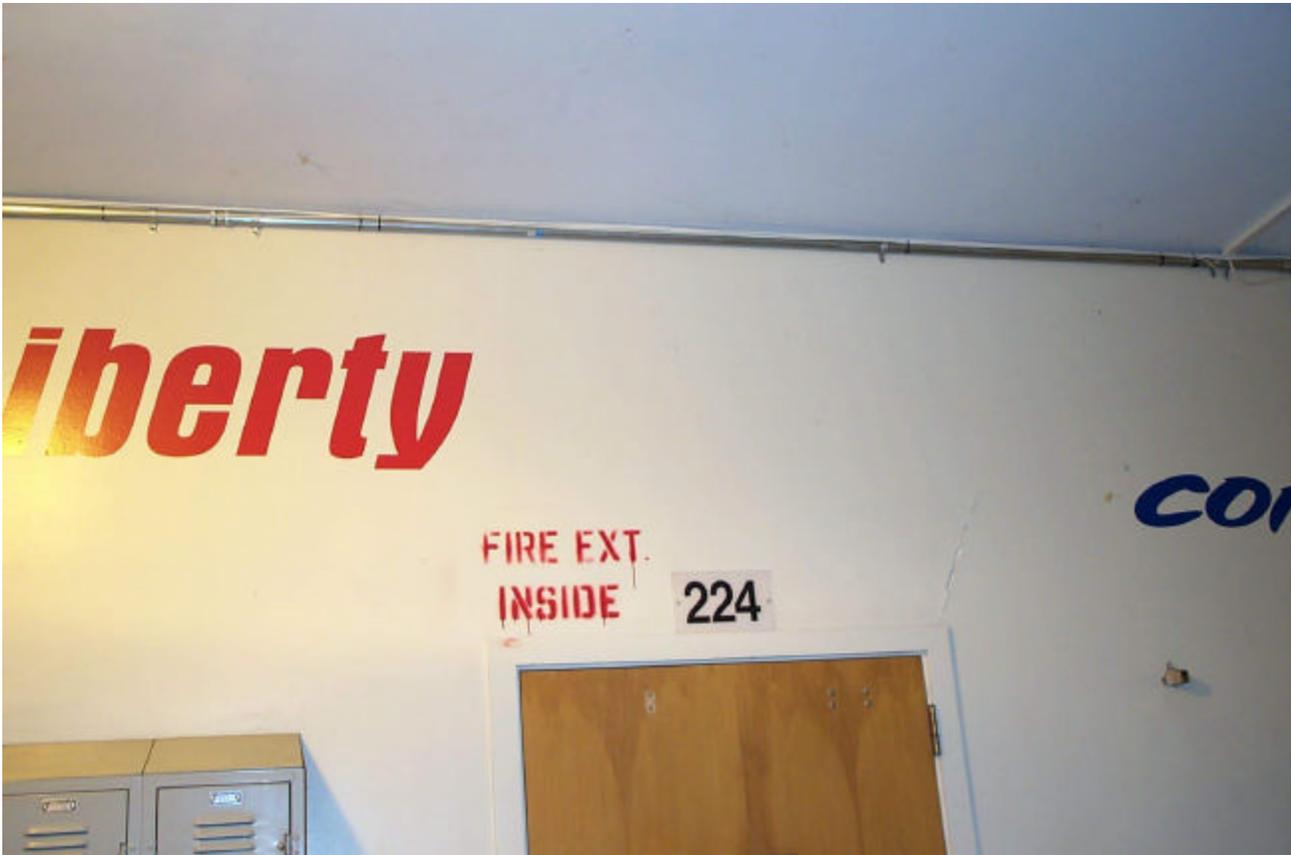
FIGURE 17: ACADEMIC BUILDING, CENTER STUD WALL LINTEL PLASTER CRACKS
