STRUCTURAL EVALUATION OF  
EL CERRITO HIGH SCHOOL  
WESTERN CONTRA COSTA UNIFIED SCHOOL DISTRICT  
(WCCUSD)

**October 17, 2002**

**DASSE Design Project No. 01B300 X2**

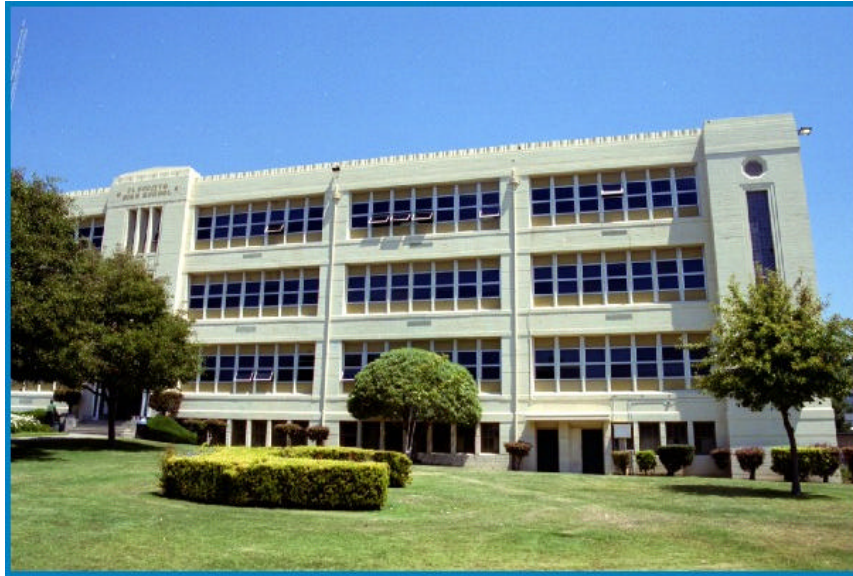
Figure 2: Unit A, Main Classroom Building

The Main Classroom building, Unit A, is a large three story reinforced concrete building with a partial basement constructed as part of the original school in 1938. The building is in good repair from a structural standpoint, however, its method of construction is now dated. It is a long and narrow non-ductile concrete building relying on exterior pier walls mostly for seismic resistance. The end walls are mostly solid and there are some interior concrete walls mostly located at stairways.

<p>shear resistance. Non-ductile concrete pier walls do not have adequate ties to avoid brittle shear failure.</p> <p>The two story covered walkway between Unit A and Unit C needs additional transverse seismic bracing to strengthen the structure.</p>

Item	Recommended Remediation	Priority	Drawing Number
1.	Unit A, Main Classroom Building. Building requires a complete seismic retrofit with addition of new concrete shear walls and associated collector beams and footings. Concrete diaphragms are adequate with the addition of new shear wall elements.  Provide 2 new transverse concrete SMRF seismic frames in the two story walkway.	1.0	B1

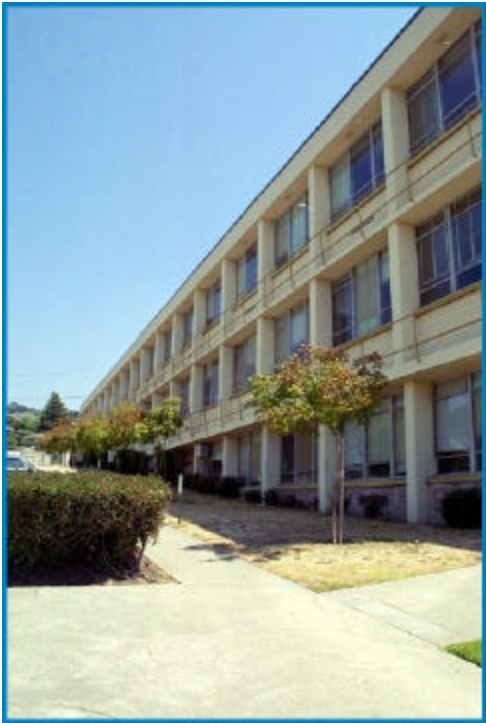
Figure 7: Unit C, Classroom Building, North Elevation

Unit C, another reinforced concrete classroom building relies on transverse moment frames and longitudinal shear walls for seismic stability. A north facing window wall has caused all of the longitudinal shear wall on that building face to be omitted, thus, the building only has longitudinal shear walls on the southern corridor side of the building. This will cause the building's seismic response to behave in a torsional manner and could have grave consequences. Additionally, the transverse concrete moment frames do not have adequate ductile detailing and could experience brittle and sudden non-ductile shear failures prior to exhibiting ductile bending

behavior. This building is a non-ductile concrete building without adequate shear strength by current standards and should be retrofitted.

The building has a three sided seismic bracing system due to the lack of shear bracing on the window wall side (north side). The transverse building moment frames are not ductile and could fail in a brittle shear manner prior to resisting code prescribed seismic forces or loads imposed by a major seismic event. Additionally, the building is built into a hillside and the east end of the building is two stories as the west end of the building is three stories.

3.	Unit C, Classroom Building. The building has a lack of adequate seismic shear resistance. Non-ductile concrete moment frames do not have adequate ties to avoid brittle shear failure.

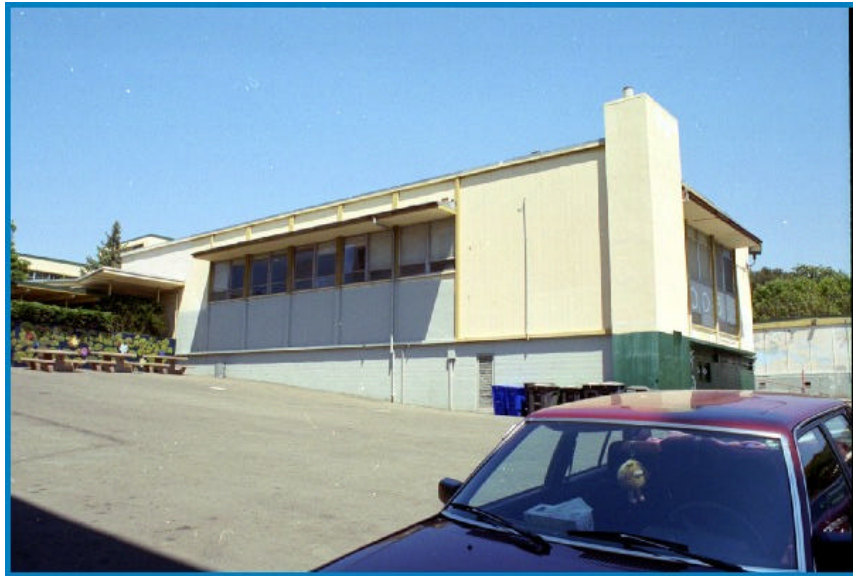
Figure 10: Unit D, Cafeteria, West Elevation

Unit D, the Cafeteria is a large kitchen and cafeteria building constructed with wood framing and on a concrete base. The roof utilizes steel beams spanning the width of the open room with infill roof joists and diagonal sheathing at the roof and shear walls. The concrete foundation utilizes spread footings and incorporates a boiler room at the southern end where the hillside slopes away. The Cafeteria building has an abundance of windows and thus does not have an adequate amount of wood shear walls. The lack of wood shear walls and the lengths that the roof diaphragm spans mean that the building is vulnerable to partial collapse if the building were subjected to a major earthquake.

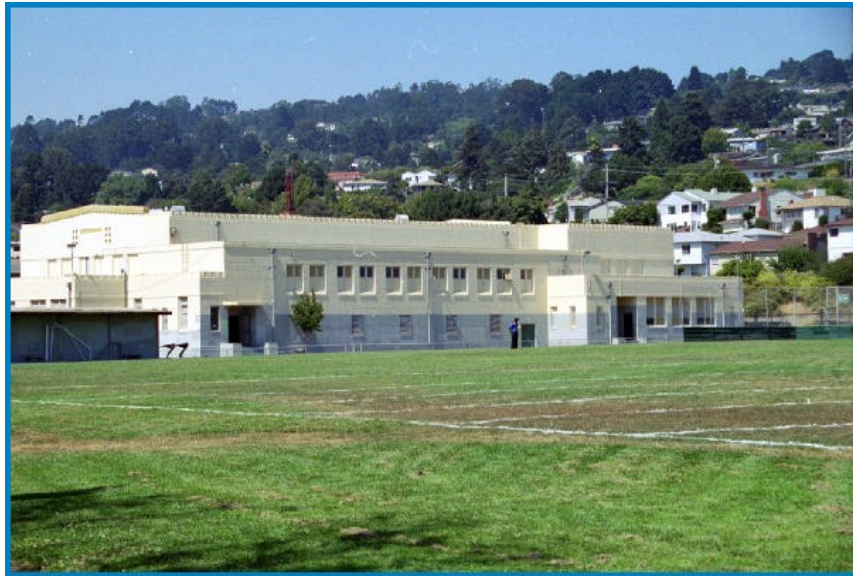
Figure 14: Unit E, Gymnasium, South Elevation

Both the gymnasium and Locked addition have adequate concrete or CMU walls to resist code level seismic forces. However, this complex building is found to not have adequate wall / roof connections for wall out-of-plane seismic forces nor adequate diaphragm shear strength. The consequences are that during a major seismic event, the walls could pull away from the roof

5.	Unit E, Main Gymnasium. Building requires a complete seismic retrofit of the roof diaphragm with the addition of angle cross ties and roof-to-wall ties. Trusses will require replacement or strengthening to support added weight of diaphragm bracing.	1.1	B5, B6

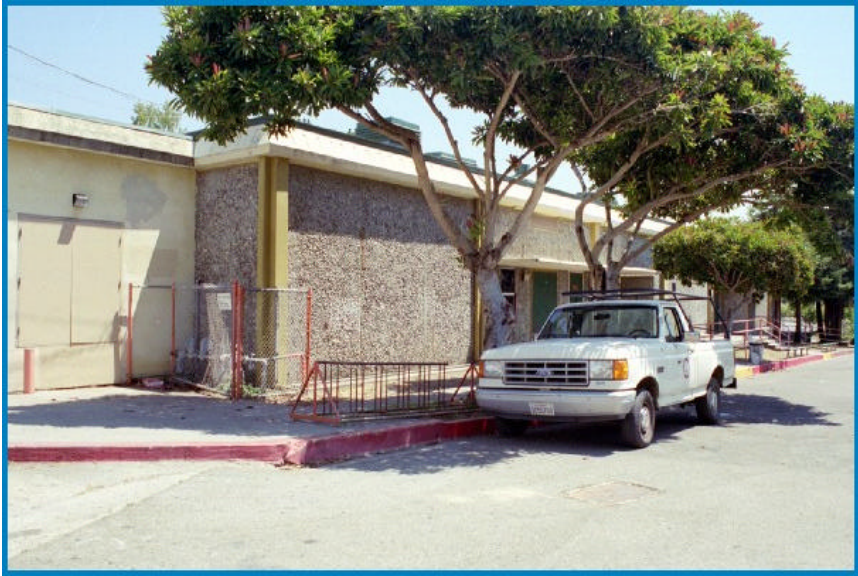
Figure 18: Unit F, Drama and Music Building, West Elevation

This building has an ample amount of concrete wall for use as shear walls. However, this class of tilt up building has been found to not have adequate wall / roof connections for wall out-of-plane seismic forces. The consequences are that during a major seismic event, the walls could pull away from the roof framing and allow partial collapse of the roof structure and/or the falling away and collapse of the heavy concrete walls.

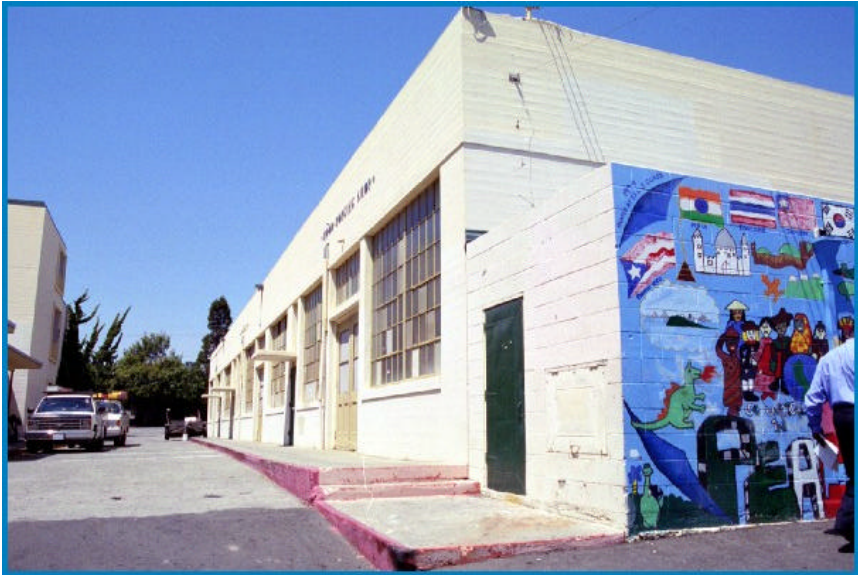
Figure 19: Unit G, Shops Building, West Elevation

Unit G, the Shop Building is a concrete walled building with a steel trussed roof. This is one of three original buildings on campus. Roof joists infill between roof trusses and straight sheathing provides the roof decking. Cross braced tie rods are provided in the truss framing to act as the roof diaphragm. The building has a slab on grade floor and a spread footing foundation system. The concrete walls are well detailed and are quite strong. The apparent seismic deficiency is the span of the roof diaphragm and the concrete wall ties at the roof level. However, the roof diaphragm construction poses the life safety threat that the concrete walls could pull away from the roof and exhibit a partial collapse during a major seismic event.

Additionally, this building is found to not have adequate wall / roof connections for wall out-of-plane seismic forces. The consequences are that during a major seismic event, the walls could pull away from the roof framing and allow partial collapse of the roof structure and/or the falling away and collapse of the heavy concrete walls.

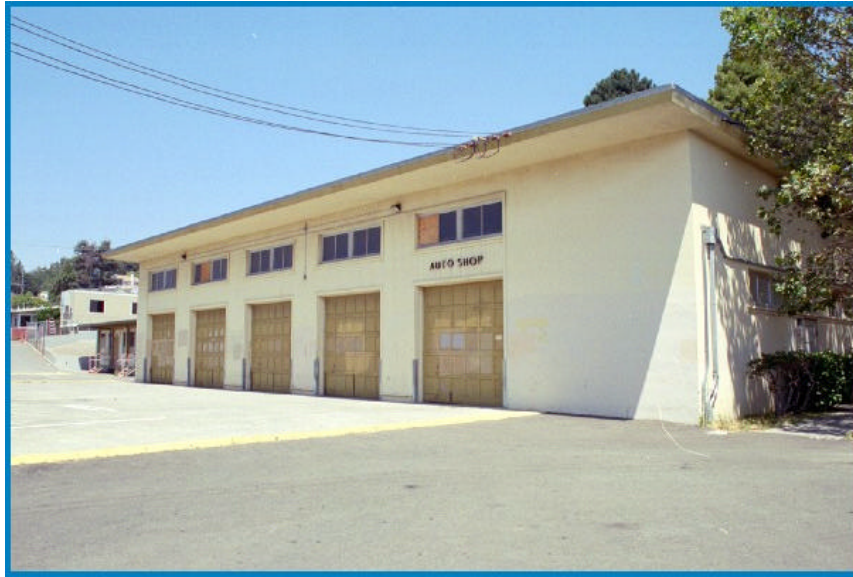
Figure 20: Unit H, Automobile Shop Building, West Elevation

Unit H, the Automobile Shop is a wood framed building with a steel trussed roof. The roof has steel tie rods in the diaphragm to act as a roof diaphragm. The building has many door and window openings and does not have adequate amounts of wood shear walls.

The building is severely lacking for adequate wood shear walls (currently of diagonal sheathing). If subjected to major earthquake shaking, this building could experience a collapse of the wood framed structure caused by a lack of shear walls.

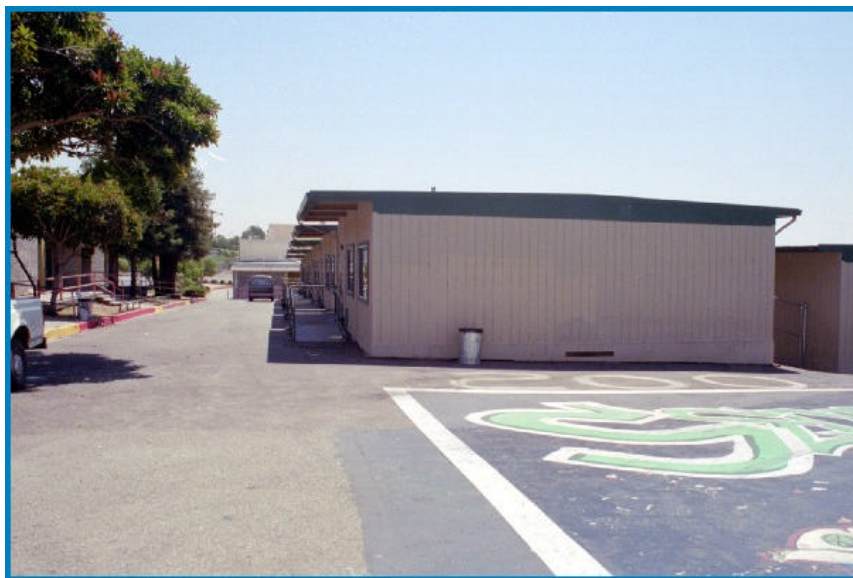
Figure 21: Site Portable Buildings

In past earthquakes, the predominant damage displayed by portable buildings has been associated with the buildings moving off of their foundations and suffering damage as a result. The portables observed during our site visits tend to have the floor levels close to the ground,

thus the damage resulting from buildings coming off of their foundation is expected to be minimal. The life safety risk of occupants would be posed from the potential of falling 3 feet to the existing grade levels during strong earthquake ground shaking. Falling hazards from tall cabinets or bookshelves could pose a greater life safety hazard than building movement. The foundation piers supporting the portable buildings tend to be short; thus the damage due to the supports punching up through the floor if the portable were to come off of its foundation is not expected to be excessive.

Because of their light frame wood construction and the fact that they were constructed to be transported, the portable classrooms are not in general expected to be life safety collapse hazards. In some cases the portables rest directly on the ground and though not anchored to the ground or a foundation system could only slide a small amount. In these instances the building could slide horizontally, but we do not expect excessive damage or life safety hazards posed by structural collapse of roofs.
