STRUCTURAL EVALUATION OF
GOMPERS CONTINUATION HIGH SCHOOL
WEST CONTRA COSTA UNIFIED SCHOOL DISTRICT
(WCCUSD)

WLC Architects
Kaiser Building
1300 Potrero Avenue
Richmond, CA 94804

DASSE Design, Inc.
33 New Montgomery Street #850
San Francisco, CA 94105
(415) 243-8400

October 17, 2002

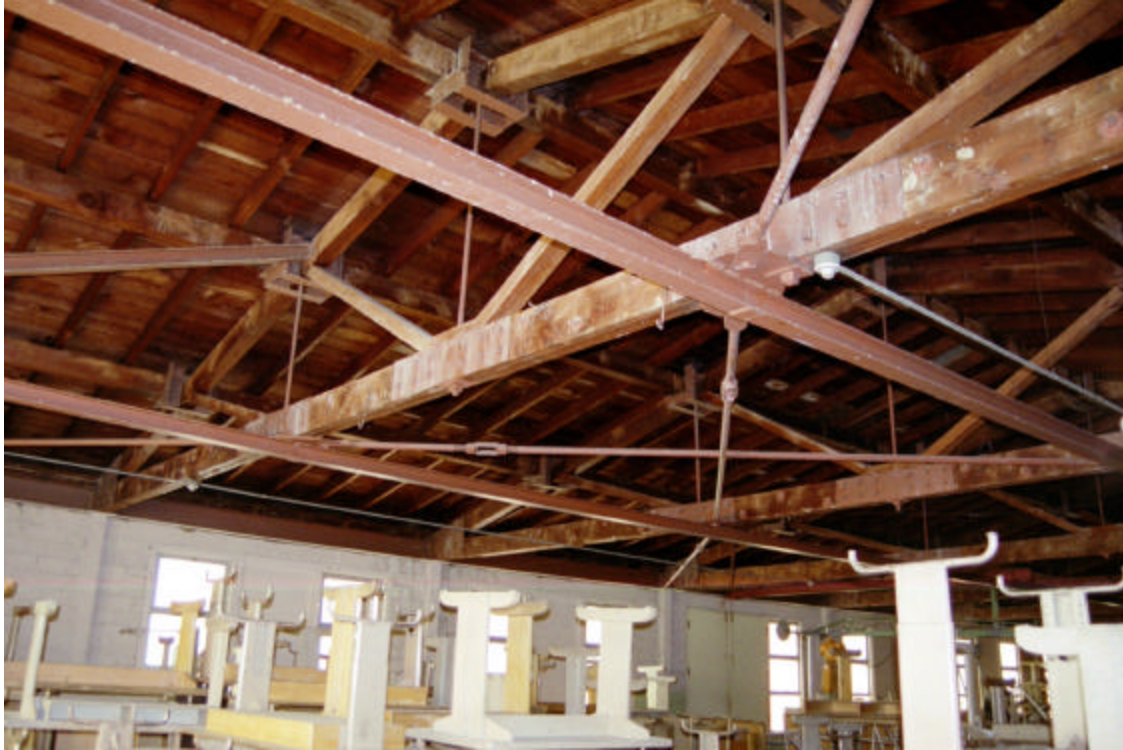
There are no drawings available for the Gymnasium building and its attached structures. The information presented is based on the site visit observations only without the removal of the finishes or destructive testing. It appears that the second floor deck has deteriorated and it is a life safety hazard. The existing lateral resisting system provide a capacity far below the required capacity to resist the design earthquake. This is a deficiency that could lead to a life safety hazard. The unreinforced masonry tile walls are not anchored to the roof and floor diaphragms properly and the wall tiles could shatter between anchors. This is a deficiency that could lead to a life safety hazard. The roof diaphragm has straight sheathing that does not have the capacity to transfer the shear to the vertical elements. This is a potential deficiency that could lead to a life safety hazard. In general, it is very expensive to retrofit this unreinforced masonry building and upgrade the lateral resisting elements to be able to resist the design earthquake.

Figure 18: Gymnasium Building, interior exposed roof framing

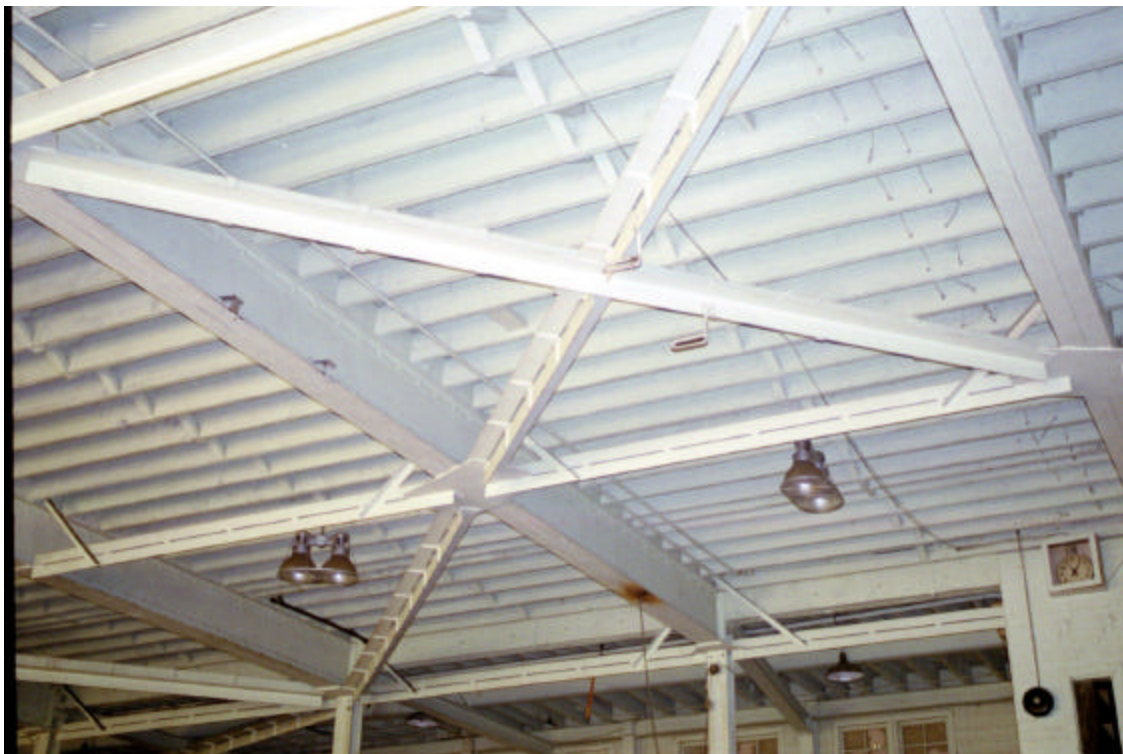
Figure 19: Gymnasium Building, interior exposed floor framing

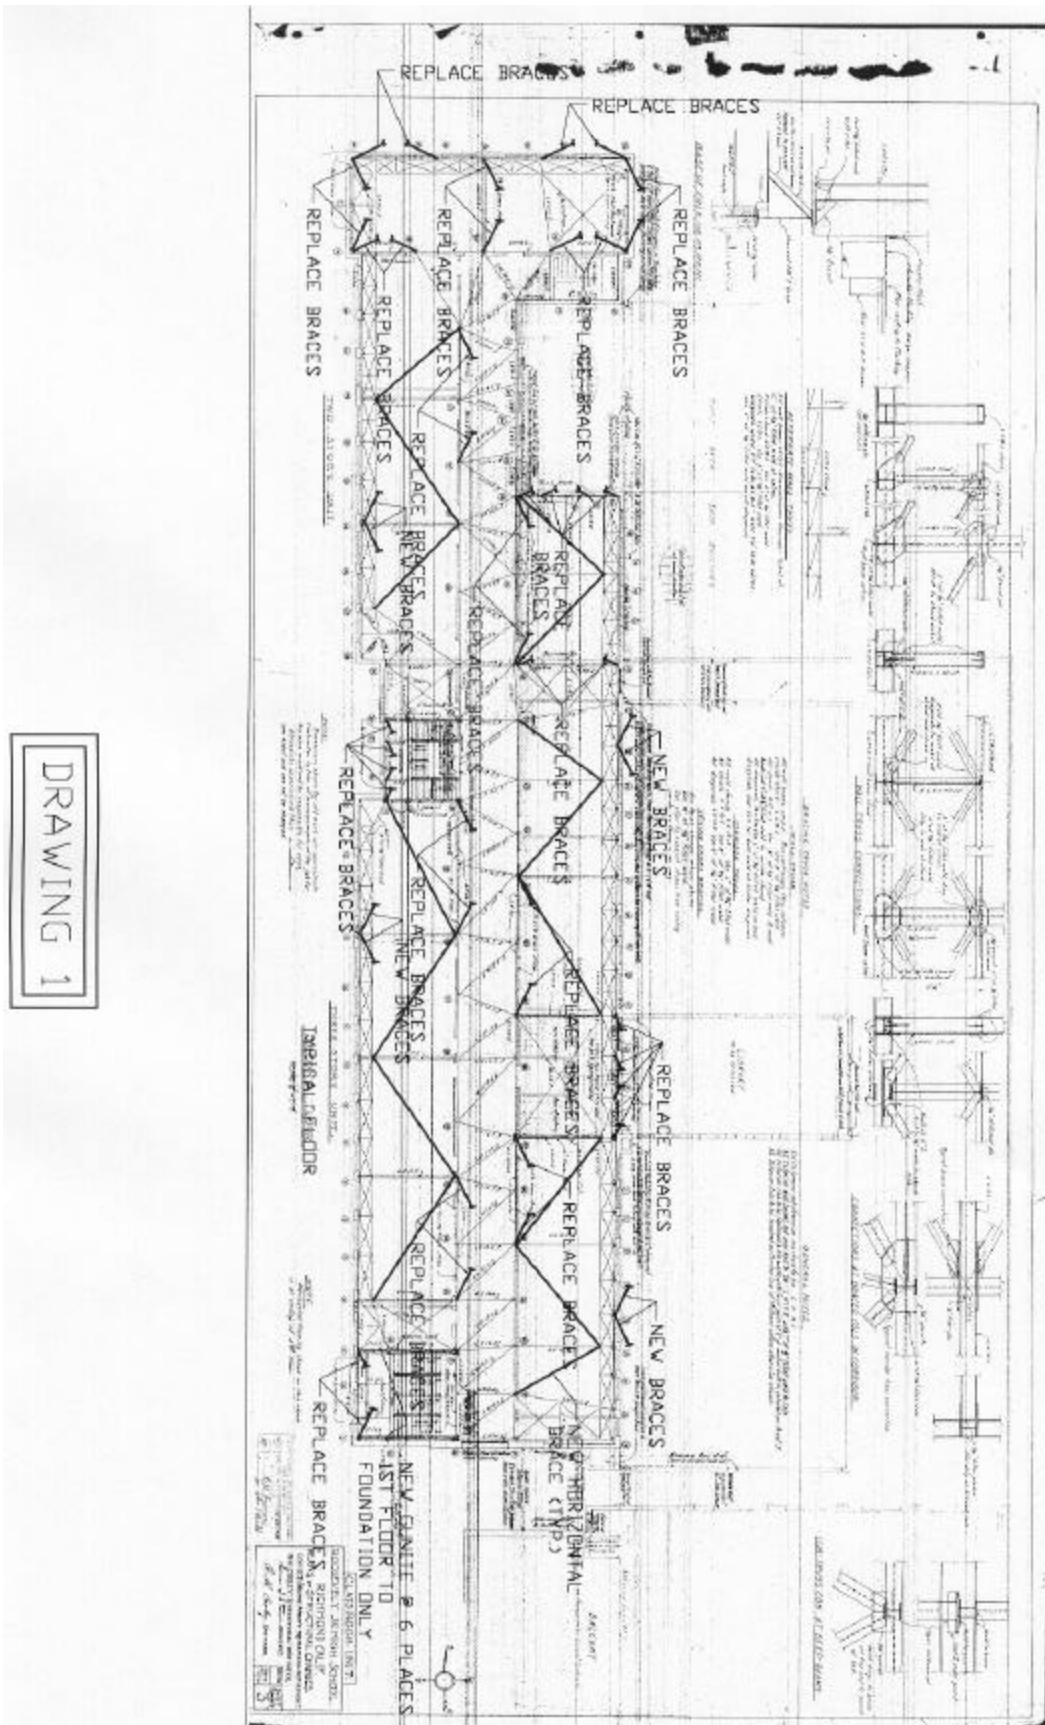
DRAWING 1

Item	Building Structural Deficiencies
1.	In the Classroom Building at the first floor level, the six concrete shear walls at the 3 stairways are not adequate in shear.

2.	In the Classroom Building, the tension only braces for this building could amplify the response and cause high drift for the “tile” walls. During the design earthquake, the braces would be overstressed as well as the brace connections.

3.	In the Classroom Building, the steel truss diaphragm is not capable of transferring the forces to the interior frames and the shear walls.
4.	In the Classroom Building, the roof straight sheathing is incapable of transferring the shear to the lateral resisting elements.

Item	Recommended Remediation	Priority	Drawing Number
1.	Add Shotcrete to one side of these walls.	1.5	1
2.	Provide new Chevron or diagonal braces or add on existing straps in the existing frames.	1.0	1
3.	Add diagonal braces at the steel truss diaphragm.	1.5	1
4.	Provide plywood sheathing over existing straight sheathing.	1.7	
5.	Perform tests to determine the as built condition.	1.0	
6.	Provide adequate anchorage at all walls by adding more horizontal braces at the attic level.	1.7	2
7.	Provide plywood sheathing over existing straight sheathing.	1.7	
8.	Perform tests to determine the as built condition.	1.0	
9.	Demolish existing Gymnasium building and its attached structures.	1.5	
10.	Remove existing walkway cover at the Gymnasium building attachment structures, and provide slotted connections at the Classroom building.	1.5

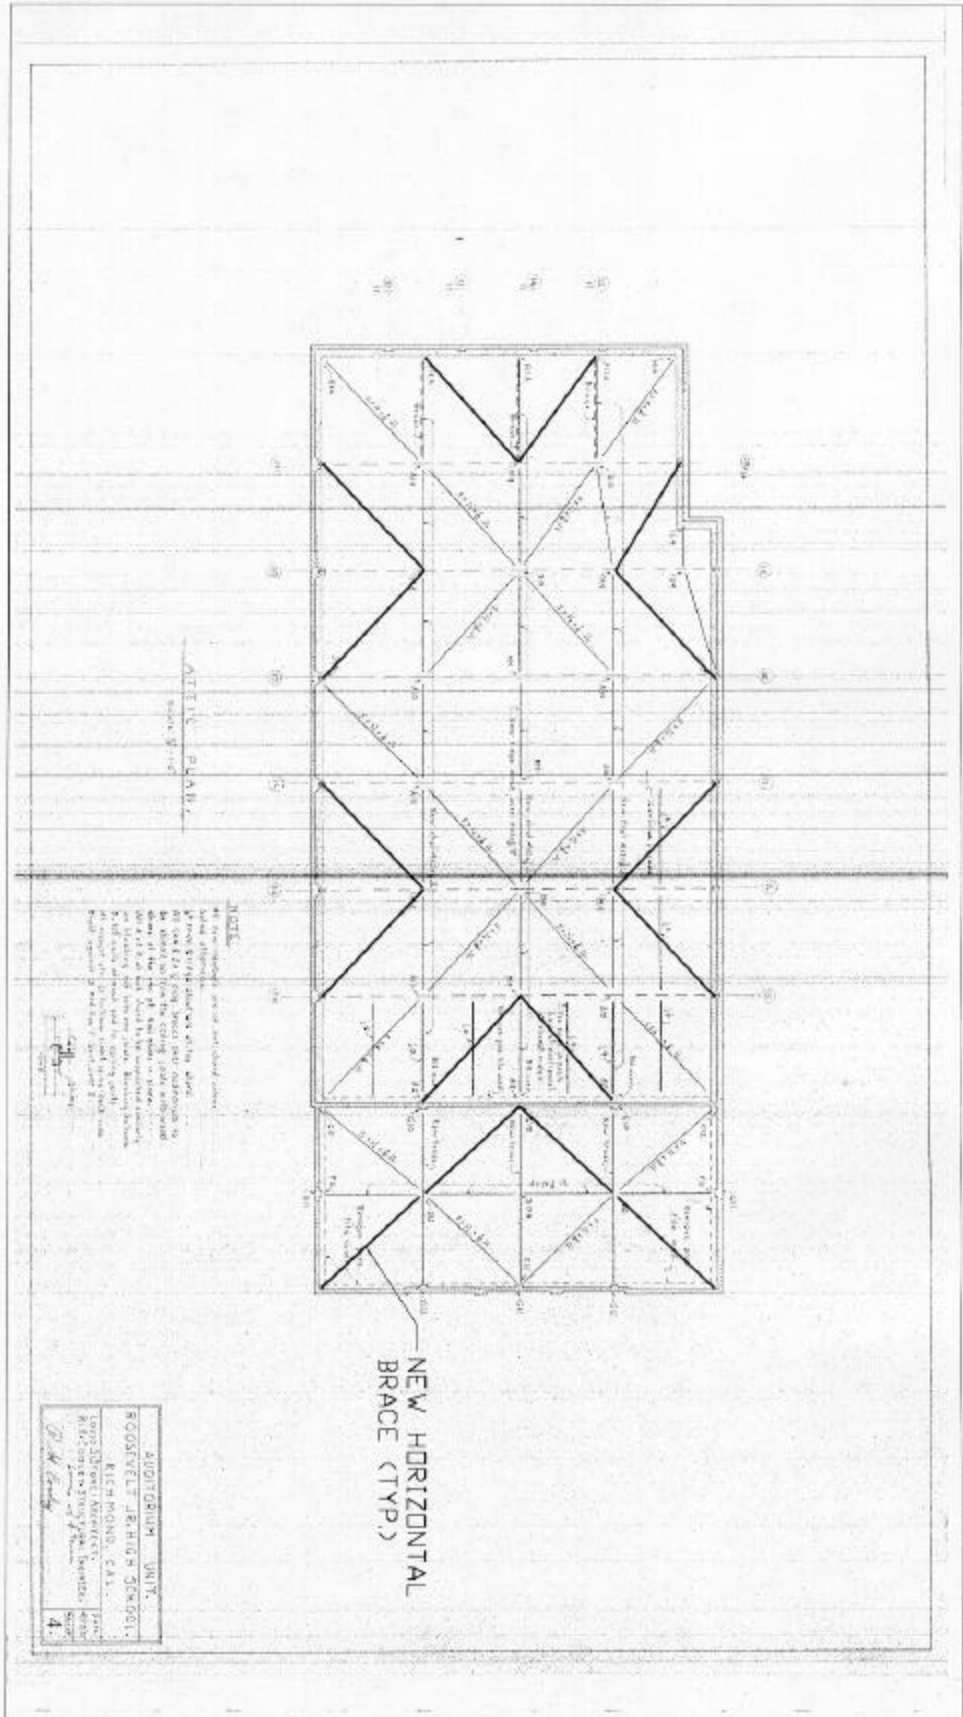
DRAWING 2

5.	In the Classroom Building, there is not enough information about the as built condition.
6.	In the Auditorium Building, the walls anchorage to the roof is not sufficient and the shear transfer from the horizontal truss to the lateral resisting elements is inadequate.

7.	In the Auditorium Building, the roof strait sheathing is incapable of transferring the shear to the lateral resisting elements.
8.	In the Auditorium Building, there is not enough information about the as built condition.
9.	The Gymnasium Building was abandoned. Deterioration was apparent in most of the building. Lateral resisting system is very week, lack of wall tile anchorage, and lack of proper roof shear transfer to the lateral system. The presence of Unreinforced Masonry tiles.
10.	The Corridor Walkway is rigidly connecting three independent structures.
