STRUCTURAL EVALUATION OF
HARBOUR WAY DAY ACADEMY
WEST CONTRA COSTA UNIFIED SCHOOL DISTRICT
(WCCUSD)

DASSE Design, Inc.
33 New Montgomery Street #850
San Francisco, CA 94105
(415) 243-8400

October 17, 2002

DASSE Design Project No. 01B300x2

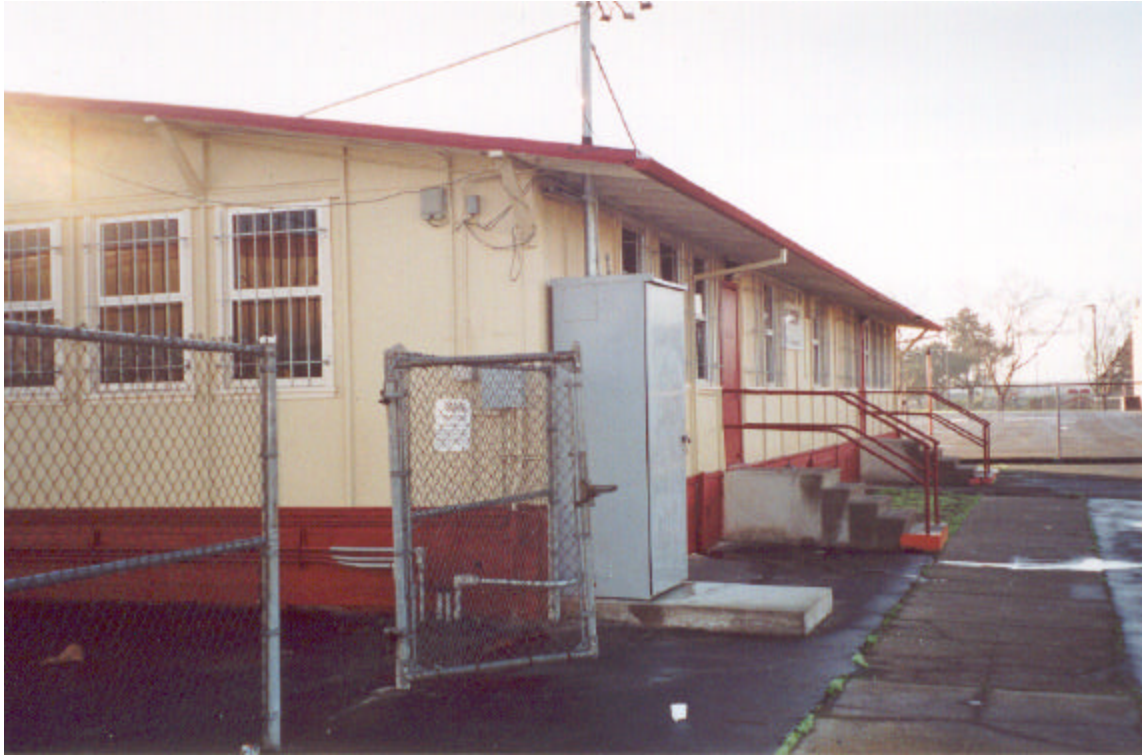
Figure 2: Front and Side of Main Building

The main building is a one-story portable wood-framed structure with wood siding (see figures 2-5). There are multiple window openings on all four sides of the building. At the front face of the building, some of the windows have been infilled with plywood (see figure 3). The connection of the plywood infill to the building does not appear to be adequate to transfer seismic forces. The building sits on a short cripple wall that appears to have straight sheathing and will not be adequate to laterally support the building, the result of which could be that the building could fall off of its foundation. The building has built-up roofing and an acoustical tile ceiling (see figure 6). The ceiling in some portions of the main building is sagging noticeably.

Item	Building Structural Deficiencies
1.	The connection of main building to its foundation may be inadequate. Straight sheathing is inadequate to brace the cripple walls laterally.

Item	Recommended Remediation	Priority	Figure Number
1.	Verify existing conditions. Provide new sill bolts and plywood sheathing at cripple walls.	1.2	2, 4, 5

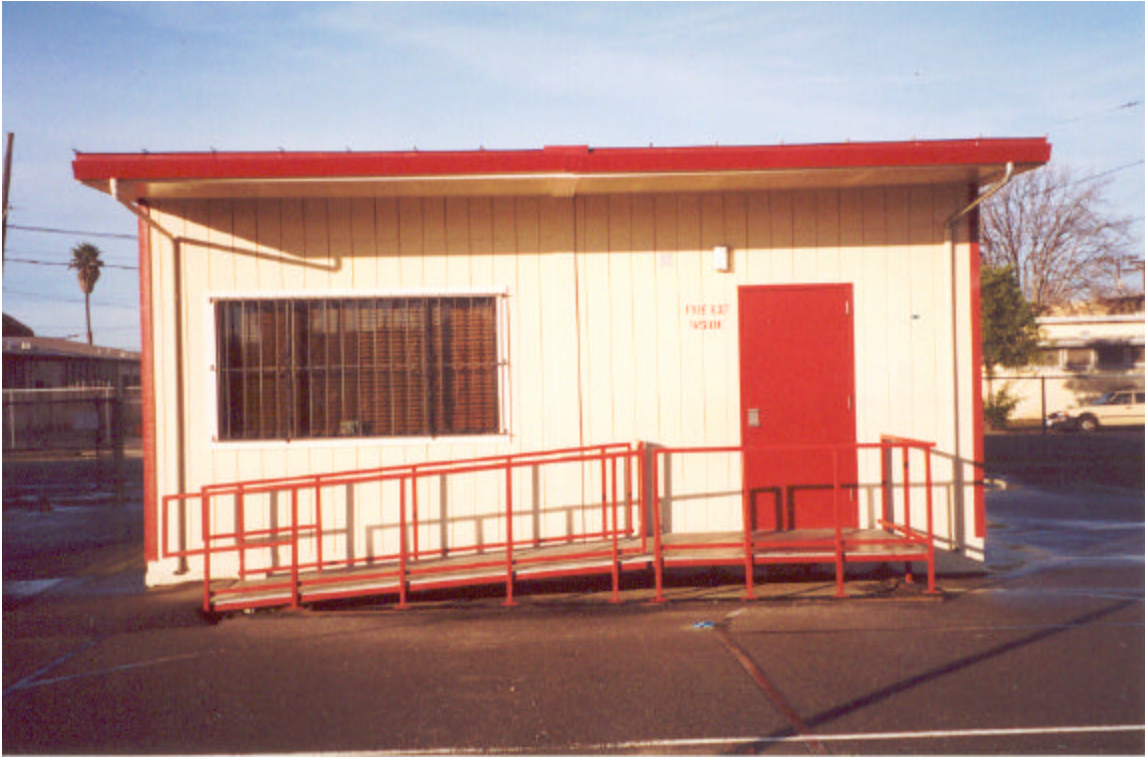
Figure 7: Front of Classroom Portable

The classroom portable is framed with sheet metal joists and studs. At the exterior of the building, there is metal roofing and T1-11 siding. The longitudinal walls do not have any openings. The openings in the transverse end walls do not appear to be excessive. There is a suspended T-bar ceiling throughout the interior.
