STRUCTURAL EVALUATION OF
JOHN F. KENNEDY HIGH SCHOOL
WEST CONTRA COSTA UNIFIED SCHOOL DISTRICT
(WCCUSD)

DASSE Design, Inc.
33 New Montgomery Street #850
San Francisco, CA 94105
(415) 243-8400

October 17, 2002

DASSE Design Project No. 01B300x2

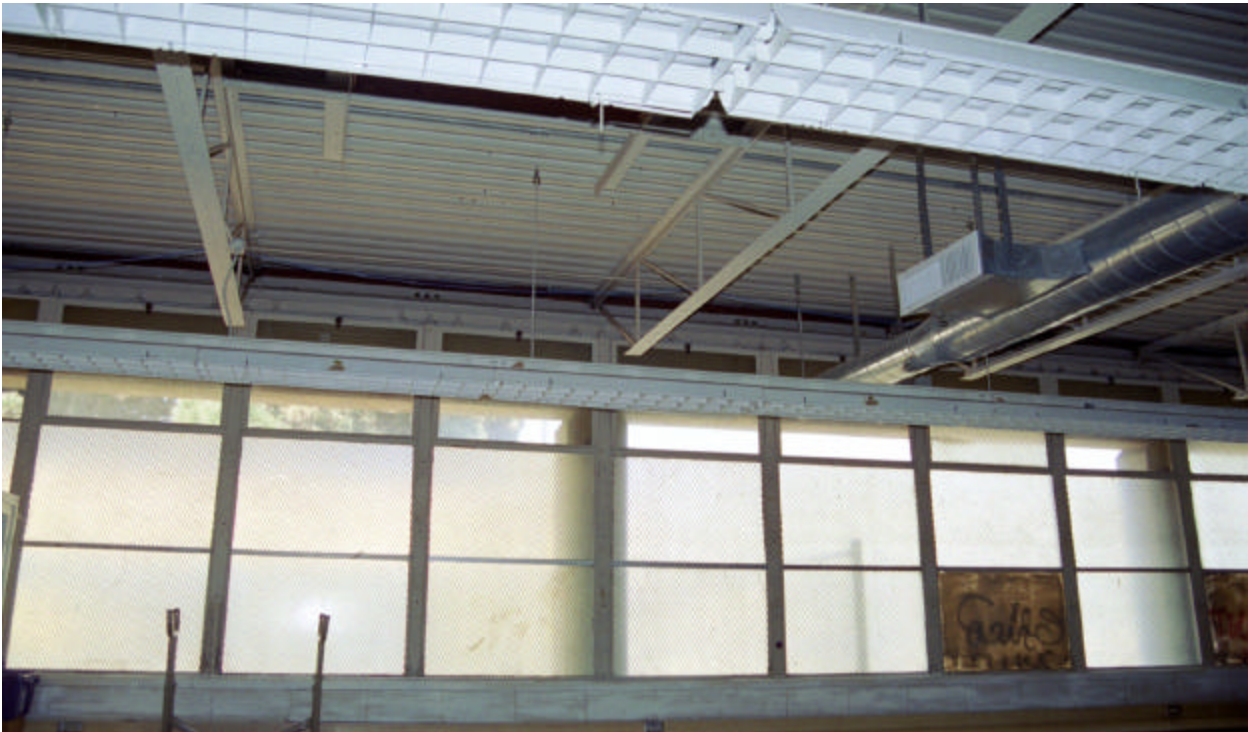
Figure 9: Roof Framing of Building IV

Building IV is called Arts, Crafts and Home-Making Building (see figure 7). This building was originally constructed in 1956 and some minor modifications were done such as adding partition walls in 1965. New covered walkways were added to the west and north side of the building in 1965. Minor modifications were performed in year 1998 to this building. The building has perimeter concrete walls with steel framing and metal deck at the roof. There are numerous openings on the south longitudinal wall of this building (see figure 8). The building has a metal deck roof with steel trusses supported on steel columns on one side and corridor shear walls on the other side (see figure 9).

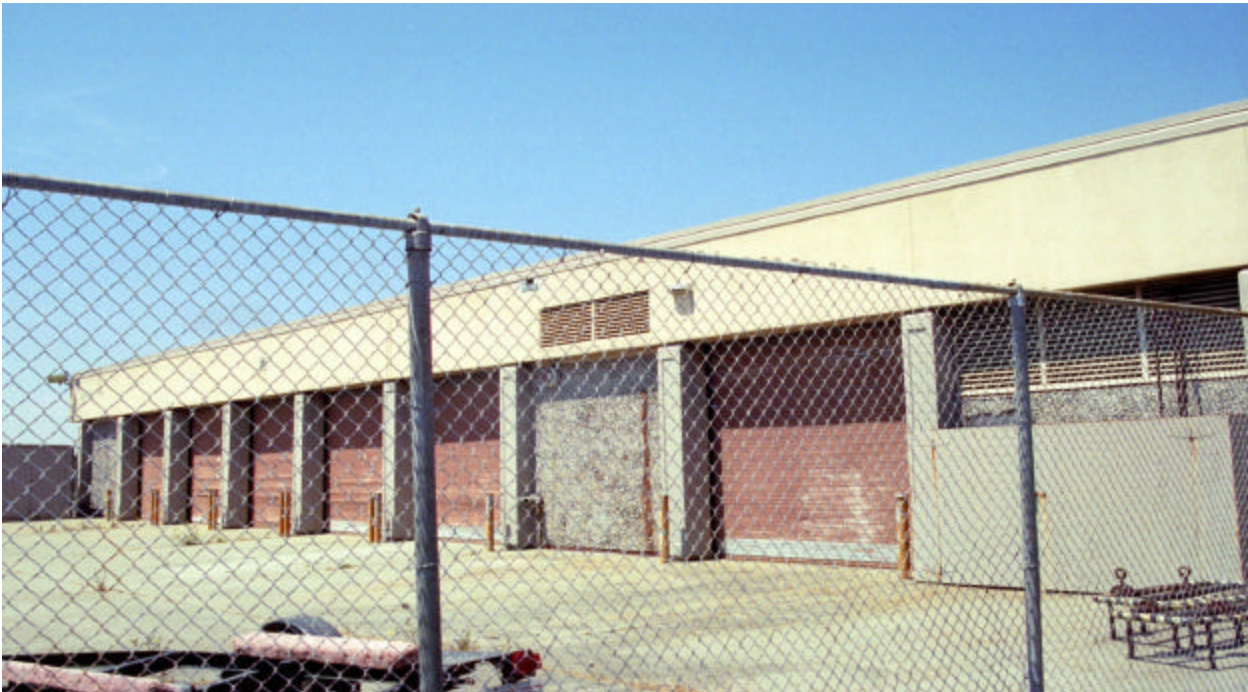
Figure 11: South Wall of Industrial Arts Building

Building VI is called the Industrial Arts building. It is a one story building with perimeter concrete walls and with wood framing at the roof and with plywood roof sheathing. There are numerous door and louver openings on the south wall (see figure 11). The exterior pre-cast

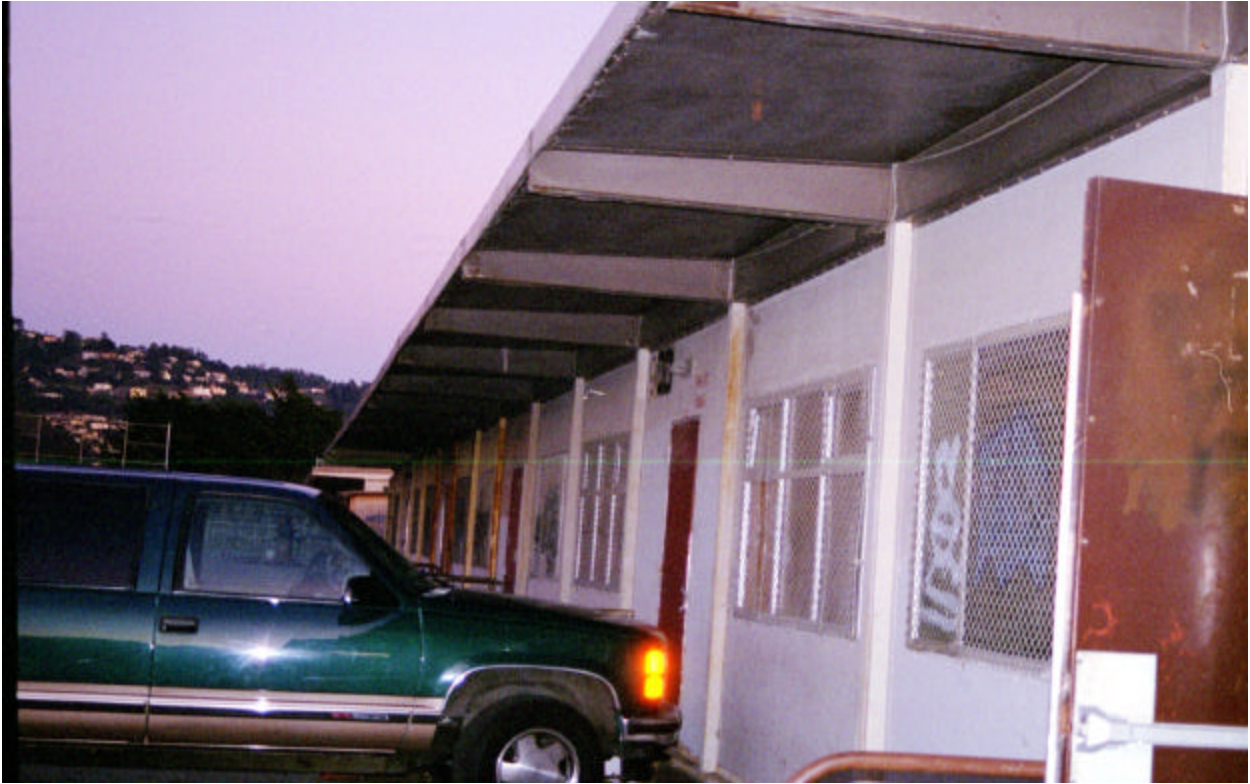
Figure 16: Exterior Wall of Portable Building

Portable buildings located behind the gymnasium building have numerous openings and do not have enough length of shear walls to adequately resist seismic loads. Steel roof beams have rusted (see figure 16) and are badly in need of repairs.

loads.
28.	Portable building has numerous openings and lack adequate length of shear wall to resist seismic force. Also, steel roof beams have rusted and are badly in need of repairs.

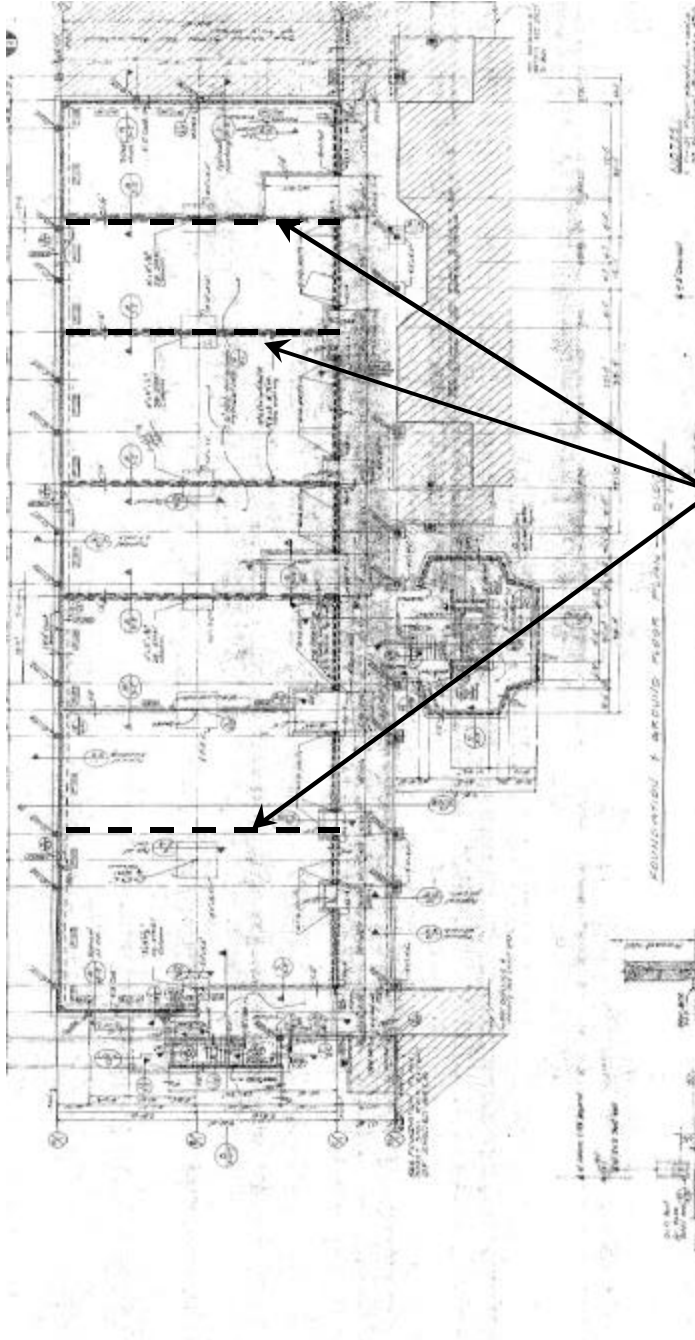
Drawing 1: Building I Foundation Plan

In Building I, the interior transverse (north-south) shear walls in the second story do not line-up with the walls in the first story creating an out-of-plane offset that results in a discontinuity in seismic load path. This irregularity is called a plan irregularity and could result in overstressing of the second floor diaphragm and the 3x16 joists that support the upper plywood shear walls in the upper story. Additionally, hold downs required at the ends of the shear walls in the second story are not present. This irregularity represents a life safety hazard. New steel braced frames and foundations as shown in appendix "B" drawings should be provided from the ground to the roof level.

Provide new steel braced frame from ground to roof level along these grid lines. Provide new foundations for braced frames.

NOTE:
Check adequacy and provide hold-downs as required at the ends of panel and adjacent to openings for all tilt-up panels. Typical for all buildings.

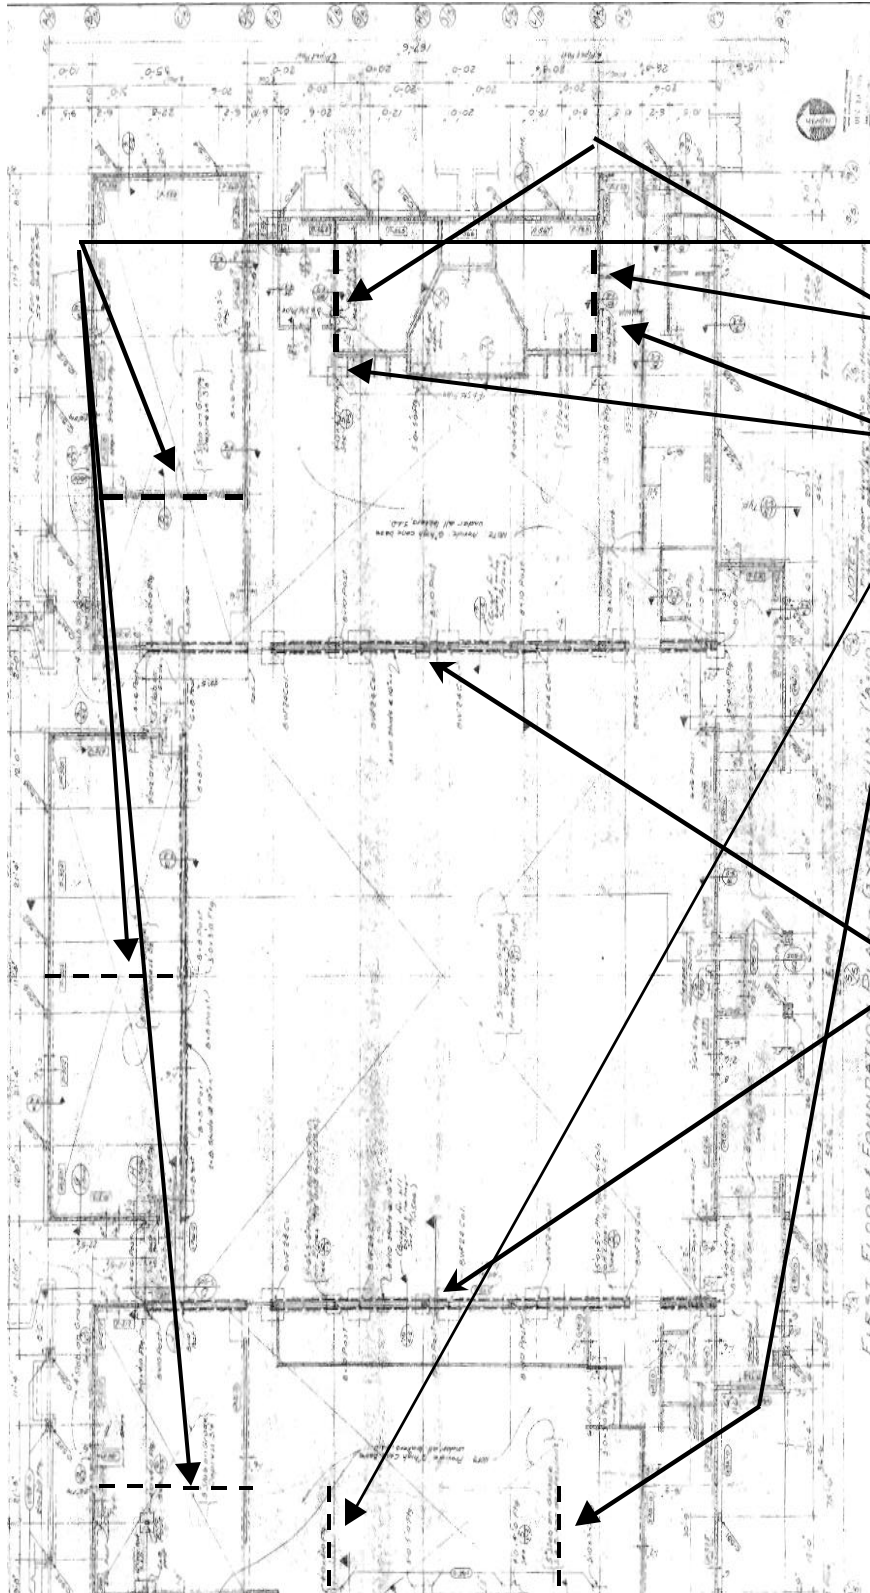
Drawing 4: Building V Foundation Plan

The plywood diaphragm between D/3 and P/5 in the locker room area has inadequate strength to resist prescribed seismic loads in east-west direction due to the long span of the diaphragm. New plywood shear walls, hold downs and collector connections should be provided as shown in drawing appendix "B".

The plywood diaphragm at the dance floor area, weight room and wrestling area between grids B/5 and D/5 has inadequate strength to resist prescribed seismic loads. New plywood sheathing should be added to existing partition walls between 6/5 and 7/5 in the music room, which will create new shear walls and reduce the diaphragm spans. New plywood shear wall should be added on line 5/5 between grids B/5 and D/5 at the weight room and on line 3/5 between grids B/5 and D/5 at the wrestling area.

Add new plywood sheathing to this face

New plywood shear wall

Strengthen shear walls by providing additional nailing (stagger with existing)

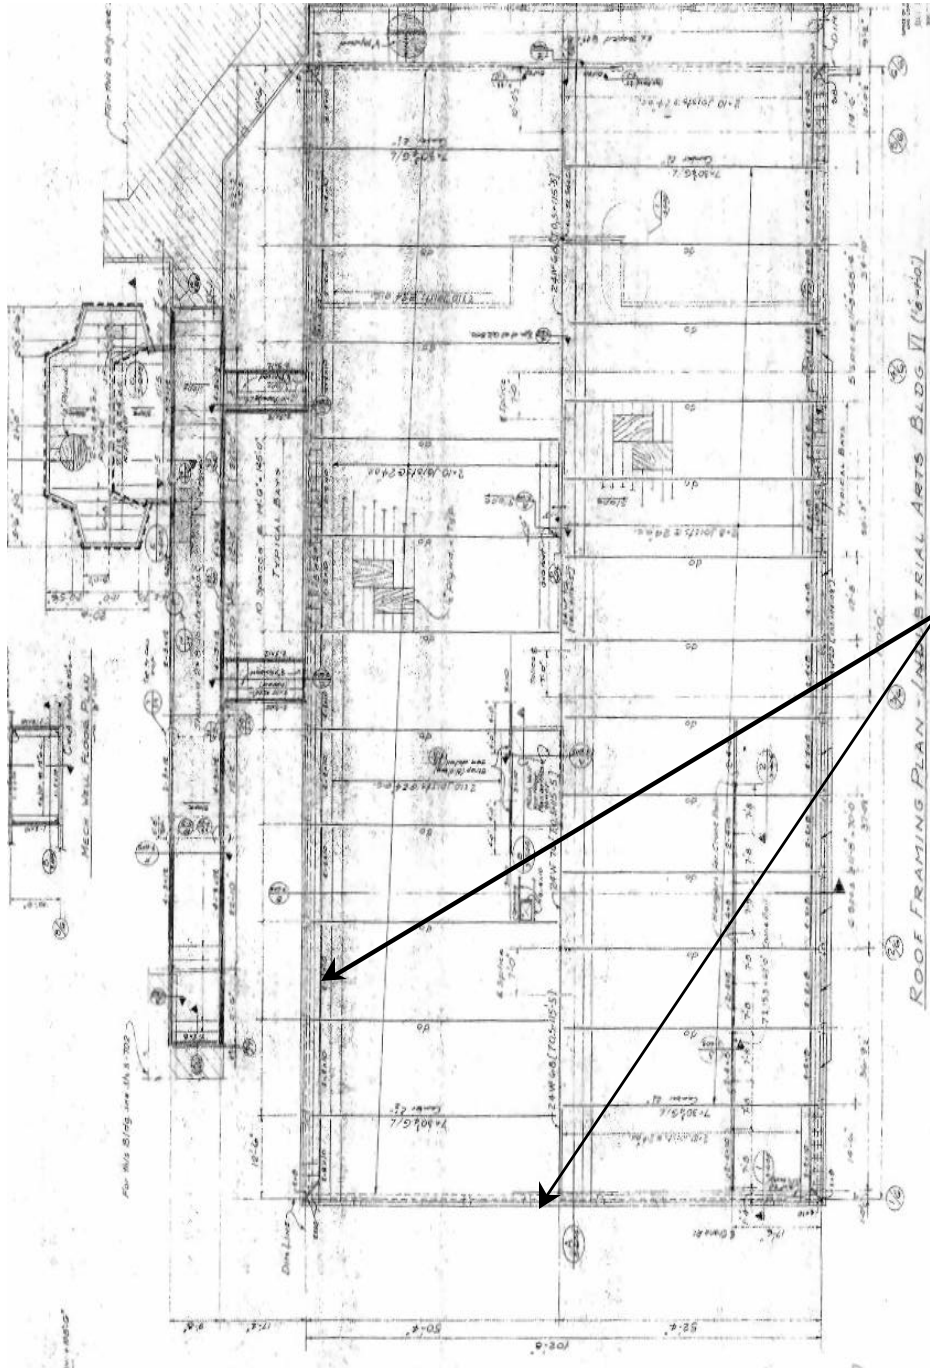
Drawing 6: Building VI Roof Plan

Connections of the concrete tilt-up walls to the roof diaphragm lack adequate strength to resist lateral loads, which poses a life safety hazard. The connections should therefore be strengthened. The roof diaphragm has inadequate strength to resist prescribed seismic loads and should be strengthened.

Strengthen connection between perimeter tilt-up and roof for wall out-of-plane loads typical

Provide additional nailing to strengthen existing roof diaphragm on Lines 1/6 and 6/6

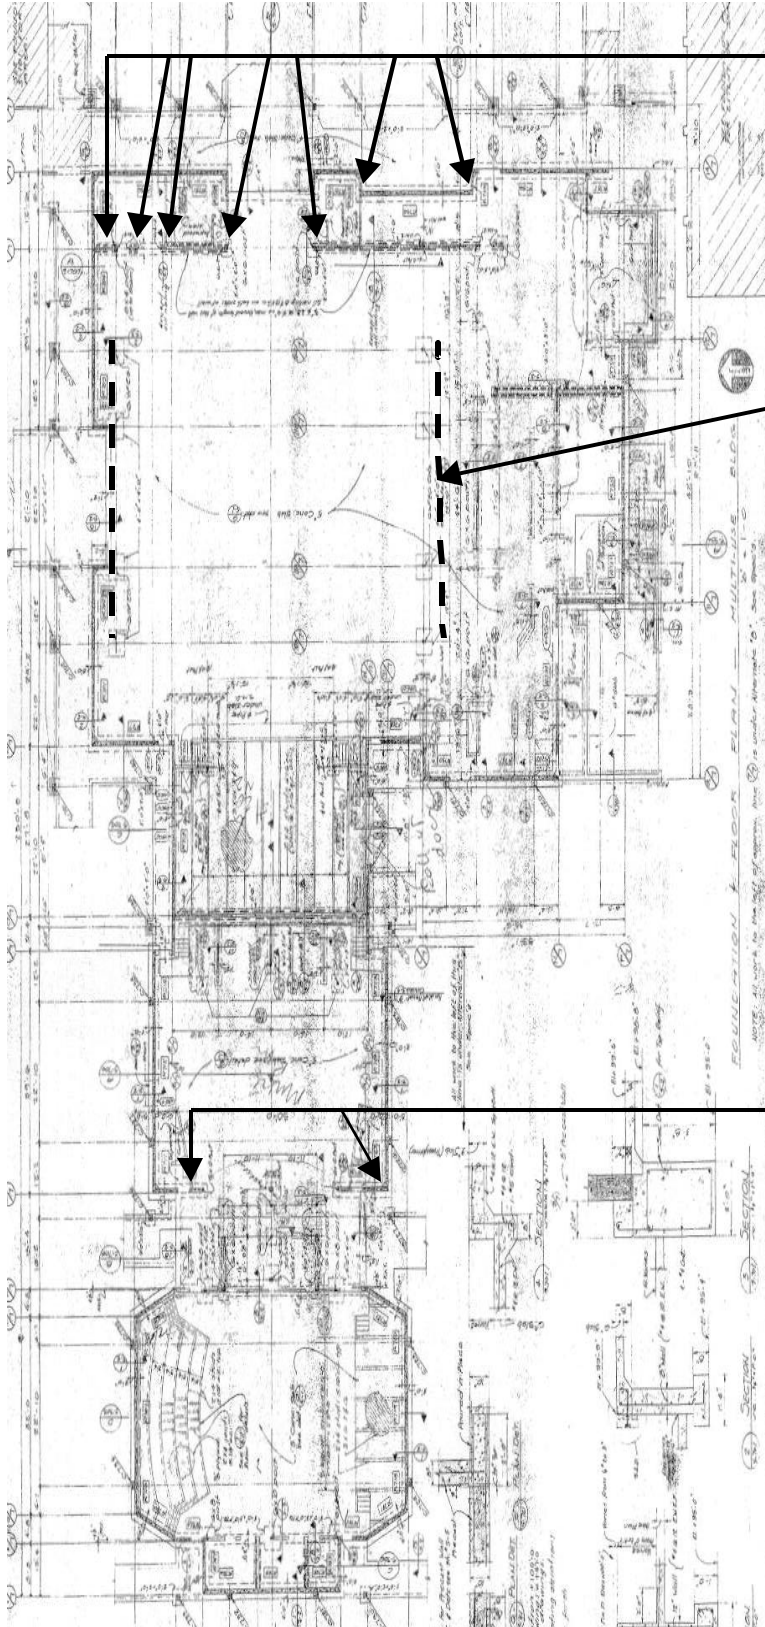
Drawing 8: Building VII Foundation Plan

The MPR has discontinuous shear walls in the east-west direction on lines B/7 and M/7 which poses a life safety hazard. A new lateral system such as a steel braced frames with new foundations should be added along the above grid lines to resist prescribed seismic loads and provide a complete lateral load path from the cafeteria roof to the foundation. It should be noted that on line M/7, there is a short piece (7'-7" length and 9'-6" tall) of 10" thick poured in place concrete wall near line 10/7 in north-south direction, which is connected to exterior pre-cast concrete wall. Since the pre-cast walls do not have hold downs to resist seismic overturning forces, the poured in place concrete wall will experience uplift forces. Also, the poured in place

23.	Building VII – Shear walls on lines B/7 and M/7 supporting cafeteria roof are discontinuous and there is no path to transfer roof diaphragm forces to foundation.

23.	Provide new steel braced frame and foundations at lines M and B from ground to support cafeteria high roof.	1.0	8
24.	Provide Simpson L50 to supplement existing L50 angle and provide new blocking as required. This is to be provided wherever detail 15/S12 is called out on the drawings.	1.2	9

Provided hold-down anchors
at ends of tilt-up panels

Provide new braced frame
on lines B/7 & M/7 from
ground to multi[purpose high
roof and collectors as
required.

NOTE: Strengthen
connection between
perimeter tilt-up panel and
roof (for wall out-of-plane
loads) typical.
