STRUCTURAL EVALUATION OF
PINOLE VALLEY HIGH SCHOOL
WEST CONTRA COSTA UNIFIED SCHOOL DISTRICT
(WCCUSD)

DASSE Design, Inc.
33 New Montgomery Street #850
San Francisco, CA 94105
(415) 243-8400

October 17, 2002

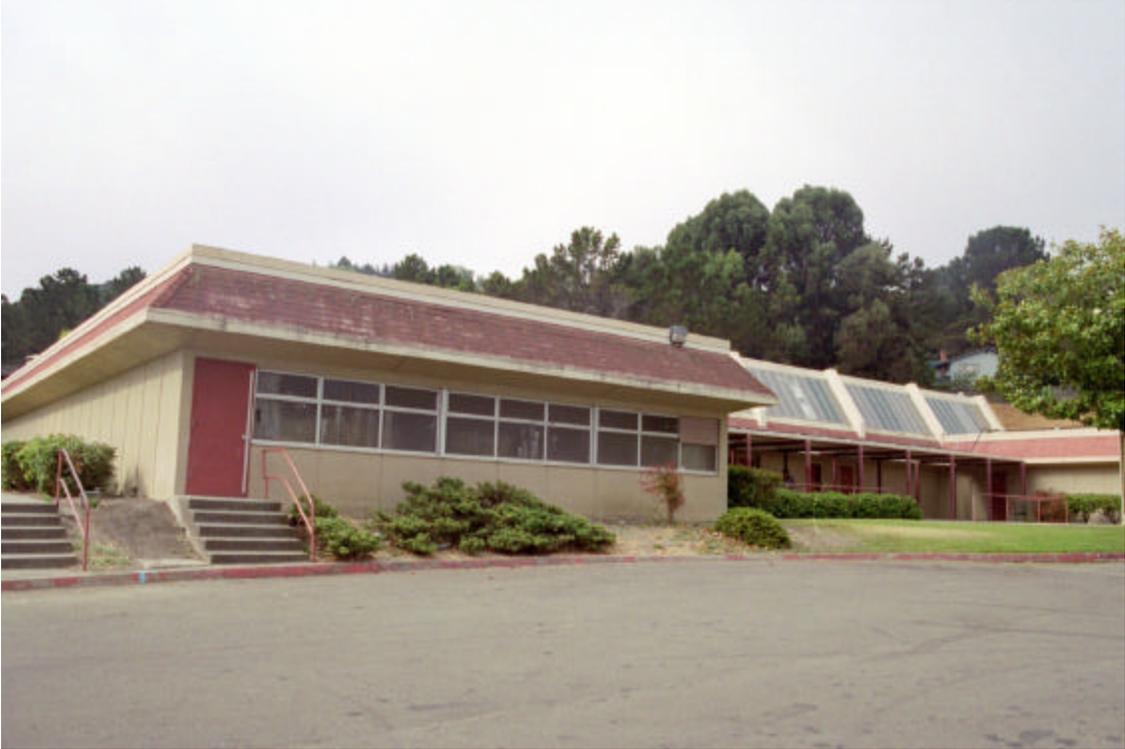
Figure 16: Northeast corner of the industrial arts building

At the north face of the low roof areas, the front of the building lacks adequate shear resistance (see figure 16). This could result in excessive diaphragm chord forces and large diaphragm deflections because the diaphragm is acting as a horizontal cantilever. At the rear wall of the building where the roof changes height, there is no collector element within the shear wall. This could result in some damage to the wall at this location and, if the tall and short portions of the wall become separated from each other, it could result in the loss of vertical support for some roof framing.

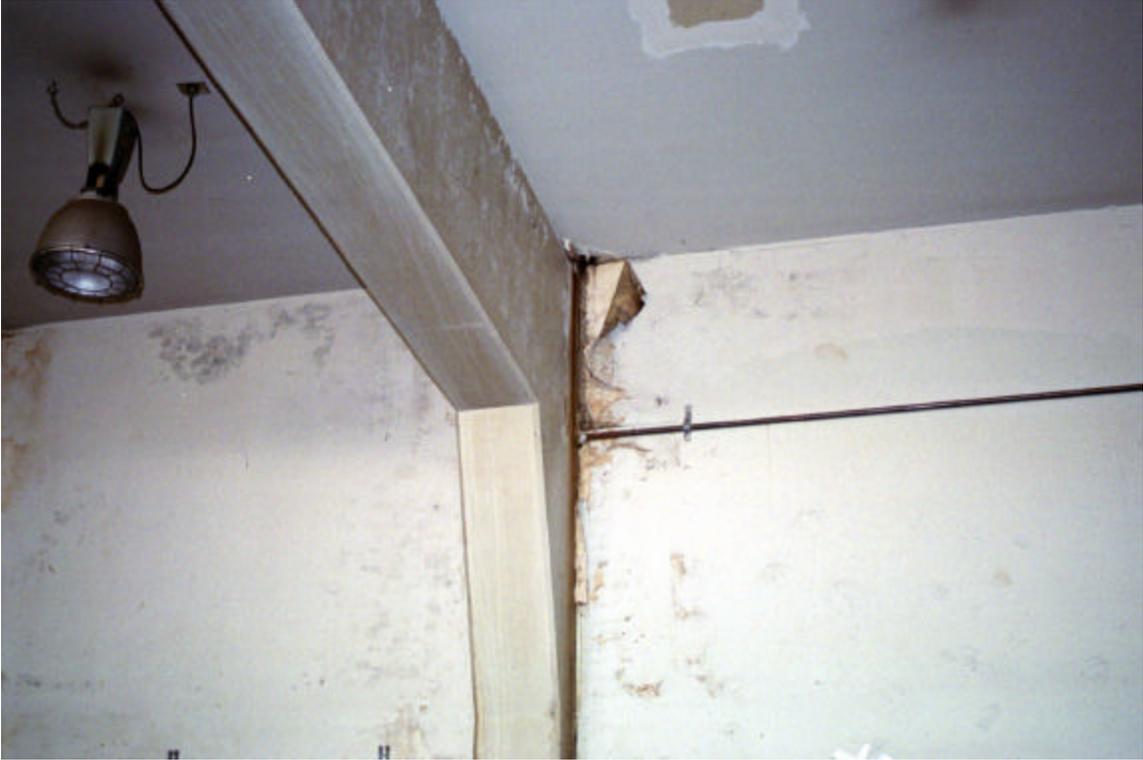
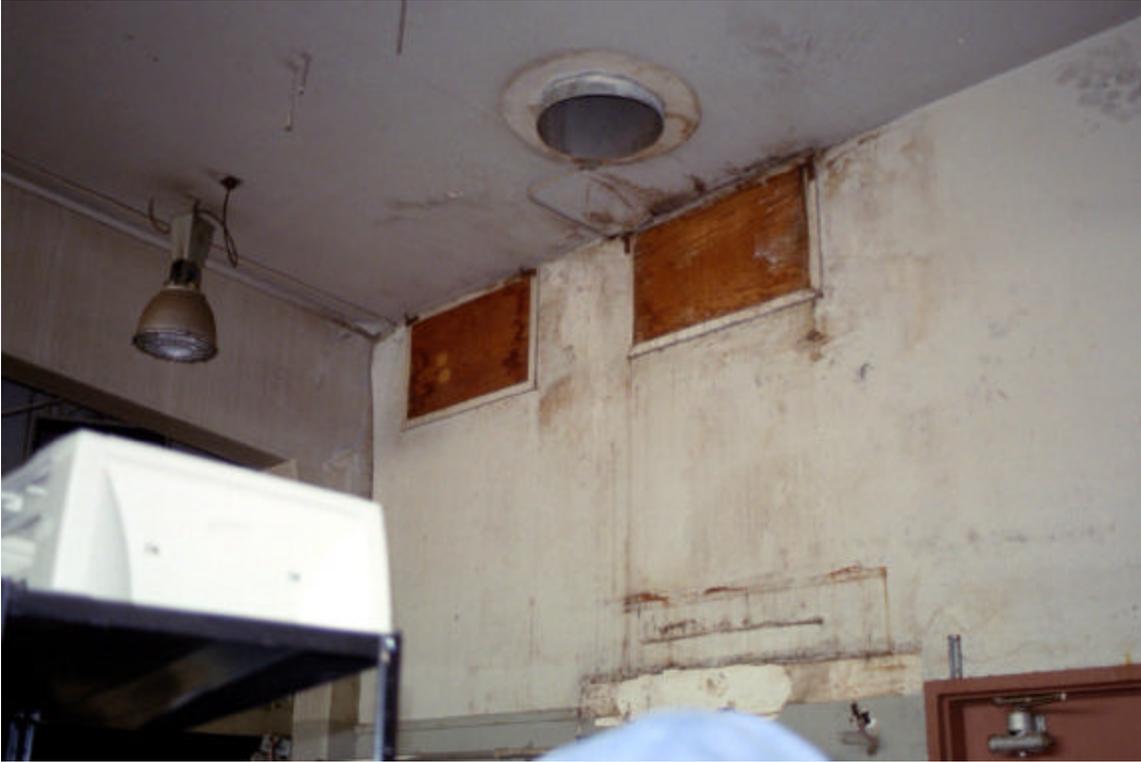
Figure 19: Deterioration of the wall in the industrial arts building

The industrial arts building (Building H) is C-shaped in plan. The central area has a high roof supported by pre-cast concrete frames and the two wings have low roofs. At the front of the side wings, there are no windows along the exterior of the building, which would cause the roof diaphragm to have to cantilever out horizontally to resist lateral loads (see figure 16). Also, there are clerestory windows along the north side of the concrete frame (see figures 16 and 17). The building has gypsum board ceilings in most of the area, with suspended acoustical tile ceiling in the northern ends of the low roof wings. There is also a partial mezzanine level at the north side of the building in room 503 (see figure 1). Some moisture damage was noted at the rear wall of the building (see figures 19 and 20), which may have led to some deterioration of the structural members. This potential damage should be investigated and repaired if necessary, and measures should be taken to prevent the entry of water in the future.

| Item | Building Structural Deficiencies |
|---|--|
| 10. | At the south wall of the industrial arts building, there is some moisture damage to the stud wall. |

| Item | Recommended Remediation | Priority | Drawing Number |
|---|---|---|---|
| 10. | Remove the existing wall and roof finishes and ceiling as required to repair the members with water damage. Ensure adequate waterproofing of the wall. Determine extent of damage in field. | 2.5 | 16 |

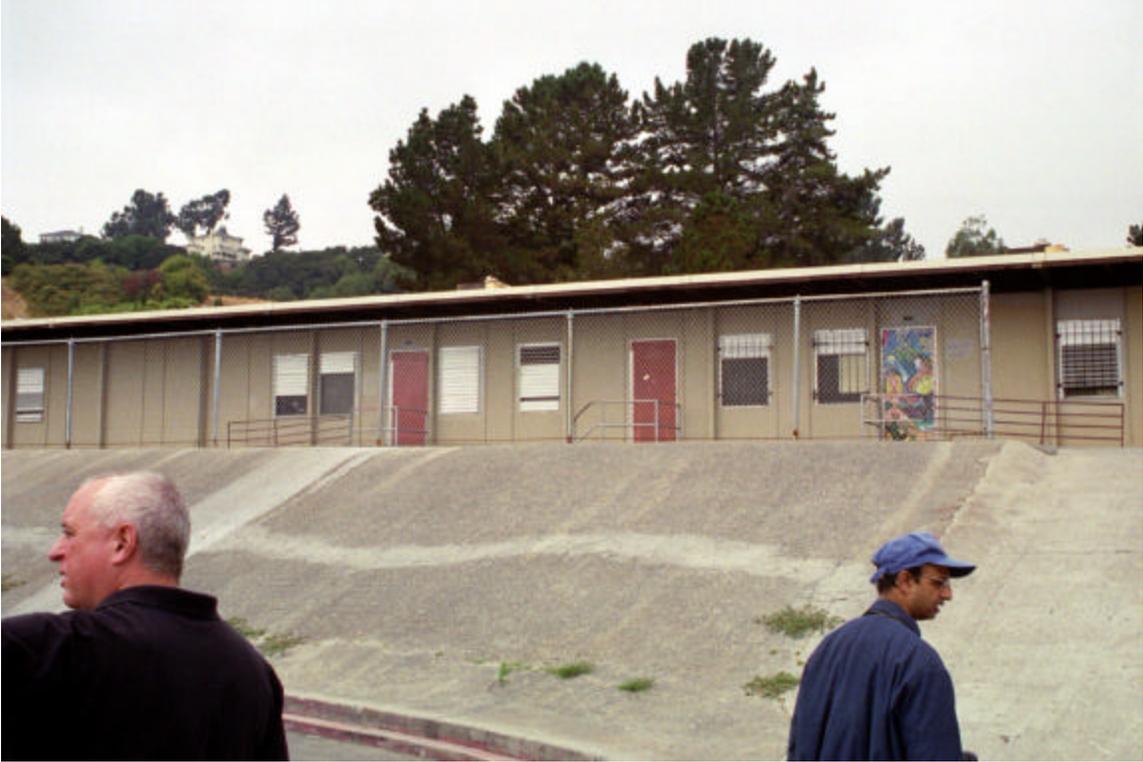
Figure 22: Portable classroom units

At the portable classrooms, there is electrical conduit running between the classroom units near the roof level (see figure 22). There are no flexible connections to allow for relative movement of the units. During an earthquake these conduits may be damaged and pose a threat to life safety due to falling electrical lines.

| Item | Building Structural Deficiencies |
|---|--|
| 11. | At the portable classrooms, there is conduit running between the portable classrooms at the roof level. |

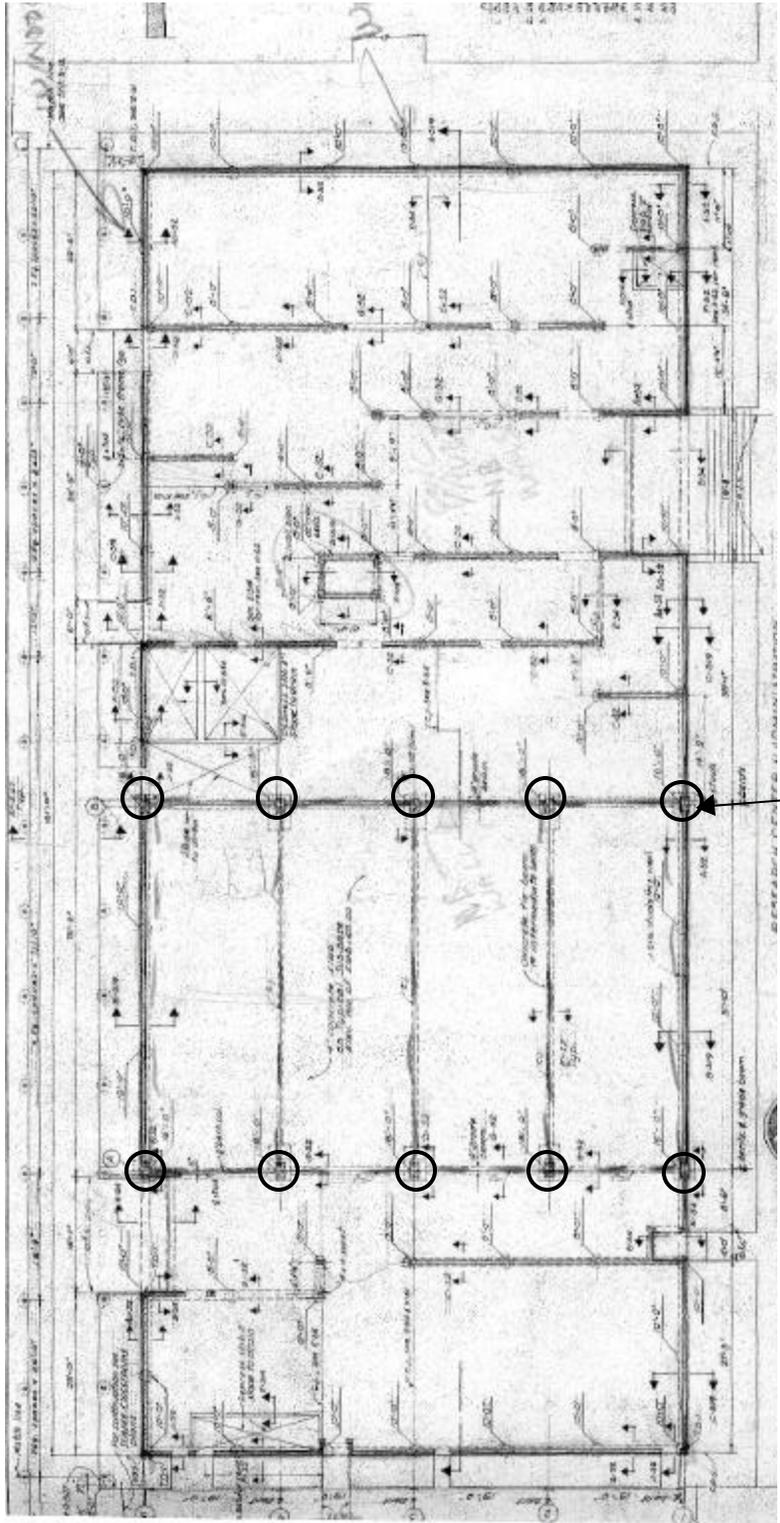
Drawing 1: Academic and library building (A/B) floor plan

| Item | Building Structural Deficiencies |
|---|--|
| 2. | At the library and administration, performing arts, cafetorium, and industrial arts buildings, the detailing of the pre-cast concrete frames may be inadequate to provide the required ductility during an ultimate level earthquake. There is no positive connection to resist uplift or jumping of the frame. |

Provide new steel angles bolted to the concrete frames and to the foundation to resist uplift, typ. at 10 locations.

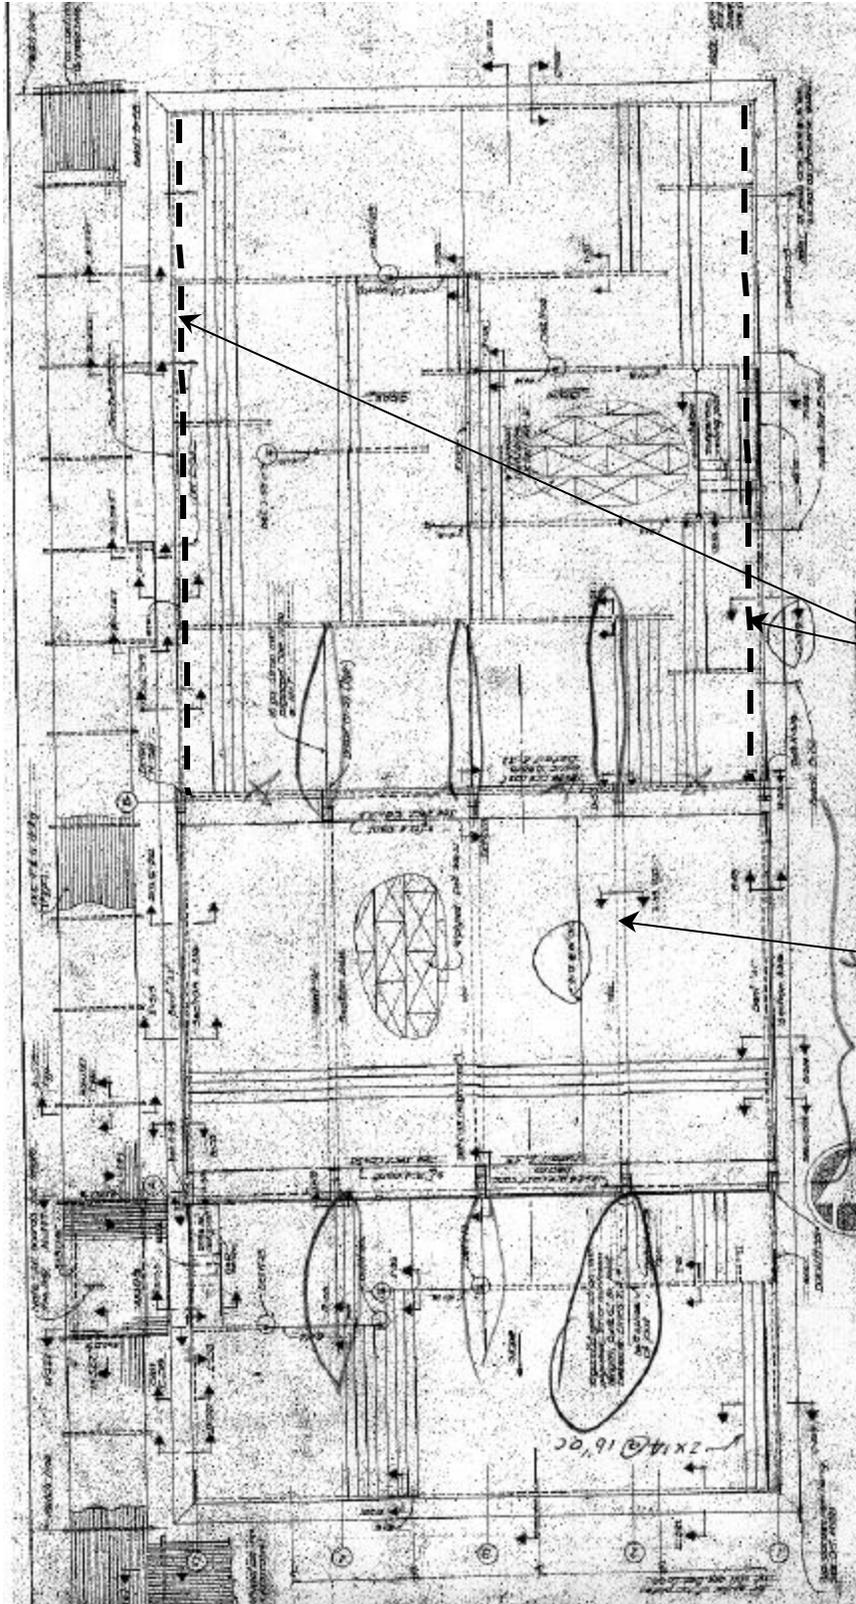
Drawing 2: Academic and library building (A/B) roof plan

| Item | Building Structural Deficiencies |
|---|--|
| 1. | At the exterior longitudinal walls of the Library and Administration building, the top plate splices are inadequate to transfer the roof diaphragm chord forces. |

(N) CMST straps above existing roof sheathing.

Wrap (E) pre-cast concrete frame beams and columns with a fiber reinforced polymer system to provide additional confinement and shear capacity, typ. at all frames.

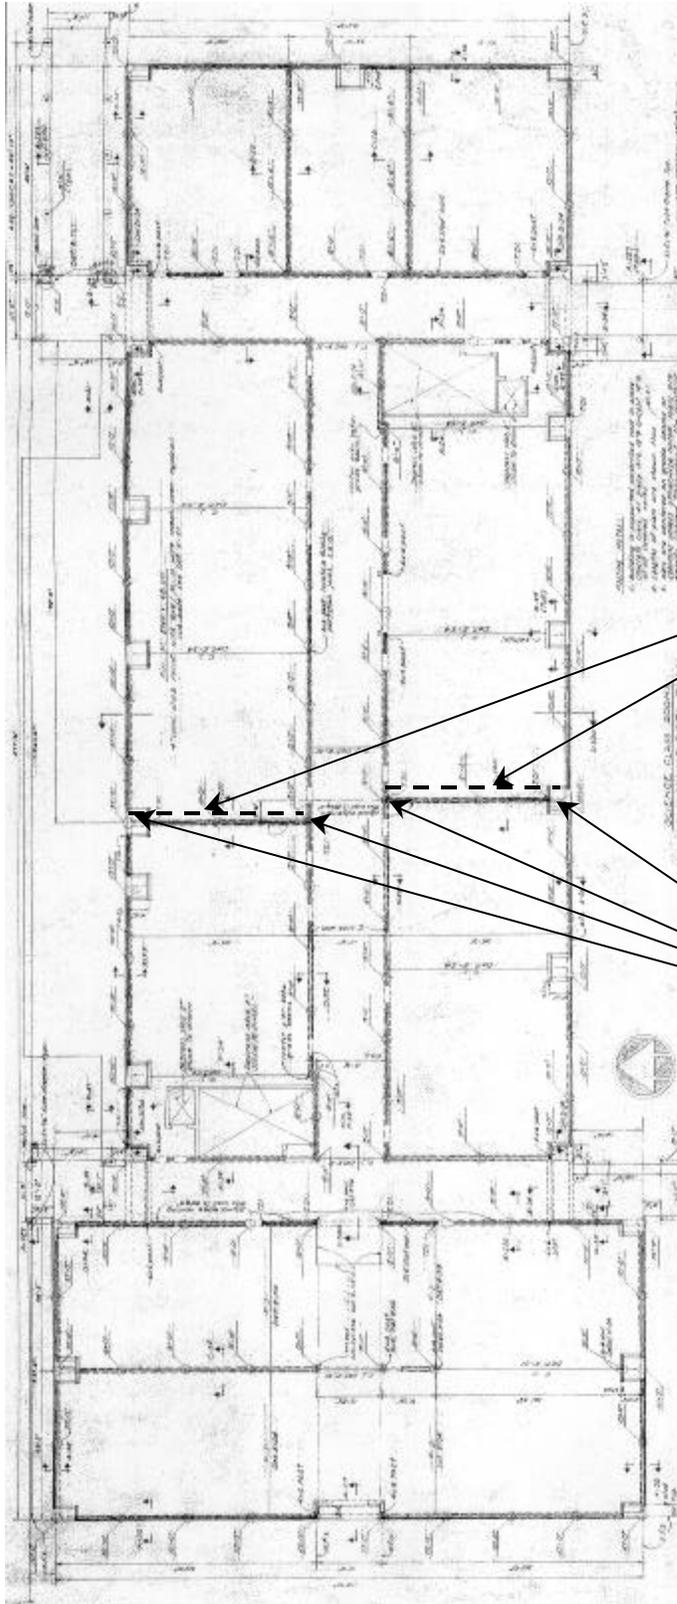
Drawing 3: Classroom building C floor plan

| Item | Building Structural Deficiencies |
|---|--|
| 5. | The interior transverse shear walls near the center of the classroom buildings (C and D) are overstressed in shear. The holdowns are overstressed. The sill bolts are inadequate. |

(N) plywood wall sheathing at
(E) shear wall. Provide 3x
studs sistered to the existing
wall framing. Provide add'l
sill bolting.

(N) holdowns at the ends of
shear walls.

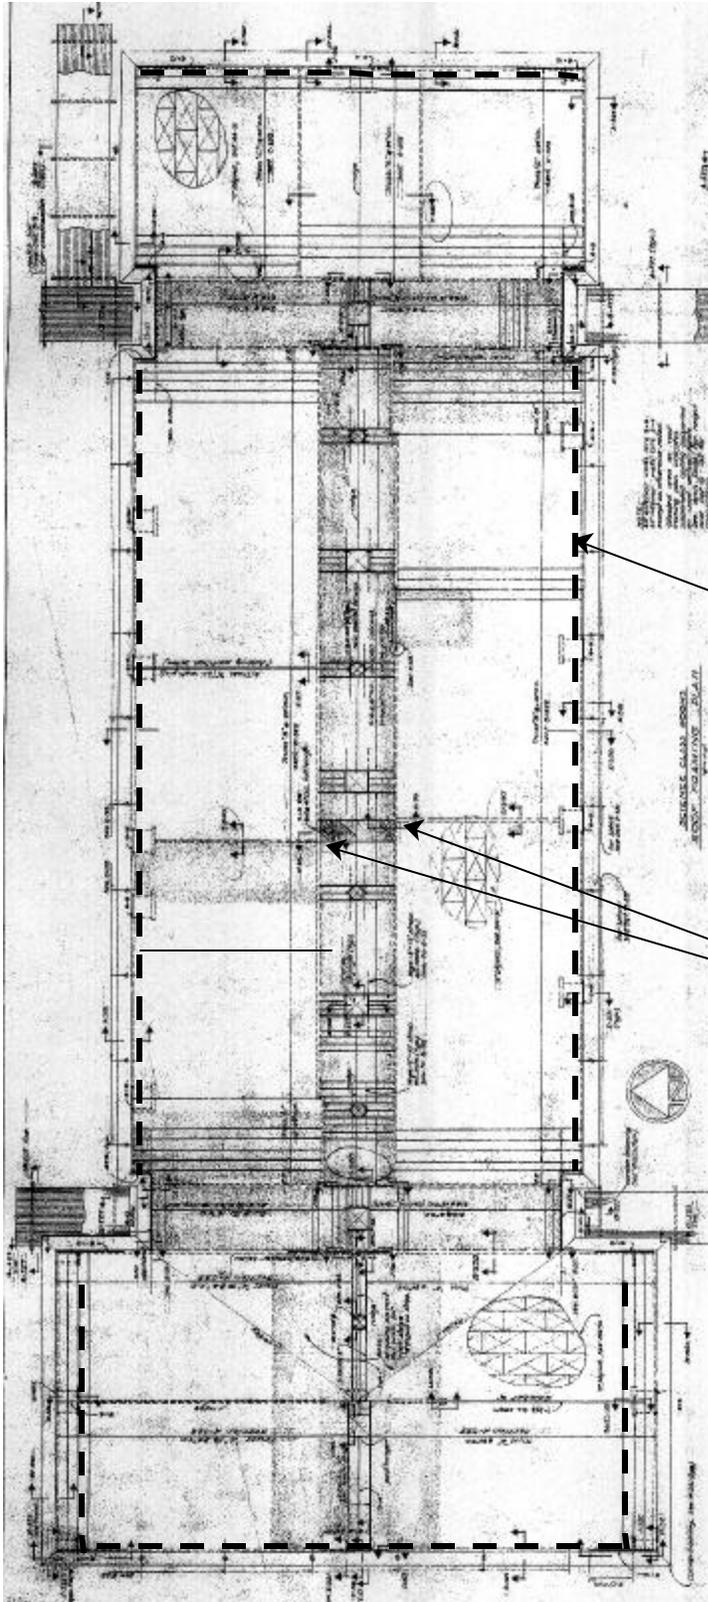
Drawing 4: Classroom building C roof plan

the central corridor. Collector elements at the roof level allow the diaphragm to transfer the collector forces between the provided shear walls. At building C, the connection of this collector to the shear wall is not adequate, which could lead to roof diaphragm damage during an earthquake. At buildings C and D, the diaphragm spans on each side of the middle interior shear wall line are very long, ranging from 76 ft to 104 ft. This could result in the diaphragm chords and the shear walls along this wall line being overstressed during a code-level earthquake event.

| Item | Building Structural Deficiencies |
|---|--|
| 4. | At the exterior walls of the classroom buildings (C and D and DR), the top plate splices are inadequate to transfer the roof diaphragm chord forces. |

(N) CMST straps above
existing roof sheathing, typ.
where shown thus.

Strengthen (E) collector
connections.

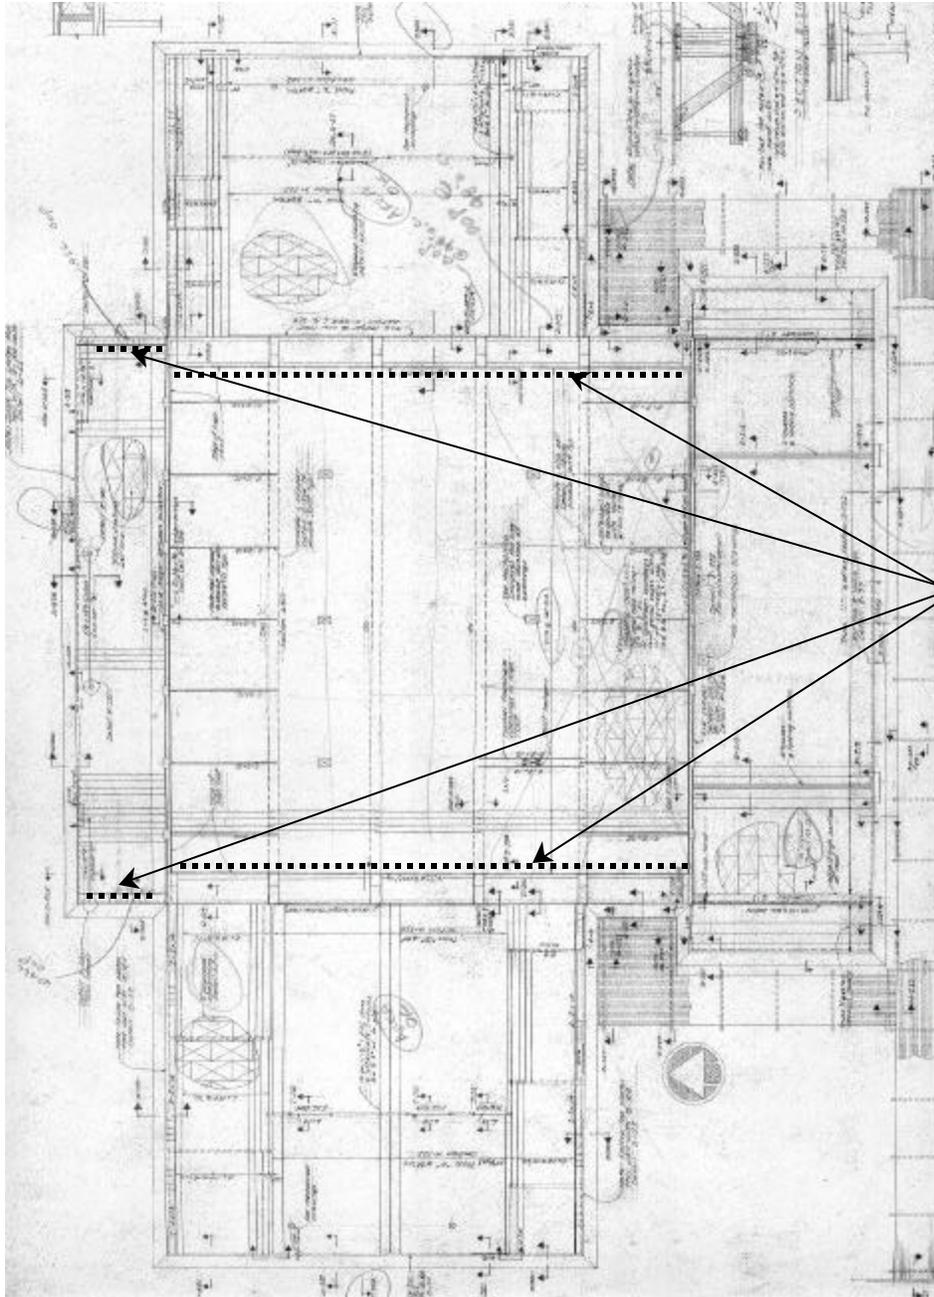
Drawing 14: Gymnasium (G) roof plan

| Item | Building Structural Deficiencies |
|---|--|
| 7. | At the gymnasium, the out-of-plane anchorage of the east and west concrete wall panels to the diaphragm does not continue far enough into the roof diaphragm. This condition occurs at the high roof and at the north low roof area. The aspect ratio of the sub-diaphragm is excessive and may lead to failure of the wall anchorage system. |

Provide (N) blocking between (E) roof joists and continuous metal straps spaced at 48" o.c. to develop the wall anchorage forces into the diaphragm and create a sub-diaphragm at least 8 ft. deep.

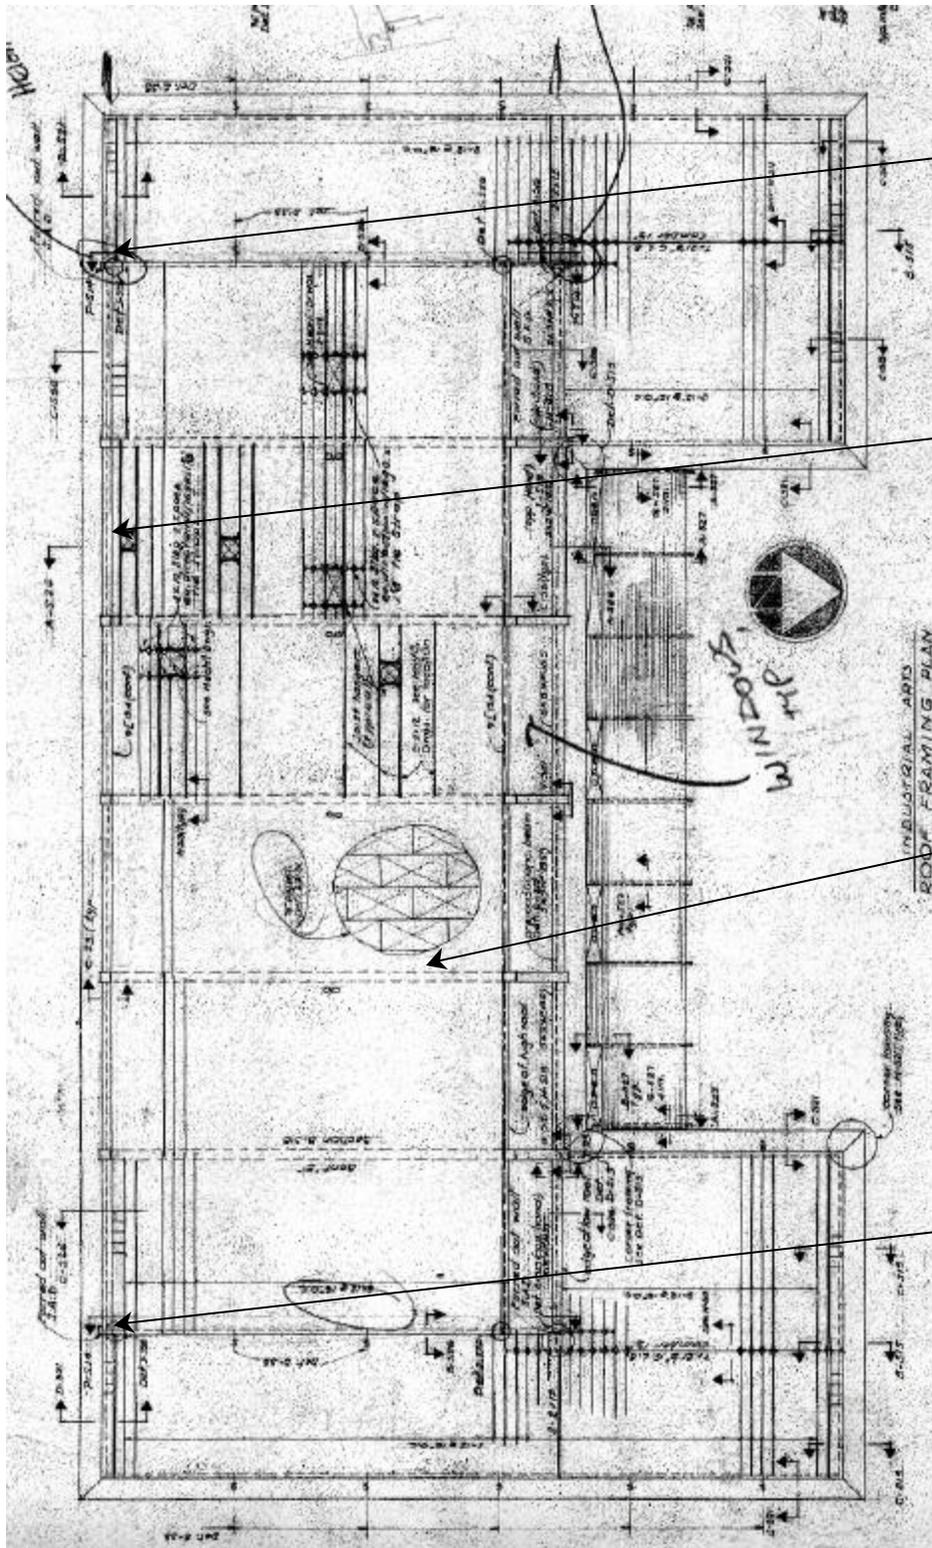
| Item | Building Structural Deficiencies |
|---|--|
| 9. | At the south wall of the industrial arts building, there is no collector element where the wall changes height between the low and high roof areas. This may result in some damage to the building at this location. If the high and low roof areas of the building were to tear free from each other during an earthquake, there may be a loss of gravity support for some roof framing, resulting in a partial collapse of the roof. |

Provide (N) blocking and collector straps in the (E) stud wall where the roof height changes.

Remove the existing wall and roof finishes and ceiling as required to repair the members with water damage. Ensure adequate waterproofing of the wall. Determine extent of damage in field.
