STRUCTURAL EVALUATION OF  
PORTOLA MIDDLE SCHOOL  
WEST CONTRA COSTA UNIFIED SCHOOL DISTRICT  
(WCCUSD)

October 17, 2002

DASSE Design Project No. 01B300x2

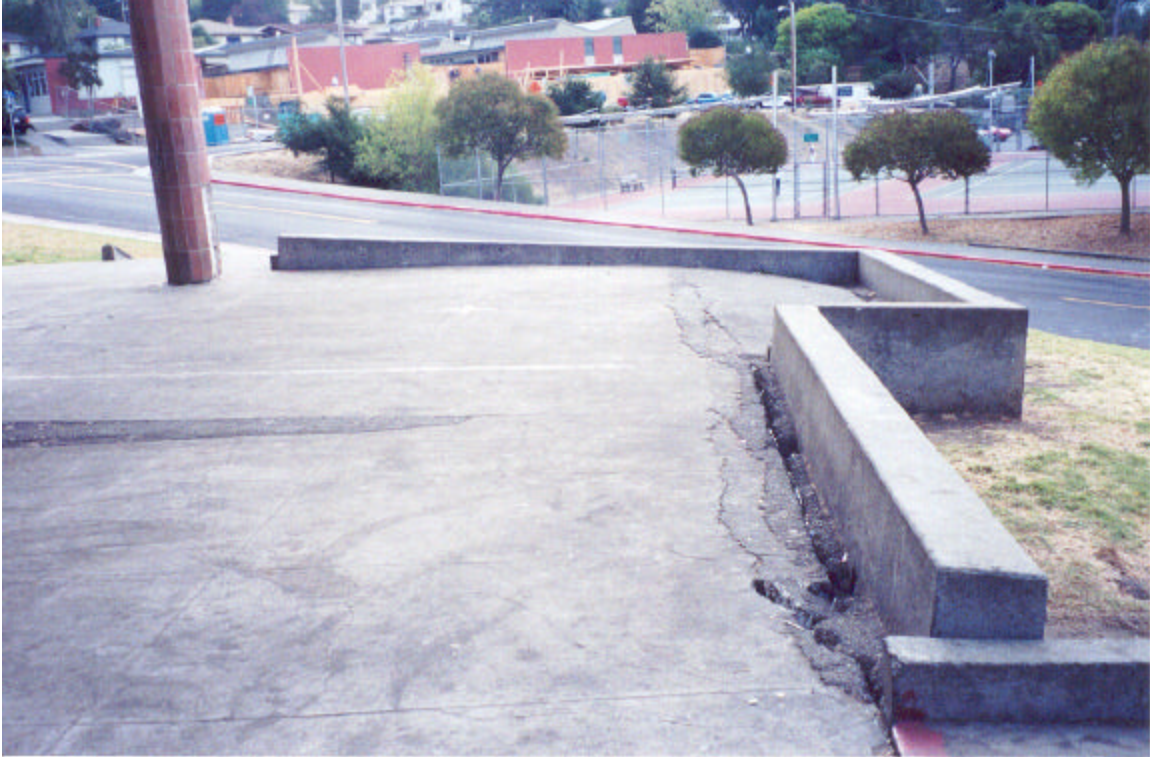
The entire campus is located on a sloped site. There is evidence of a neighboring land slide that occurred in the distant past and settlement in the paved areas which has resulted in significant cracking of the site pavement (see figure 3). We did not see any evidence of building sliding.

Item	Building Structural Deficiencies
1.	There is some apparent localized settlement or sliding of the slope on which the school is built. This is made evident by the significant cracking of site paving.

Figure 3: Settlement of site paving adjacent to Main Classroom Building

Item	Recommended Remediation	Priority	Figure Number
1.	Consult with a geotechnical engineer to determine if there is a slope stability problem that would affect the building structures.	1.9	None

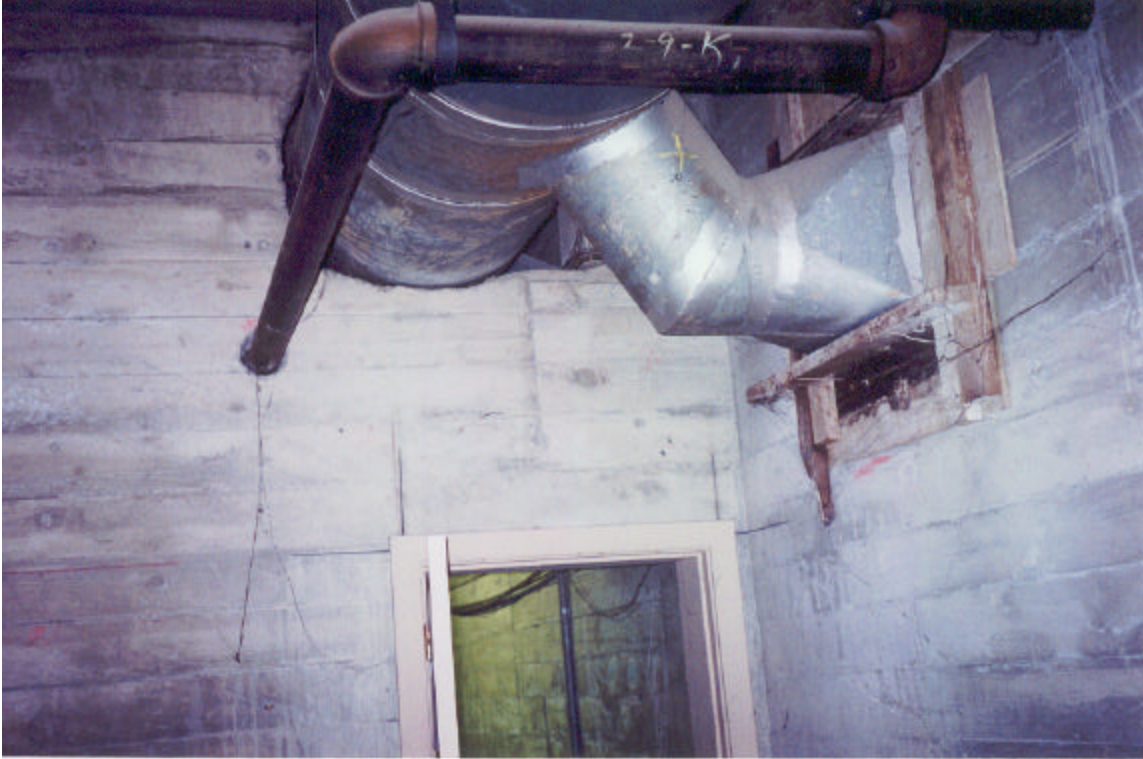
Figure 9: Sawcut opening in basement wall of Main Classroom Building

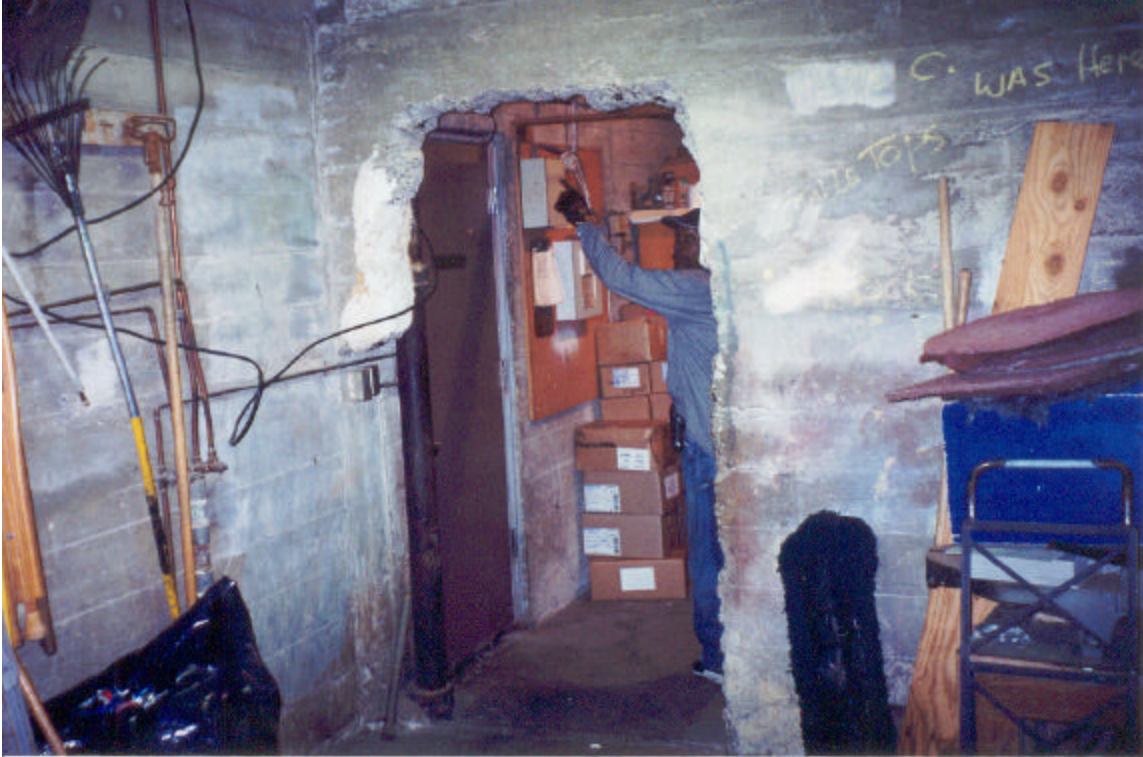
Figure 10: Rough cut opening in basement wall of Main Classroom Building

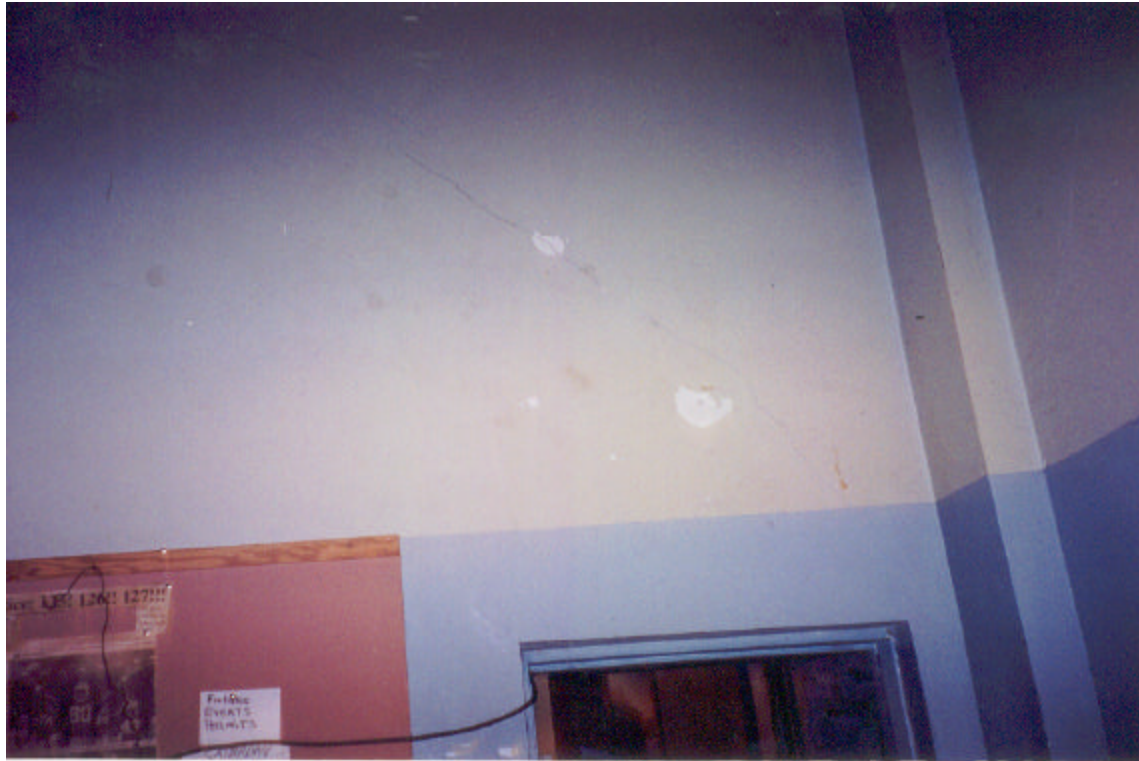
Figure 11: Diagonal cracking in the basement wall of Main Classroom Building

5.	Pressure inject epoxy grout to seal the cracks. At the doorway cuts, burn back the exposed rebar 1" from the surface and patch.	3.0	4
6.	Provide new welding of the brace to the gusset plate, total of 16 locations	1.0	5

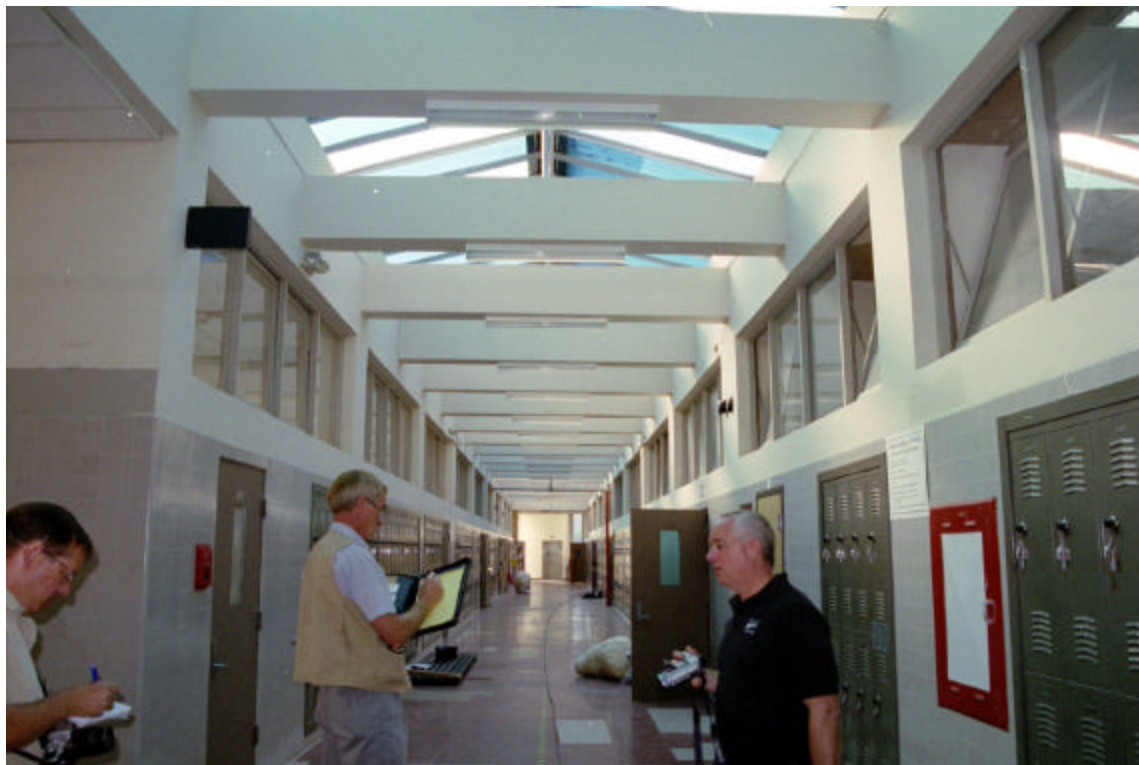
columns to about 4'-6" tall (see figure 12). These short columns are therefore much stiffer than the exterior columns and will resist the majority of the seismic loads in the longitudinal direction. Because of the high shears that the columns are subjected to, these columns have #4 ties spaced at 4" o.c. instead of the typical #3 ties spaced at 9" o.c. These stirrups do not continue into the beam and wall at the tops and bottoms of columns respectively as is required by the current code. Nor are the beam-column connections sufficiently detailed so as to create a ductile flexural failure mode. These short columns are shear-critical at the both the first and second floors, and are expected to behave in non-ductile manner, possibly leading to the complete collapse of the structure.

2.	At the main building, there are short columns between the partial height wall and slab at 1st and 2nd stories that create high windows along the corridor. These elements are flexible relative to the walls and do not have sufficient capacity to resist the seismic loads. Furthermore, the columns are shear-critical, and therefore will have non-ductile behavior.

Figure 12: Central second floor corridor and skylights at Main Classroom Building

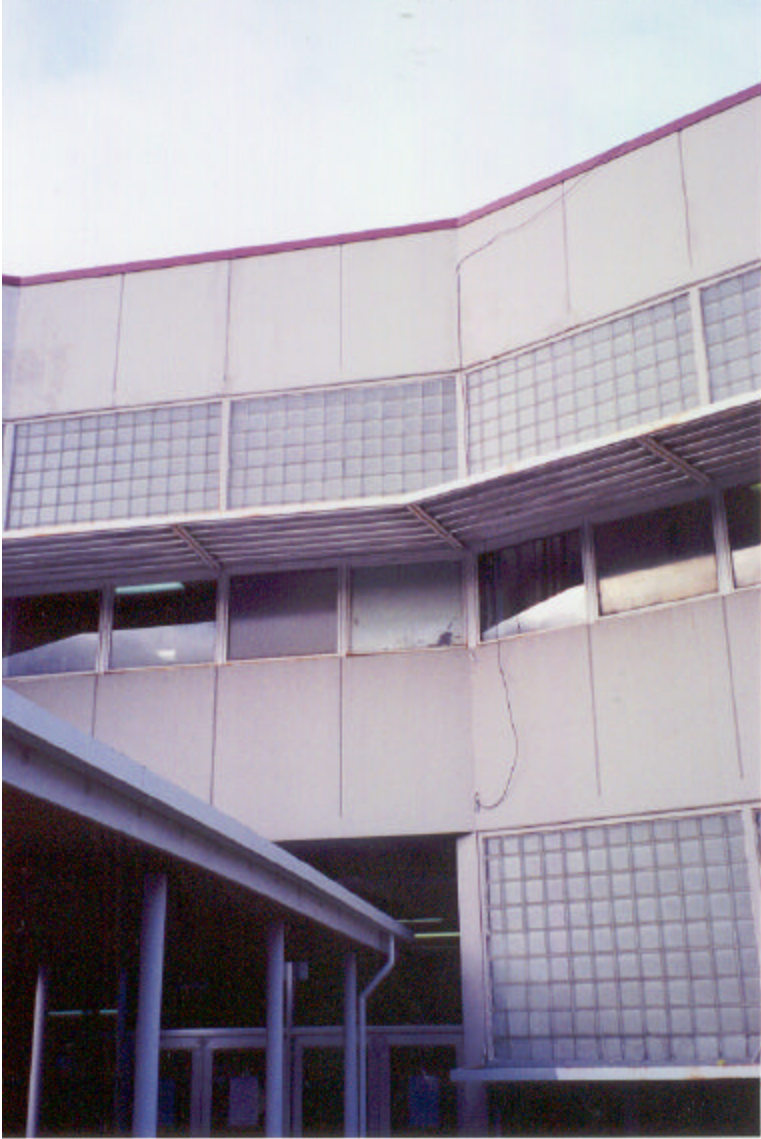
4.	At the main building re-entrant corners, the manner in which the concrete reinforcement is detailed may lead to spalling of concrete.
5.	There are cracks in the concrete walls in the north wing basement storage area of the main building. There are also exposed reinforcing bars at the doors that have been cut into the basement walls. The exposed reinforcing bars may corrode if exposed to moisture.

Figure 13: Re-entrant corner at the front of Main Classroom Building

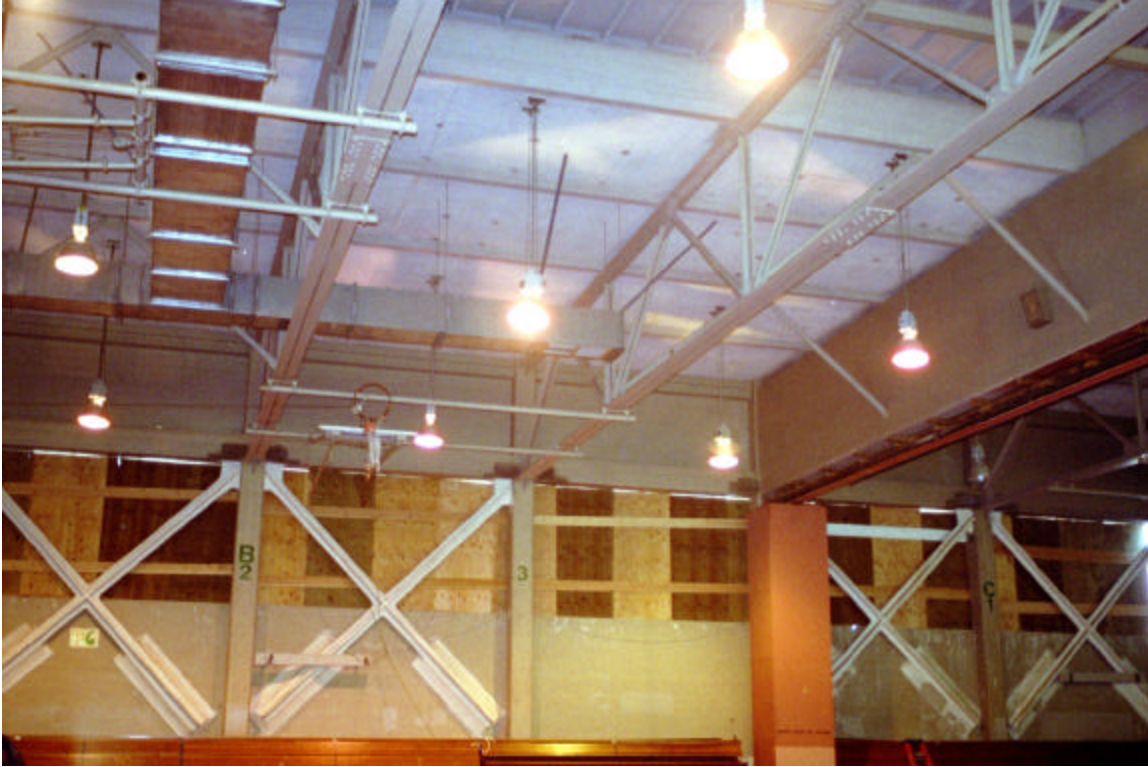
The gymnasium building shows evidence of some cracking in the exterior concrete walls (see figure 18). There are vertical cracks that are attributable to shrinkage and some diagonal cracking at the corners of door and window openings. There is an acoustical tile ceiling in the main gymnasium that is attached to the underside of the roof slab and there is no ceiling in the locker rooms. The low roof and main gymnasium skylight openings have been infilled with wood framing (see figure 19). There is an accordion partition that hangs from the center truss of the gymnasium roof framing (see figure 16).

6.	The diagonal bracing used in the 1990 retrofit of the Gymnasium uses WT-sections. The bolted top connections of these braces, which provide lateral resistance at the east and west walls, are overstressed

Figure 16: Retrofit bracing at interior of Gymnasium

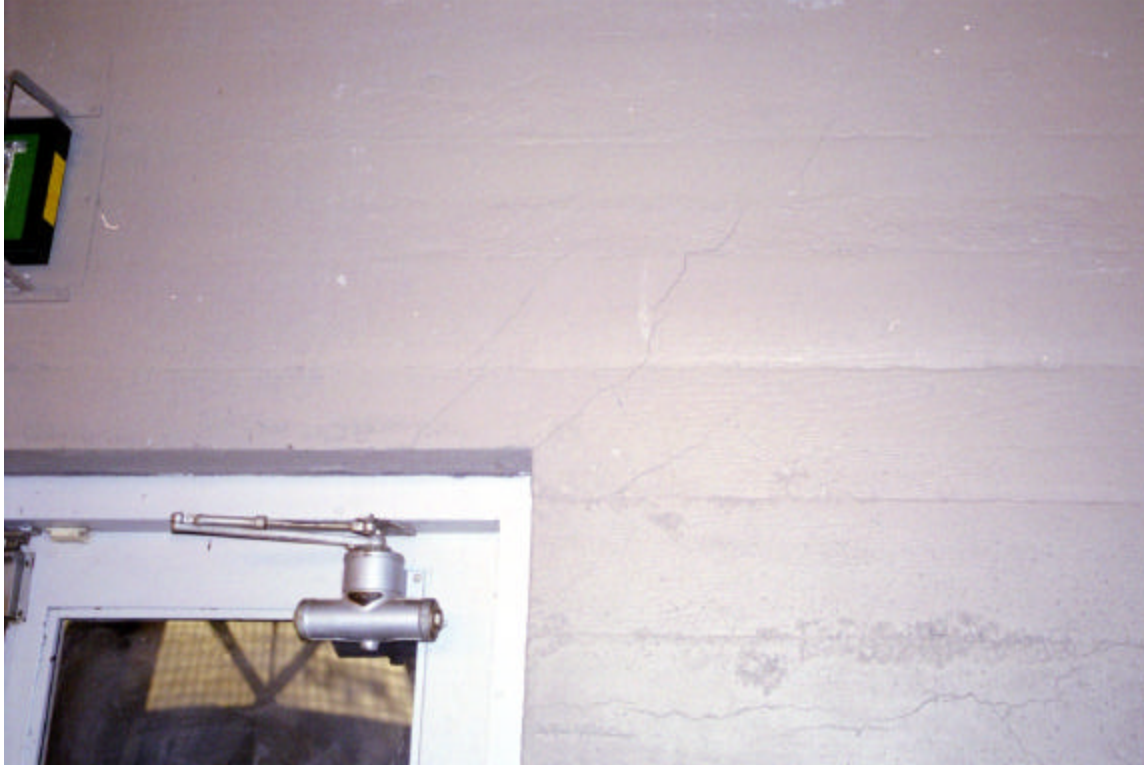
8.	The north and south walls of the gymnasium may have inadequate capacity to span vertically between the first floor and roof under seismic loading
9.	There are some minor cracks in the concrete walls of the gymnasium.

Figure 18: Cracks in the wall of Gymnasium Building

9.	Pressure inject epoxy grout to seal the cracks.	3.0	5
10.	Provide new columns for secondary gravity support of the covered walkway.	1.1	5
11.	Provide additional diagonal bracing similar to existing bracing OR replace existing bays of angle braces with new double angle braces. 14 braces at lab building, 28 (estimated) at shops building.	1.3	7

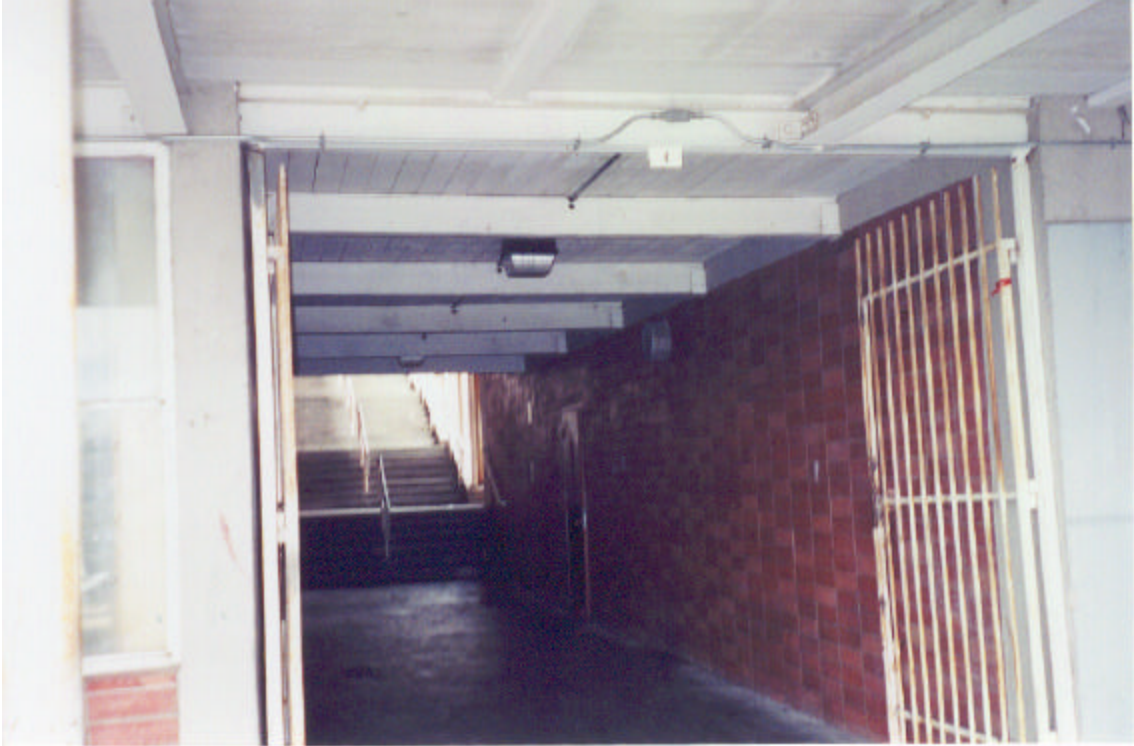
10.	There is a covered walkway between the gymnasium and the attached classroom. This walkway is supported by two structurally separate buildings. As they move independently, the covered walkway may lose gravity support and collapse.

Figure 20: Covered walkway at Gymnasium Building between locker rooms and attached classroom building

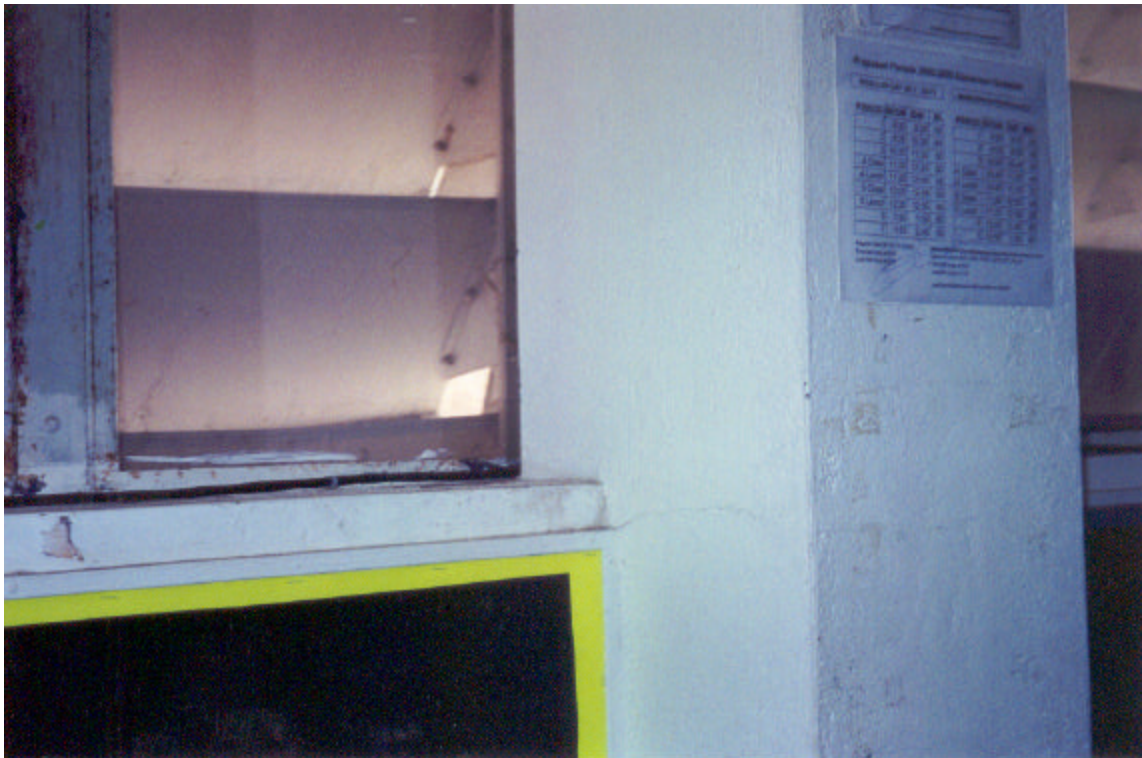
Figure 23: Cracks at the base of columns in Laboratory Building

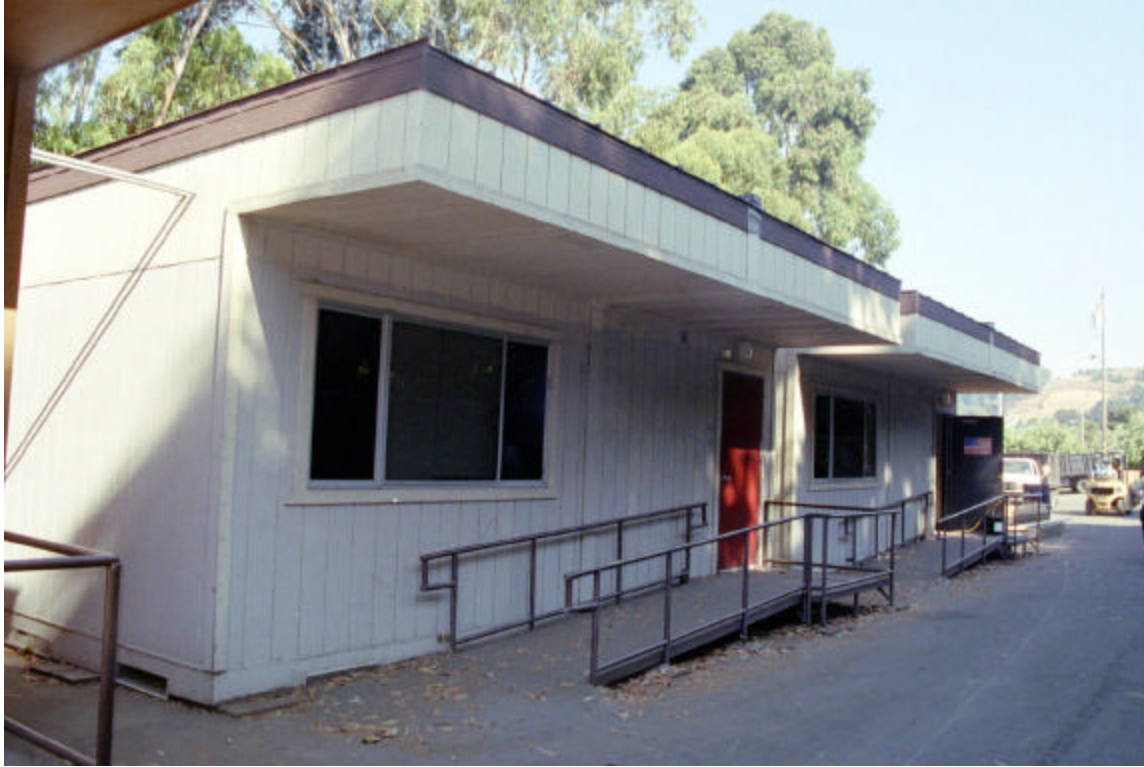
demands on the connecting beams.
14.	At the portable classrooms, there is conduit running between the portable classrooms at the roof level.

Figure 26: Conduit between portable classrooms
