STRUCTURAL EVALUATION OF

BAYVIEW ELEMENTARY SCHOOL

WEST CONTRA COSTA UNIFIED SCHOOL DISTRICT
(WCCUSD)

April 30, 2002

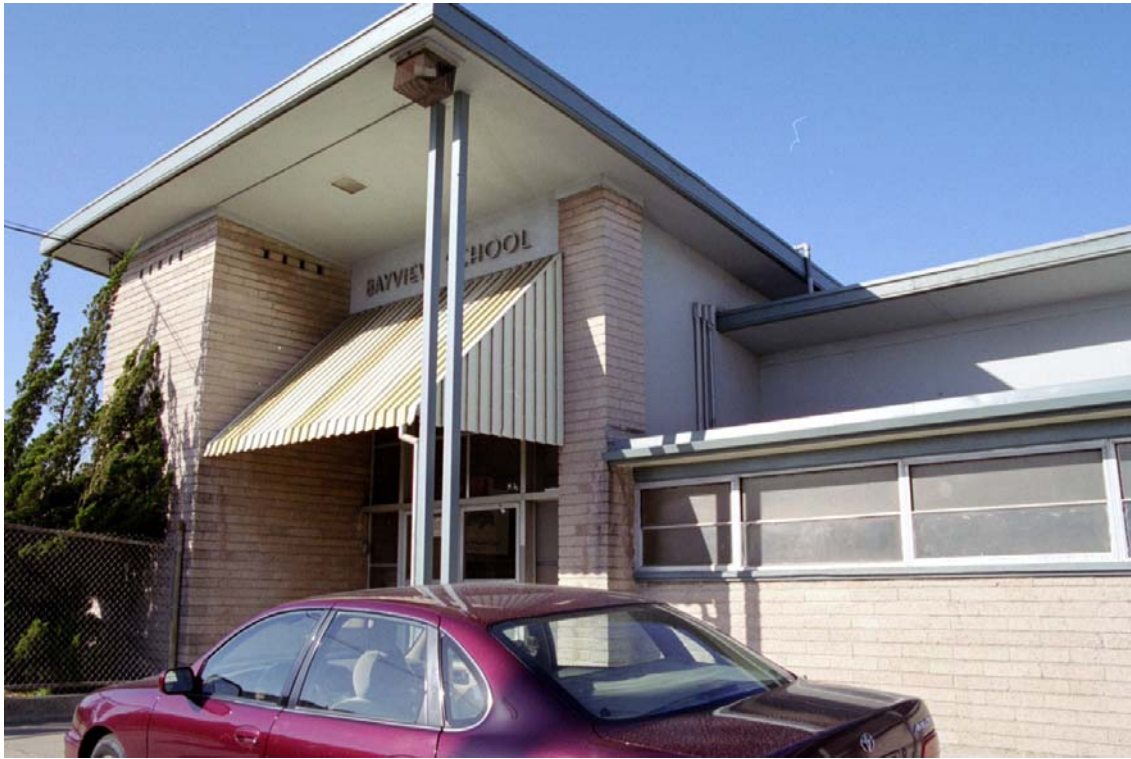
Figure 1: School Layout Plan

5.	At the office area of the main building, the top plate chord splices of the longitudinal walls are overstressed.
6.	At the main entrance to the main building, the tube steel posts supporting the roof overhang are very slender and may require lateral bracing to reduce their unbraced length.

6.	Provide lateral bracing at 1/3 points. Connect the two posts by lacing them together at 12" intervals.	1.8	2
7.	Provide additional out-of-plane anchorage and wall cross-ties	1.0	2, 3

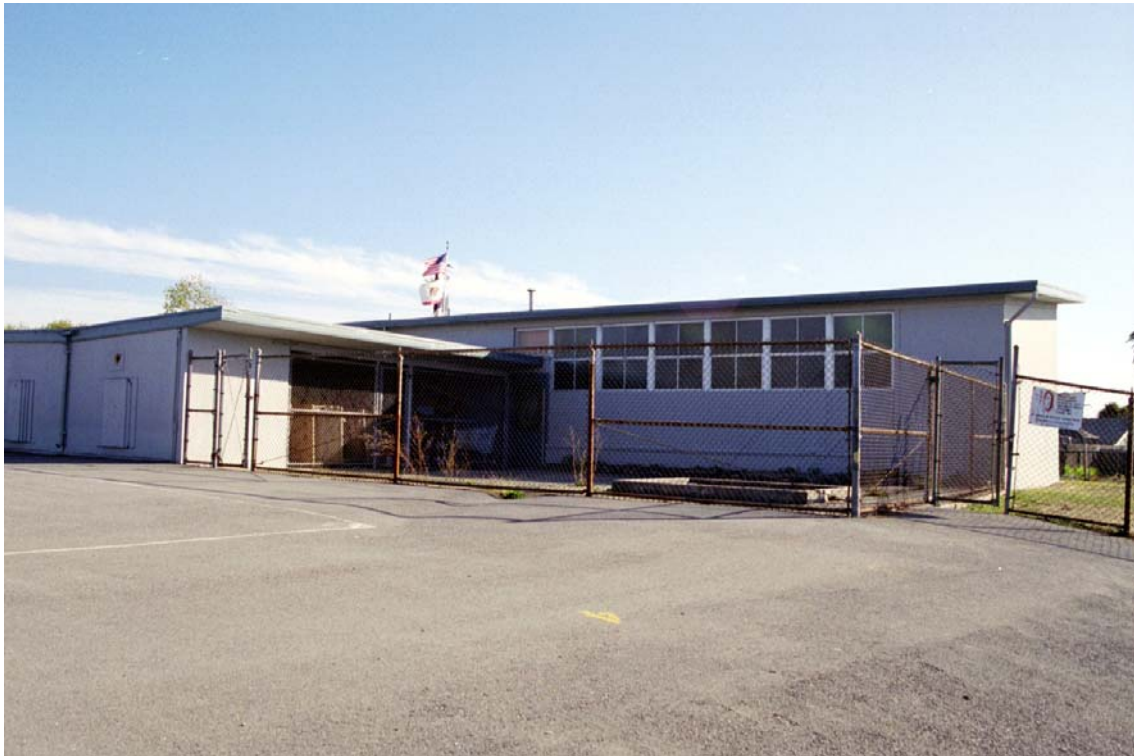
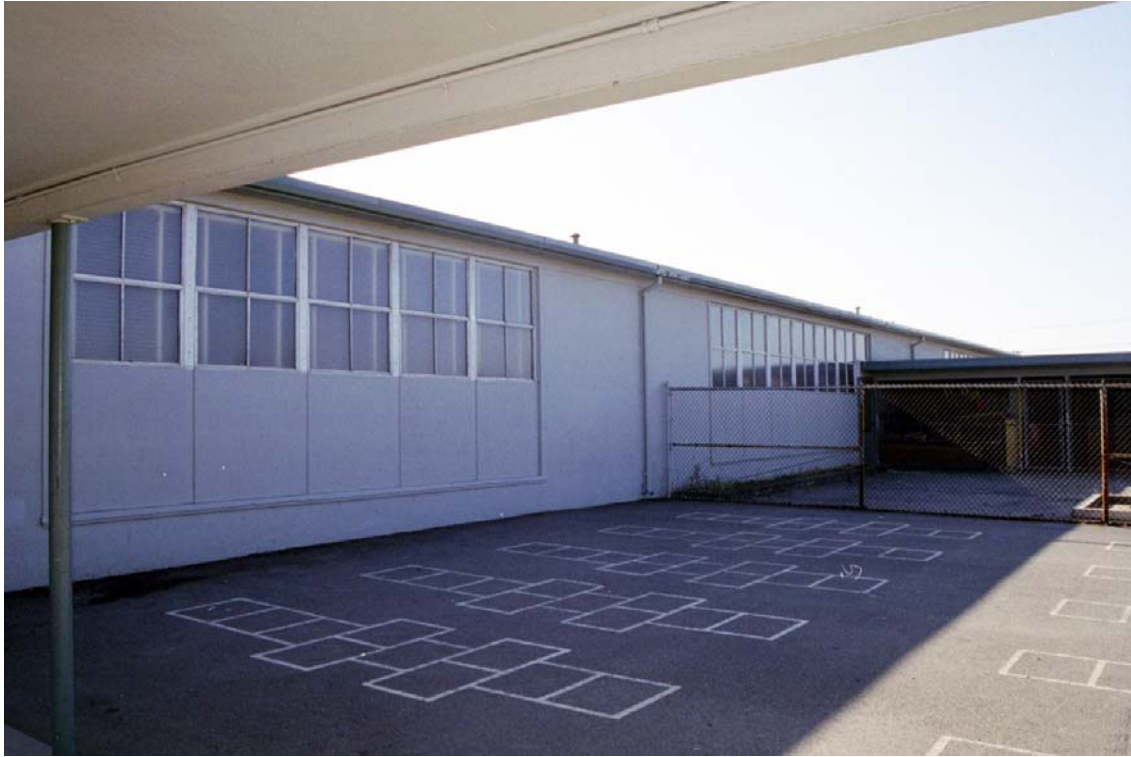
2.	At the rear longitudinal wall of the northeast portion of the main building, there are excessive window openings. Therefore, the shear wall is overstressed.

Figure 4: Interior of Library

Figure 5: Rear View of Northeast Wing of Main Building

2.	Infill some windows with new plywood shear wall. Strengthen existing collectors and add new holdowns as required.	1.2	5, 6
3.	Add plywood sheathing to the unsheathed side of the wall. Strengthen existing collectors and add new holdowns as required.	1.2	4

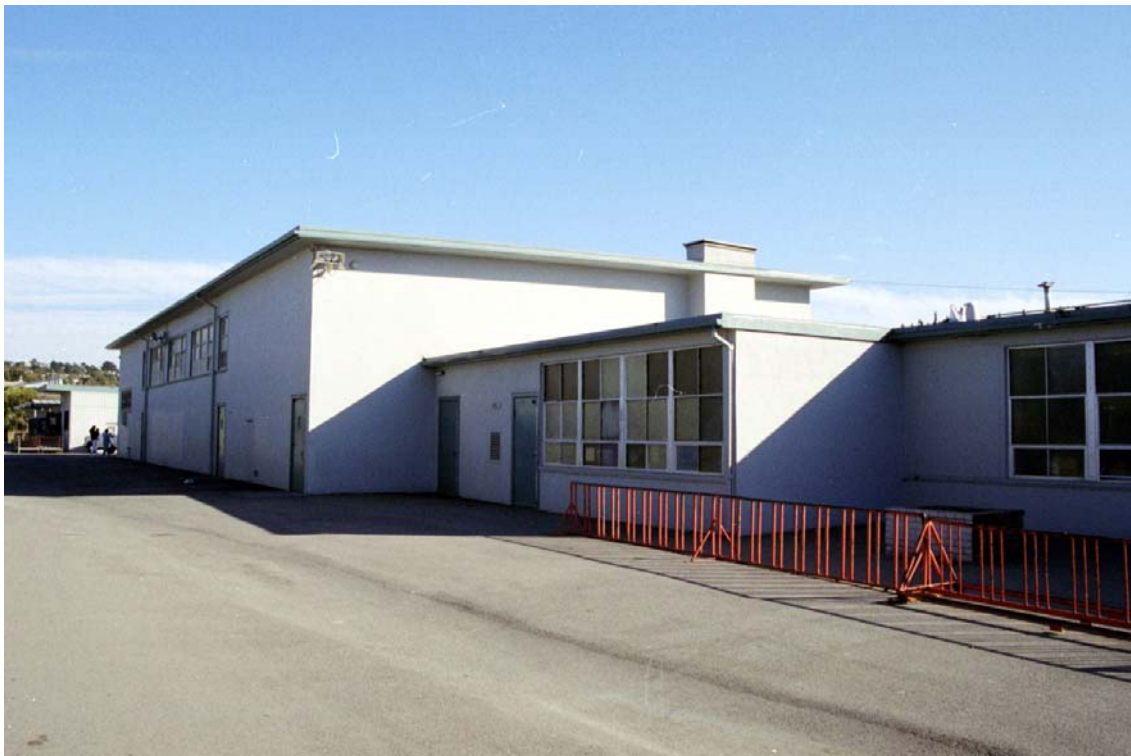
3.	The interior transverse walls at the northeast portion of the main building are overstressed.
4.	The longitudinal walls at the middle portion (offices) of the main building have excessive window openings. The shear walls are overstressed.

8.	At the main building, the exterior longitudinal walls of the multi-purpose room have excessive window openings and are overstressed.
9.	At the main building, the interior transverse wall of the multi-purpose building has inadequate shear wall nailing.

Figure 6: Rear View of Northeast Wing of Main Building

4.	Infill some windows with new plywood shear wall. Strengthen existing collectors and add new holdowns as required.	1.1	7, 8
5.	Add a new continuous strap at the roof above the existing sheathing	1.4	7, 8

8.	Infill some windows with new plywood sheathing. Strengthen existing collectors and add new holdowns as	1.3	7, 8

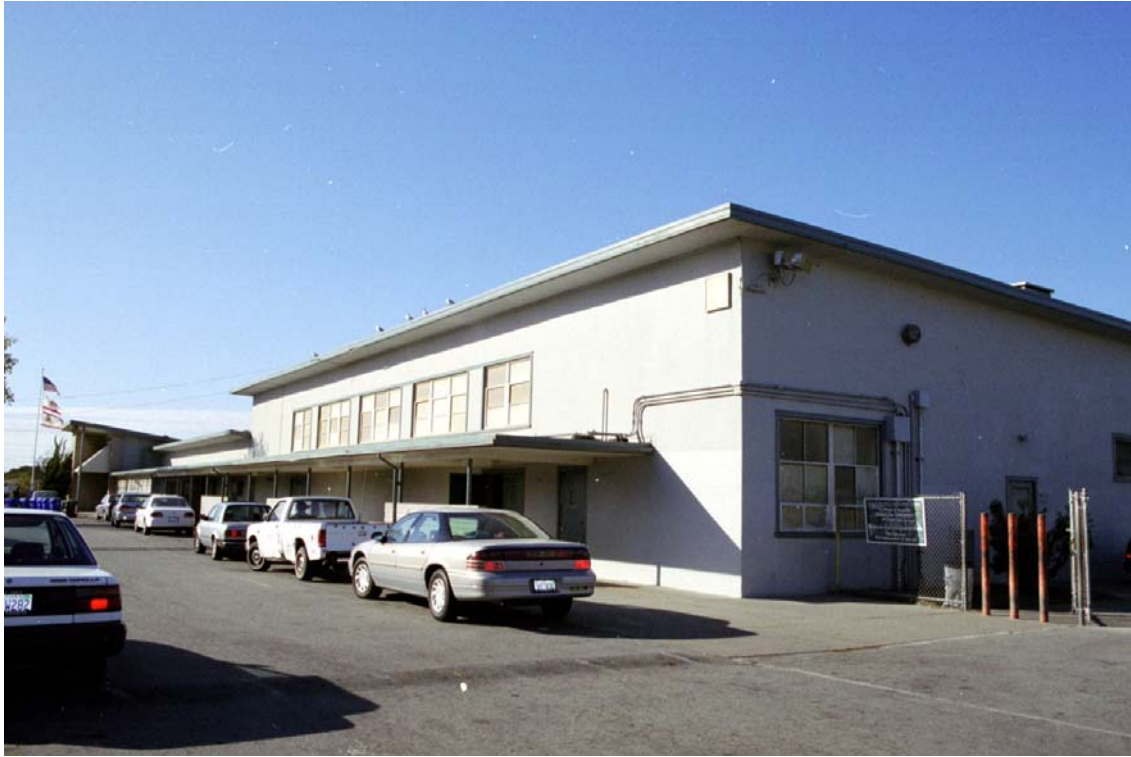
10.	At the main building, the southeast transverse end shear wall of the multi-purpose room is overstressed.
11.	At the main building, the top plate chord splices at the longitudinal walls of the multi-purpose room are overstressed.

Figure 7: Rear View of Offices and Multi-Purpose Room at Main Building

required.		
9.	Add additional nailing at the existing wall sheathing. Strengthen existing collectors and add new holdowns as required.	1.2	N/A
10.	Add new plywood sheathing a the unsheathed face of the wall. Strengthen existing collectors and add new holdowns as required.	1.0	8

11.	Provide a new continuous strap at the roof above the existing sheathing	1.4	7, 8
12.	Provide new strapping and blocking in walls that align with each other	2.1	2, 8

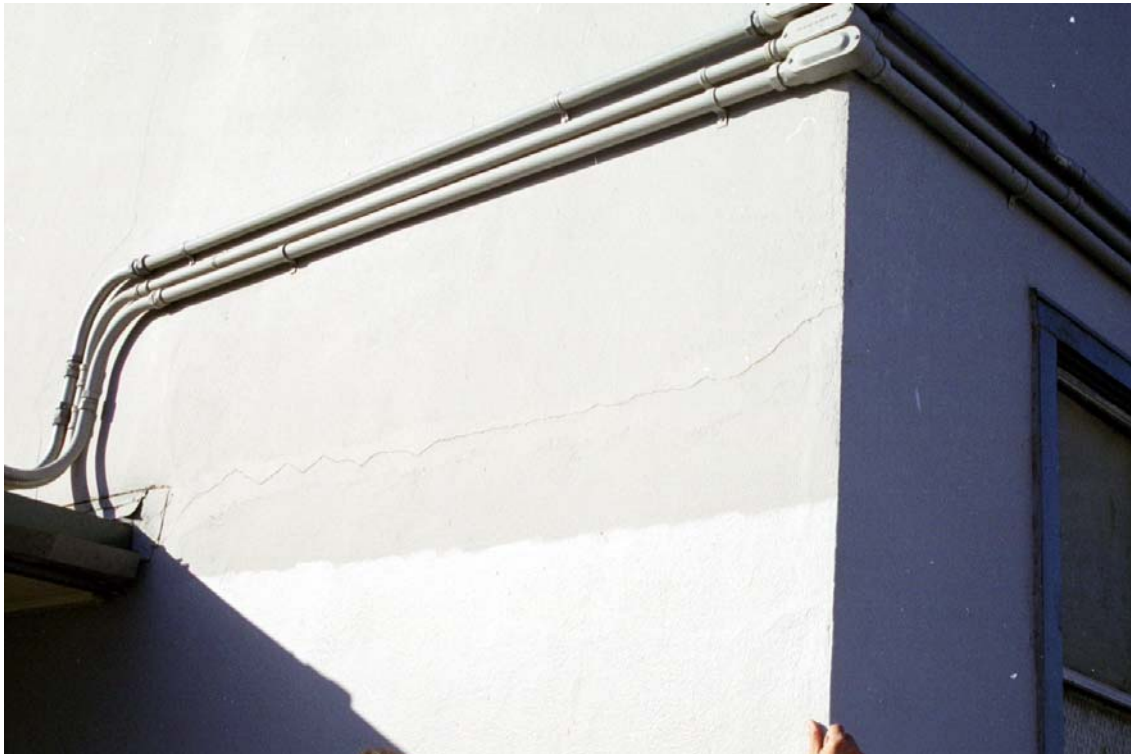
14.	There is cracking in the stucco finish at the southwest corner of the multi-purpose room. This cracking may lead to deterioration of the wall.
15.	There are clerestory windows at the 1952 classroom buildings. The shear walls between the windows may be overstressed.

Figure 8: South Corner of Multi-Purpose Room

13.	Strengthen the existing connection of the office roof into the wall of the multi-purpose room.	2.1	6
14.	Patch the existing stucco	3.0	9
15.	Infill some of the clerestory windows with new plywood shear wall or add new plywood sheathing to the inside face of the existing shear wall. Strengthen existing collectors and add new holdowns as required.	1.7	11

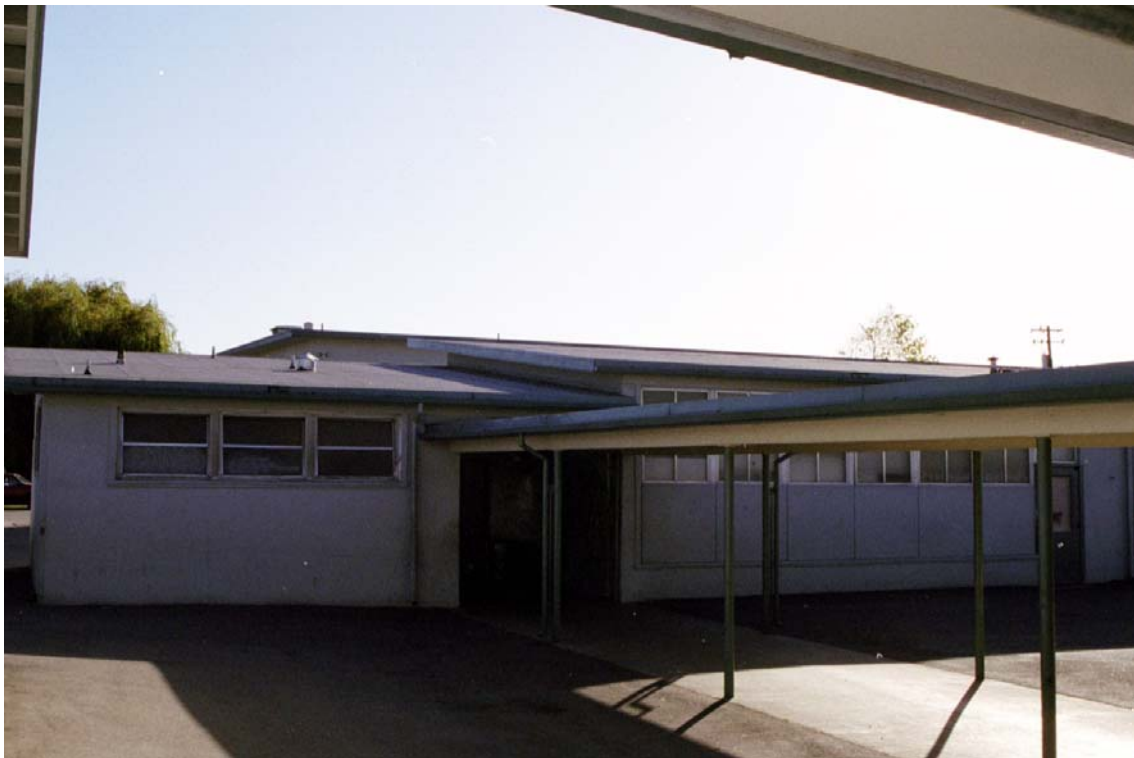
17.	The top plate chord splices at the longitudinal walls of the 1952 classroom buildings are overstressed.
18.	At two of the 1952 classroom buildings, there are restrooms with a low roof at the end of the building. There is a lack of collector continuity at this roof discontinuity that may lead to damage and partial collapse of the corridor roof at this location.

Figure 12: Rear View of 1952 Classroom Building (Typical)

18.	Infill the adjacent windows and provide new collector elements to the longitudinal walls. Strengthen existing collectors and add new holdowns as required.	1.9	13

19.	Provide lateral bracing at the covered walkways	2.0	10, 13
20.	Add new beams and columns to provide a secondary system for gravity support of the walkway.	1.6	10, 13

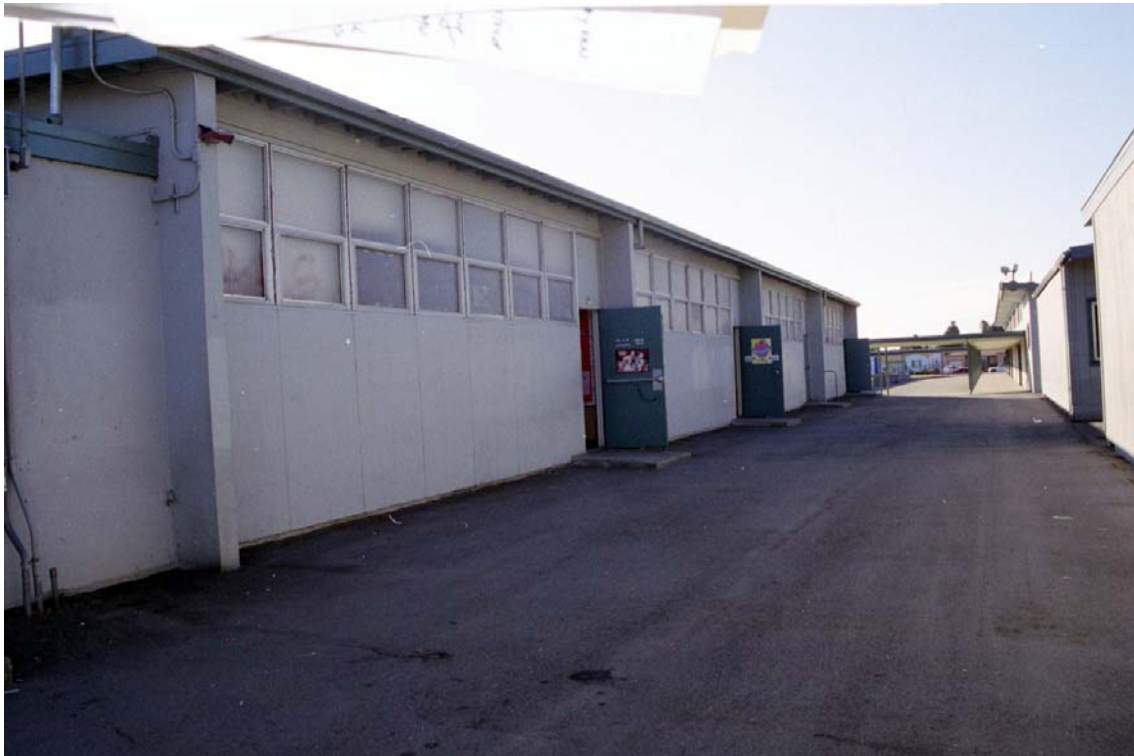
Figure 14: Southeast end of 1957 Classroom Building

21.	The exterior longitudinal walls of the 1957 classroom building have excessive window openings. There is a lack of shear wall at these locations that causes an overstress in the shear wall panels along the corridor.

21.	Infill windows with new plywood shear wall. Strengthen existing collectors and add new holdowns as required.	1.0	15
22.	Provide a flexible connection for conduit crossing the building separations	1.9	18

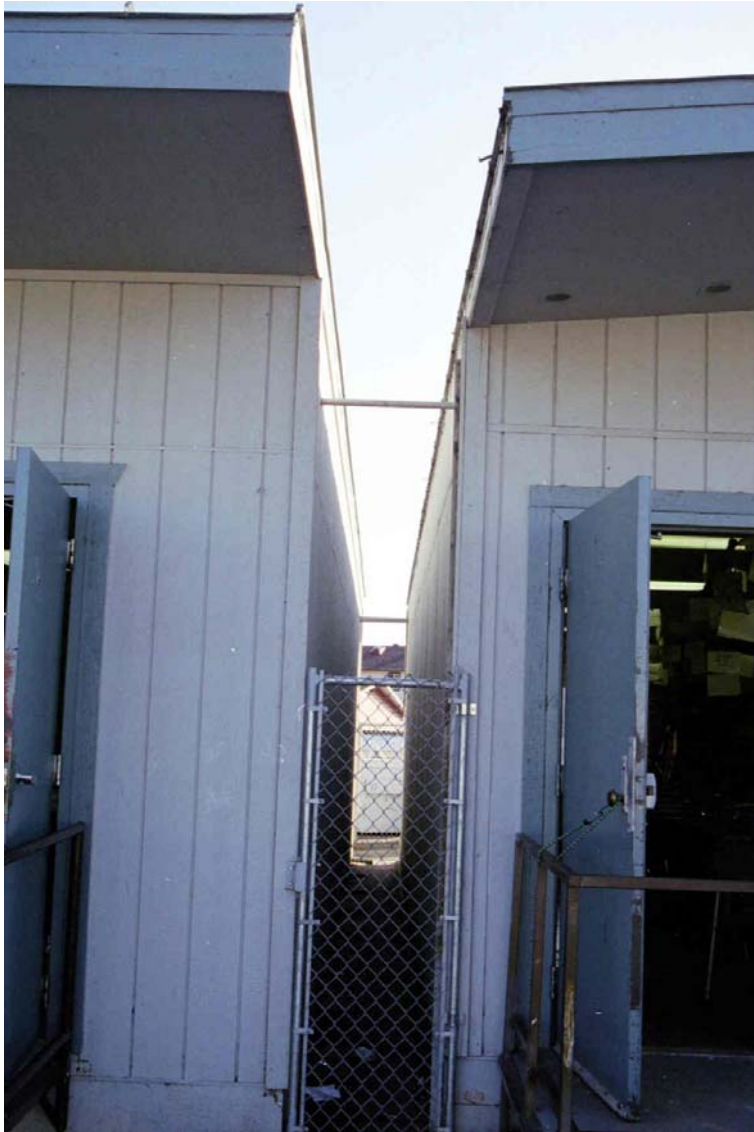
22.	The electrical conduit running between the portable classrooms near the roof level has no flexible connection. It may be damaged as the buildings move independently.

Figure 18: Electrical Conduit between Portable Classrooms
