STRUCTURAL EVALUATION OF  
COLLINS ELEMENTARY SCHOOL  
WEST CONTRA COSTA UNIFIED SCHOOL DISTRICT  
(WCCUSD)

DASSE Design, Inc.  
33 New Montgomery Street #850  
San Francisco, CA 94105  
(415) 243-8400

April 30, 2002

DASSE Design Project No. 01B300

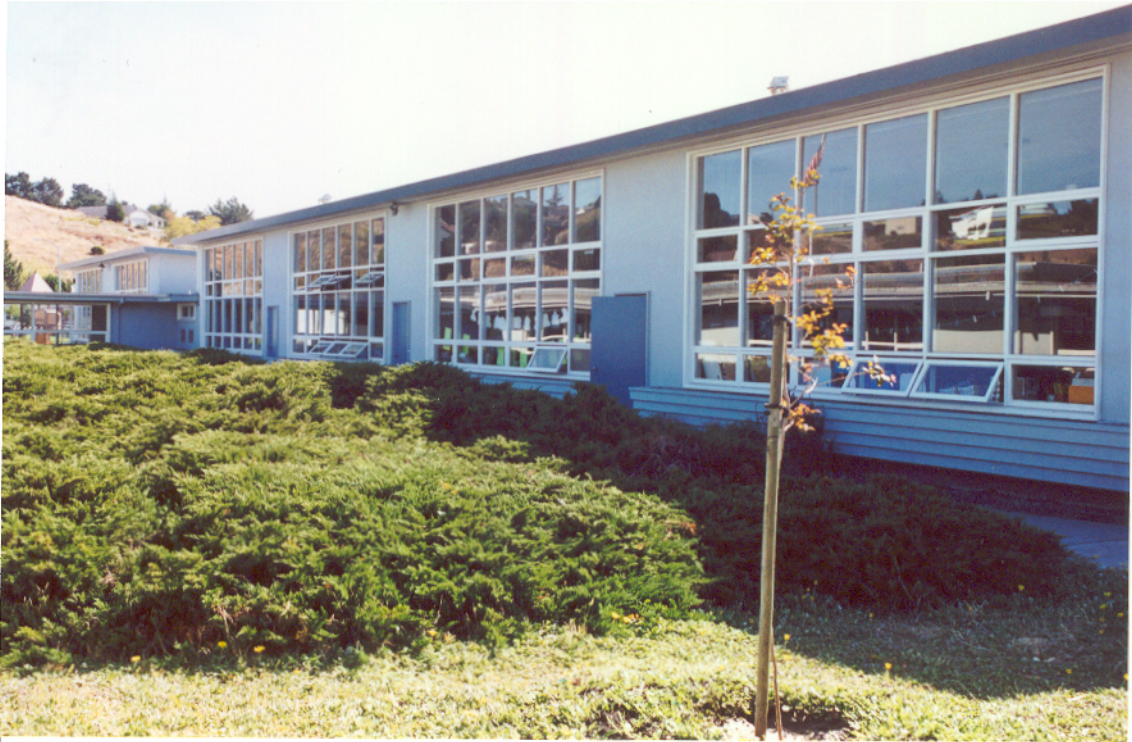
Item	Building Structural Deficiencies
1.	Exterior longitudinal walls of classroom numbers 1 through 6, 17 through 22, K1, K2, 25, and 26 have large portions of wall window openings (see figures 3, 4, 5, & 6), resulting in inadequate length of shear wall to resist seismic forces.
2.	Transverse shear walls of classroom numbers 1 through 6, and 17 through 22 are overstressed.
3.	Multi-Purpose room has continuous high windows on exterior longitudinal walls. Hence there is no mechanism to transfer the roof diaphragm (seismic) forces to shear wall below.

Figure 3: Exterior (front) wall of Classrooms 19 through 22

Item	Recommended Remediation	Priority	Figure Number
1.	Increase the length of shear walls by filling-in existing window openings with new plywood and framing. Provide new collectors to transfer the seismic forces to the new shear walls. Provide holdowns as required.	1.2	3, 5
2.	Reinforce transverse shear walls.	1.2	N/A
3.	Fill-in some of the existing high window openings at each end of the wall with new plywood and framing. Provide new collectors and holdowns as required.	1.2	N/A
4.	Use epoxy grout to fill in existing cracks in slabs on grade and follow Geotechnical Consultant's recommendations regarding treatment of expansive soil.	3.0	8
5.	At pre 1960 buildings install new plywood sheathing over existing 1x sheathing when new roofing is installed.	2.5	N/A
6.	Provide supplemental support adjacent to building so that damage will not lead to collapse of the walkway.	1.9	7

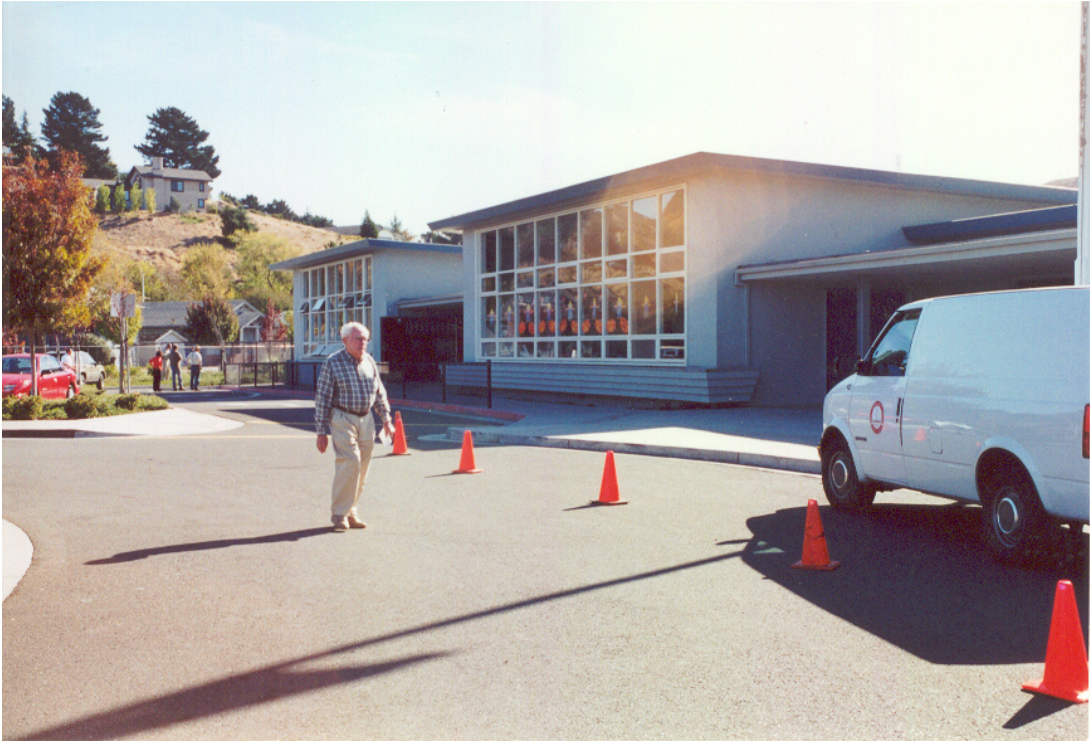
Figure 4: Exterior (front ) wall of Kindergarten classroom

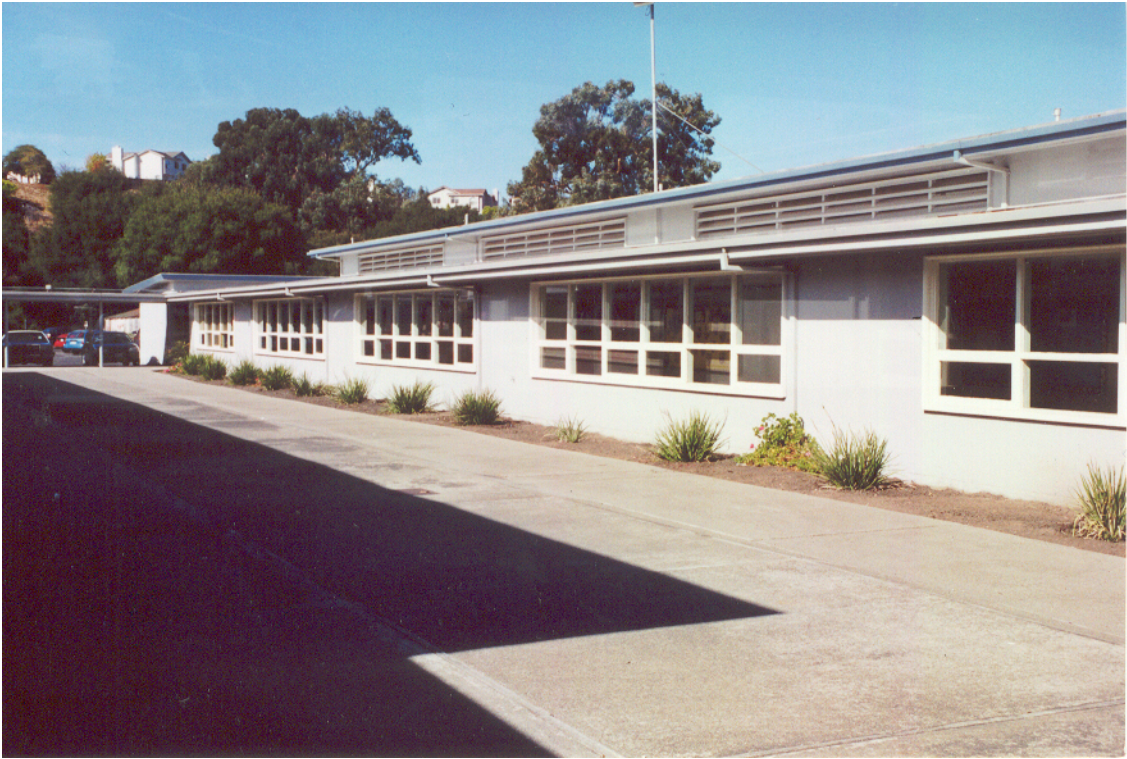
Figure 5: Exterior longitudinal (back) wall of class rooms with clerestory windows

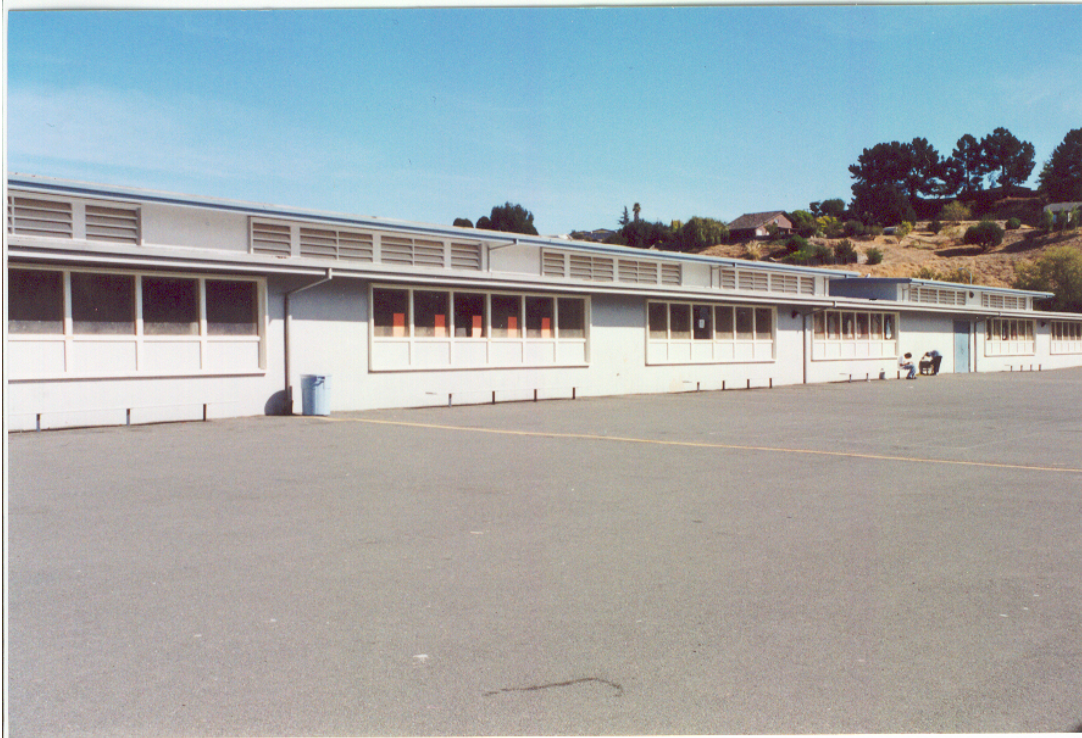
Figure 6: Exterior longitudinal (rear) wall of classrooms ( No.'s 19 to 22) with clerestory windows.

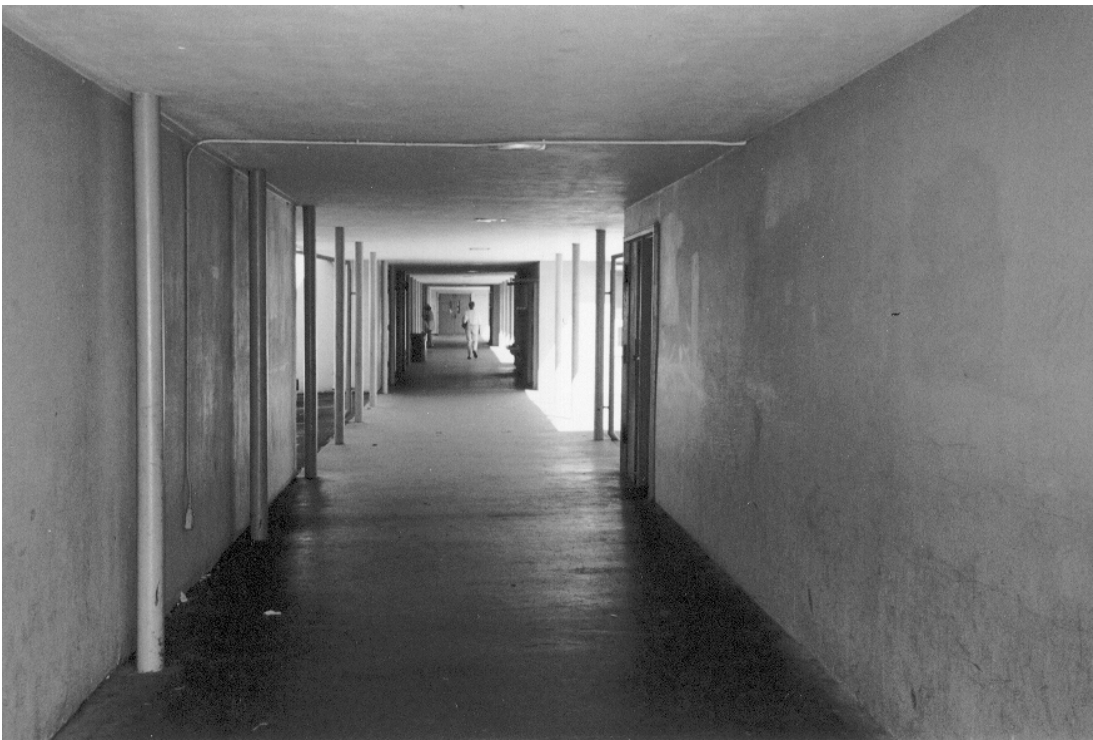
There are no seismic joints between the original building built in 1949 and subsequent additions in the years 1954, 1960, and 1965. It is expected that the covered walkways connecting the various wings will suffer some distress in a major earthquake and as a result they should be modified to prevent collapse as a result of the expected damage.

4.	Large cracks in slabs on grade indicate presence of expansive soil.
5.	Existence of 1x sheathing on roof limits roof diaphragm capacity.
6.	The covered walkways that connect the buildings do not have any provision to accommodate the movement of the adjacent buildings and thus will likely experience damage in a major seismic event.

Figure 7: Covered walkway supported on pipe columns

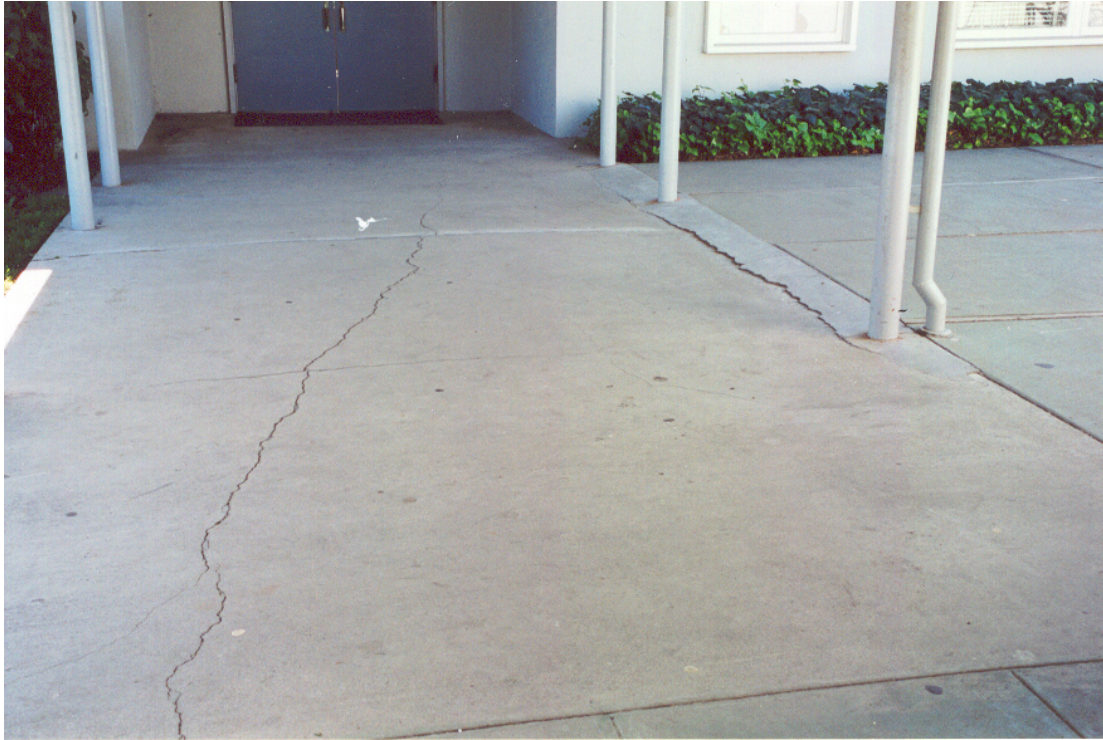
Large cracks in the slab on grade were observed and this might be due to the presence of expansive soil (see figure 8).

Figure 8: Cracks in existing slab-on-grade
