STRUCTURAL EVALUATION OF  
CORONADO ELEMENTARY SCHOOL  
WEST CONTRA COSTA UNIFIED SCHOOL DISTRICT  
(WCCUSD)

WLC Architects  
Kaiser Building  
1300 Potrero Avenue  
Richmond, CA 94804

DASSE Design, Inc.  
33 New Montgomery Street #850  
San Francisco, CA 94105  
(415) 243-8400

April 30, 2002

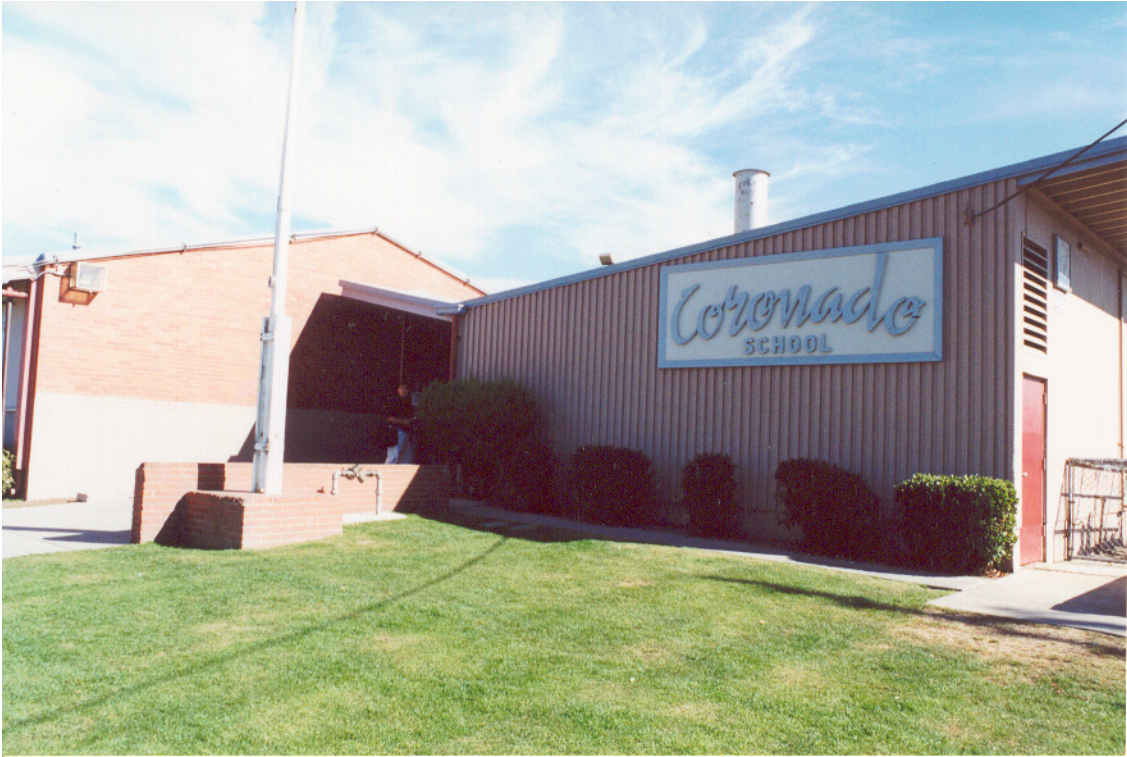
Figure 2: Front Entrance

The office building has wood siding at the transverse end walls (see figure 2). The exterior longitudinal walls have stucco finish and openings along a large portion of their length (see figures 3 and 4). The roof overhang at the office building has a plaster soffit instead of exposed sheathing (see figure 4) and connects to the building at an angle, creating a valley along the length of the building where it intersects the main roof.

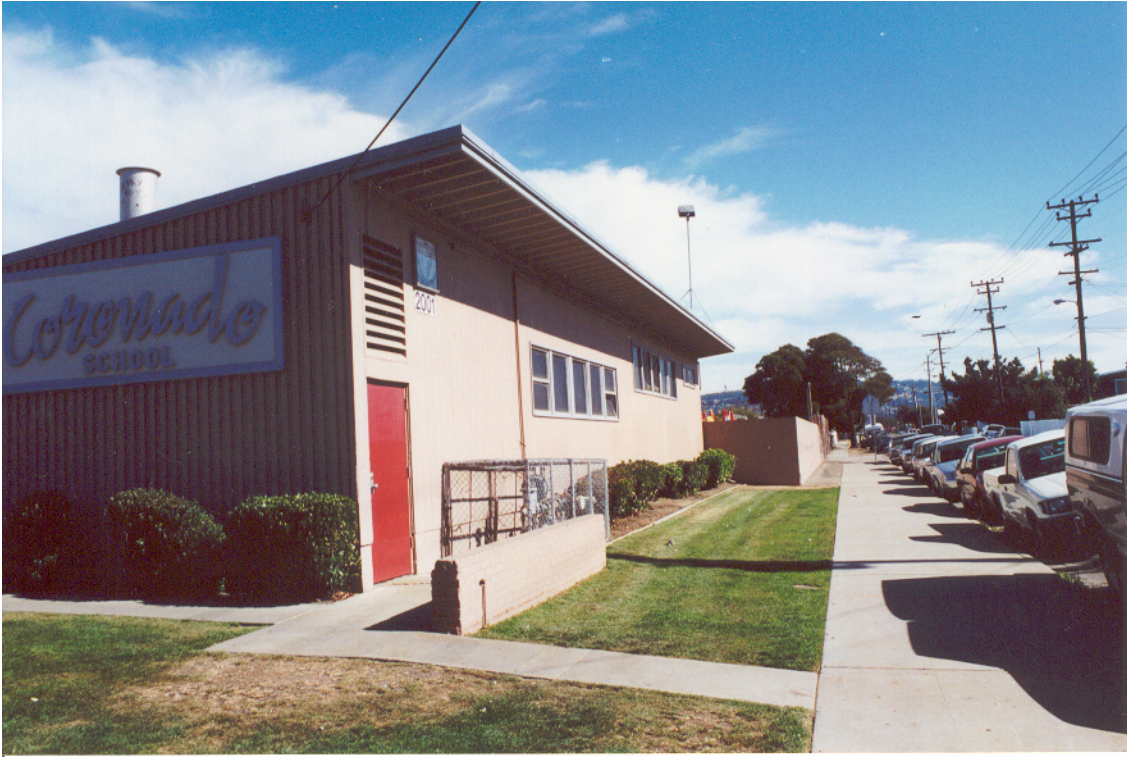
Figure 3: North Corner of Office Building

7.	The northwest longitudinal wall of the office building has high windows along a significant portion of its length, resulting in a lack of shear wall.

6.	Add new wall sheathing. Strengthen existing collectors and provide new holdowns as required.	1.0	N/A
7.	Same as item number 1.	1.1	3
8.	Same as item number 1.	1.1	6, 9

14.	Provide flexible connections in the conduit at building separations.	1.9	7, 11
15.	Same as item number 14.	1.9	11
16.	Same as item number 14.	1.9	24
17.	Remove the existing brick wall.	1.9	3, 8

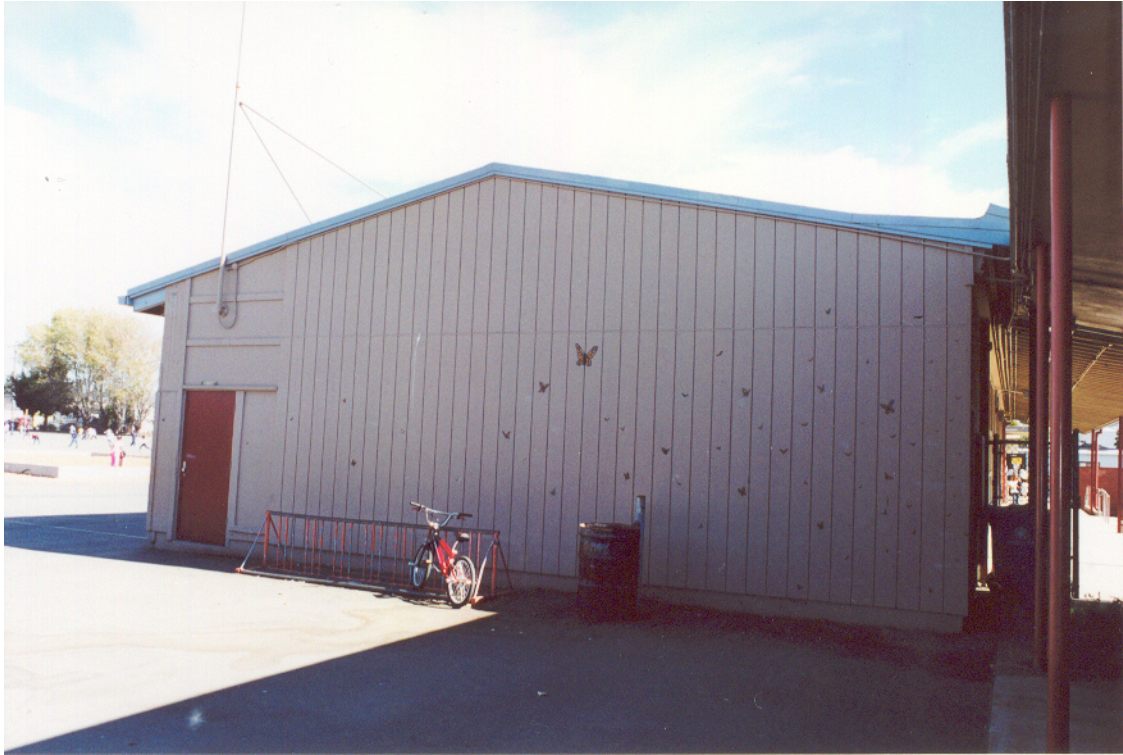
Figure 5: Northeast Face of Kindergarten Building

The kindergarten building has wood siding on all four walls. The longitudinal walls have a significant number of window openings. The wood siding at the southwest end wall of the kindergarten building is warped, apparently from water damage (see figures 5 through 9).

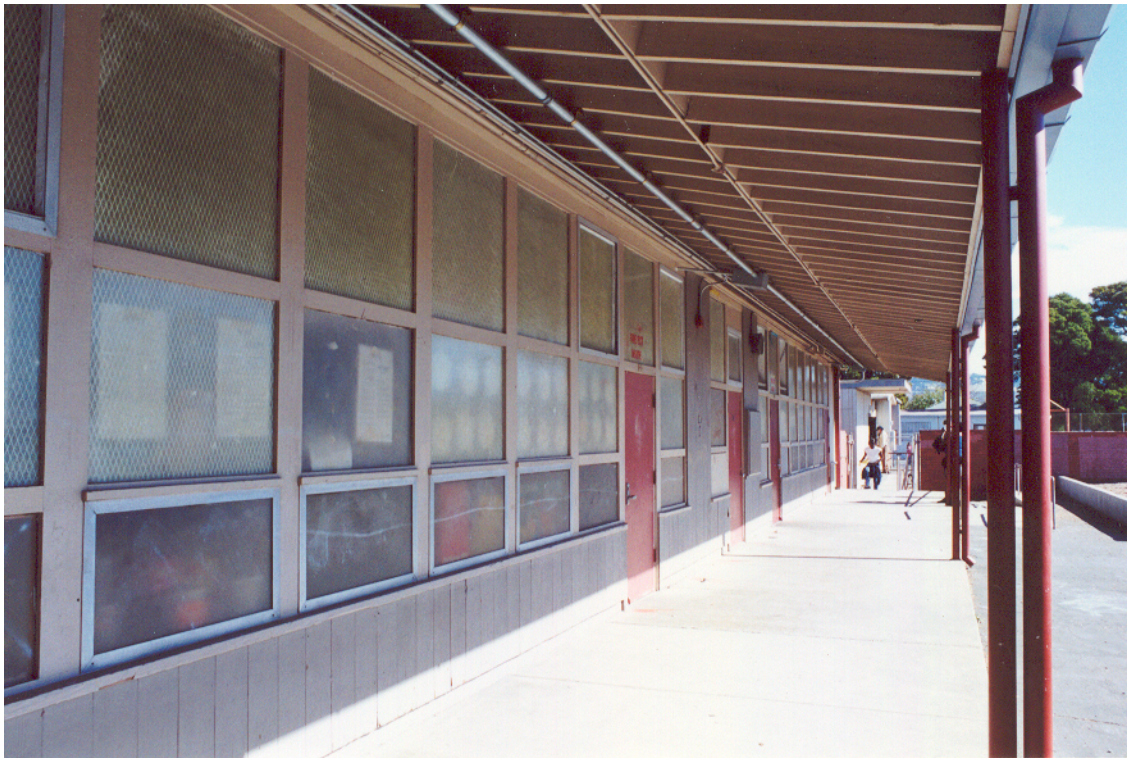
Figure 6: Northwest Face of Kindergarten Building

8.	The exterior longitudinal walls of the kindergarten building lack adequate shear wall. The northwest face of the building has window walls and the southeast face has high windows.

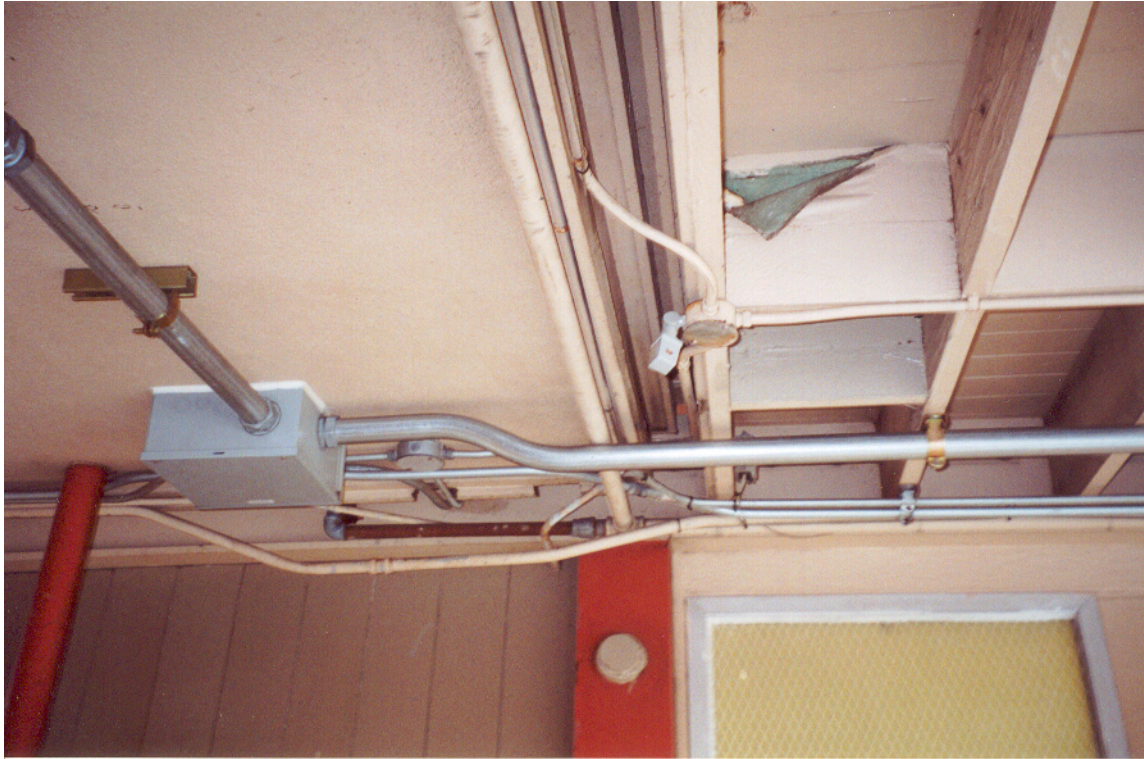
13.	There is significant rusting at the base of the columns at the freestanding covered walkway.
14.	There is conduit attached to the covered walkways that crosses the seismic gaps between buildings. As the buildings move independently, the conduit may be damaged and is a life safety hazard.

Figure 7: Conduit at Seismic Joint Between Office and Kindergarten Buildings

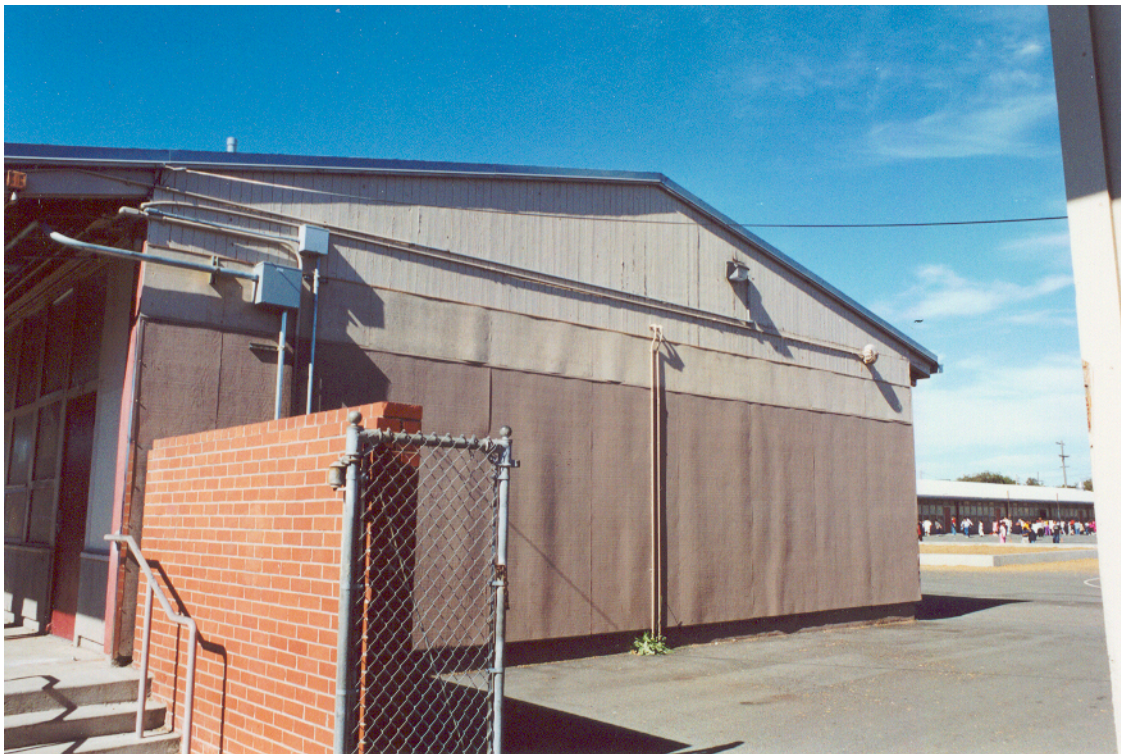
Figure 8: Southwest Face of Kindergarten Building

There is a freestanding 5ft. tall, 9" thick brick wall next to the kindergarten building (see figure 8). The wall is reinforced with #3 bars at 12" on center in the mortar between the brick wythes. There are other freestanding brick walls on campus that are assumed to be similarly reinforced although they are not indicated on the drawings.

9.	The wood siding at the southwest face of the kindergarten building is warped and appears to have water damage.
10.	The top plate splices at the exterior walls of the multi-purpose building are inadequate to carry the diaphragm chord forces.

17.	The freestanding brick walls next to the kindergarten building and at the campus perimeter have inadequate reinforcement and may collapse. This is a life safety hazard.
-----	--

9.	Remove the existing siding and replace it with new T1-11 siding	3.0	8
10.	Provide new continuous straps at the roof above existing sheathing.	1.4	22, 23

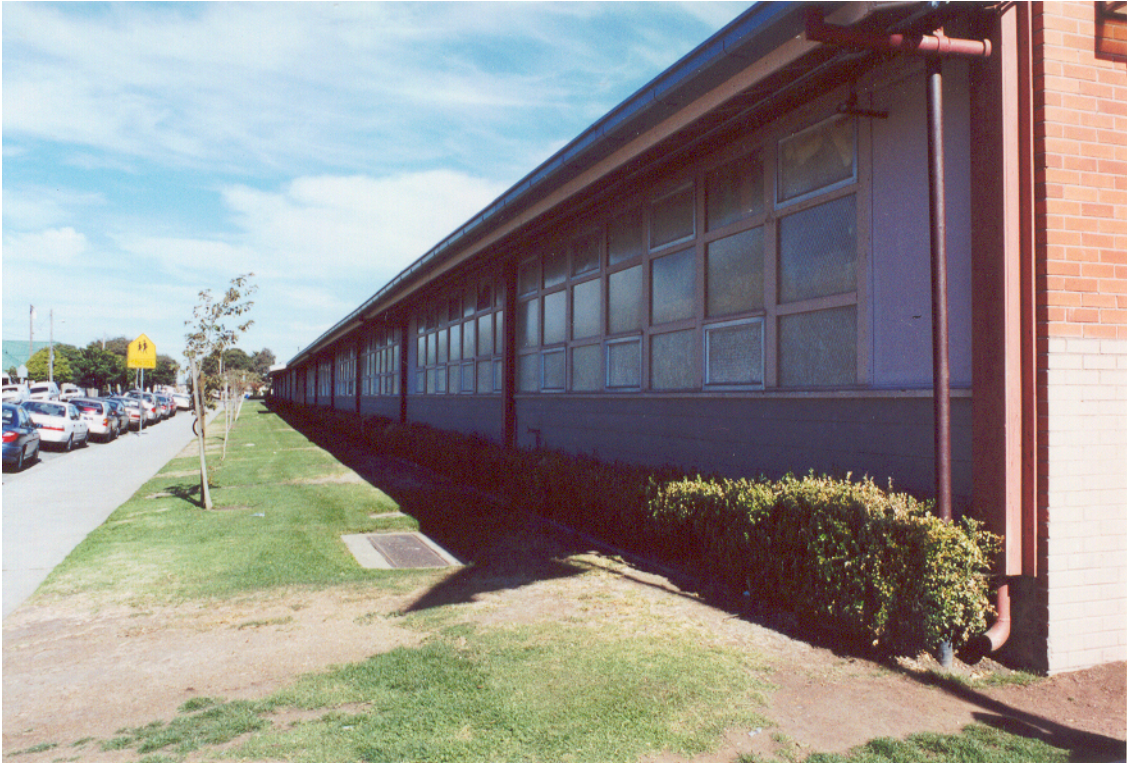
Figure 10: Northeast Face of 1952 Classroom Building

The 1952 classroom building has windows along almost the entire northeast longitudinal wall. There is wood siding up to the bottom of the windows and stucco finish elsewhere (see figure 10). Where the southwest longitudinal wall is at the exterior, it has similar finishes, except that the windows are in a high band along the length of the exterior face of the building (see figure 12). Where the walkway has been enclosed (at room numbers 6 through 14), the southwest wall of the 1952 classroom building has plaster finished walls with wood wainscoting at the lower 3 ft (see figure 14). The northwest and southeast end walls of the building have brick veneer (see figure 2) and stucco finish (see figure 21) over their full heights, respectively. There is also brick veneer at the restrooms near the middle of the building (see figure 15).

Item	Building Structural Deficiencies
1.	The exterior longitudinal walls of the 1952 classroom building lack adequate shear wall. The northeast face of the building has window walls and the southwest face has high windows.

Item	Recommended Remediation	Priority	Figure Number
1.	Infill some windows with new plywood shear wall and framing. Replace straight sheathing below windows with plywood where occurs. Strengthen existing collectors and provide new holdowns as required.	1.1	10, 12, 15

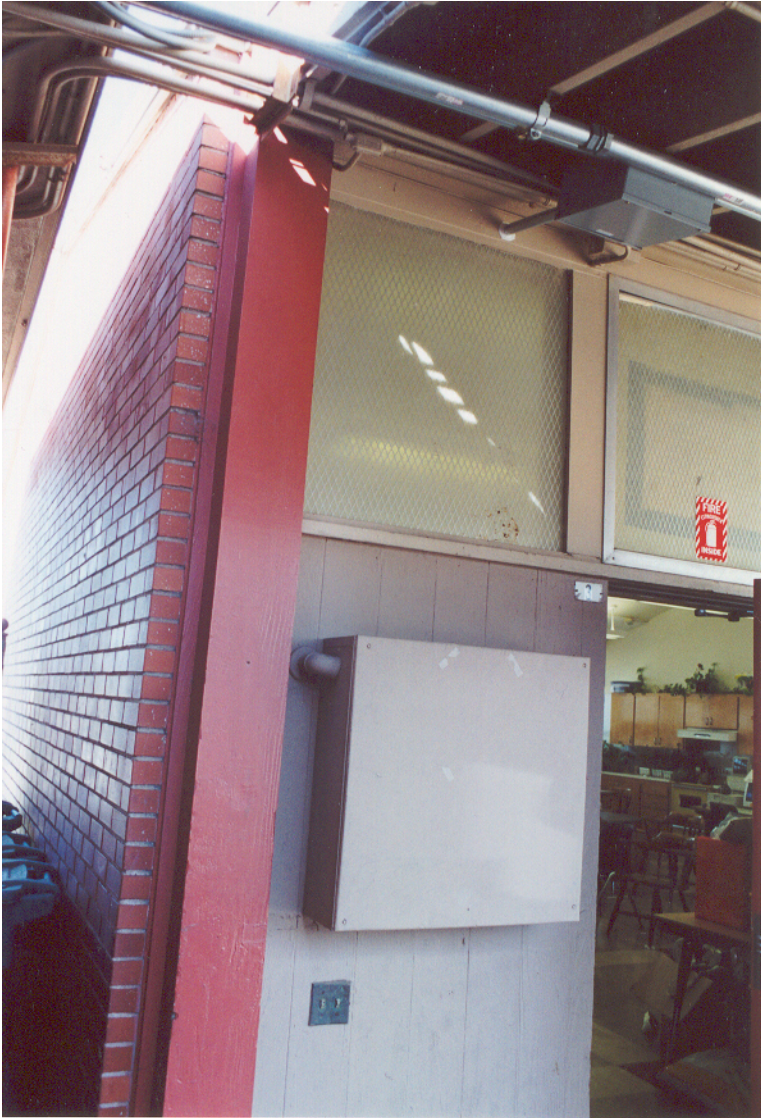
separated by seismic gaps, but in many areas there is electrical conduit that crosses these gaps with rigid connections (see figures 11 and 14).

15.	There is conduit and ducts that cross the building separation between the 1952 classroom building and the 1960 and 1962 classroom buildings. As the buildings move independently, they may be damaged and are a life safety hazard.

Figure 11: Seismic Joint between Office Building and 1952 Classroom Building

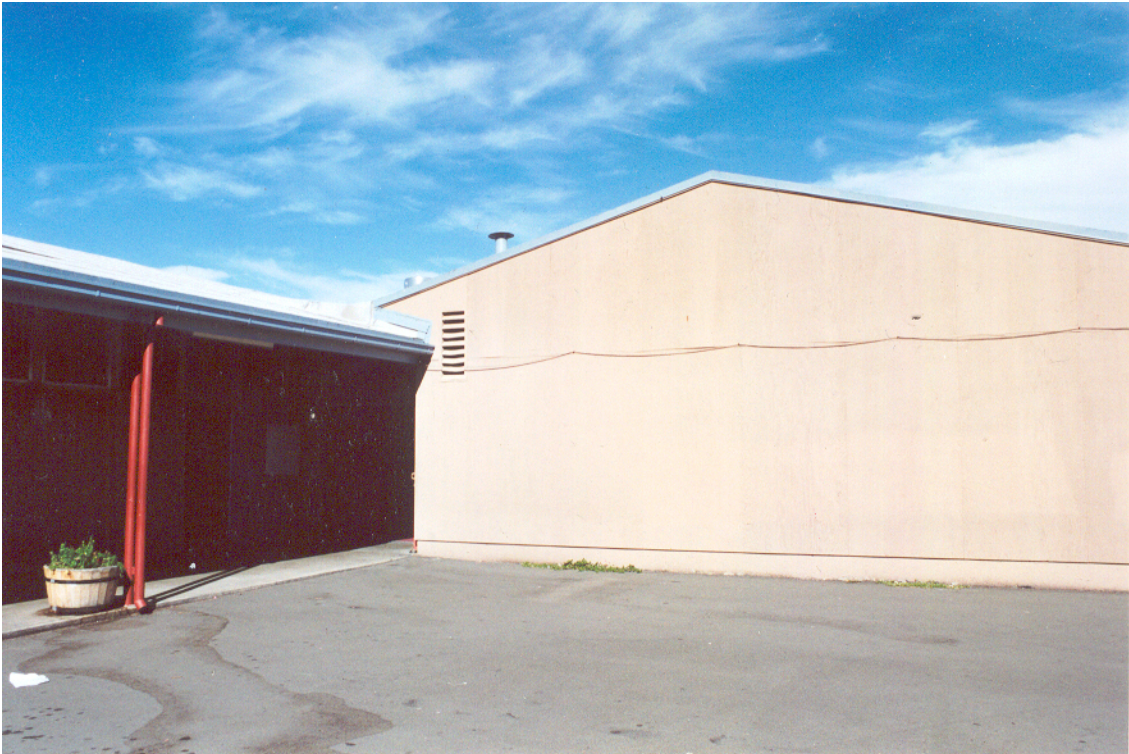
Figure 13: Northwest Face of 1962 Classroom Building at 1952 Classroom Building

The 1960 and 1962 classroom buildings have large windows along the southwest longitudinal wall with wood siding below (see figure 17). The northeast longitudinal walls have plaster finish and wood wainscoting similar to the enclosed portion of the 1952 classroom building. The transverse end walls of these buildings have wood siding over the entire height (see figures 13 and 21).

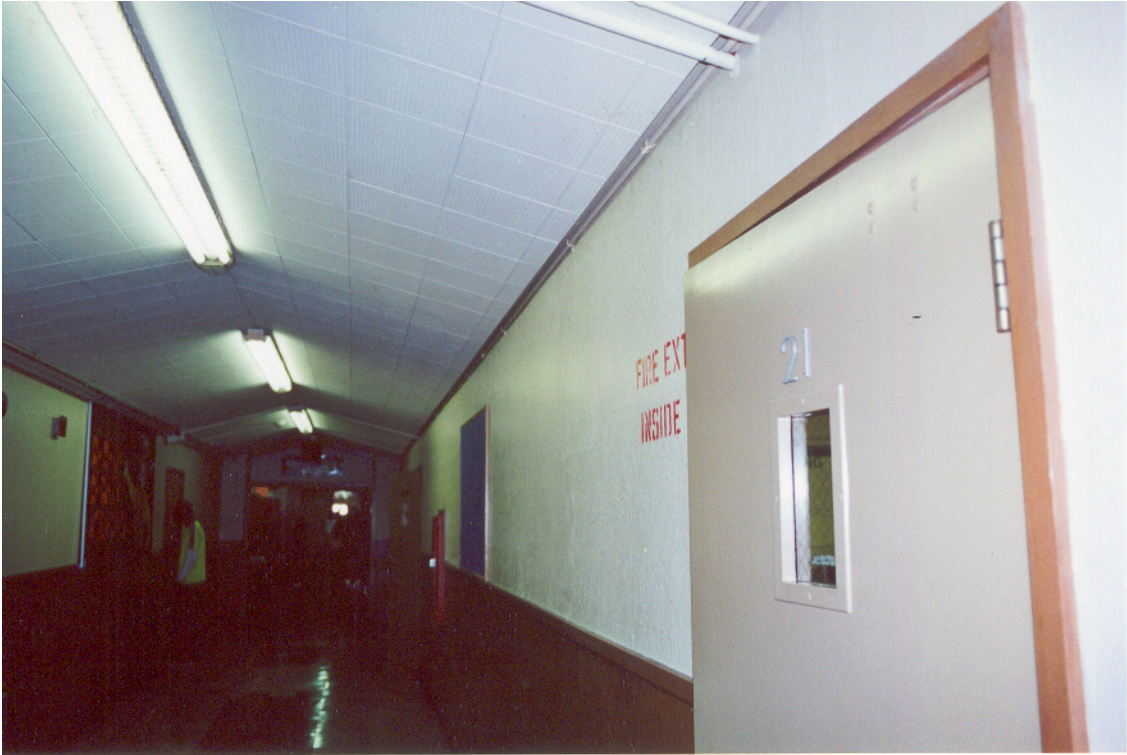
Figure 14: Corridor between Classroom Buildings

The classroom buildings, which at first glance appear to be one building, are actually three separate structures with seismic gaps between them. The 1952 classroom building, which includes rooms number 4 through number 14, originally had a covered exterior walkway along the entire southwest side. In 1960, classrooms number 15 through number 19 were added. This new building was built right next to the existing 1952 classroom building. The northeast wall of the 1960 building, together with the roof overhang and southwest wall of the 1952 building, effectively enclosed the existing walkway (see figure 13). Although small seismic gap was left between the two buildings and the roof was flashed so as to prevent the entry of water, some ductwork and electrical conduit crosses the building separation (see figure 14). A new ceiling

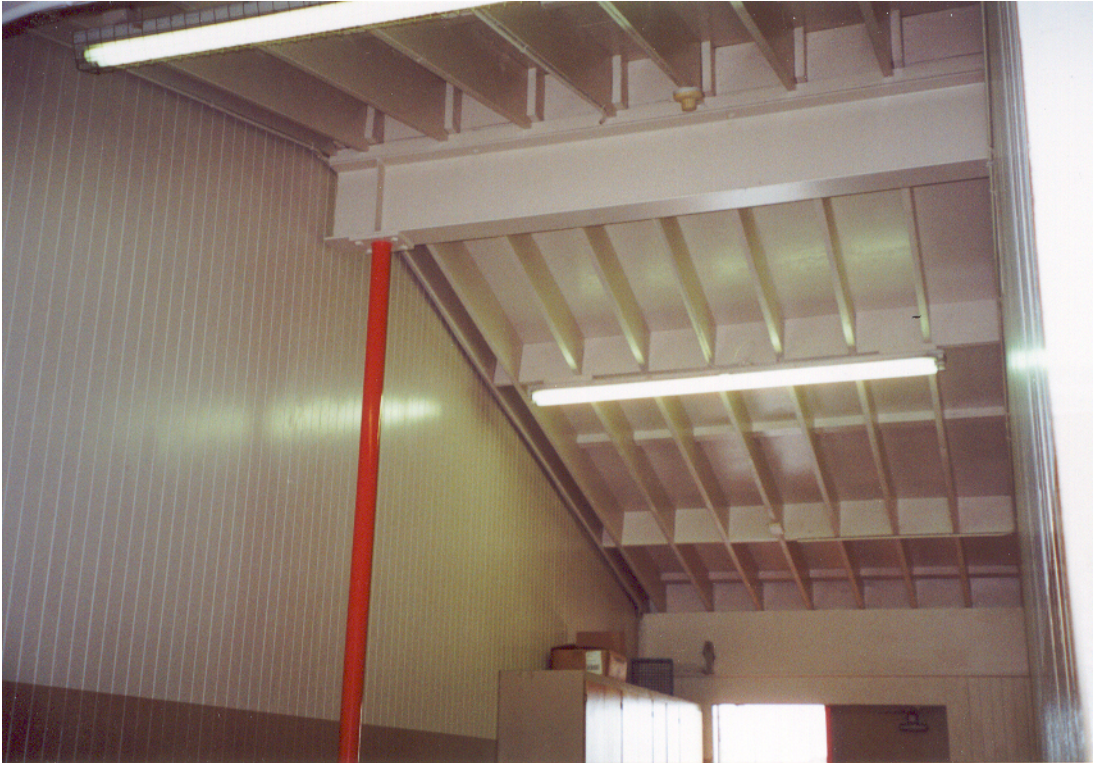
Figure 16: Corridor between 1960 and 1962 Classroom Buildings

4.	At the 1962 classroom building, there is a covered passageway near room 20A. The collector connection from this roof area to the shear walls on the northeast face of the building is overstressed.

4.	Provide additional strapping at the collector.	1.4	16
5.	Add new plywood to the unsheathed face of the walls. Provide new strapping and blocking at the roof. Strengthen existing collectors and provide new holdowns as required.	1.2	N/A

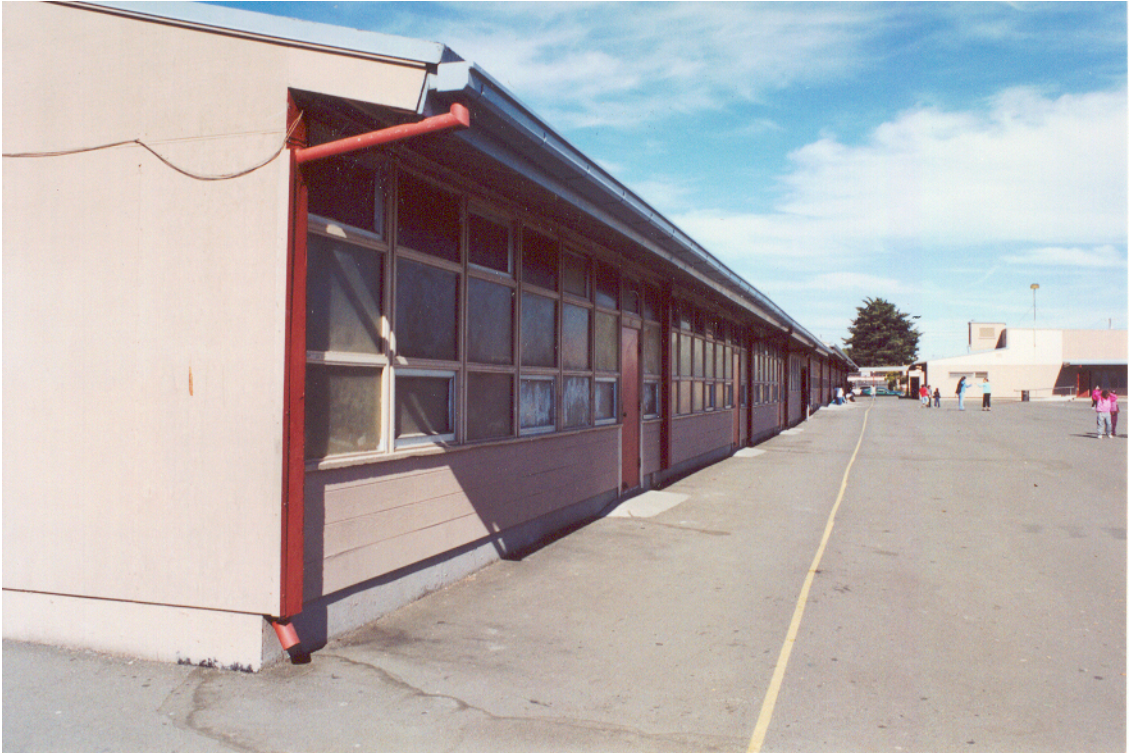
Figure 17: Southwest Face of 1960 and 1962 Classroom Buildings

2.	The transverse shear walls of the 1960 and 1962 classroom buildings are overstressed.
3.	The southwest longitudinal wall of the 1962 classroom building has windows along the entire length, resulting in a lack of shear wall.

2.	Provide new plywood sheathing at the unsheathed side of the wall. Strengthen existing collectors and provide new holdowns as required.	1.7	N/A
3.	Same as item number 1.	1.8	17

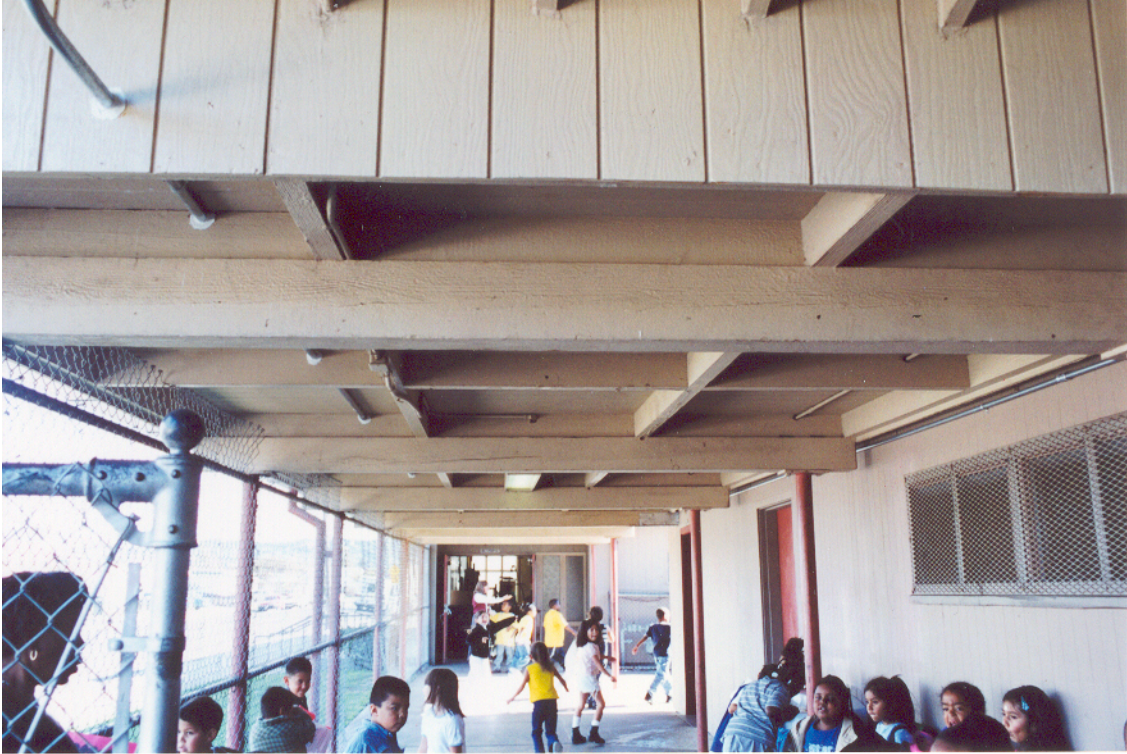
Figure 18: Covered Walkway at Southeast End of Classroom Buildings

The freestanding covered walkway is supported both vertically and laterally by pipe columns (see figures 18 and 21) and is intended to be seismically separate from the adjacent buildings. It appears that a modification of the original design has been made at the covered walkway; one of the columns has been removed and a new bucket seat was installed to support the beam that it was underneath (see figure 19). This bucket seat is connected to the wall of the 1960 classroom building and crosses the seismic separation. There is also significant rusting at the base of the covered walkway columns (see figure 20).

11.	The covered walkway that runs between the classroom buildings and multi-purpose building lacks adequate lateral bracing.
12.	One of the columns at the freestanding covered walkway has been removed and replaced with a bucket seat that is attached to the wall of the 1960 classroom building. As the building and walkway move independently, this connection may be damaged and cause a partial collapse of the covered walkway.

11.	Provide new lateral bracing in both directions.	1.5	18, 21
12.	Re-install a column at that location	1.2	19
13.	Determine level of damage and replace column if necessary.	1.9	20

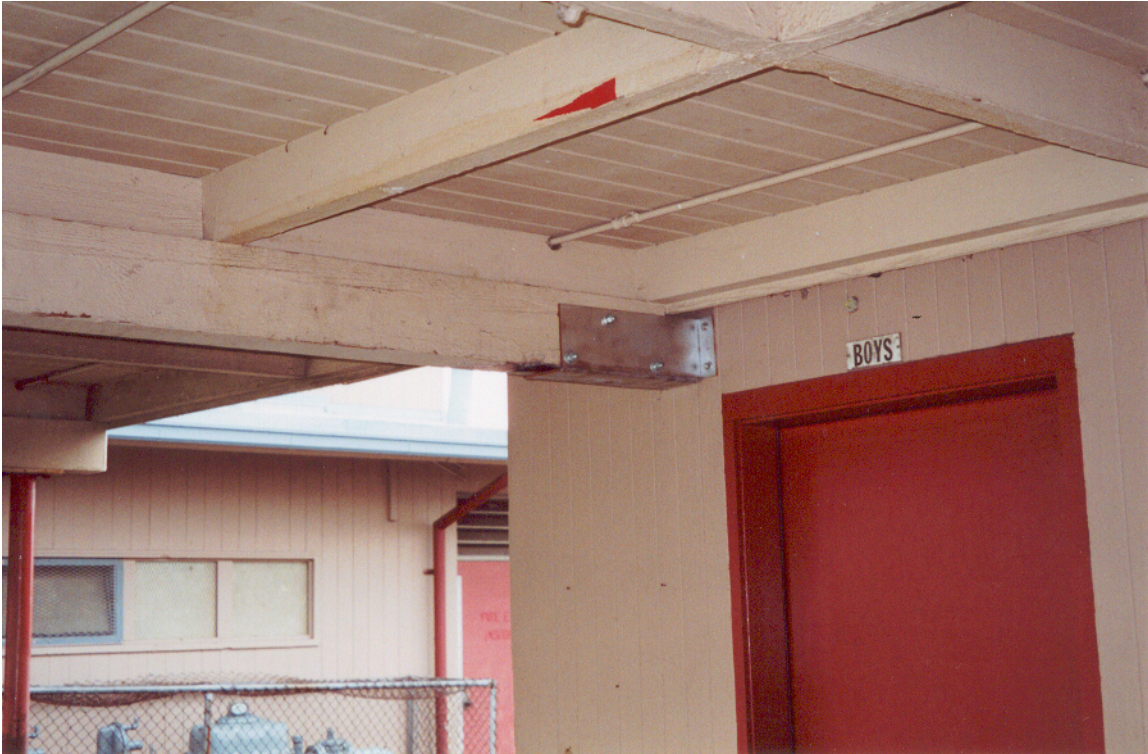
Figure 19: Beam Support at Covered Walkway

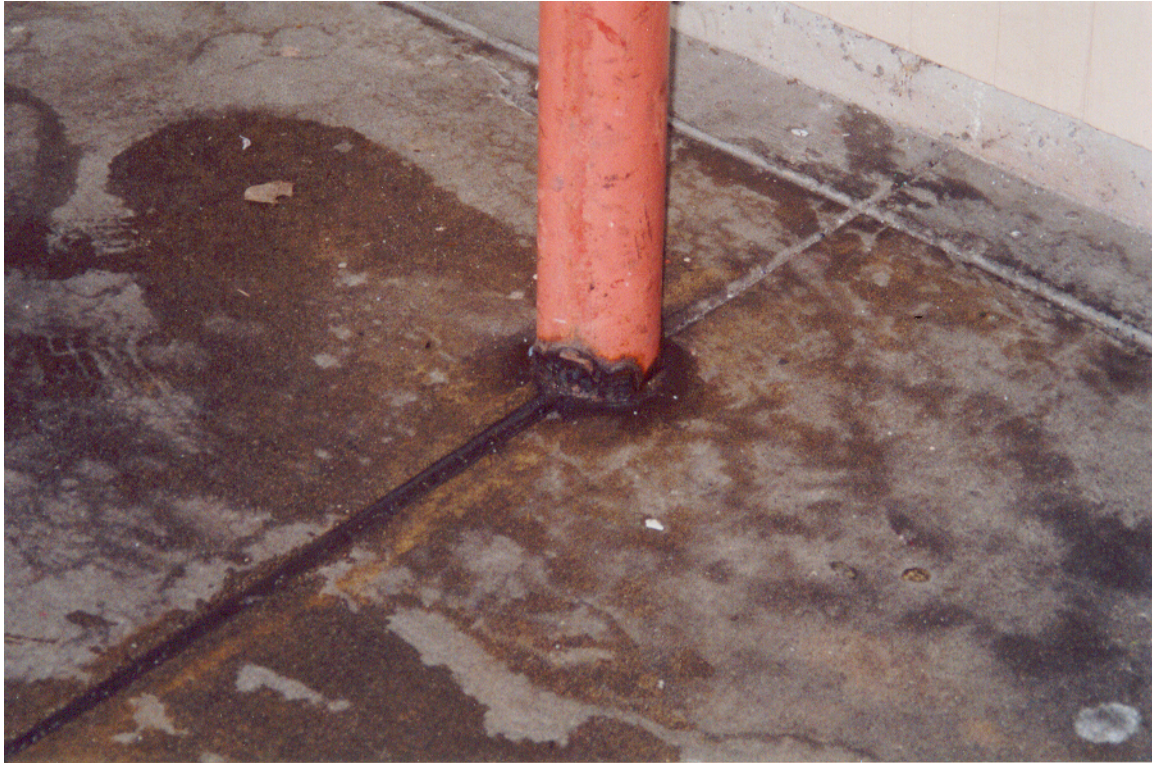
Figure 20: Rust at Covered Walkway Column

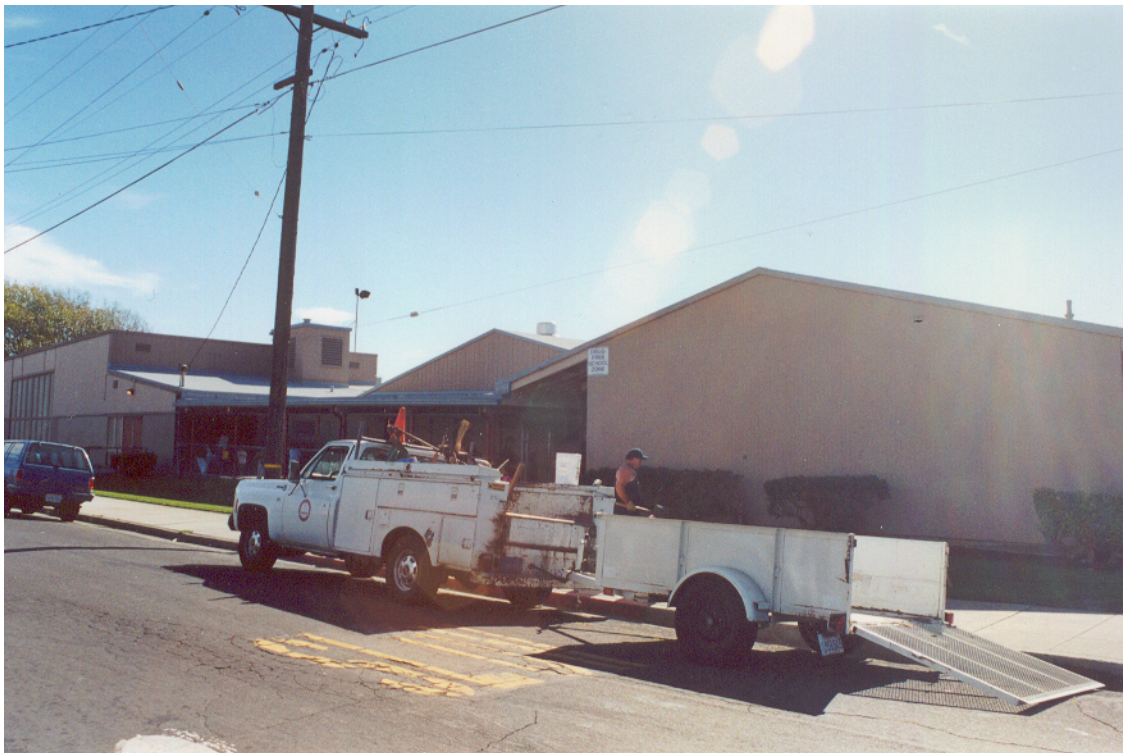
Figure 21: East View of Classroom Buildings, Covered Walkway, and Multi-Purpose Building

The multi-purpose building has a low roof at the front area and a high long-span roof over the main interior space. There are moderate-size openings on all four faces of the building. The northwest face of the building has stucco finish up to the level of the roof canopy, but otherwise the building has wood siding (see figures 21-23).

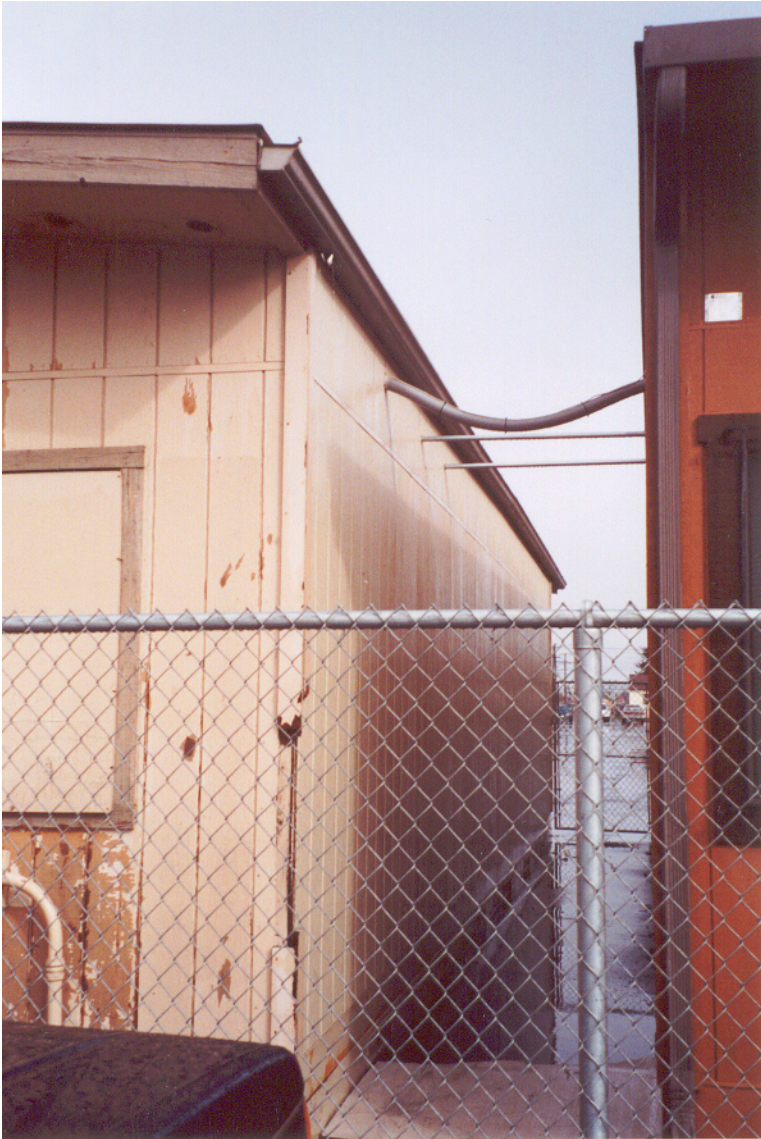
There is electrical conduit that runs between the portable classroom units near the roof level. The conduit does not have flexible connections to allow for differential motion of the portable units.

16.	There are conduits that runs between the portable units near the roof level. As the buildings move independently, they may be damaged and are a life-safety hazard.

Figure 24: Conduit between Portable Units
