STRUCTURAL EVALUATION OF
DOVER ELEMENTARY SCHOOL
WEST CONTRA COSTA UNIFIED SCHOOL DISTRICT
(WCCUSD)

DASSE Design, Inc.
33 New Montgomery Street #850
San Francisco, CA 94105
(415) 243-8400

April 30, 2002

DASSE Design Project No. 01B300

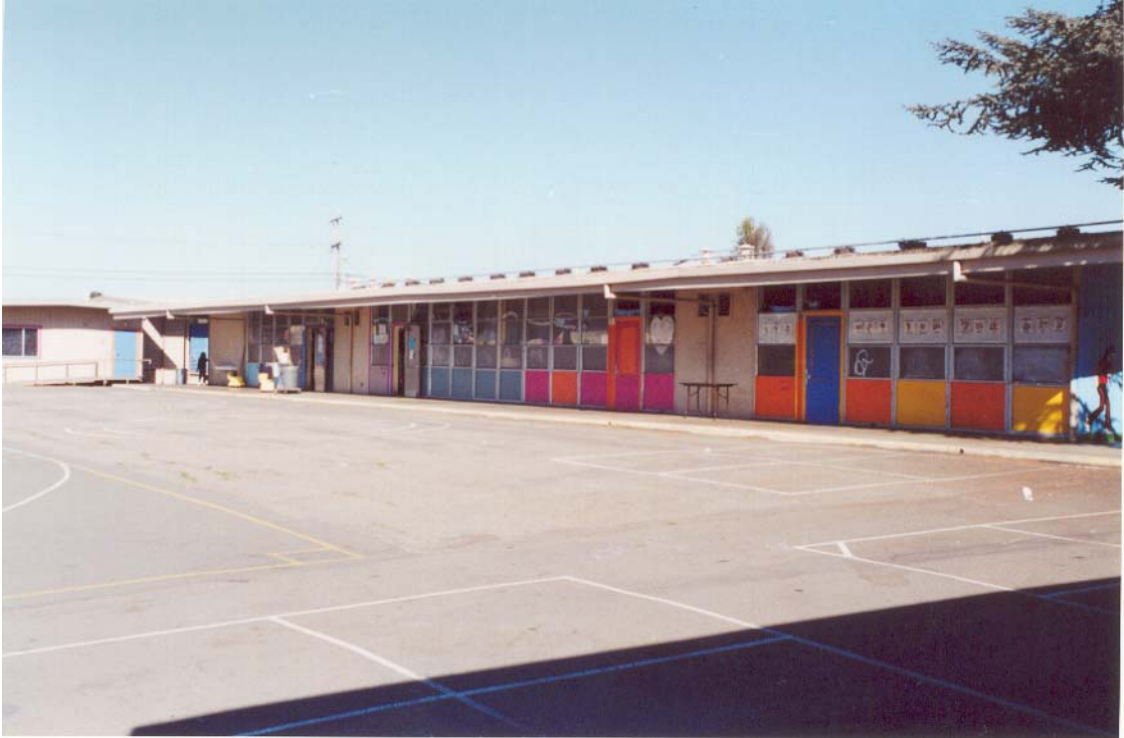
The Classroom and administration buildings are wood construction with vertical wood siding. The classroom buildings have a lot of windows on the sides (figure 3) but this is compensated for by the existence of cross walls and a continuous wall down the center.

Item	Building Structural Deficiencies
1.	Covered walkways are attached to the buildings at both ends with no provision to accommodate differential movement.
2.	There is a lack of capacity in the classroom buildings bracing systems that resist lateral forces parallel to the central wall.
3.	Electrical conduit spanning between roof of portable classrooms and between covered walkways.

Figure 3: Classroom Building

2.	Reinforce longitudinal walls.	1.9	3
3.	Relocate electric conduit or install flexible connection when conduit passes between adjacent portable classrooms and covered walkways. above ground level.	1.9	6

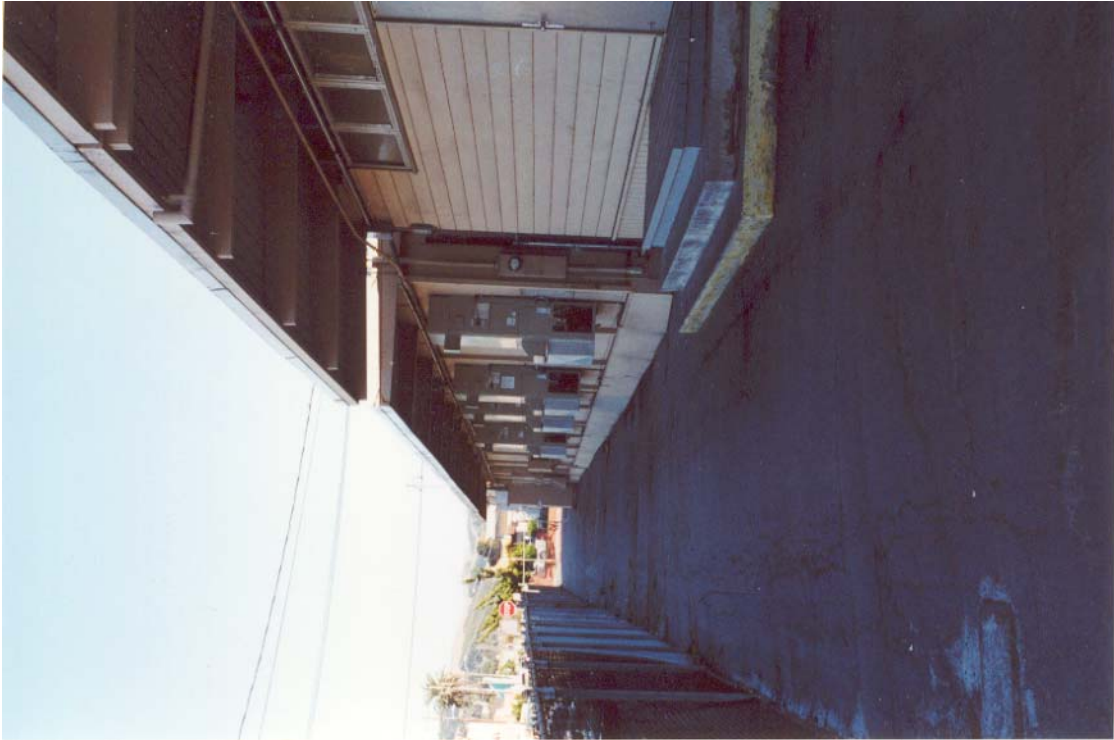
Conduit and pipes were observed running between portable buildings (figure 6) and between permanent classrooms. This could potentially be a fire and life safety hazard, when the buildings move differentially in an earthquake and damage the conduits.

Figure 6: Conduit Between Classrooms.

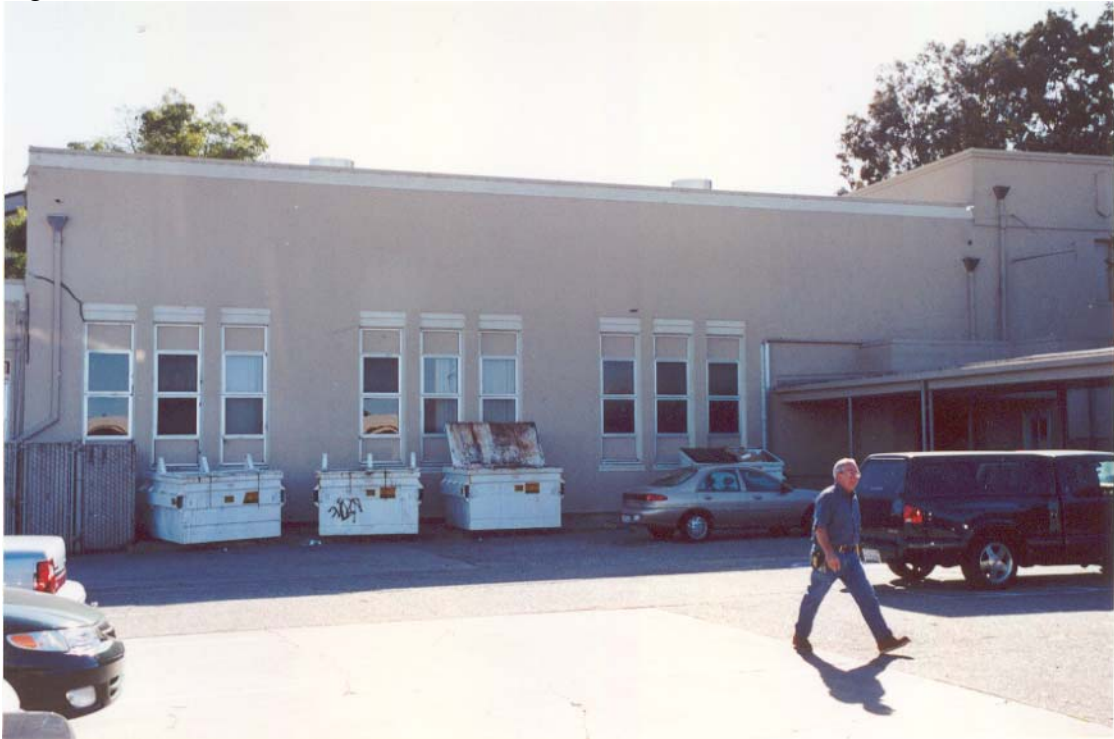
The 1936 Multi-Purpose building is wood frame construction with stucco finishes. Several significant cracks were identified in the stucco (figures 7 & 8), which indicate that the crack is moving over time. These cracks did not extend through the foundation thus implying that the cause is not related to foundation problems. In addition there were signs of horizontal movement of the wood super structure with respect to the concrete foundation on the South-West side.

4.	The longitudinal shear walls in the Kindergarten Classroom Building are overstressed.
5.	Cracks in stucco on Multi-Purpose Building that are continuing to move.
6.	For the Multi-Purpose Building the horizontal truss at the bottom of the roof trusses is overstressed.
7.	For the Multi-Purpose Building the transverse walls at each end of the Multi-Purpose room are overstressed.
8.	Water damage was observed in the ceiling of Classroom #28 and on the inside of the Multi-Purpose Room.

Figure 7: Multi-Purpose Building – Cracks in Plaster

5.	Identify the cause of the cracking in the cracks in the Multi-Purpose building stucco and repair.	2.4	7,8
6.	Add plywood over the roof sheathing on the Multi-Purpose Building or retrofit horizontal roof truss to resist seismic loads.	1.9	N/A

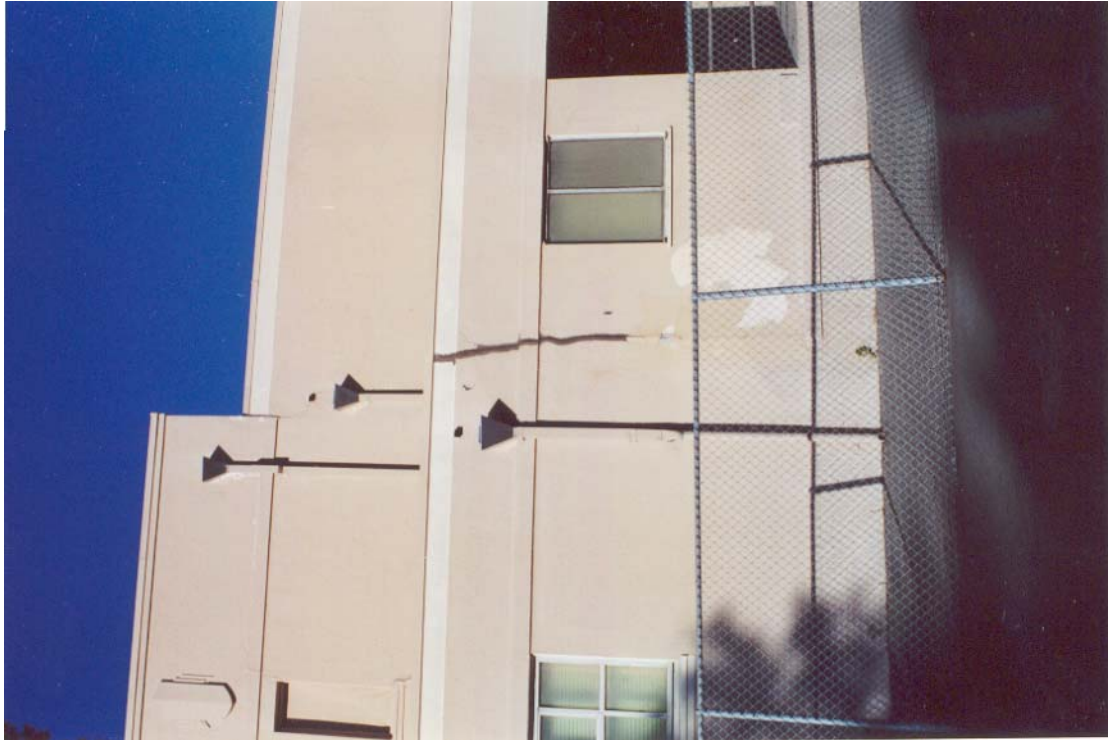
Figure 8: Multi-Purpose Building – Cracks in Plaster.

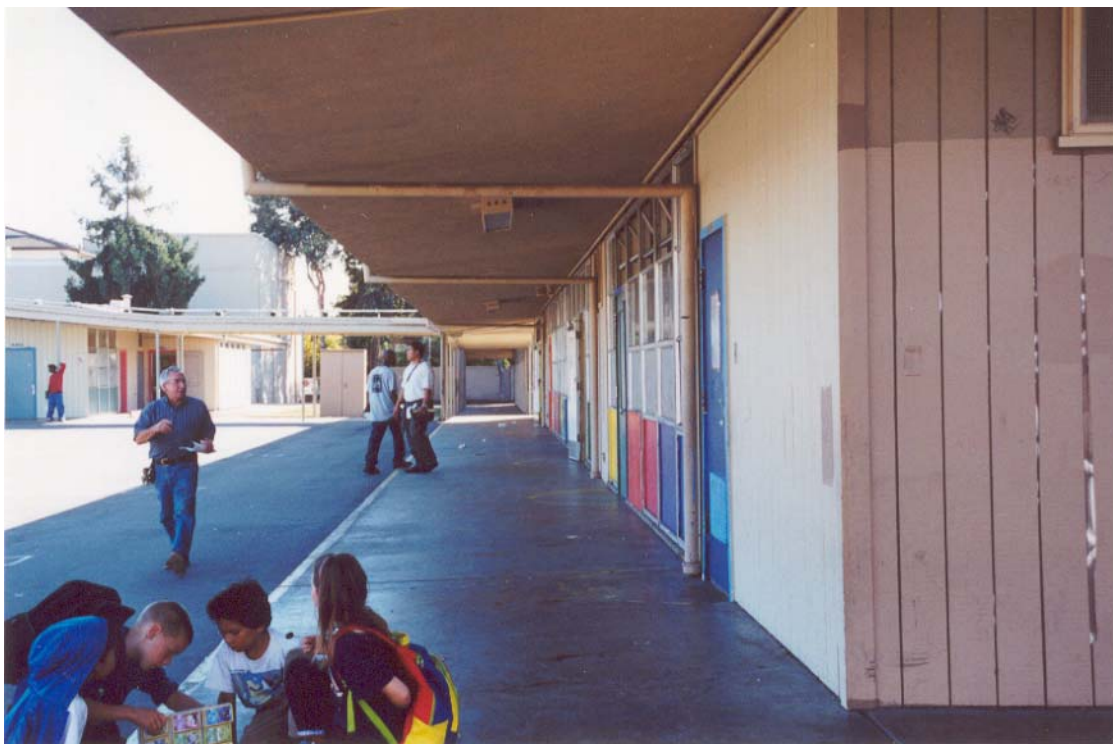
The covered walkways that run between the several wings are supported by 3" diameter steel pipe columns. They do not have their own independent lateral force resisting systems, and there is no seismic joint between them and the wings they connect (figure 9).

Figure 9: Covered Walkway Connecting Buildings.

Item	Recommended Remediation	Priority	Figure Number
1.	Provide new beams and columns close to the building so that damage will not lead to collapse of the walkway.	1.9	9
