STRUCTURAL EVALUATION OF

FORD ELEMENTARY SCHOOL

WEST CONTRA COSTA UNIFIED SCHOOL DISTRICT
(WCCUSD)

April 30, 2002

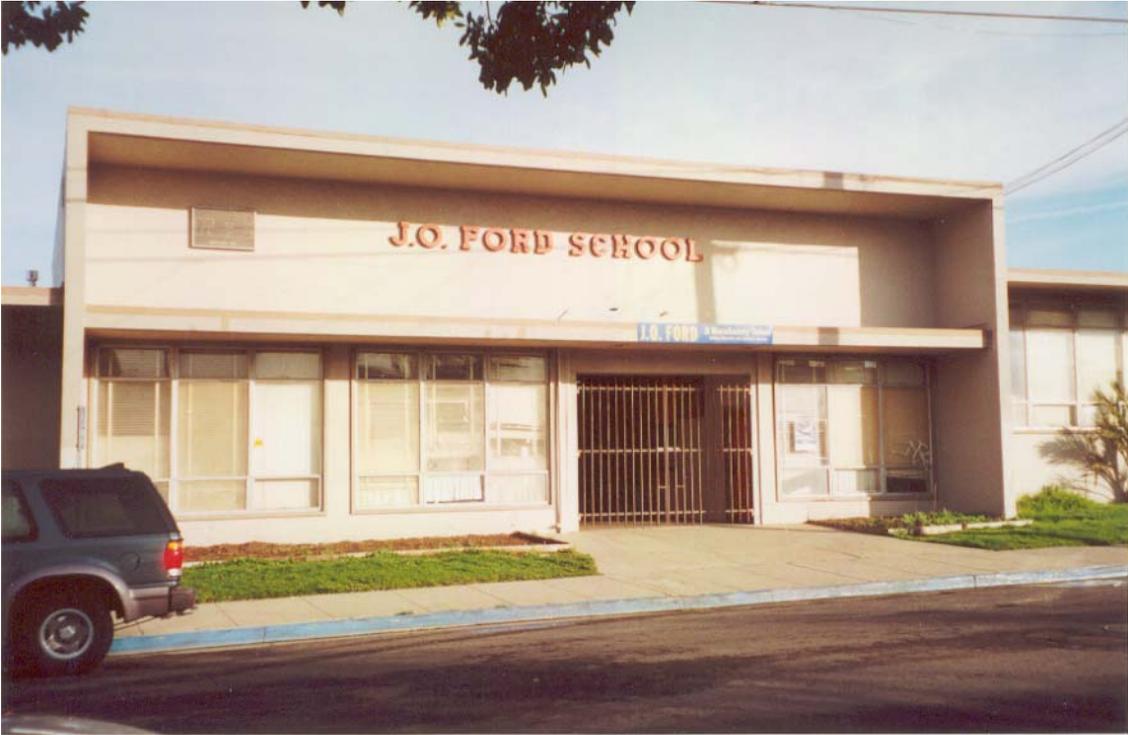
Figure 2: Front Entrance

The permanent school buildings are one story wood construction with stucco finish (figures 2,3 & 4). The main building has a lot of windows along the front as well as clerestory windows along the back wall (figures 3 & 6).

| Item | Building Structural Deficiencies |
|---|---|
| 1. | At the Main building wall facing the street, there is a lack of adequate shear walls in the longitudinal direction as a result of the large number of windows. |

| | | | Number |
|---|---|---|---|
| 1. | Add supplemental plywood shear walls to the main building wall facing the street by filling in some windows. Provide new collectors and holdowns as required. | 1.5 | 2, 3, 5 |

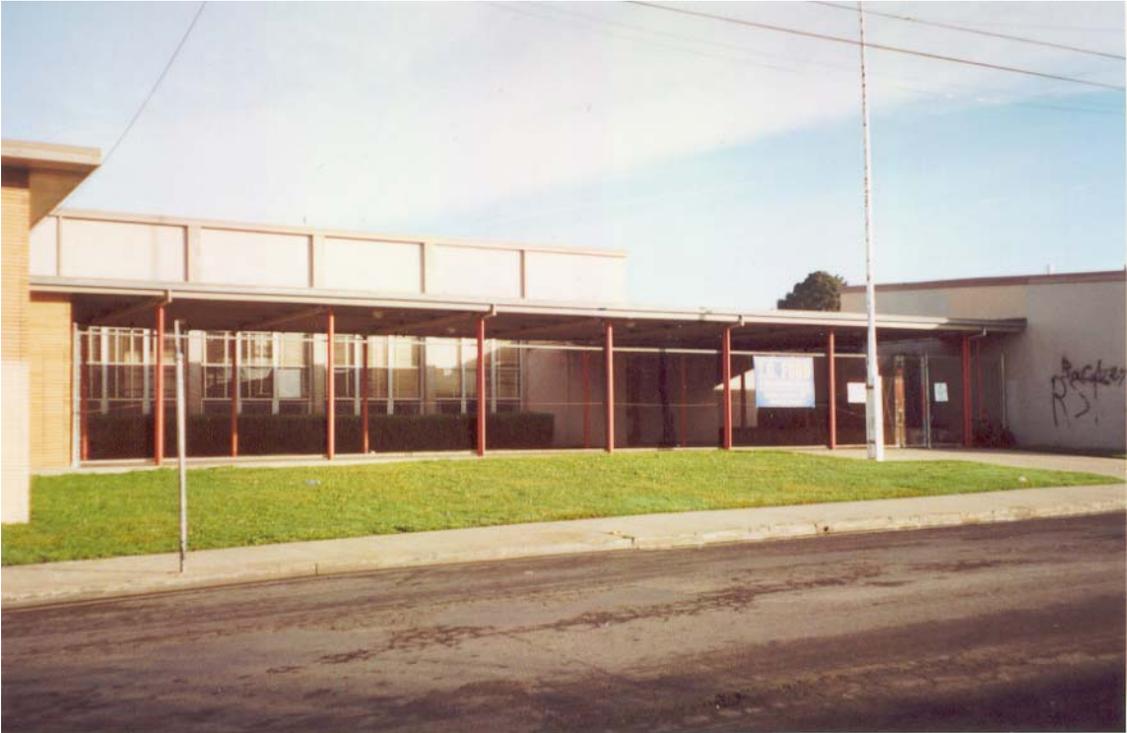
Figure 4: Multi-Purpose Building

| Item | Building Structural Deficiencies |
|---|---|
| 3. | Covered walkways connecting buildings are likely to experience damage as a result of differential movement of the buildings. |
| 8. | The shear walls of the Multi-Purpose Room are overstressed. |

| | | | Number |
|---|---|---|---|
| 3. | At the covered walkways connecting the buildings, provide new beams and columns close to the building so that damage will not lead to collapse of the walkway. | 1.9 | 4 |
| 8. | Reinforce the shear walls around the Multi-Purpose room. | 1.9 | 4 |

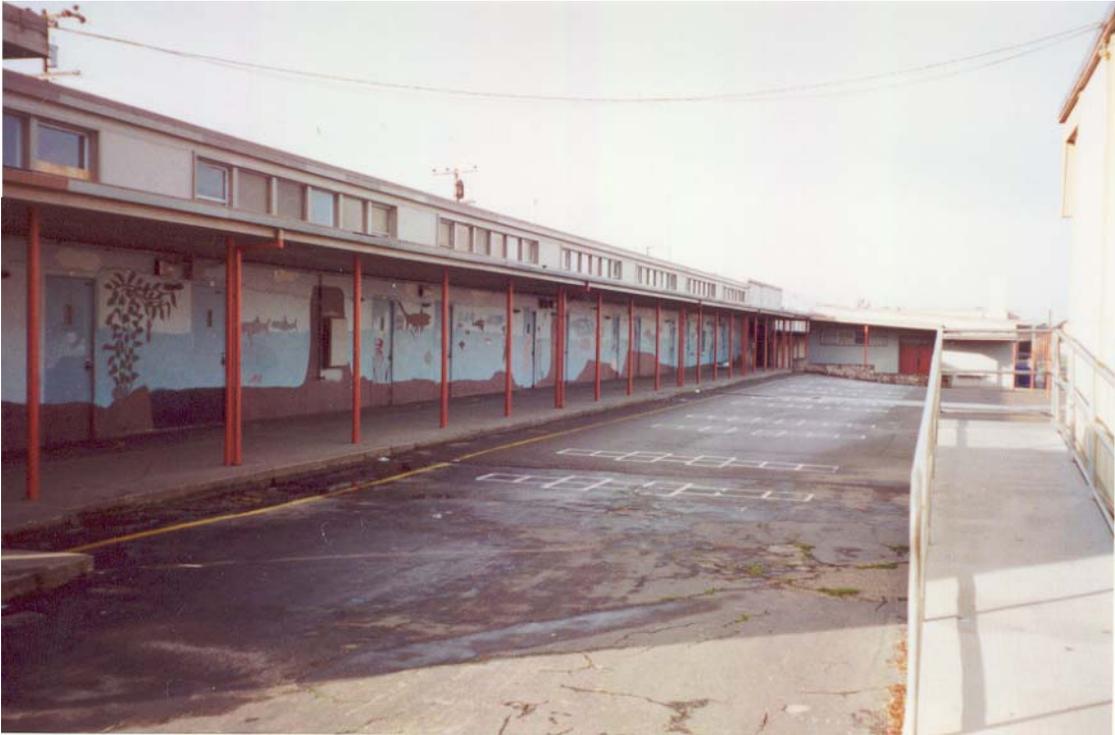
Figure 6: Rear of Classroom Building

| Item | Building Structural Deficiencies |
|---|---|
| 2. | At the Main building wall at the entrance to the classrooms, there is a lack of shear wall resistance in the longitudinal direction due to the clerestory windows. |

| | | | Number |
|---|---|---|---|
| 2. | Add additional plywood shear walls to the wall at the entrance to the typical classrooms by filling in some windows. Provide new collectors and holdowns as required. | 1.5 | 6 |

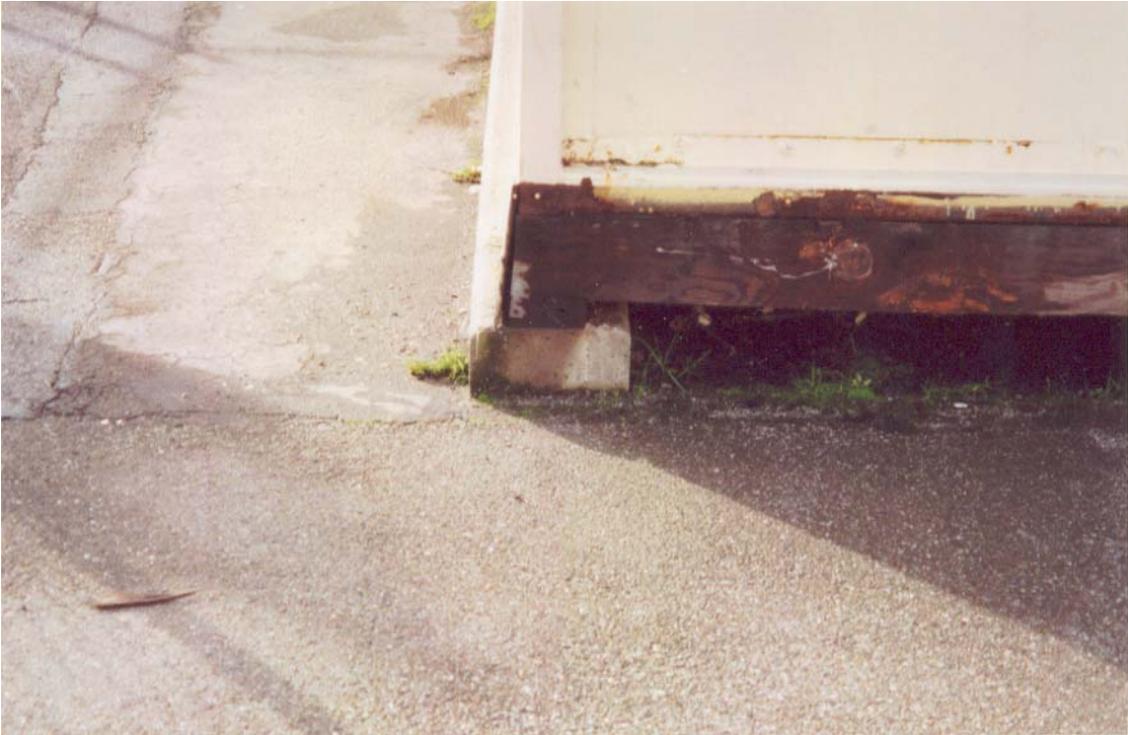
Figure 7: Foundation of Portable Classroom.

There are several old portables that rest directly on the without attachment to the ground (figure 7). Electrical conduit was observed to run between portables such that it could be damaged in an earthquake.

| Item | Building Structural Deficiencies |
|---|---|
| 10. | Some portable buildings appear to have no anchorage to the ground. |

| | | | Number |
|---|---|---|---|
| 10. | Anchor portable buildings to the ground. | 2.0 | 7,8 |

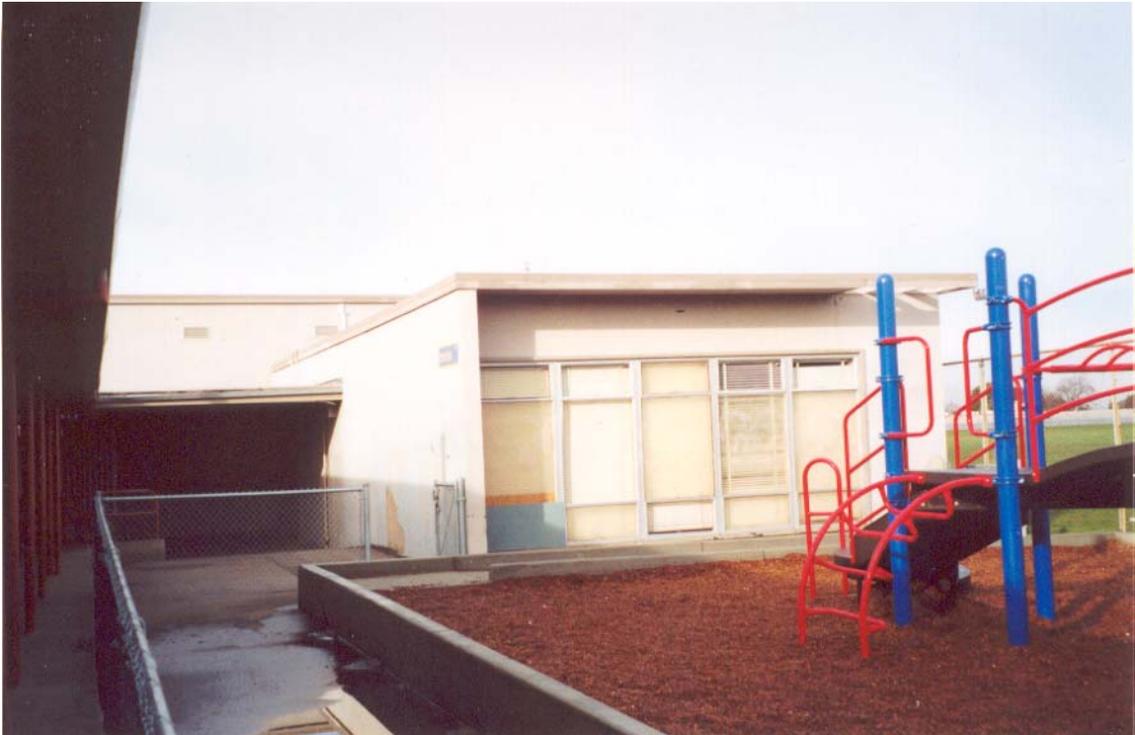
Figure 9: East Wall of Classrooms 21 &23

| Item | Building Structural Deficiencies |
|---|---|
| 6. | The shear wall at the East wall of classrooms 21 & 23 is overstressed. |

| | | | Number |
|---|---|---|---|
| 6. | Reinforce the East wall of Classrooms 21& 23 or fill in some of the existing windows. Provide new collectors and holdowns as required. | 1.9 | 9 |

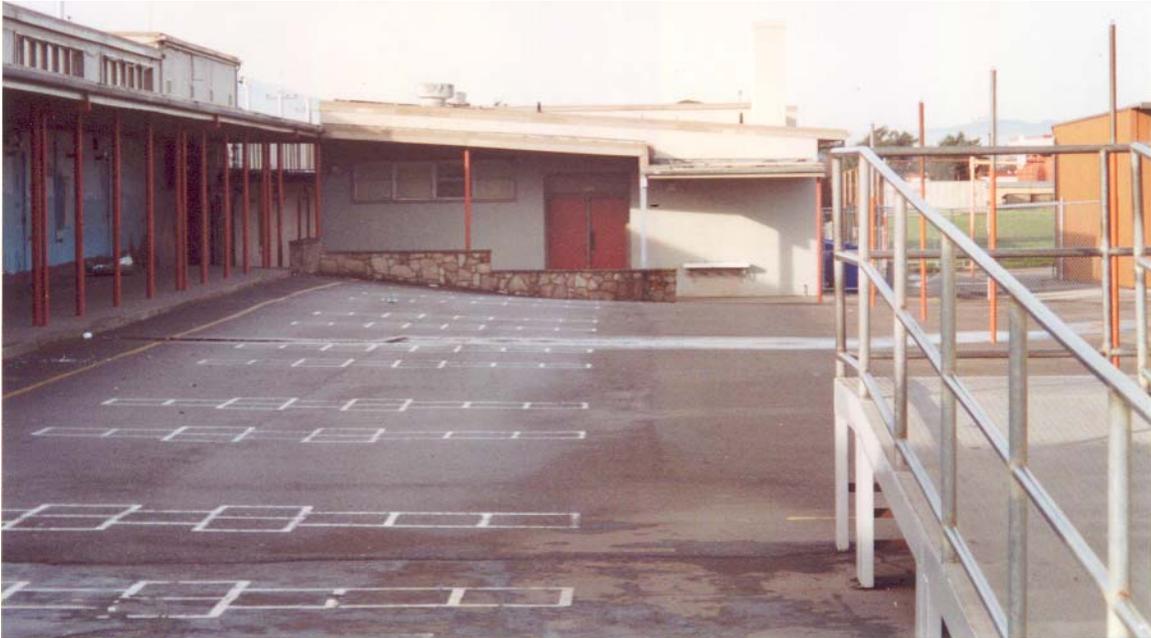
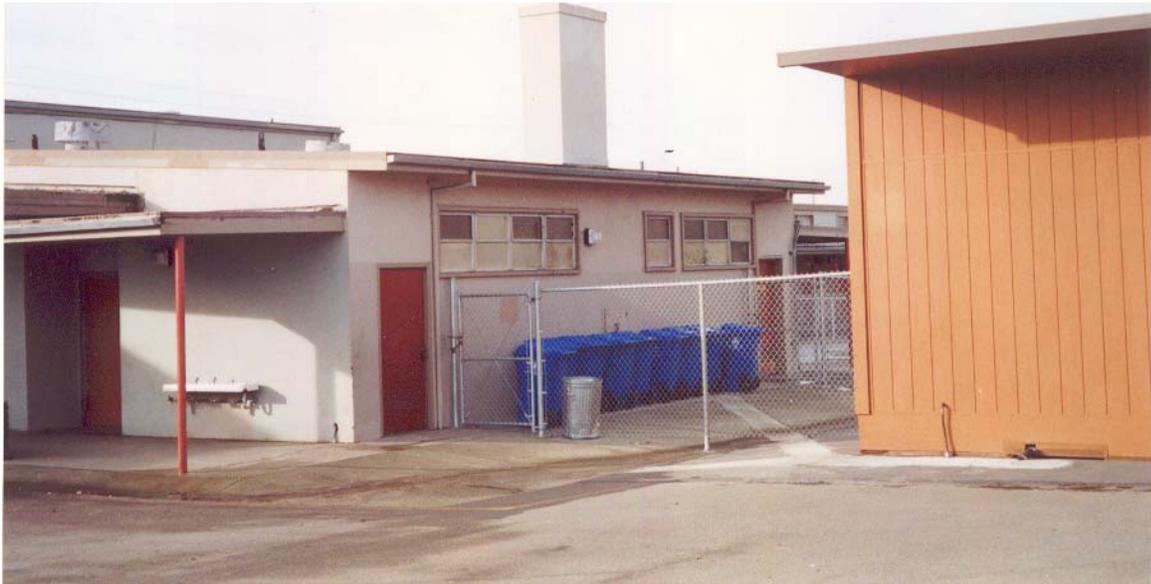
| Item | Building Structural Deficiencies |
|---|---|
| 9. | The shear walls of the Toilet Building are overstressed. |

Figure 10: Toilet Building

Figure 11: Toilet Building

| | | | Number |
|---|---|---|---|
| 9. | Reinforce shear walls around the Toilet Building. | 1.9 | 10, 11 |

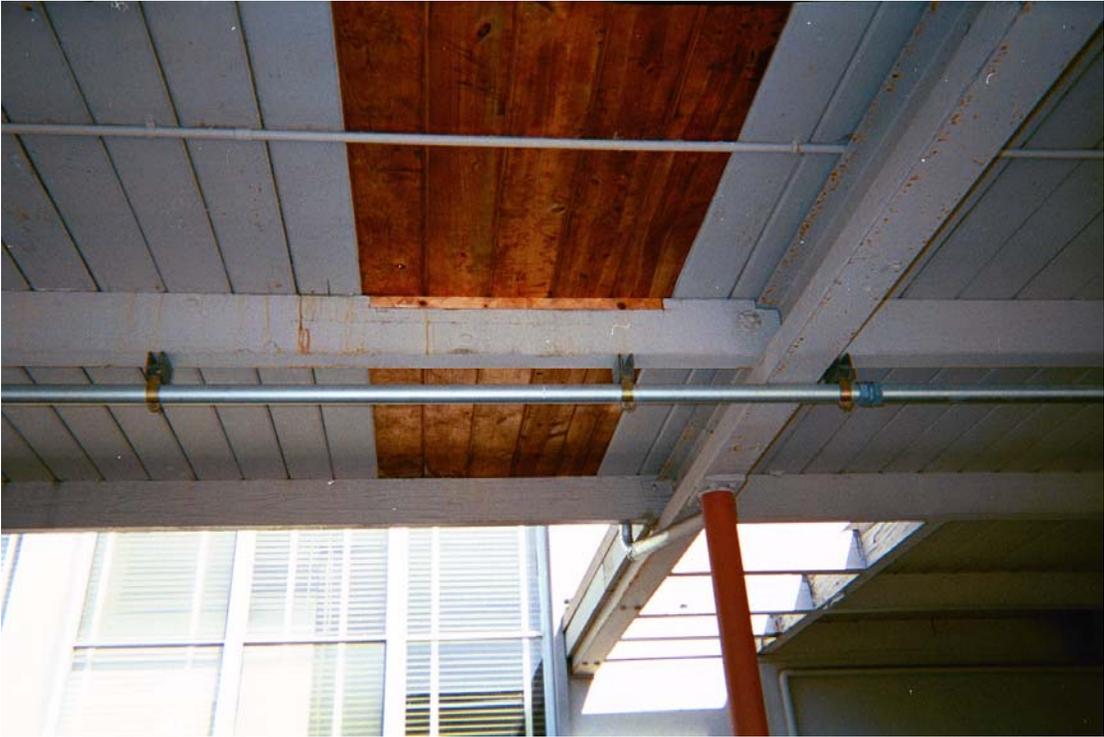
Figure 12: Repaired Beam

At the covered walkway in front of the Multi-Purpose Room decayed lumber was removed thus weakening the member. As a result the beam should be replaced.

| Item | Building Structural Deficiencies |
|---|---|
| 11. | At the covered walkway in front of the Multi-Purpose Room decayed lumber was removed thus weakening the member. |

| | | | Number |
|---|---|---|---|
| 11. | Replace the beam that had decay removed. | 1.2 | 12 |

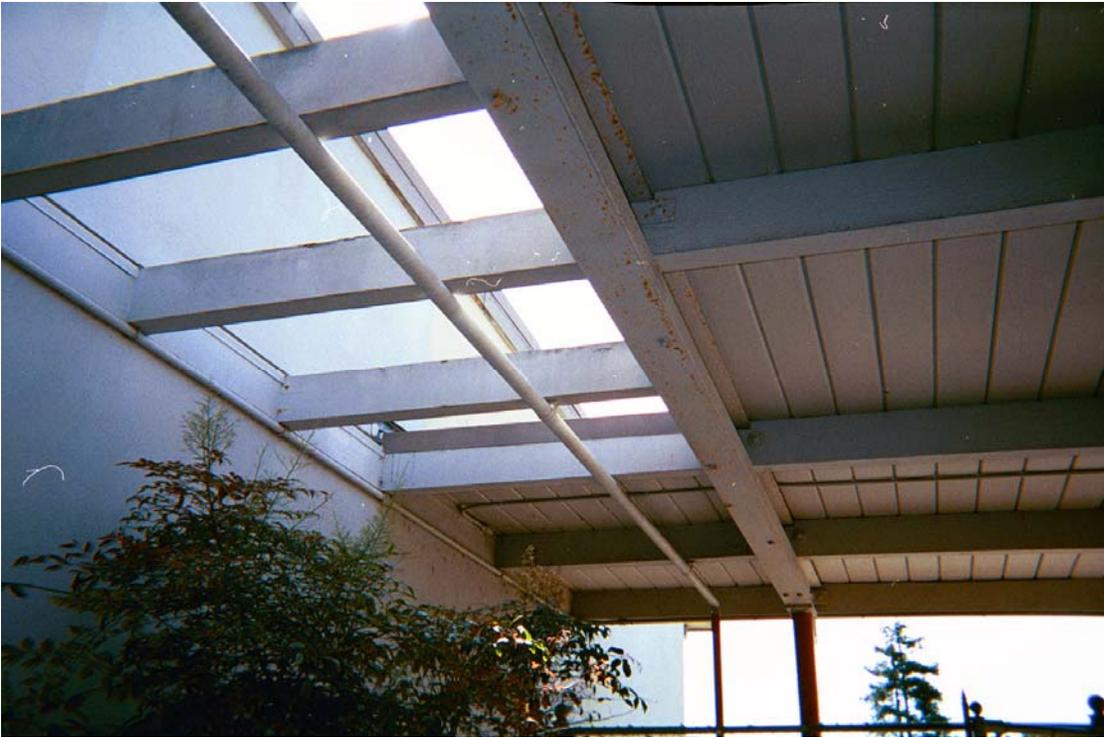
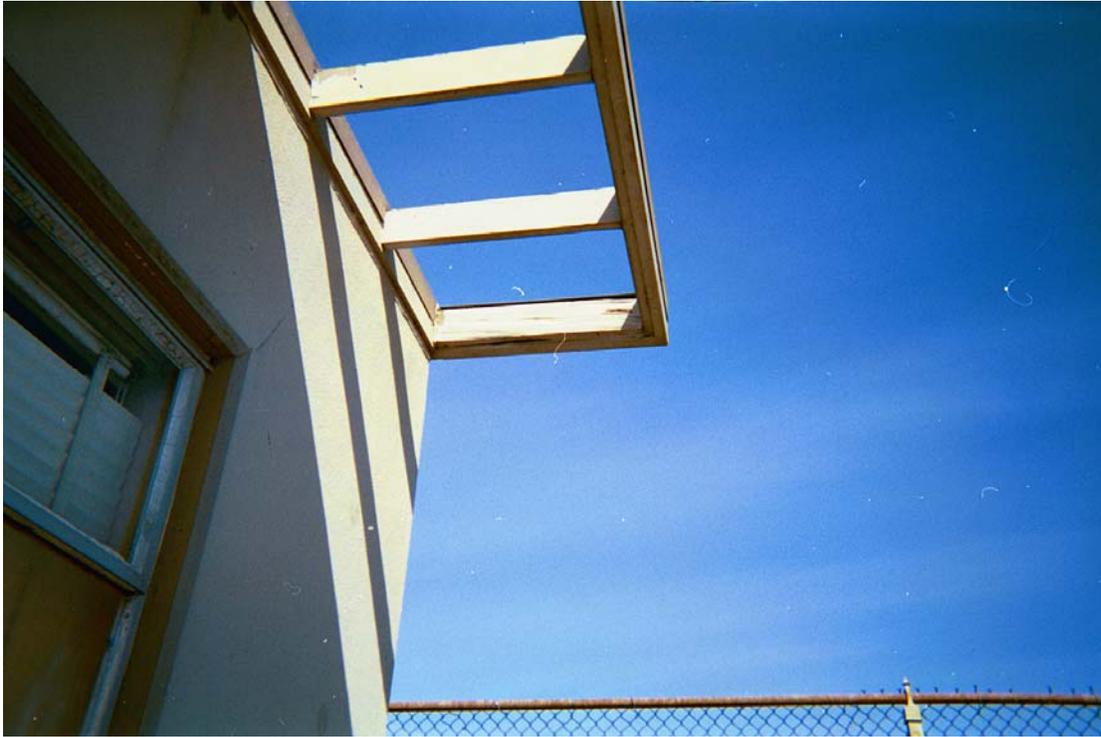
At the covered walkway to the West of Classroom number 2 and at the overhang to the east of Classroom number 23 beams and joist are not protected by roofing and thus show signs of decay. The decayed members should be repaired and the beams and joists should be protected from direct exposure to the rain.

| Item | Building Structural Deficiencies |
|---|---|
| 12. | At the covered walkway to the West of Classroom #2 and the overhang to the East of Classroom #23 beams and joist are not protected by roofing and thus show signs of decay. |

Figure 13: Covered Walkway

Figure 14: Roof Overhang

| | | | Number |
|---|---|---|---|
| 12. | Repair decayed members and provide protection. | 2.1 | 13,14 |
