STRUCTURAL EVALUATION OF
HARDING ELEMENTARY SCHOOL
WEST CONTRA COSTA UNIFIED SCHOOL DISTRICT
(WCCUSD)

DASSE Design, Inc.
33 New Montgomery Street #850
San Francisco, CA 94105
(415) 243-8400

April 30, 2002

DASSE Design Project No. 01B300

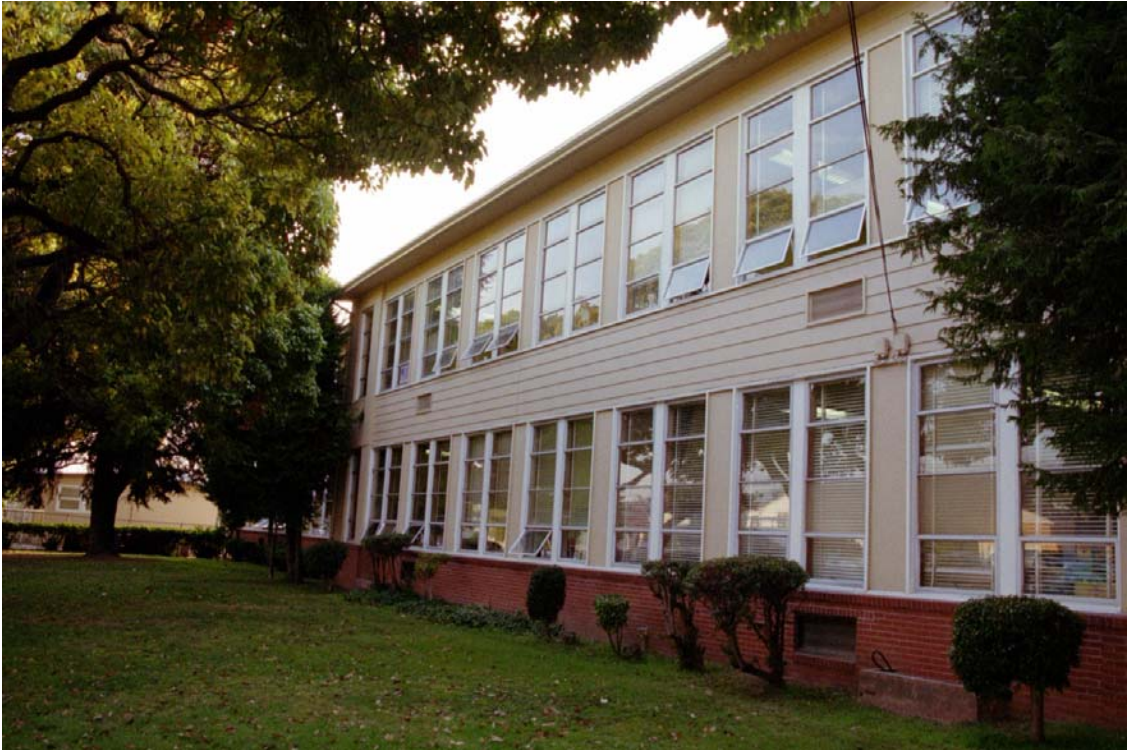
Figure 4: Main Classroom Building facing Ashbury Avenue

Item	Building Structural Deficiencies
1.	Main Classroom Building: Strength of wood shear walls in the longitudinal direction and at some transverse locations is inadequate to resist prescribed forces.

Item	Recommended Remediation	Priority	Figure Number
1.	Replace existing diagonal sheathing with new plywood sheathing at inadequate locations. Remove some windows and replace with new stud framing and plywood sheathing.	1.0	4, 7

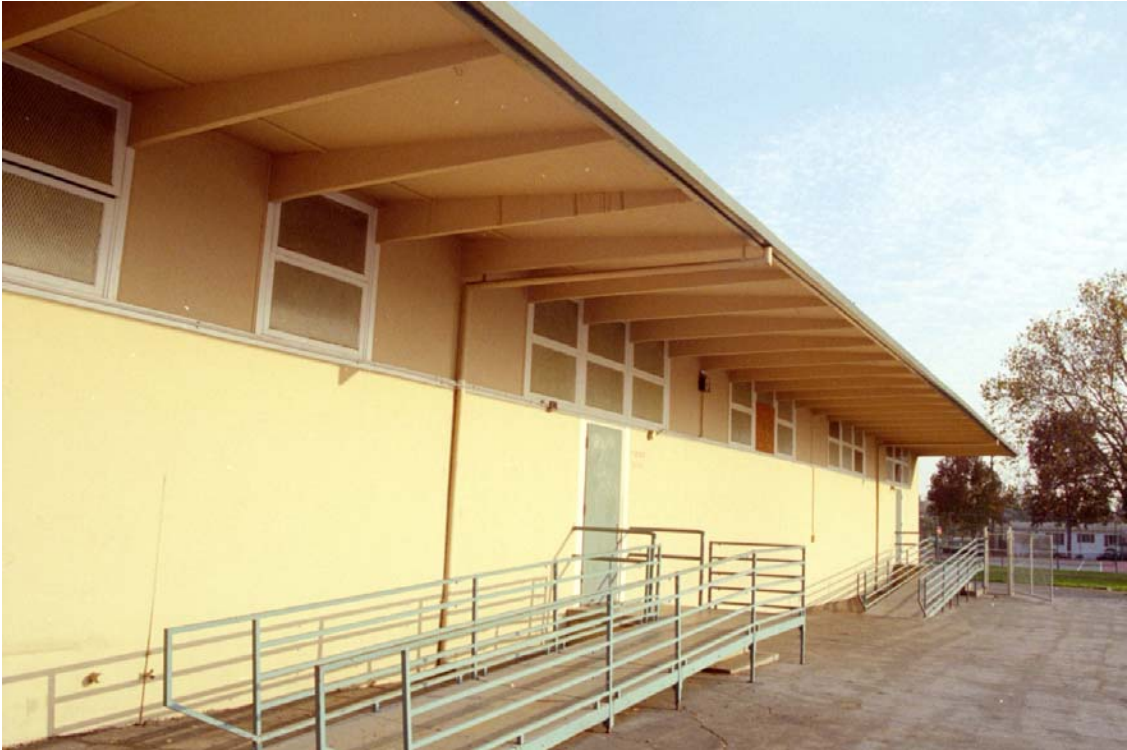
Figure 5: Cafeteria Building east face

4.	Auditorium Building: Strength of chord/collector splices at the longitudinal walls is inadequate to resist prescribed forces.
5.	Cafeteria Building: Existing wood shear panels are discontinuous between the roof and foundation levels.

4.	Provide new strapping and blocking at inadequate locations.	1.5	N/A
5.	Provide new plywood sheathing at longitudinal walls between window locations.	1.1	5

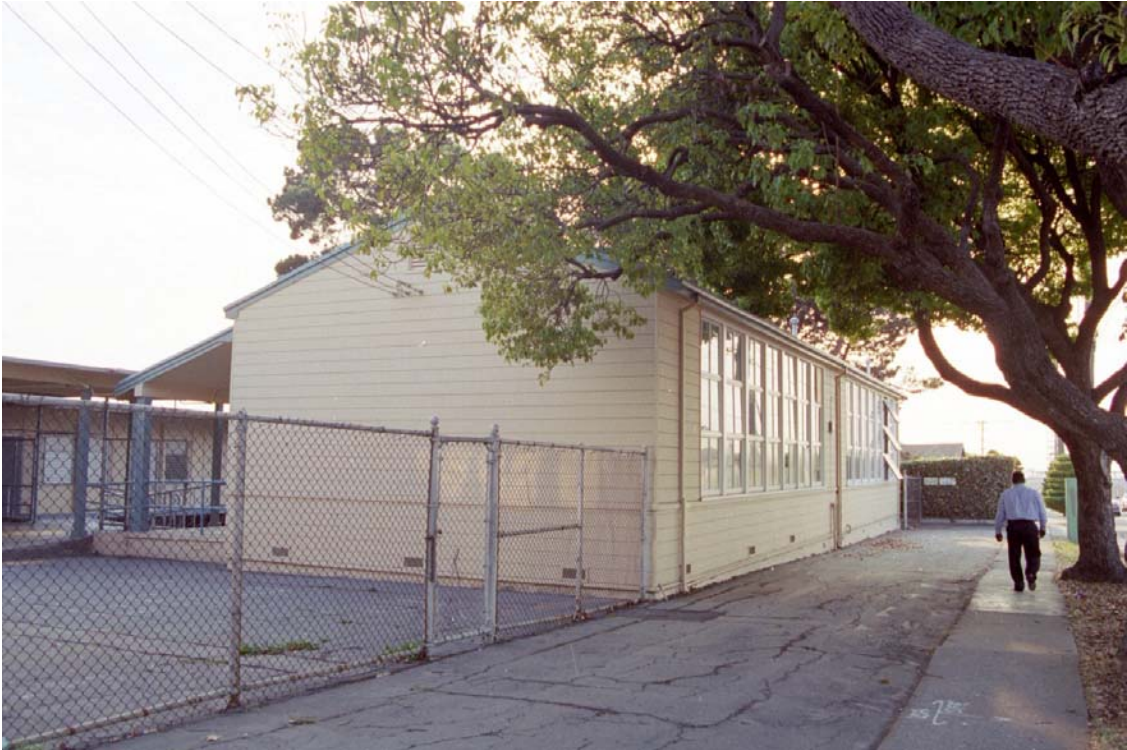
Figure 11: Additional Classroom Building 2 north face

6.	Cafeteria Building: Positive tie across three-hinged arch is lacking. Foundation connection of three-hinged arch is unclear.
7.	Additional Classroom Buildings: Strength of wood shear walls at some locations is inadequate to resist prescribed forces.

7.	Replace existing diagonal sheathing with new plywood sheathing at inadequate locations.	1.1	11
8.	Provide new strapping and blocking at inadequate locations.	1.5	N/A
