STRUCTURAL EVALUATION OF
HIGHLAND ELEMENTARY SCHOOL
WEST CONTRA COSTA UNIFIED SCHOOL DISTRICT
(WCCUSD)

WLC Architects
Kaiser Building
1300 Potrero Avenue
Richmond, CA 94804

DASSE Design, Inc.
33 New Montgomery Street #850
San Francisco, CA 94105
(415) 243-8400

April 30, 2002

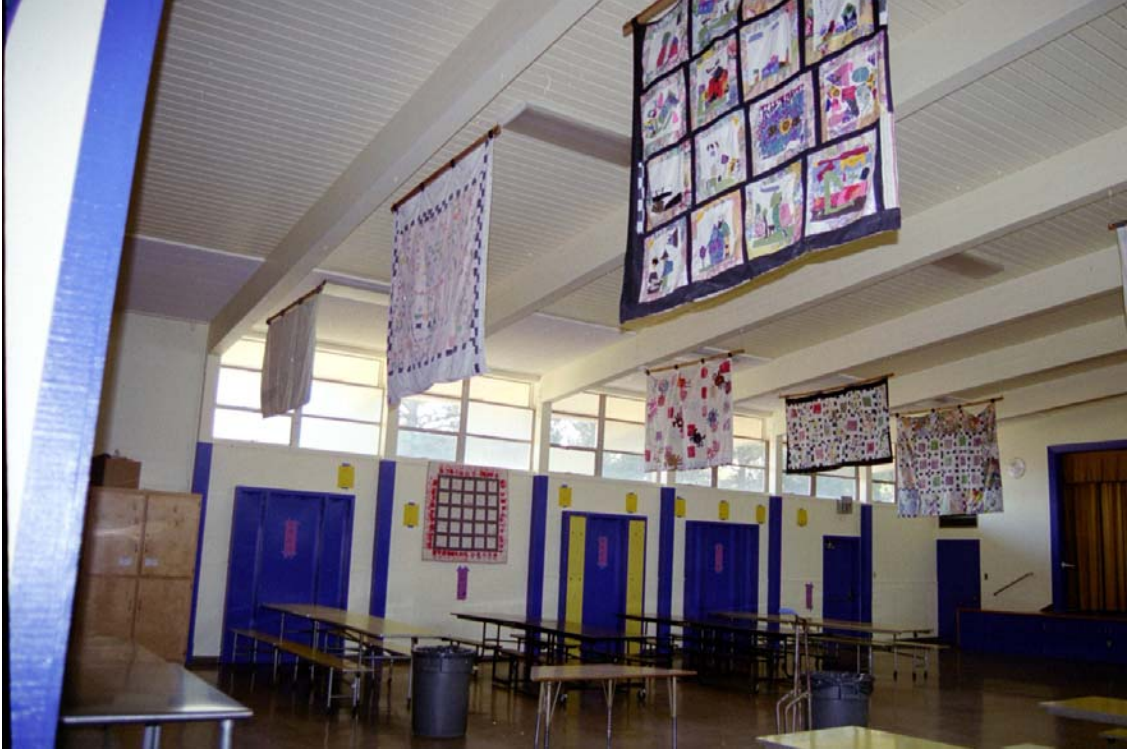
Figure 5: Multipurpose Building, interior

The main classroom building (see figures 6, 7, and 8) and the adjacent classroom building (see figures 11) share many similarities in appearance and construction. Both of these buildings are single story with exterior stucco finishes. On the interior, the corridor ceilings are acoustical tile, while the classrooms have a suspended T-bar ceilings. A few skylights were also observed in the corridors of these classroom buildings. The main classroom building uses a hybrid steel/wood framing system that is evident by the transverse steel beams that are visible at the roof eaves. At the other classroom building these transverse beams are wood beams. The outside classroom walls are window walls whose length of solid wall appears to be inadequate to resist the seismic shear forces. This condition also occurs at the high windows found at the administration wing of the main classroom building. This inadequacy of shear strength represents a life safety concern. The multipurpose building is another single story, wood-framed building (see figures 3, 4, and 5). At the multipurpose building glue-laminated beams are used to span across the transverse width of the building. These glue-lam beams are spaced at 8'-0" on center and are supported by wood posts. The beam-to-post connections are minimal and, consequently, vulnerable to coming

apart when subject to displacements induced by a seismic event. Due to the magnitude of load carried by these beams, the questionable integrity of these connections constitutes a life safety hazard. Covered walkways throughout the campus are constructed with very substantial steel frames that will resist lateral loading (see figures 9 and 10). However, these walkway structures are supported by multiple buildings giving them the potential to pull apart if the buildings experience opposing displacements during a seismic event. Additionally, electrical conduit mounted to some of the covered walkways passes into adjacent buildings, without compensation for the potential differential displacements. These two conditions also represent life safety hazards. At the portable buildings, hard conduits were observed to be passing from structure to structure, posing a life safety hazard similar to that observed at the covered walkway.

collectors as required		
3.	Provide new beam-to-post connection.	1.3	5
4.	Provide new beams and columns in the covered walkway near its connection to adjacent buildings.	1.9	N/A
5.	Provide new flexible conduit with deformation capacity.	1.9	10

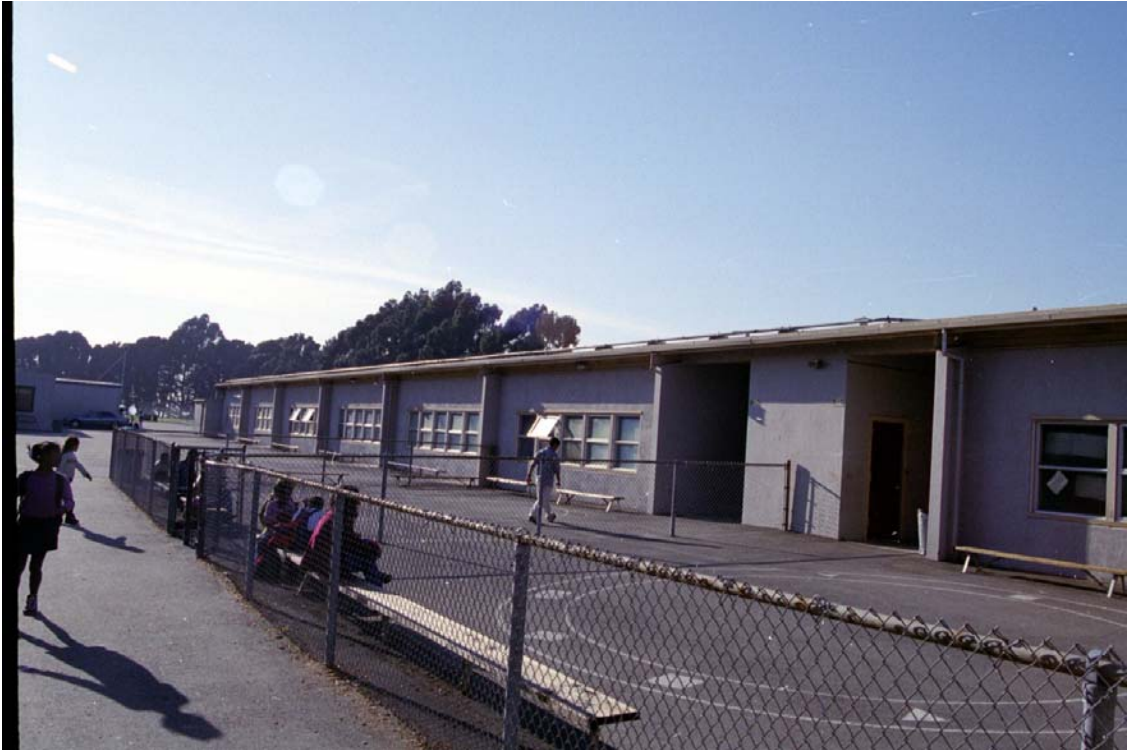
Figure 6: Main Classroom Building, south face

Item	Building Structural Deficiencies
1.	Main Classroom Building: Wood shear walls at the classroom window walls are likely to be inadequate to resist prescribed forces. Wood shear walls at the high windows of the administration wing are likely to be inadequate to resist prescribed forces.
2.	Classroom Building: Wood shear walls at the classroom window walls are likely to be inadequate to resist prescribed forces.
3.	Multipurpose Building: Beam-to-post connection is likely to be vulnerable to failure when subjected to seismic displacements.
4.	Covered Walkway: Structure is tied to multiple adjacent buildings with no provision to accommodate differential displacements.
5.	Covered Walkway/Portable Buildings: Electrical conduit passing into adjacent buildings with no provision to accommodate differential displacements.

Item	Recommended Remediation	Priority	Figure Number
1.	Remove some windows and replace with new stud framing and plywood sheathing. Provide new holddown anchors and collectors as required.	1.1	6, 7, 8
2.	Remove some windows and replace with new stud framing and plywood sheathing. Provide new holddown anchors and	1.1	11
