STRUCTURAL EVALUATION OF

LAKE ELEMENTARY SCHOOL

WEST CONTRA COSTA UNIFIED SCHOOL DISTRICT  
(WCCUSD)

April 30, 2002

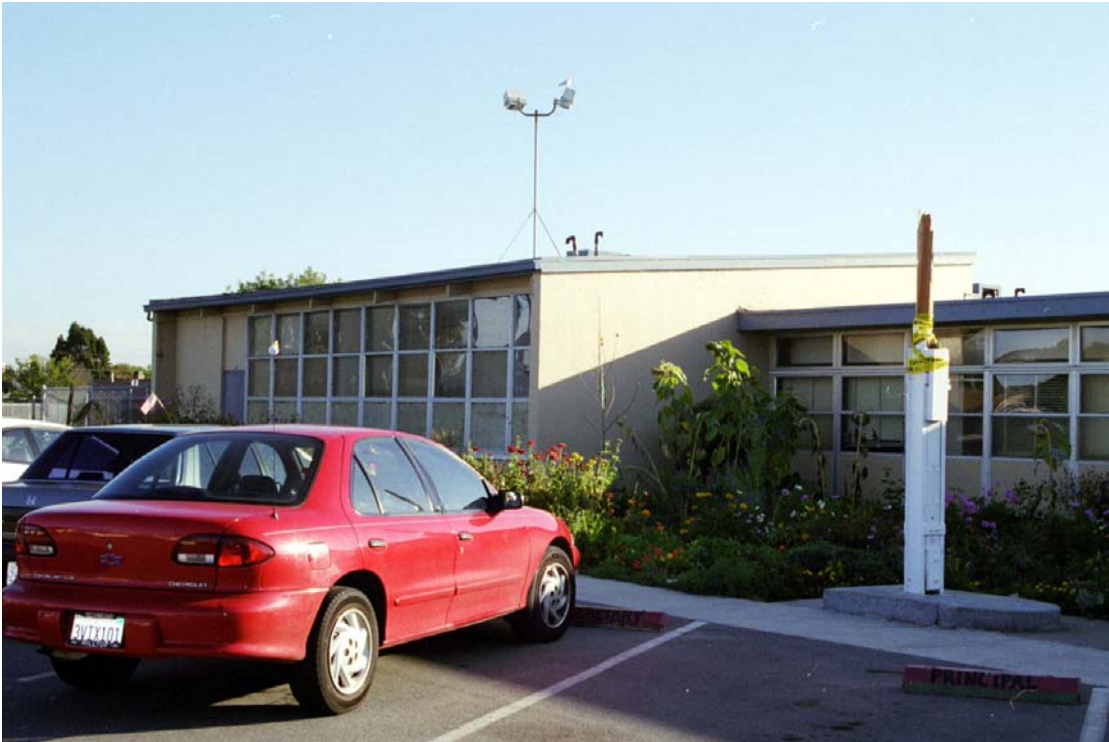
Figure 3: Library and Administrative Bldg.

The Multi-Purpose, Office/Library (Figures 3, 4 & 5), and 1956 Classroom Buildings are wood framed with wood shear walls providing lateral resistance.

3.	At Library, office , and administration rooms add plywood shear walls in the wall facing the front of the school. Provide new collectors and holdowns as required.	1.5	2, 3, 5

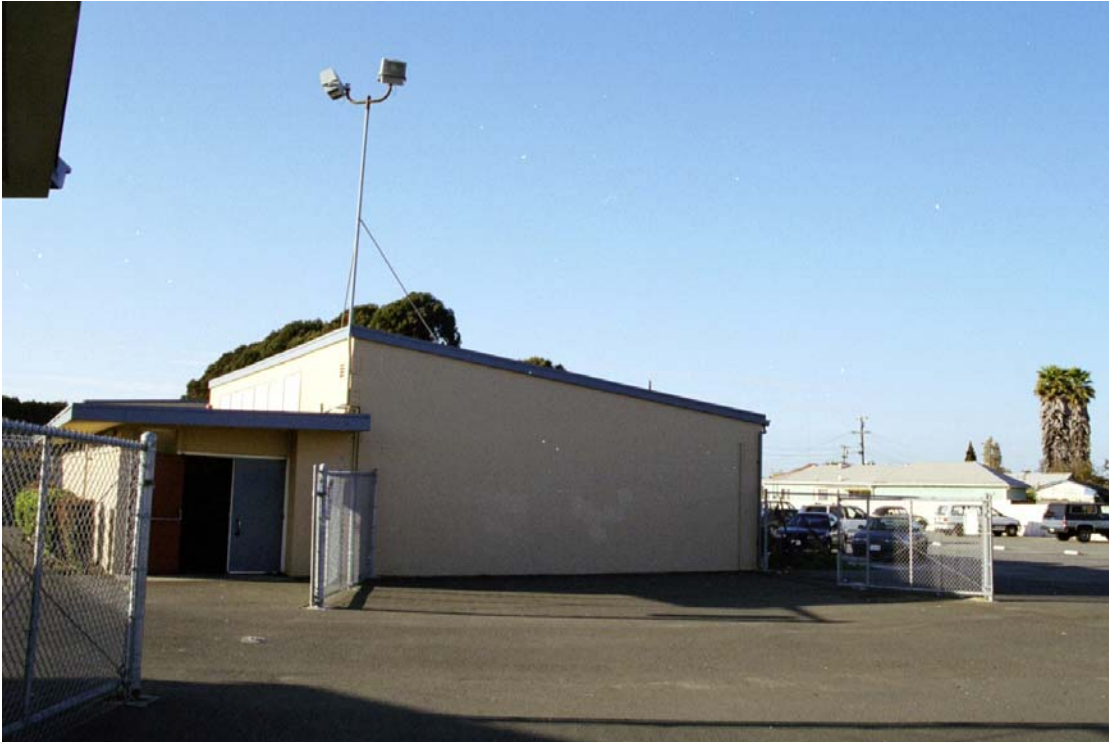
Figure 4: Library

The Library has extensive windows on the wall facing the front of the school and the wall adjacent to the corridor has extensive clerestory windows (Figures 4&5). The office and administrative rooms have extensive windows on the wall facing the front of the school as well as continuous high windows in the exterior corridor wall.

Item	Building Structural Deficiencies
1.	At Library at the corridor inadequate length of shear walls as a result of clerestory windows in Library and continuous slit windows in exterior corridor wall.

Item	Recommended Remediation	Priority	Figure Number
1.	Add plywood shear walls at Library clerestory windows and provide new collectors.	1.5	4
2.	Fill in some of the existing slit windows with new plywood shear walls and provide new collectors.	1.5	4

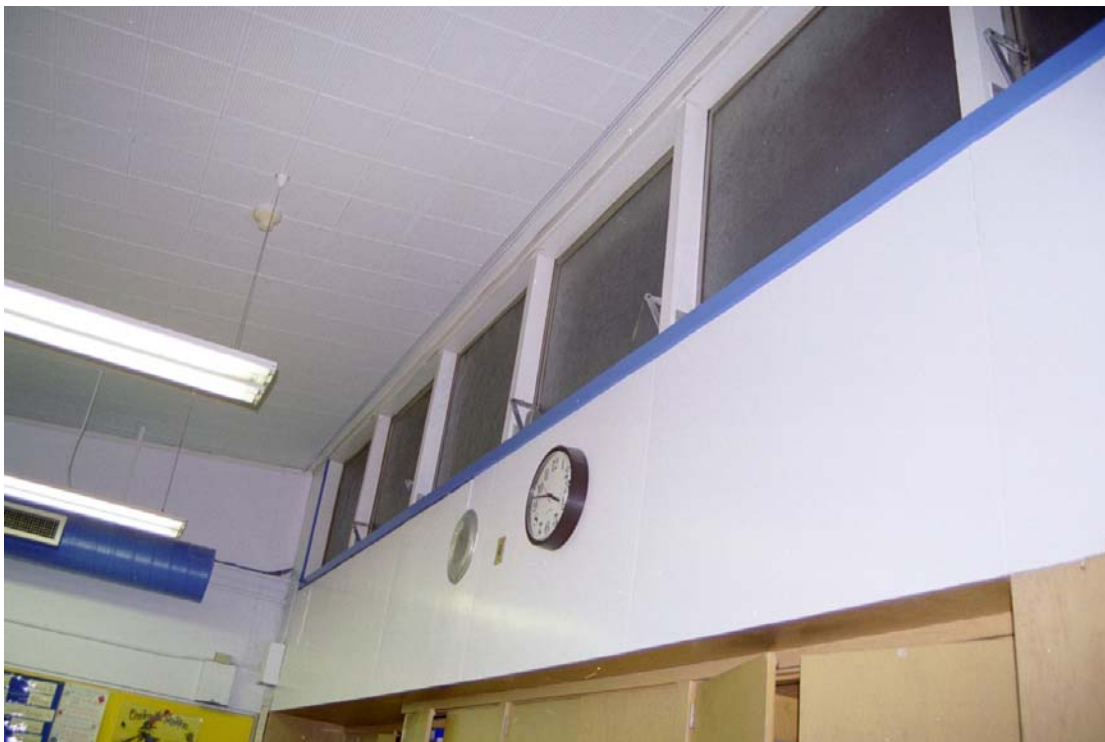
The 1956 Classroom building has extensive windows on the exterior longitudinal walls (Figure 8). In addition the walls on each side of the corridor have clerestory windows (Figure 7) thus resulting in a lack of lateral resistance in the longitudinal direction.

Figure 7: Clerestory Windows at Classroom.

4.	Add plywood shear walls at Classroom clerestory windows.	1.5	7
5.	Add plywood shear walls at exterior longitudinal classroom walls. Provide new collectors and holdowns as required.	1.5	6, 8

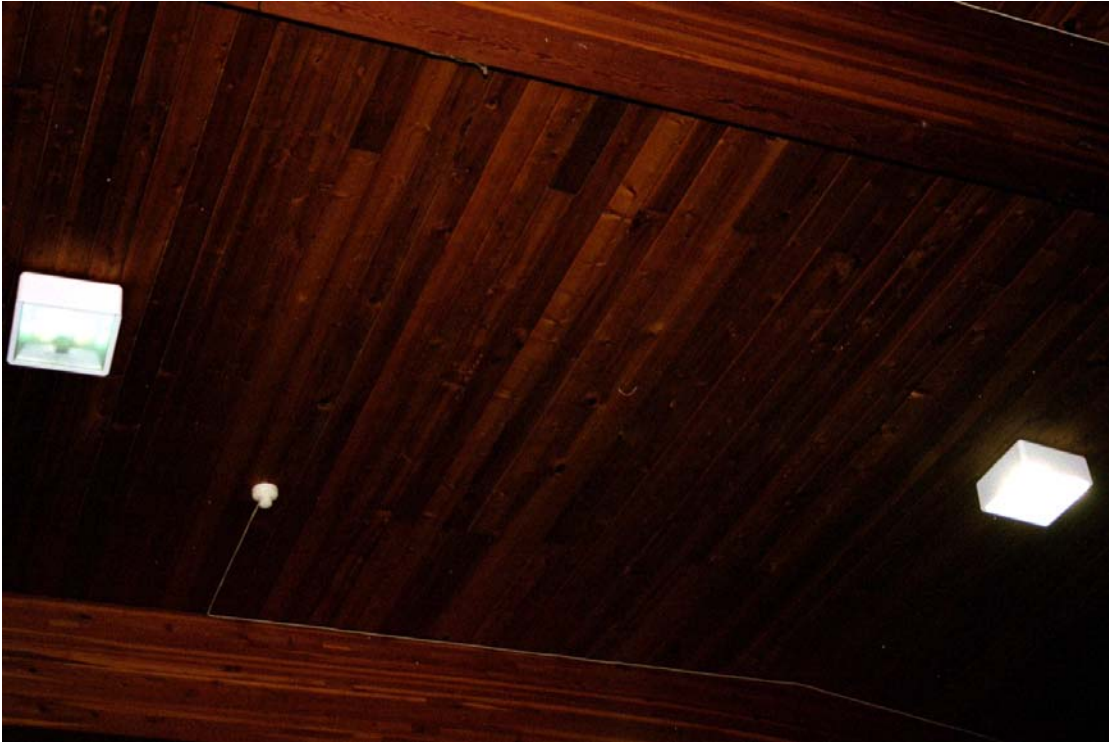
Figure 10: Ceiling Multi-Purpose Room.

The Multi-Purpose building (Figure 7) roof is supported by glued-laminated beams that span the width of the building. Straight sheathing was observed spanning between the glu-laminated beams at the framing soffit.(Figure 10).

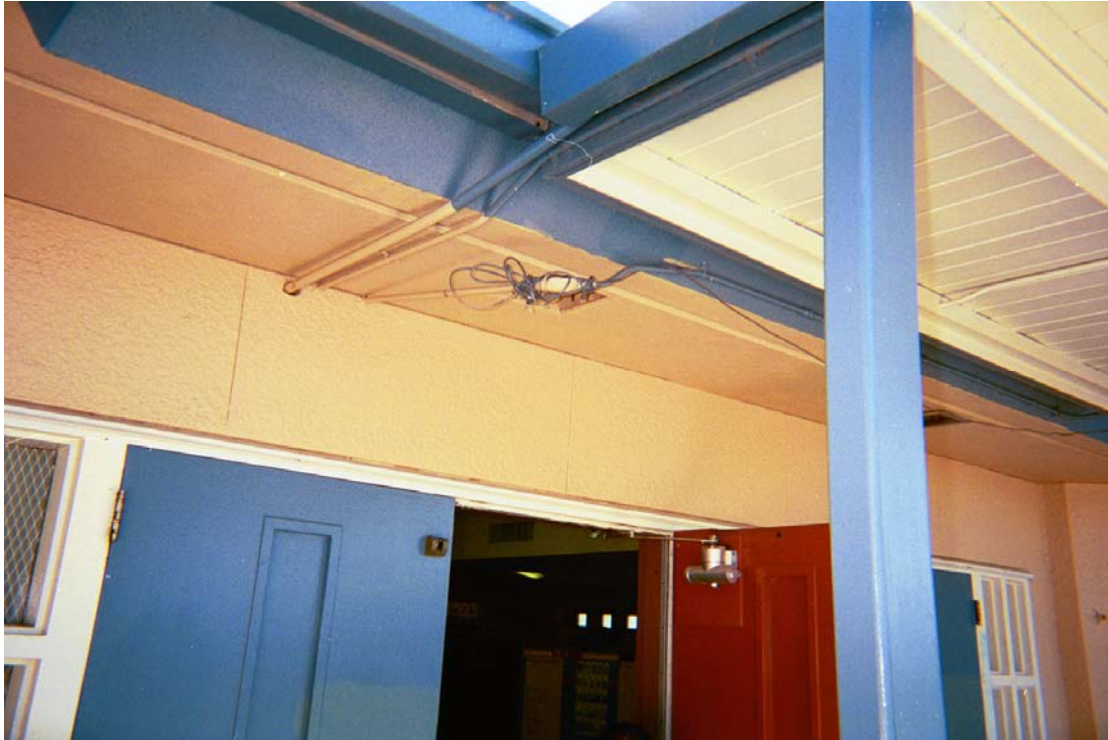
The exterior covered walkway connecting the 1956 classroom building to the 1968 classroom building has a series of tubular moment frames that provide lateral bracing (Figure 11). A seismic joint separates the 1968 Classroom building from the covered walkway. We observed electrical conduits that cross the seismic joint (Figure 14) and could experience damage and possible severing in a major earthquake.

Figure 14: Conduit Crossing Seismic Joint at Unit A

6.	Reroute or provide flexible connection to allow conduit that crosses the seismic joint to accommodate the expected seismic movements.	1.9	14
7.	Reroute or provide flexible connection to allow conduit that connects the portable classrooms to accommodate the expected seismic movements.	1.9	15

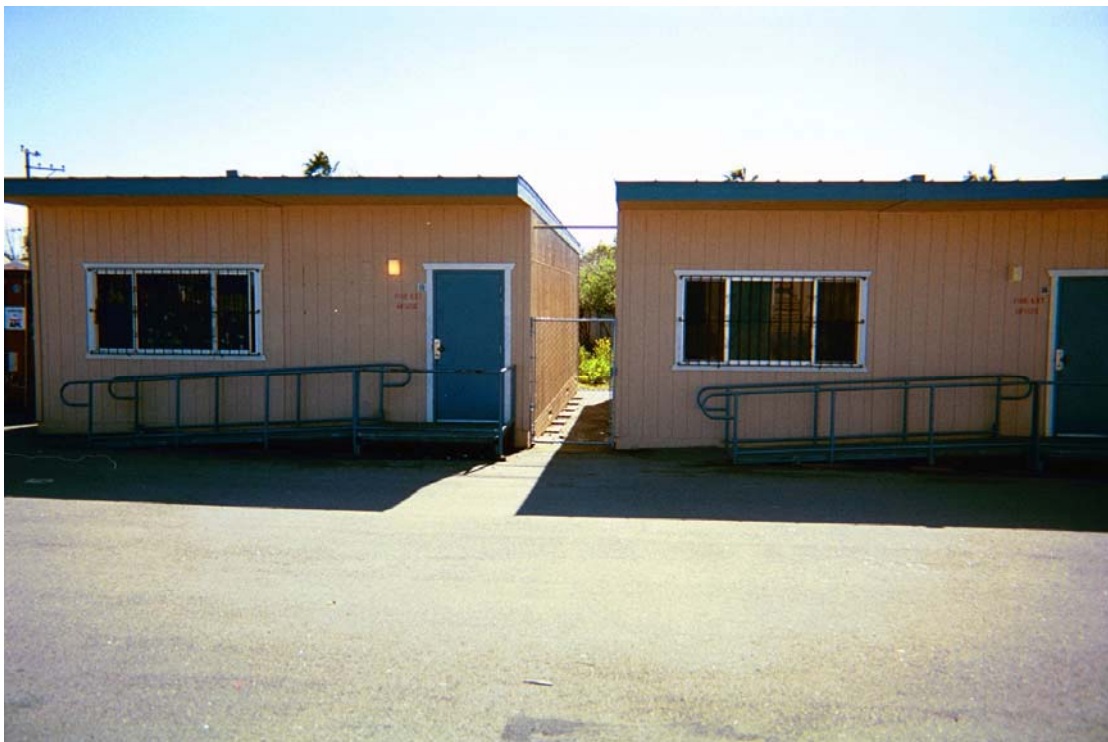
Rigid electrical conduits were observed connecting the portable classrooms at the roof level (Figure 15) which could experience damage and possible severing in a major earthquake. In addition we found that the portable classrooms were supported on wood pads which rest directly on the ground (Figure 16). It is expected that these wood pads could decay and become a source of dry rot spreading to the framing under the portable classrooms.

Figure 15: Portable Classroom Building Connected with Electrical Conduit.

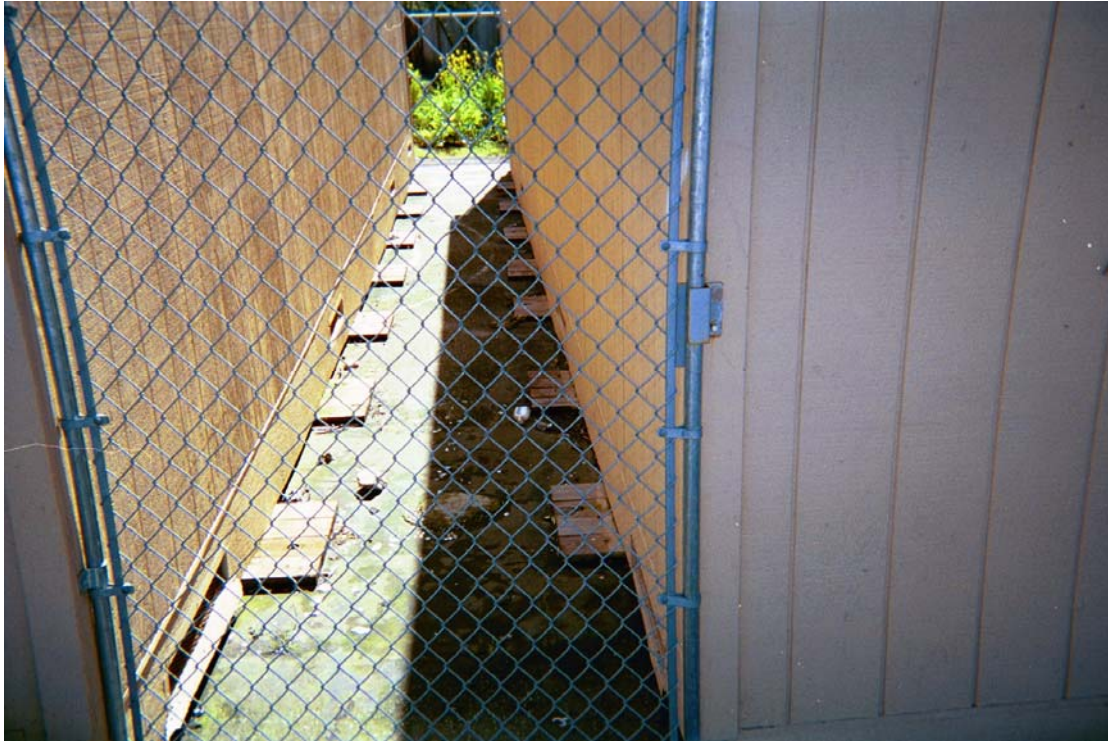
Figure 16: Portable Buildings Resting on Ground.
