STRUCTURAL EVALUATION OF

LINCOLN ELEMENTARY SCHOOL

WEST CONTRA COSTA UNIFIED SCHOOL DISTRICT
(WCCUSD)

April 30, 2002

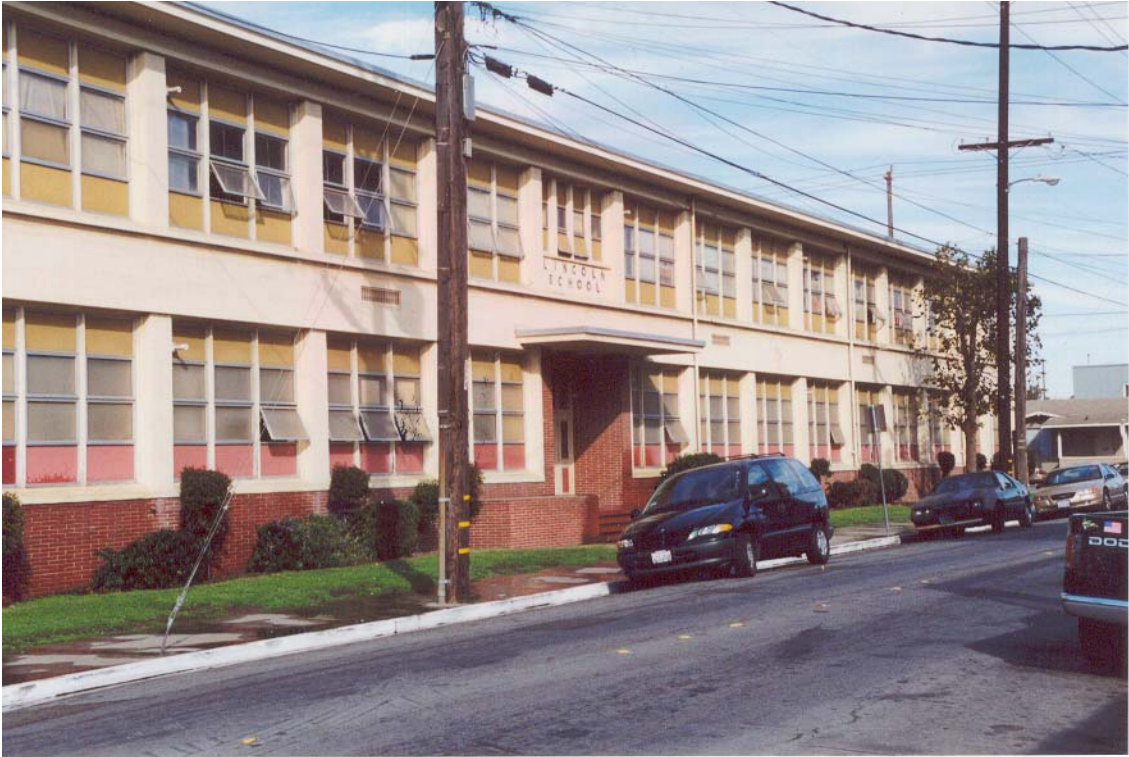
Figure 2: Main Entrance

The main building is a two-story concrete structure (see figures 2 and 4). The east and west faces of the building have multiple large window openings with concrete columns in between. The north and south faces have long segment of shear wall. There are concrete beams and columns along the interior longitudinal corridor with light-framed infill panels (see figure 3).

Item	Building Structural Deficiencies
1.	In the longitudinal direction of the main building there is not an adequate length of shear wall. Much of the lateral resistance is provided by non-ductile concrete columns and gravity concrete beams acting as moment frames. Non-ductile moment frames are prohibited in seismic “Zone 4” area because of their tendency for hazardous brittle failures.
2.	Insufficient shear walls in the transverse direction of the main structure, which

Item	Recommended Remediation	Priority	Figure Number
1.	Add new infill shear walls in longitudinal direction to provide adequate seismic resistance. Provide new collectors and holdowns as required.	1.0	2
2.	Add new shear wall panels in transverse direction between classrooms. Provide new collectors and holdowns as required.	1.2	N/A
3.	Provide new beams, columns and footings adjacent to each building so that damage will not lead to the collapse of the walkway.	1.5	6, 7
4.	Cover roof with new plywood sheathing.	1.5	N/A

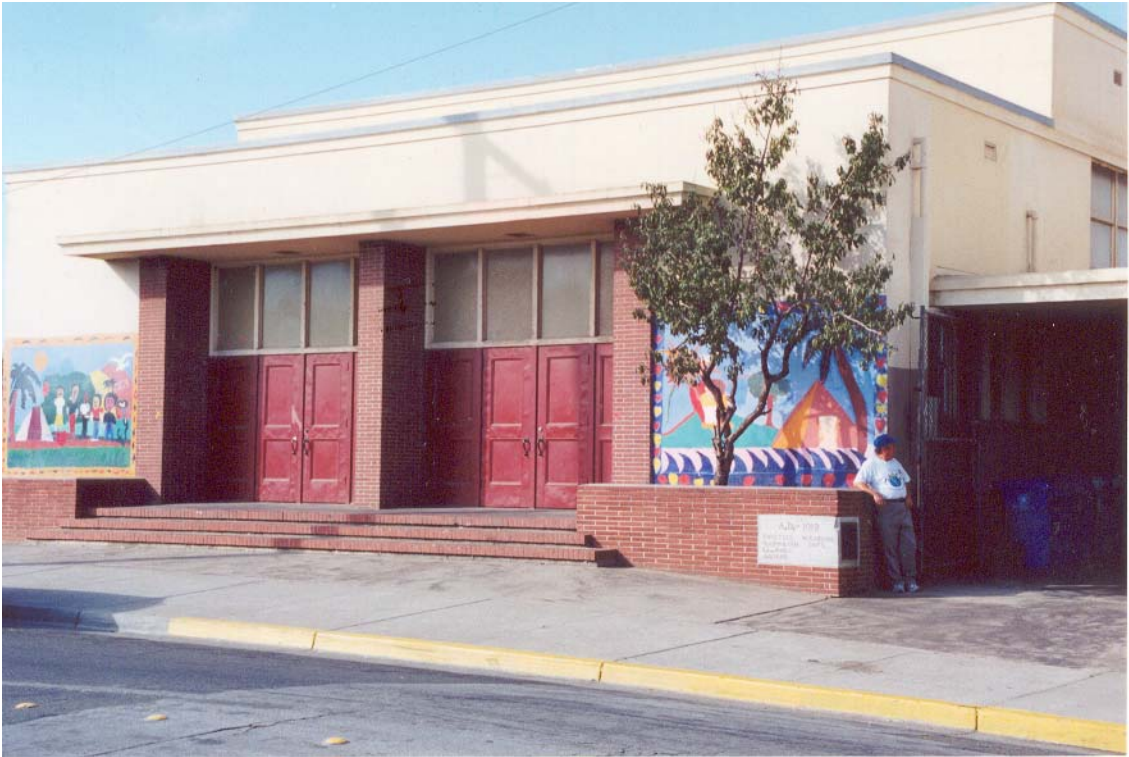
Figure 5: Cafeteria building east entrance

The school is located in the city of Richmond and was built in 1949. The original buildings are a two-story concrete structure (main building) and a one-story wood- and steel-framed structure (cafeteria building) with cement plaster finish on the exterior (see figure 5). There is also a small wood-framed classroom building (rooms 37 and 38) built in 1989. There are three main buildings (permanent structures) and seven portable buildings (see figure 1). There is one 1960 portable, two 1989 portables, one 1996 portable, one 1997 portable, two 1998 portables, and one 2000 portable. The total square footage of the permanent structures is about 38,741 square feet.

The cafeteria building is a one-story wood and steel structure with cement plaster exterior and some brick veneer (see figures 5 and 7). The ceiling appears to be plaster. There are multiple window openings along the south wall (see figure 6) and large door openings on the east face of

the building (see figure 5). The other walls only have minor wall openings. At the east end of the building, there is a low roof area over the entry lobby. There appears to be some deterioration of the wood at the windows on the south side of the building (see figure 8).

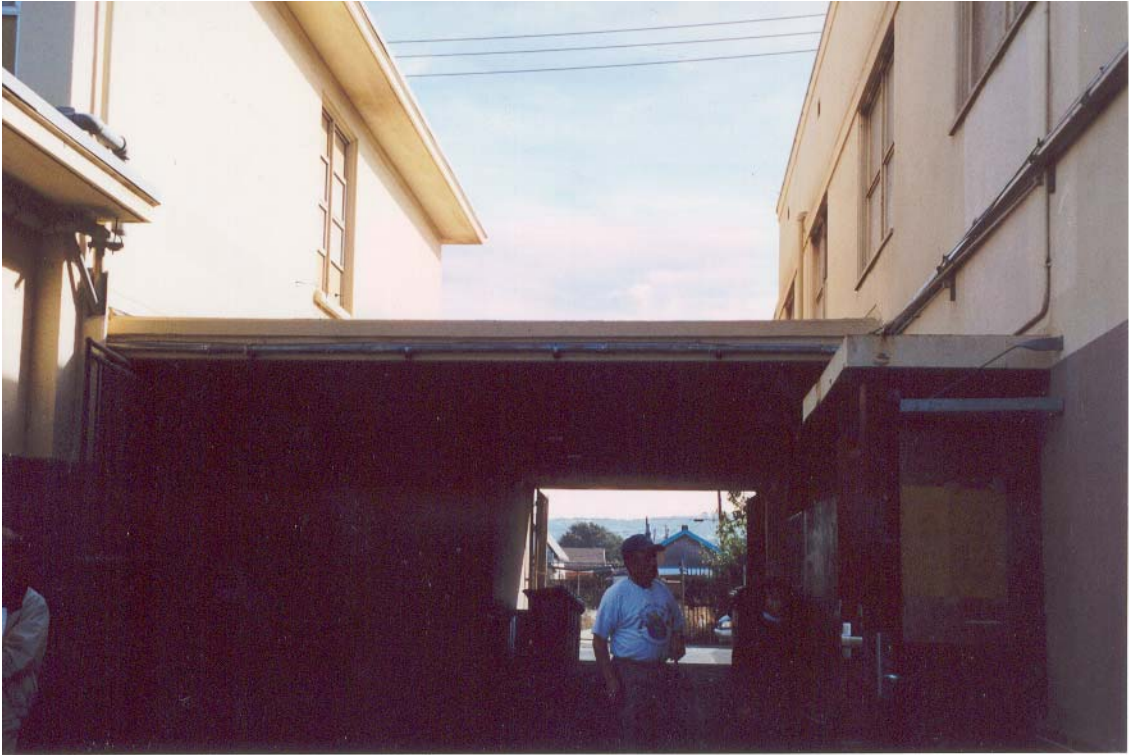
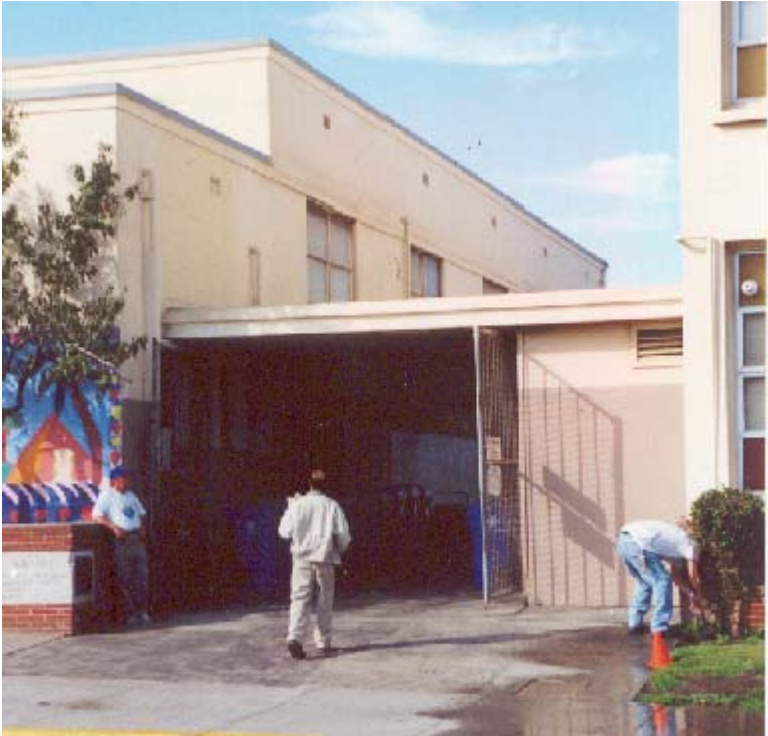
Between the main and cafeteria buildings, there is a small covered walkway area (see figures 6 and 7). This covered walkway is supported by the walls of the two buildings, and does not have its own gravity support system. There are electrical conduits between the two buildings that are supported by the covered walkway.

The covered walkway that spans between the main building and the cafeteria building does not have its own independent gravity or lateral force resisting systems, and there is no seismic joint between the covering and either building.

3.	The covered walkway spans between the classroom building and the cafeteria building. These buildings will have different displacements. The walkway may suffer severe damage and is a life safety hazard because it does not have its own gravity support framing and could collapse if it were separated from one of the buildings.

Figure 6: Covered walkway

Figure 7: Covered walkway and cafeteria building north face

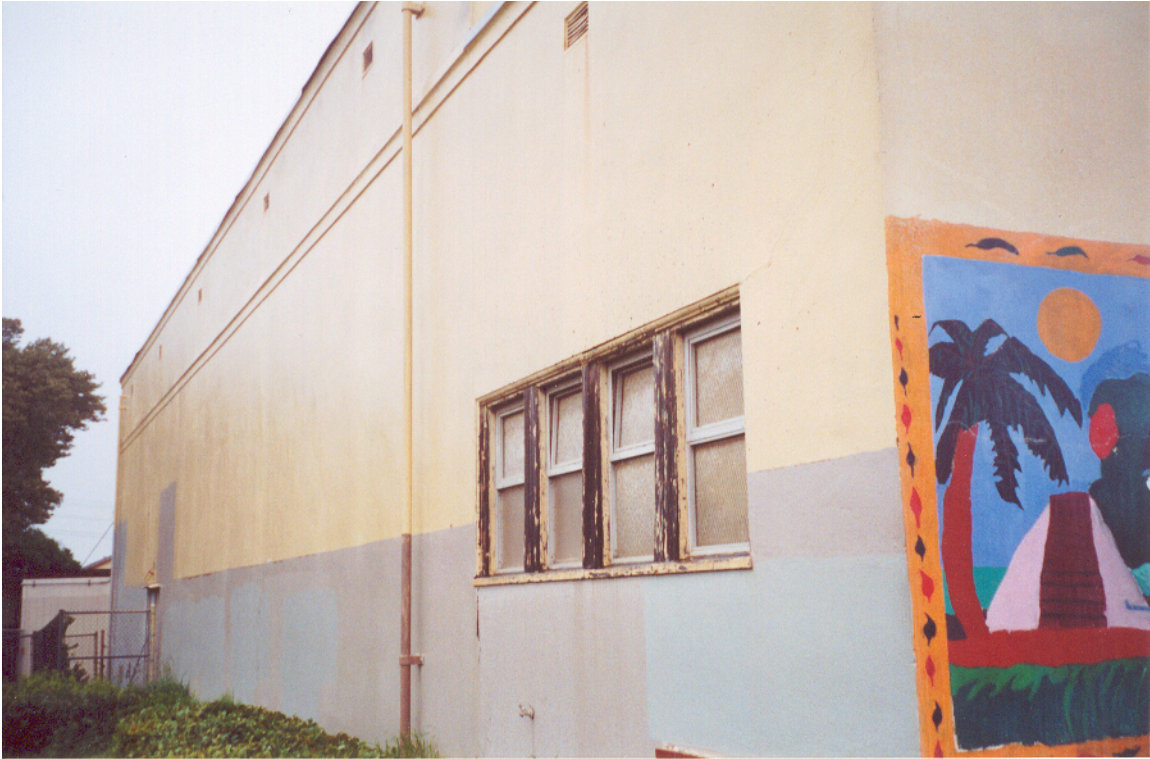
6.	The wood around the window at the south side of the cafeteria building is deteriorating due to wood decay. This may lead to deterioration of the remainder of the wall.

Figure 8: South face of cafeteria building

5.	Add new plywood sheathing to the interior face of the wall. Provide new collectors as required. Add new holdowns at the ends of shear wall panels.	1.4	N/A
6.	Replace damaged wood and paint to protect from weather.	1.9	8
7.	Infill some windows with new framing and shear wall. Provide new collectors and holdowns as required.	1.3	10
8.	Replace damaged members, and paint to protect from weather	1.5	12
9.	Shore existing posts and replace concrete pedestals.	1.5	11
10.	Provide new flexible connection at conduit	1.9	13

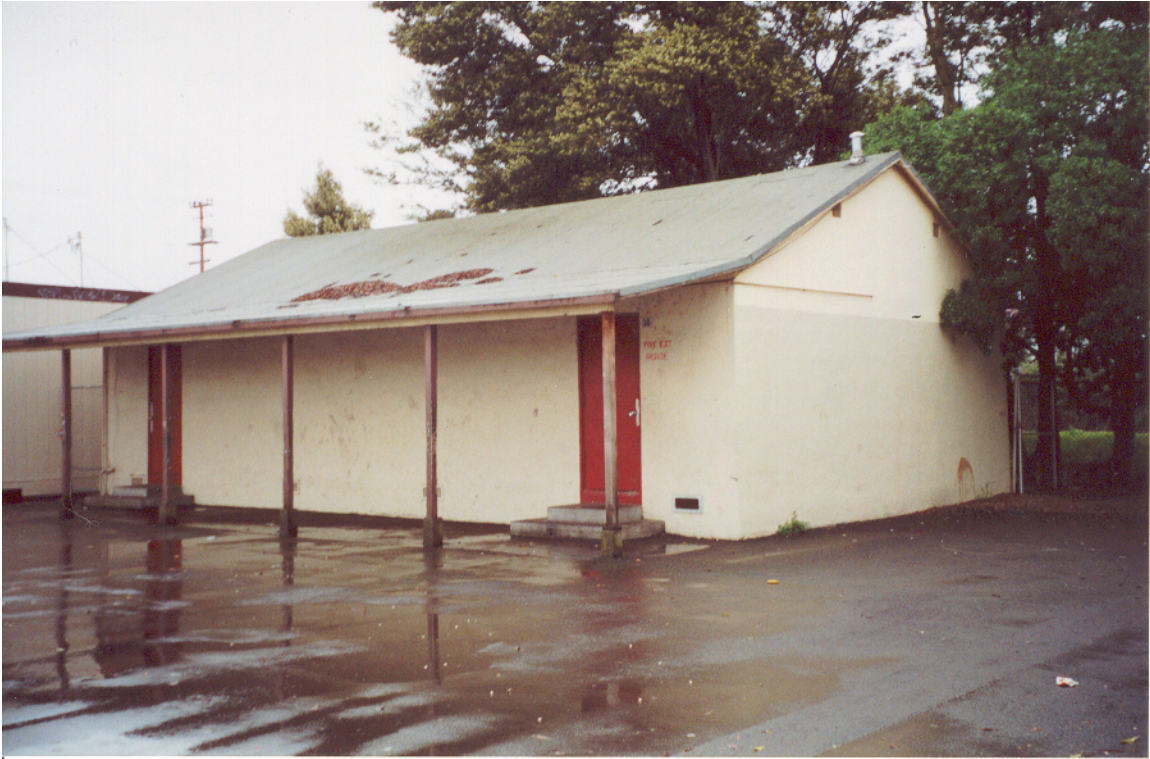
Figure 9: Front view of classroom building

The classroom building is a wood-framed structure with a covered walkway attached to the front of the building (see figure 9). The rear face of the building has multiple window openings (see figure 10). The 4x4 posts that support the covered walkway sit on small concrete pedestals. One of these pedestals has significant cracking that appears to go most of the way through the section (see figure 11). At the top of that same post, there appears to be some rotting of the beam (see figure 12). At the east side of the building, there is electrical conduit that runs across to the cafeteria building near the roof level (see figure 13).

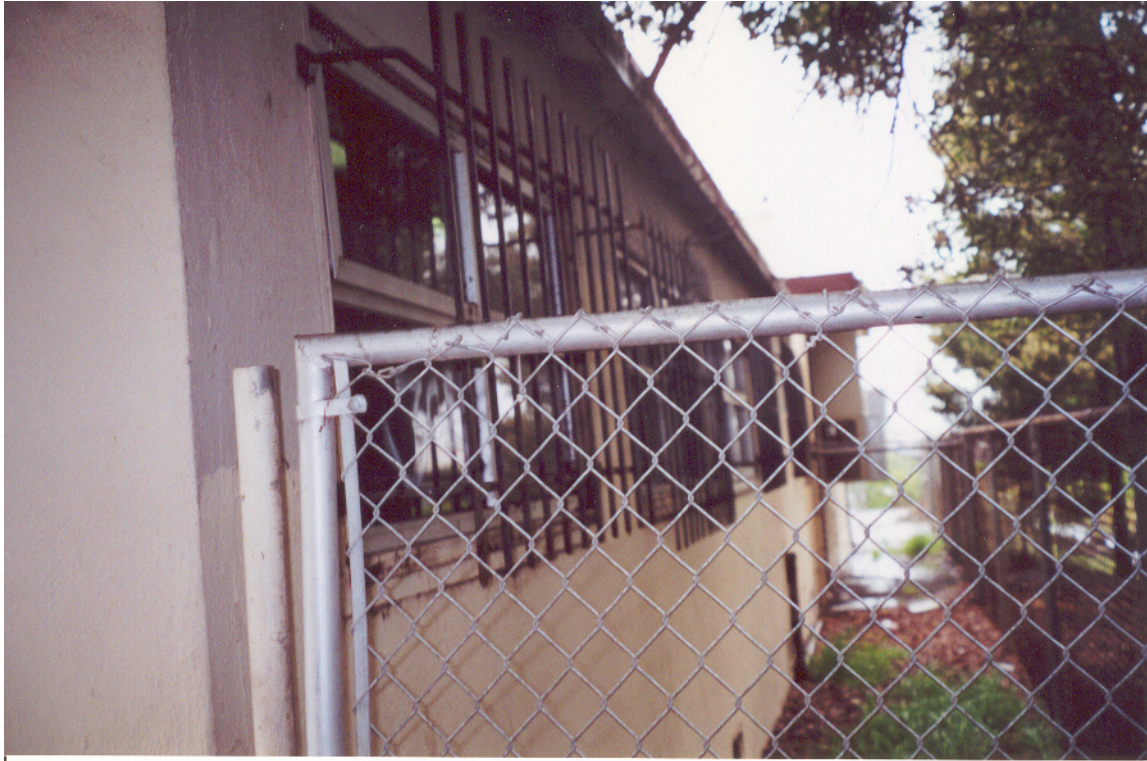
7.	The rear wall of the classroom building has excessive window openings, resulting in a lack of adequate shear wall.
8.	At the covered walkway at the front of the classroom building, the connection of the post to the roof beam has some rot. This may result in partial collapse of the covered walkway if subjected to major earthquake ground motions.

Figure 10: Rear face of classroom building

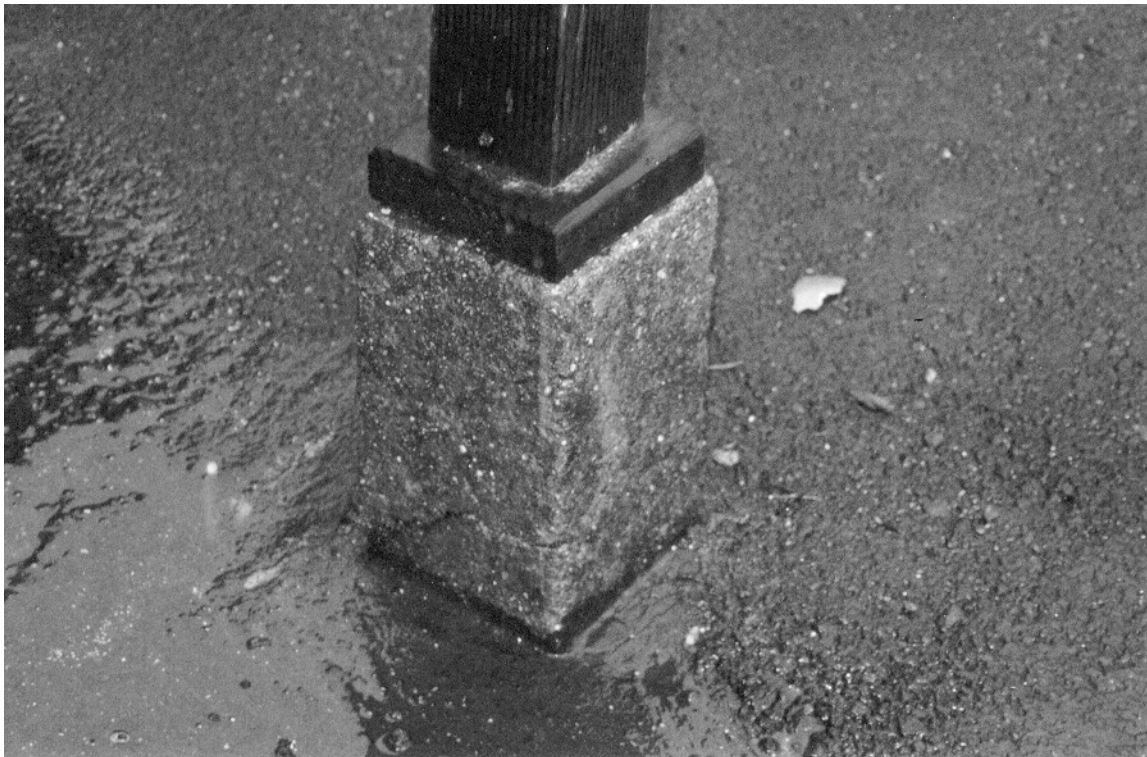
9.	At the covered walkway at the front of the classroom building, the posts rest on unreinforced concrete pedestals that could fall over and cause the post and supported roof framing to lose vertical support. Also, one of the pedestals has significant cracking, making the failure of the pedestal and subsequent partial collapse of the overhang during an earthquake more likely to occur.

Figure 11: Concrete pedestal at classroom building covered walkway

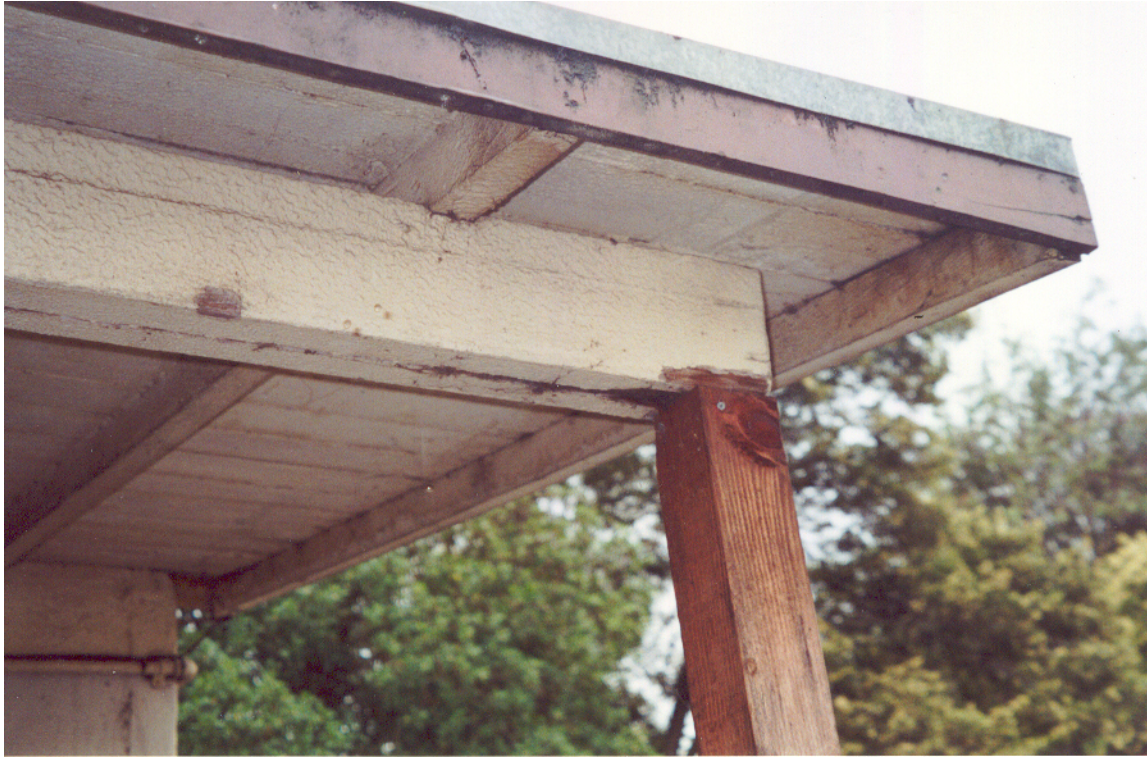
Figure 12: Deterioration of beam at classroom building covered walkway

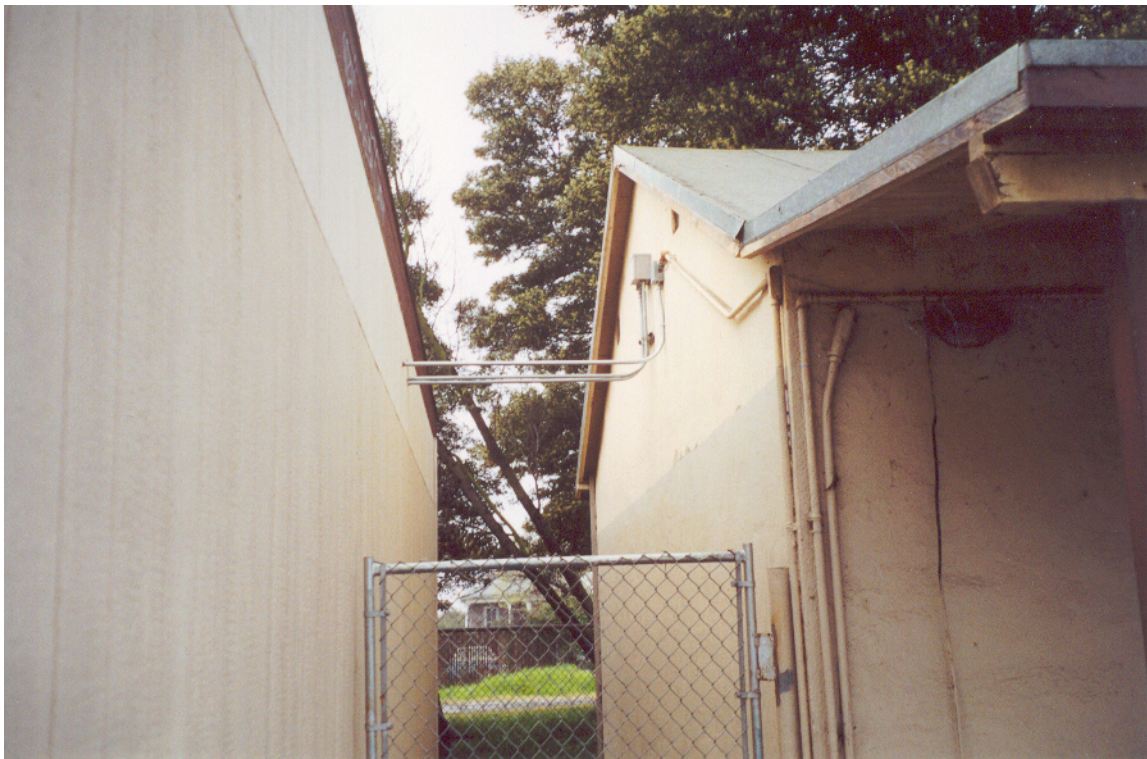
10.	There is conduit running between the classroom building and the cafeteria building. Because the conduit has a rigid connection, it could be severed as the buildings move apart and is a life-safety hazard..

Figure 13: Conduit between cafeteria and classroom buildings
