STRUCTURAL EVALUATION OF
MADERA ELEMENTARY SCHOOL
WEST CONTRA COSTA UNIFIED SCHOOL DISTRICT
(WCCUSD)

WLC Architects
Kaiser Building
1300 Potrero Avenue
Richmond, CA 94804

DASSE Design, Inc.
33 New Montgomery Street #850
San Francisco, CA 94105
(415) 243-8400

April 30, 2002

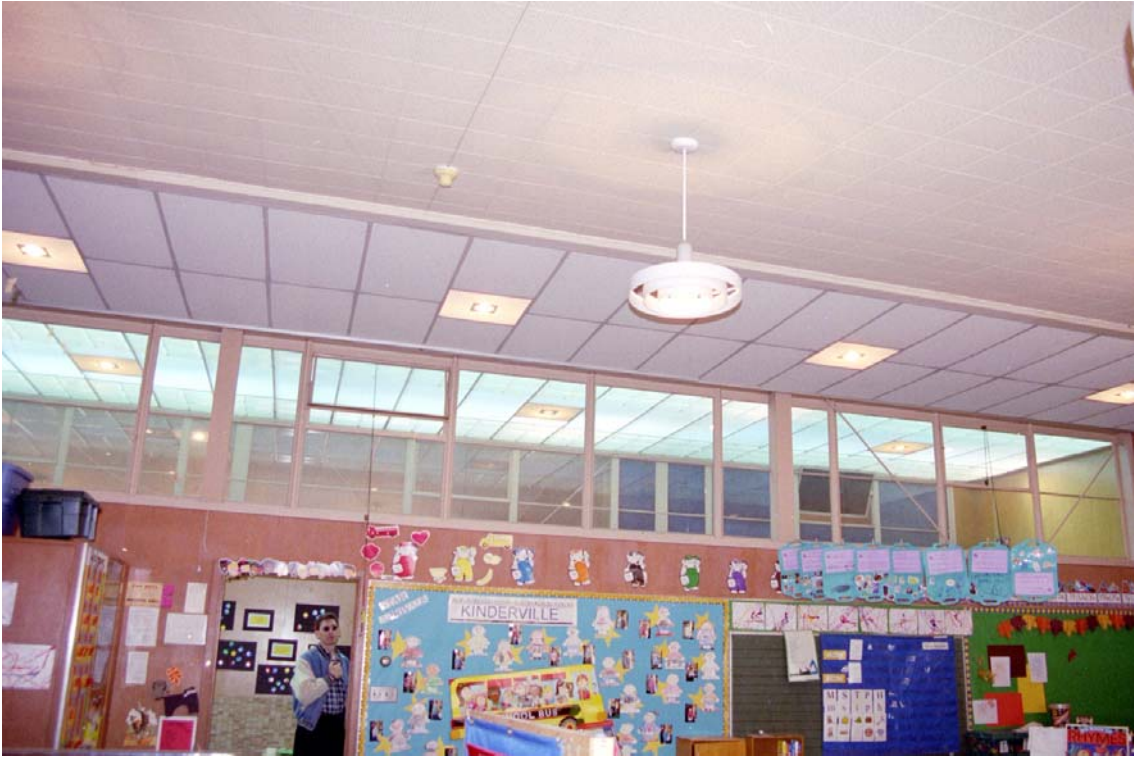
Figure 5: High Windows at Central Corridor with a Partial View of Diagonal Tie-Rod Bracing

Item	Building Structural Deficiencies
1.	The tie rods in the classroom wing roof at the skylights only carry tension forces and are overstressed.
2.	The tie-rods at the classroom wing corridor frames only carry tension forces and are overstressed.

Item	Recommended Remediation	Priority	Figure Number
1.	Replace tie rods with new double-angle bracing.	1.2	7
2.	Provide double-sided full-height plywood shear walls, infilling the high windows at these locations. Strengthen collectors and add new holdowns as required.	1.2	5
3.	Infill windows at the east wall of the multi-purpose wing with new plywood-sheathed shear wall. Strengthen collectors and add new holdowns as required.	1.3	8
4.	By adding new shear wall in item number 3 above, this deficiency will also be remedied.	1.6	N/A
5.	Provide new blocking and straps at the roof.	1.8	N/A
6.	Provide new collector elements to tie these portions of the building together	1.0	10
7.	Replace the damaged wood and paint to protect it from weather.	3.0	14
8.	Repaint column to protect it from corrosion.	3.0	13

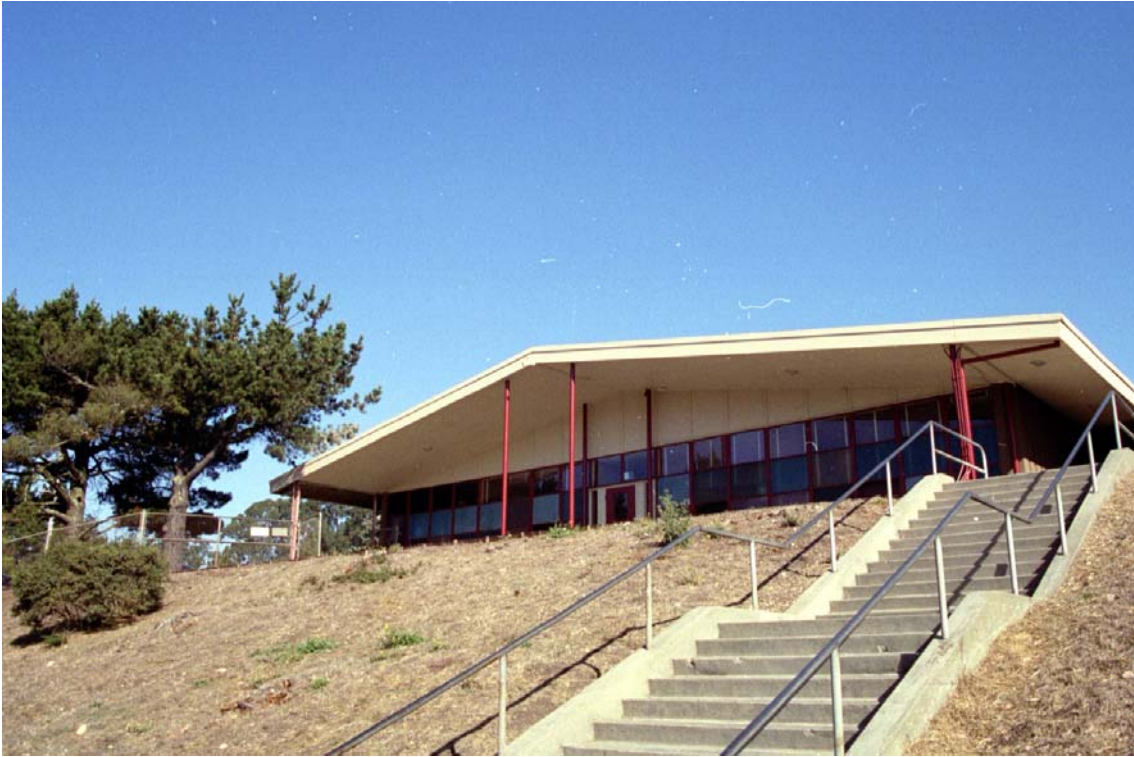
Figure 9: South face of Administration Area

5.	The east-west shear walls at the administration area are not aligned with each other and no collector elements are present.
6.	There is a lack of building continuity between the classroom wing and administration area of the building. Because there are no collectors, these portions of the building may separate and cause a partial collapse.

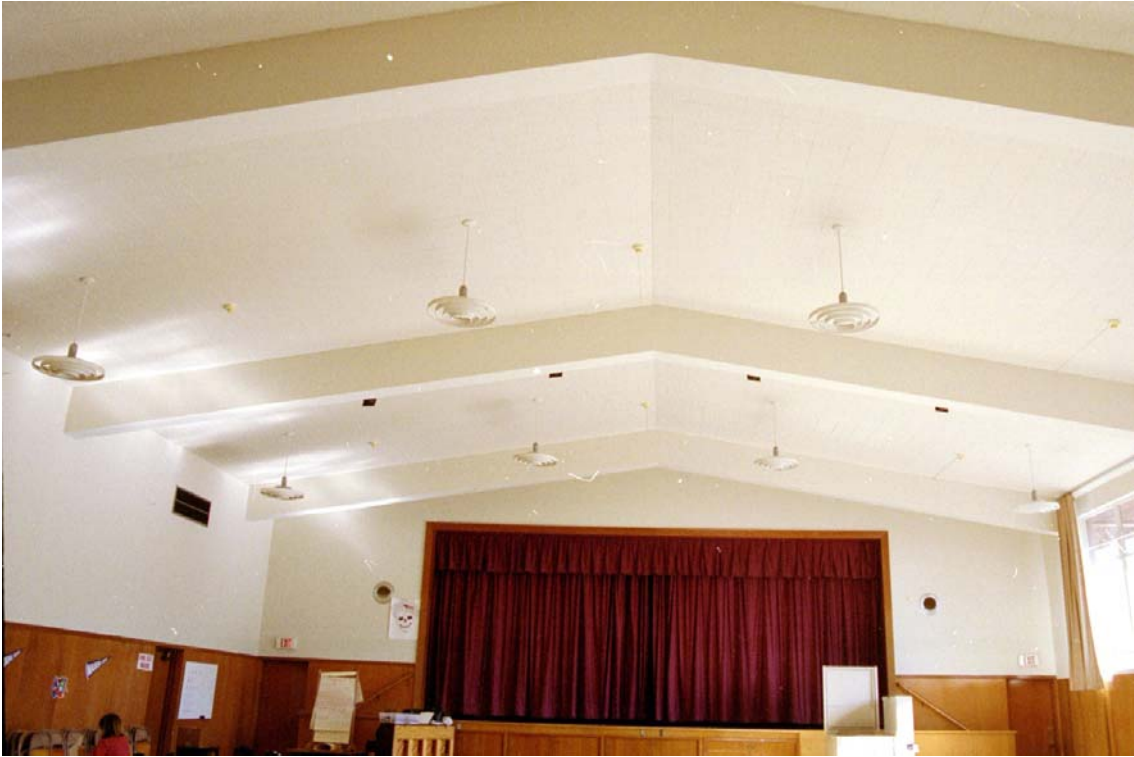
Figure 12: Interior of Multi-Purpose Room

3.	The roof diaphragm chords at the multi-purpose room are overstressed because the diaphragm is cantilevered laterally off of the central frame.
4.	The connection of the roof diaphragm to the steel braced frame at the multi-purpose room is overstressed.

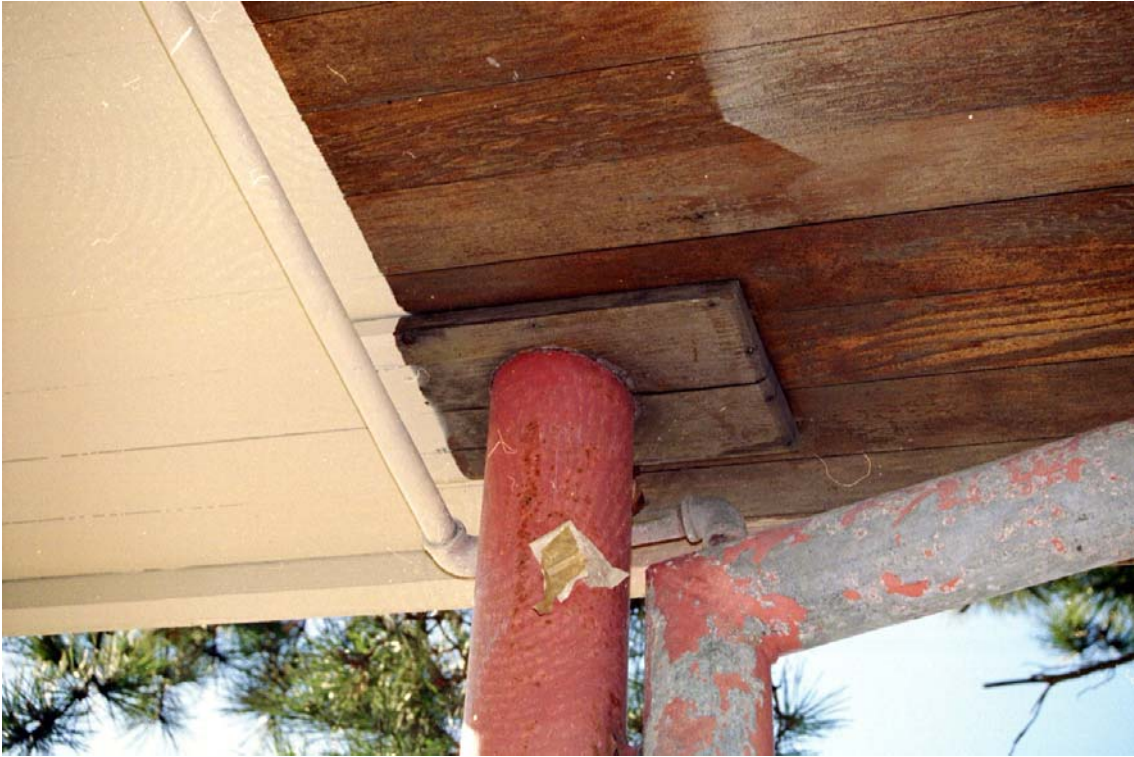
7.	The overhang soffit appears to have some deterioration of wood.
8.	The exterior pipe columns appear to have some rust.

Figure 13: Rust at Exterior Pipe Column

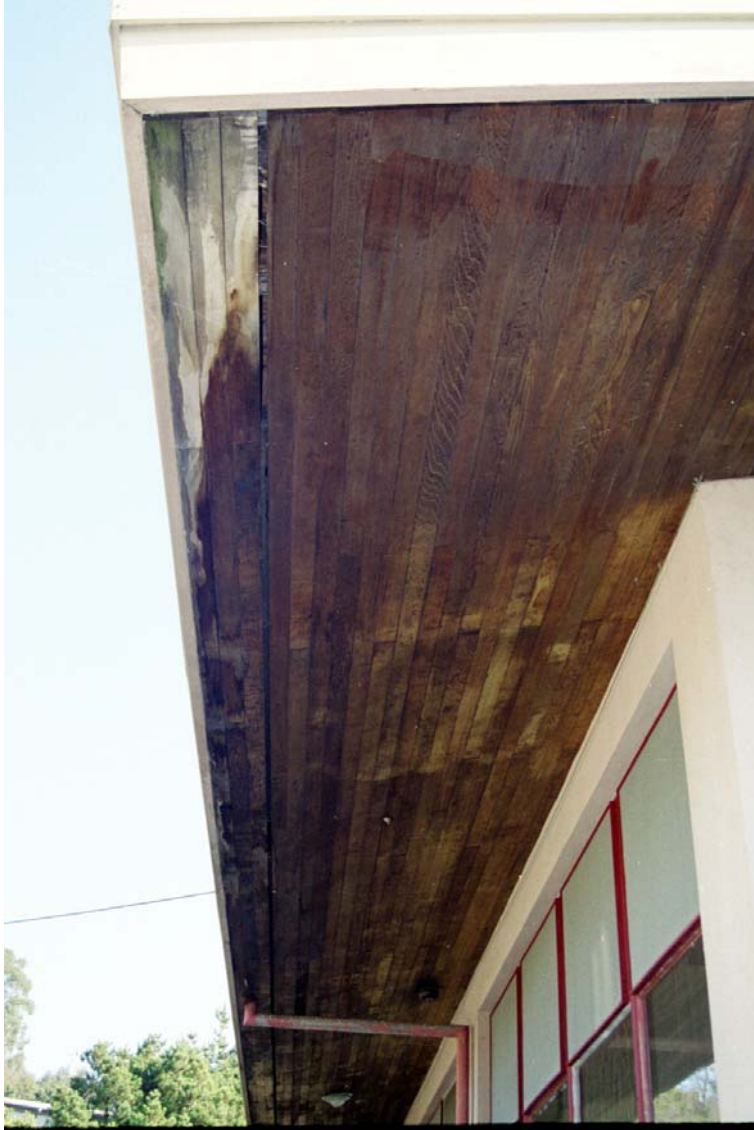
Figure 14: Deterioration of Wood at Soffit
