STRUCTURAL EVALUATION OF
MIRA VISTA ELEMENTARY SCHOOL
WEST CONTRA COSTA UNIFIED SCHOOL DISTRICT
(WCCUSD)

DASSE Design, Inc.
33 New Montgomery Street #850
San Francisco, CA 94105
(415) 243-8400

April 30, 2002

DASSE Design Project No. 01B300

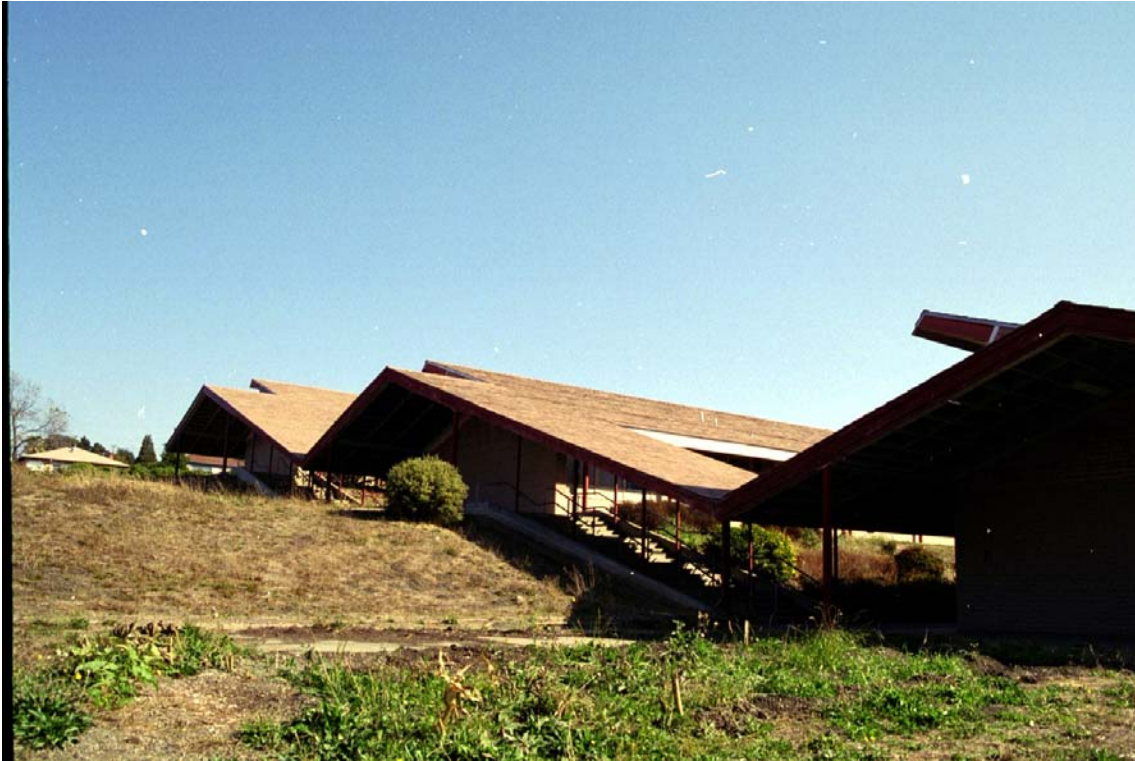
Figure 3: Covered Walkways Between Buildings

The covered walkways that connect the buildings are interconnected and thus will likely be damaged in an earthquake. Thus consideration should be given to adding seismic movement joints between the buildings and providing additional seismic bracing of the covered walkways.

Item	Building Structural Deficiencies
1.	Covered walkways are connected at each end to buildings creating possibility that when buildings move independently the walkway may tear away and collapse.
2.	At the overhangs and covered walkways the exposed steel is showing some signs of rust.

Item	Recommended Remediation	Priority	Figure Number
1.	Provide supplemental support adjacent to each building so that damage will not lead to collapse of the walkway. Reroute conduits and piping so that it is not supported by covered walkways.	1.9	3

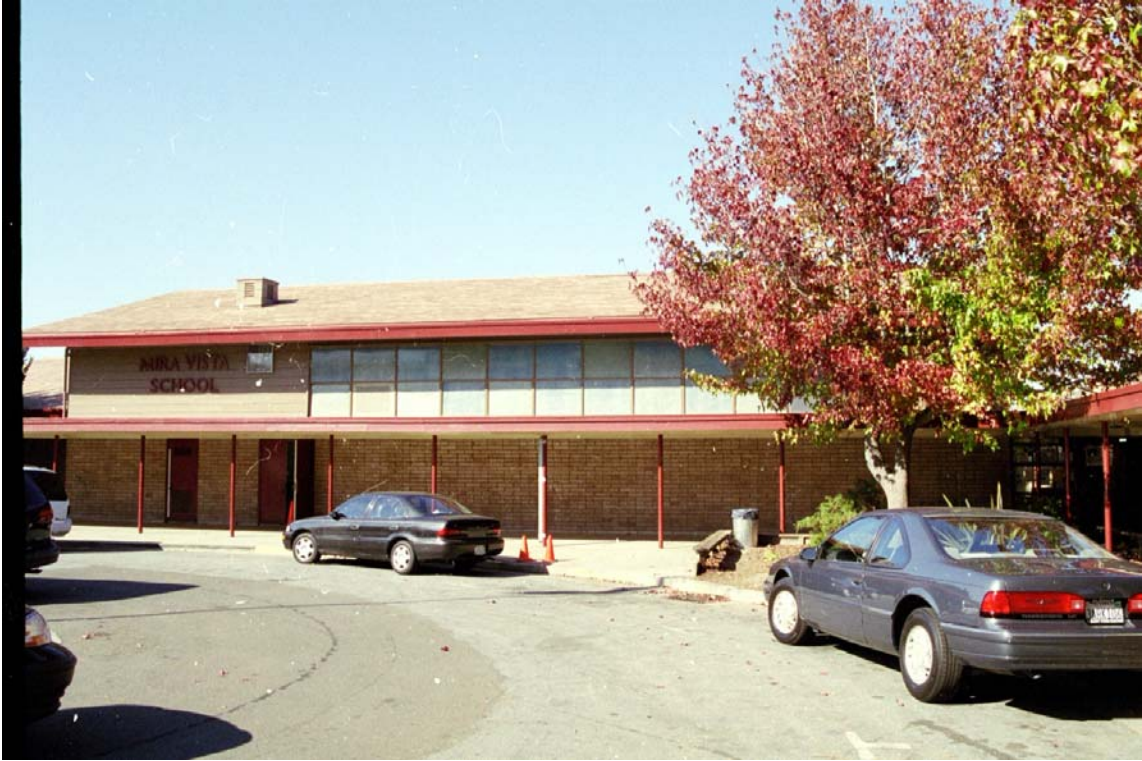
Figure 5: Covered Walkway at Front

The front canopy walkway needs bracing because of the minimal lateral resistance provided by the 3" diameter pipe columns. The covered walkways connect the buildings without any provision for building movement and as a result are likely to be damaged in an earthquake. In addition the electrical conduits and pipes that run along these covered walkways are likely to break as a result of the differential movement (Figure 17).

3.	At the front covered walkway between the Multi-Purpose Bldg. and the Kindergarten Classrooms there appears to be a lack of lateral bracing.
4.	There is some slight cracking of the rear wall of the Multi-Purpose Building
5.	The connections of the braced frames on the north and south sides of the Multi-Purpose Building are overstressed.
6.	The connections of the braced frame at the front of the Multi-Purpose room stage are overstressed.
7.	The water stains on the acoustical ceiling tiles in the Classrooms may indicate roof leaks.
8.	The rod bracing used to transfer the roof shears across the clerestory windows in the classrooms are slightly overstressed.
9.	Exposed roof joists and covered walkway members that are not protected from the elements show some signs of decay

2.	Remove the rust and paint the steel that is rusting.	3.0	4
3.	Add new moment connections or knee bracing, at walkway columns.	1.9	5
4.	Grout and seal the cracks in the Multi-Purpose rear walls	3.0	6

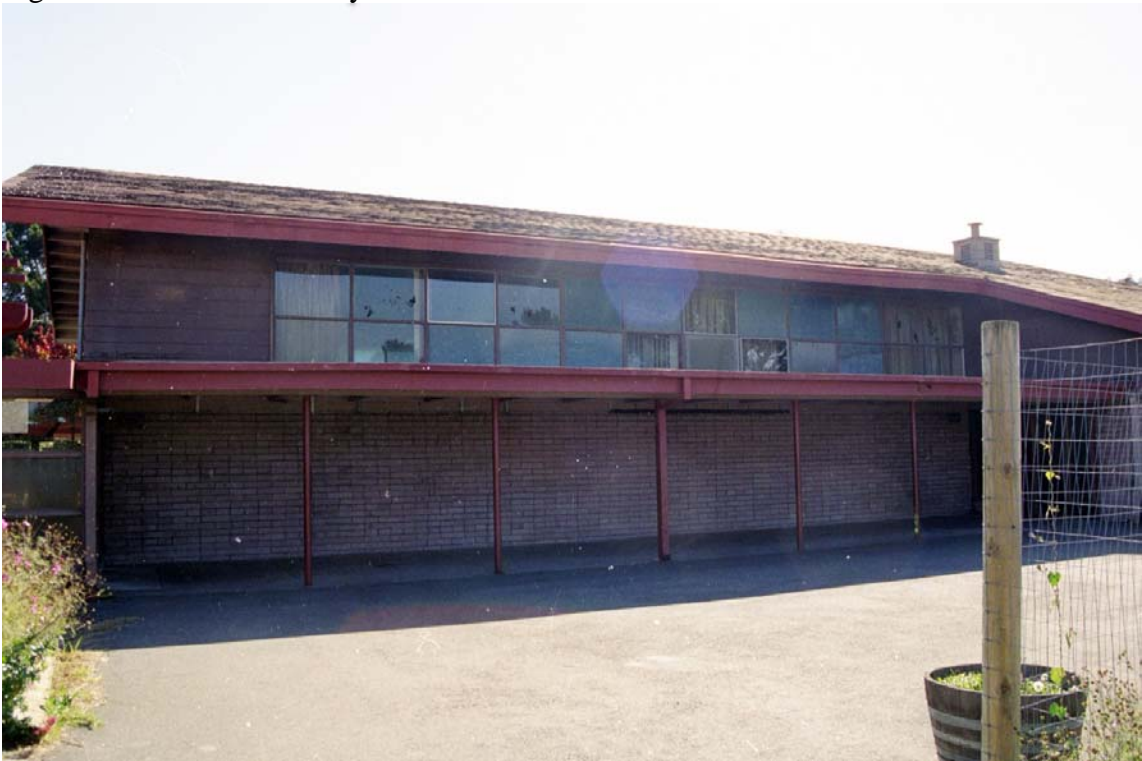
Figure 6: Rear Wall of Multi-Purpose Building

At both exterior walls there are high windows limiting the available length of shear wall. At the back wall of the Multi-Purpose there are some slight cracks.

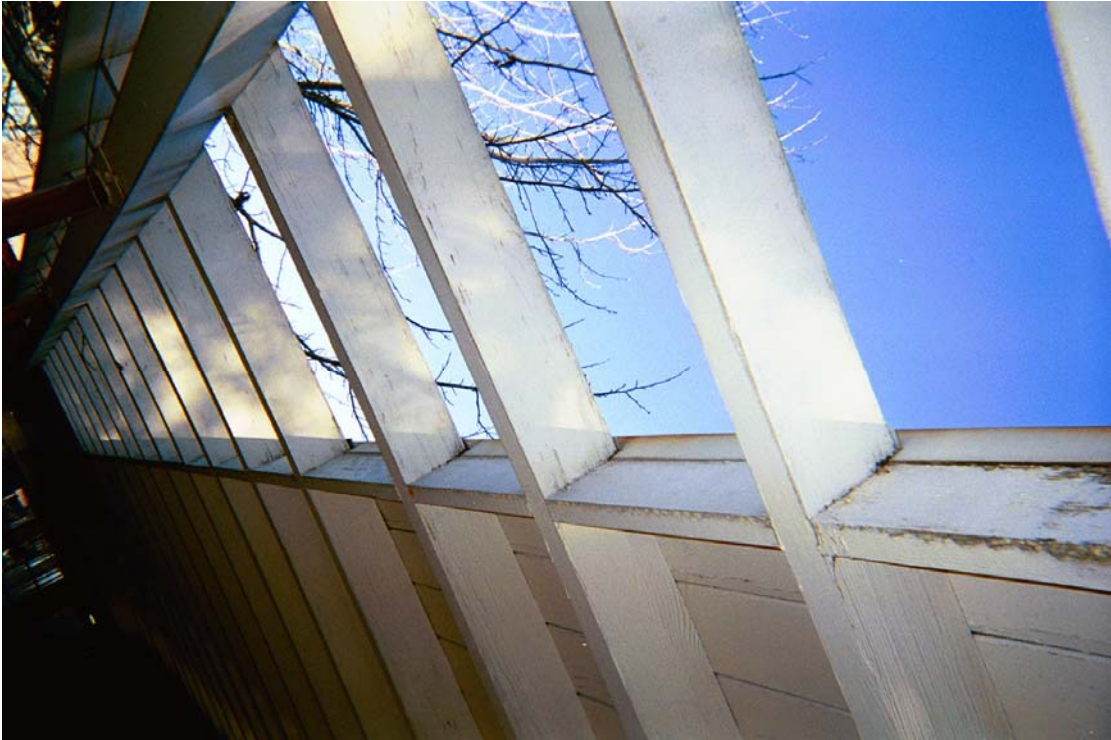
Figure 14: Trellis Overhang

At a number of locations there are trellis and roof overhangs that are not protected by roofing or flashing (Figures 14 & 15). There is some signs that these exposed wood members are subject to decay because of this condition.

7.	Inspect the roof, repair roofing and wood rot as required.	3.0	7
8.	Add additional bays of rod bracing at clerestory windows.	1.9	N/A
9.	Repair exposed roof and covered walkway members with decay and protect members from further exposure to rain	2.5	14,15

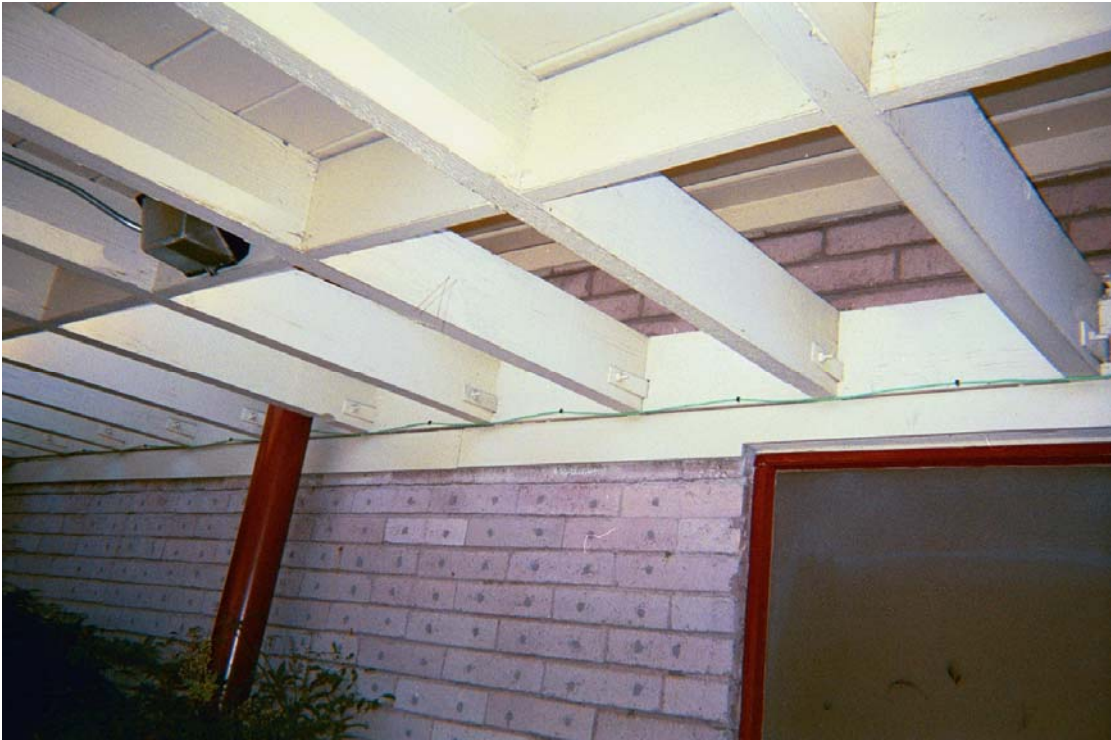
Figure 15: Holes in CMU Walls

Much of the full height CMU walls showed signs that holes had been drilled into the cells and later filled with grout (Figure 15). We noted that a number of the CMU walls showed signs of small vertical cracks (Figure 16).
