STRUCTURAL EVALUATION OF  
NYSTROM ELEMENTARY SCHOOL  
WEST CONTRA COSTA UNIFIED SCHOOL DISTRICT  
(WCCUSD)

DASSE Design, Inc.  
33 New Montgomery Street, Suite 850  
San Francisco, CA 94105  
(415) 243-8400

DASSE Design Project No. 01B300

April 30, 2002

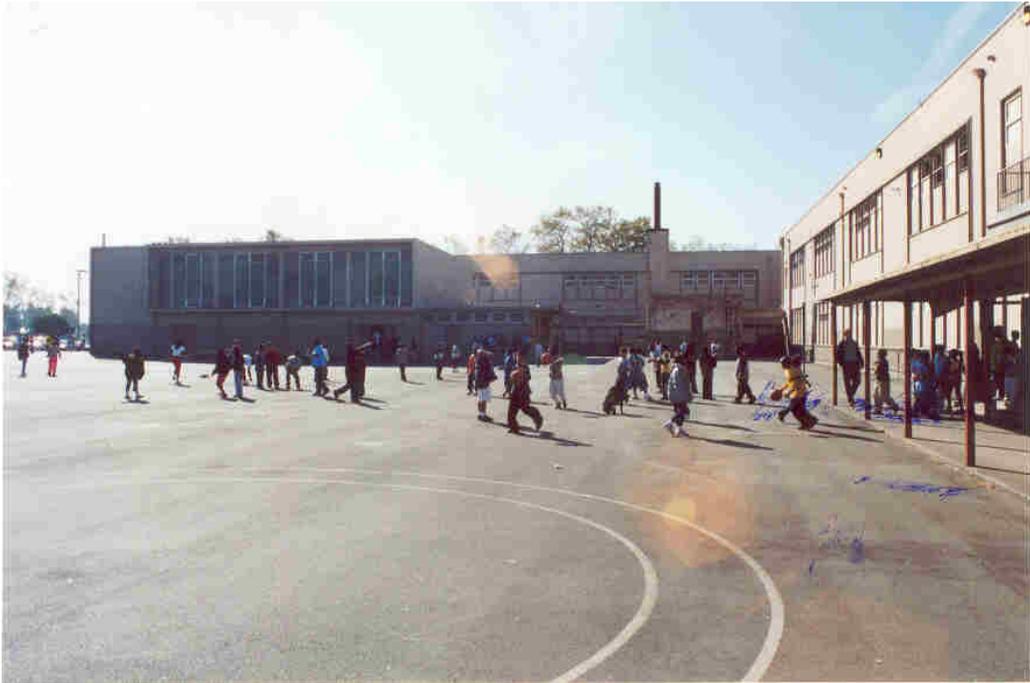
Nystrom Elementary School is located in the city of Richmond and was built in the years 1942, 1948, 1949 and 1953. The 1942 main classroom building is a two-story wood framed structure and has a hard board (transite) finish sheathing on the exterior (see Figures 2 & 3). There are three main buildings on this campus: main classroom building; multi-purpose room; kindergarten building. Thirteen older 1949 portable buildings at the rear of the yard are no longer in service. The 1948 kindergarten building is a one story building with covered walkways and window walls.

Nystrom Elementary School is a two story wood framed building with a hard board finish on the exterior (see Figures 2 & 3). The roofing is in need of replacement. Leakage was found at the east end of the main classroom building and wood rot was noticed in that wall (Figure 4).

**Figure 2: View from Rear School Yard**

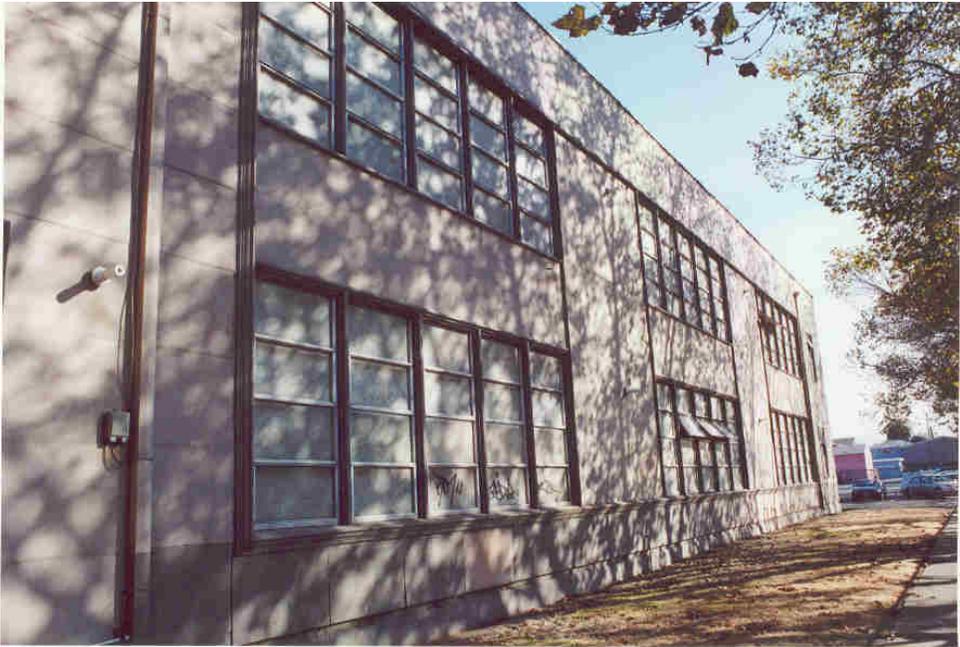
**Figure 3: South Elevation of Main Classroom Building (window wall)**

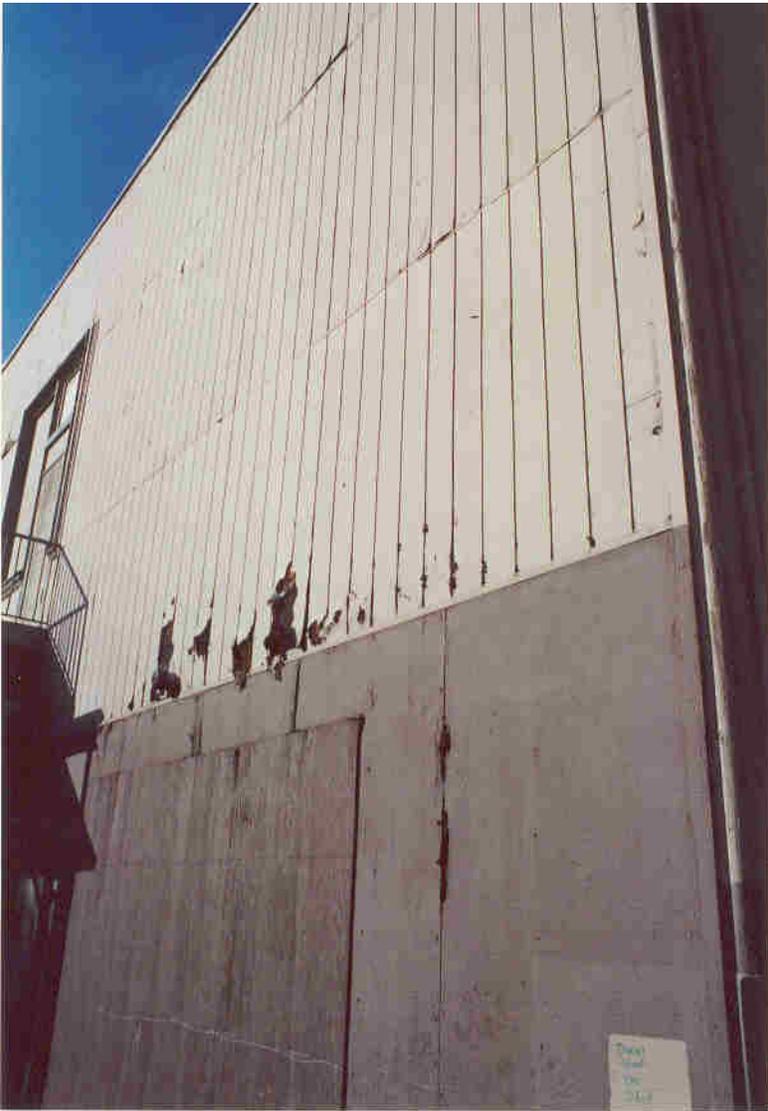
| Item | Building Structural Deficiencies |
|---|---|
| 5. | Siding decay was observed on the east wall of the main classroom building. |

**Figure 4: East Elevation of Main Classroom Building (siding decay)**

| Item | Recommended Remediation | Priority |
|---|--|---|
| 5. | Repair east wall siding and flashing. | 1.5 |

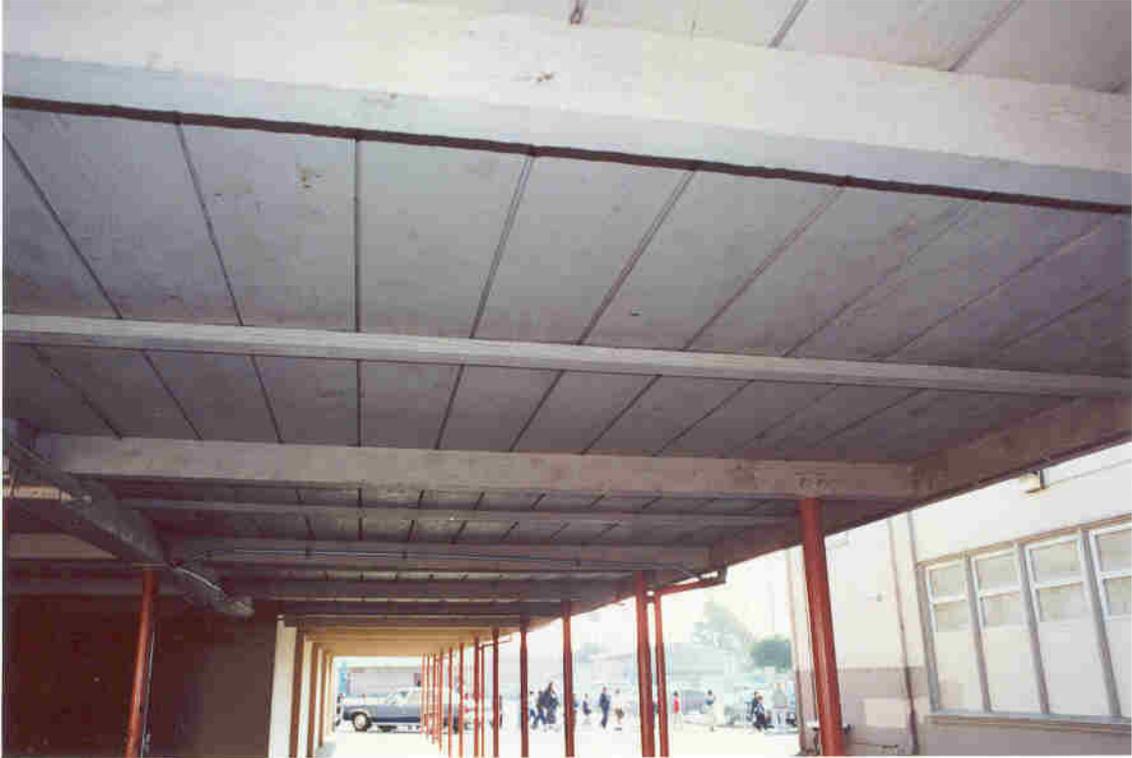
The roof diaphragm appears to be made of straight sheathing at the covered walkways (Figure 6) and diagonal sheathing above classrooms. The wall sheathing appears to be made of diagonal sheathing. Classrooms and corridors have plaster over wood lath ceilings. There are covered walkways in the school campus without adequate lateral bracing. Exterior longitudinal walls of the classrooms have numerous window openings.

| Item | Building Structural Deficiencies |
|---|---|
| 4. | Covered walkways are attached to the outside of the main classroom building and require better attachment to the building for lateral support. |

**Figure 6: Covered Walkways at Main Classroom Building**

| Item | Recommended Remediation | Priority |
|---|--|---|
| 4. | Add connections to covered walkway | 1.9 |

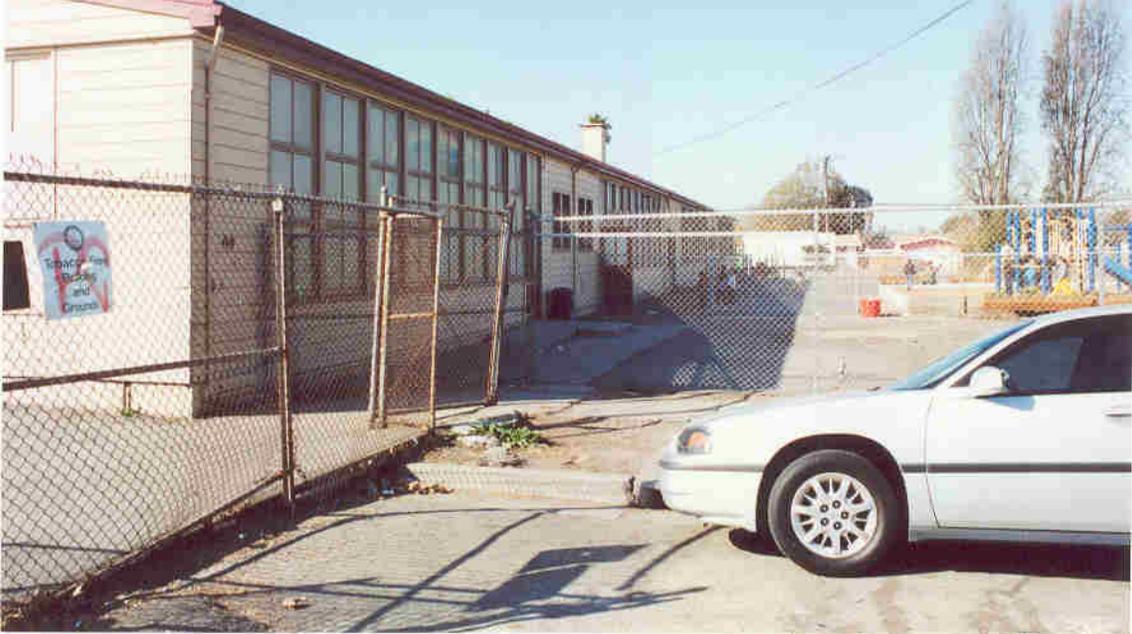
The Kindergarten Building employs typical window wall construction on the north side and clerestory window construction above a covered walkway on the south side (see Figures 7 & 8). The Kindergarten utilizes diagonal sheathing on the roof and exterior walls, however, there are not adequate amounts of walls for shear resistance.

| Item | Building Structural Deficiencies |
|---|---|
| 2. | Exterior longitudinal walls of kindergarten building, classroom numbers 1A through 4A have numerous window openings, resulting in inadequate length of shear wall to resist seismic forces. This building has a window wall on the north side and clerestory windows on the south side. |

**Figure 7: North Elevation of Kindergarten (Window Wall)**

| Item | Recommended Remediation | Priority |
|---|--|---|
| 2. | Add plywood shear walls to kindergarten building. Provide new collectors & hold downs as required. | 1.2 |

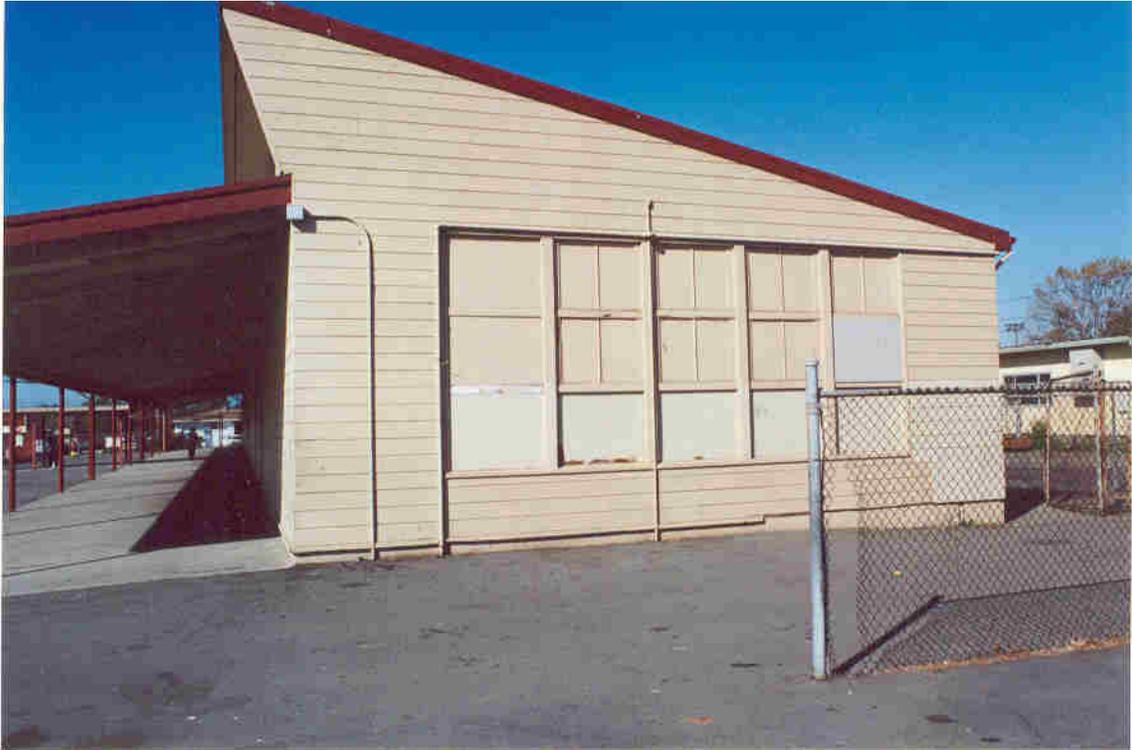
**Figure 8: East Elevation of Kindergarten (shows South Elevation clerestory)**
