STRUCTURAL EVALUATION OF

OHLONE ELEMENTARY SCHOOL

WEST CONTRA COSTA UNIFIED SCHOOL DISTRICT
(WCCUSD)

April 30, 2002

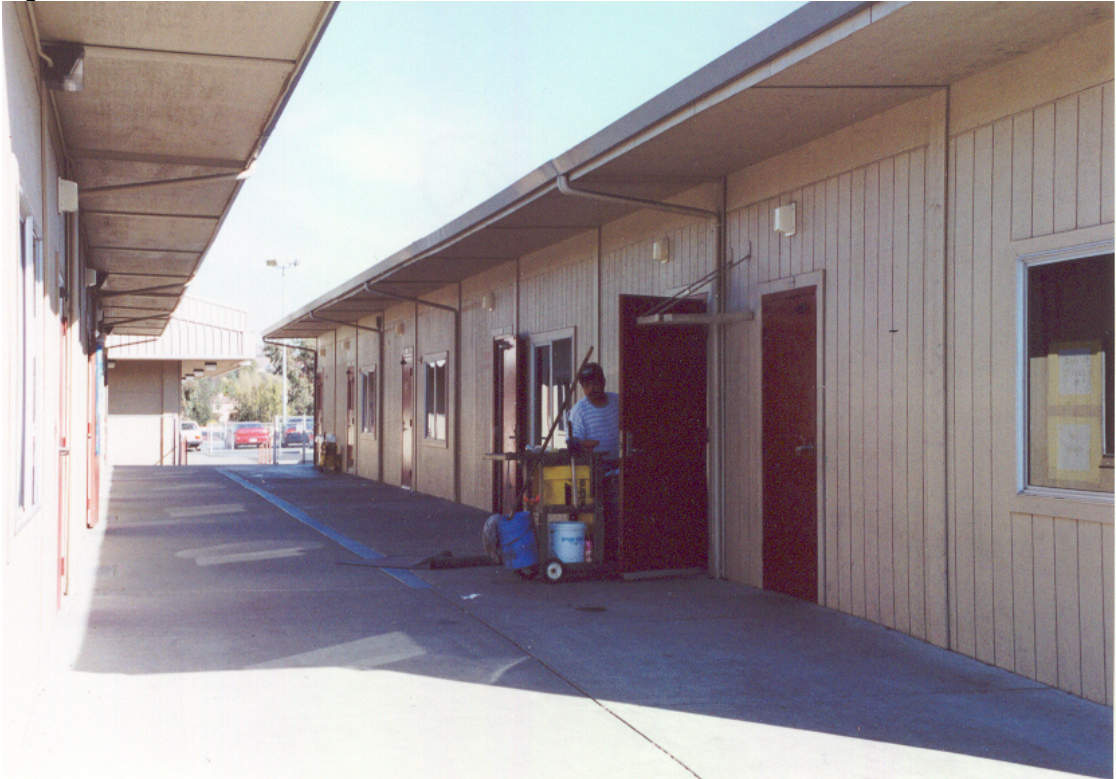
Figure 3: Front Entrance of Classroom numbers 11 to 14

The 1984 and 1985 classroom addition is a one story wood and steel framed portable building made from 11'-10" wide by 40 feet long modular units. The roof has plywood sheathing and the exterior wall has plywood. The front and rear walls of these classroom building have few openings (see figure 3, 4, & 5). The interior of the building has a suspended T-bar ceiling.

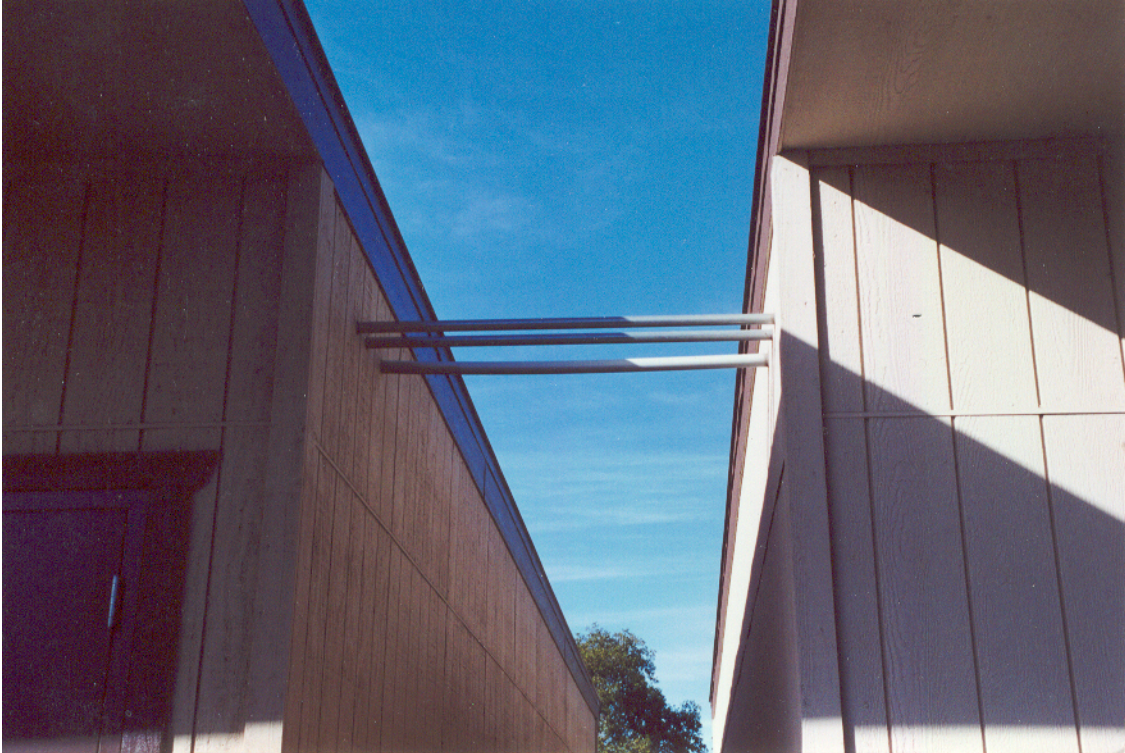
Figure 7: Electrical Conduits running between Portables

Electrical conduits were running between the portables (see figure 7), can get damaged during an earthquake due to differential movements and is a life safety hazard.

Item	Recommended Remediation	Priority	Figure Number
1.	Fill in some windows with new plywood and framing. Provide new collectors.	1.3	N/A
2.	Provide new holdowns to resist seismic uplift forces.	1.2	N/A
3.	Fill in some windows with new plywood and framing. Provide new collectors.	1.3	9
4.	Relocate electrical conduit or install flexible connection when conduit passes between adjacent buildings.	1.9	7

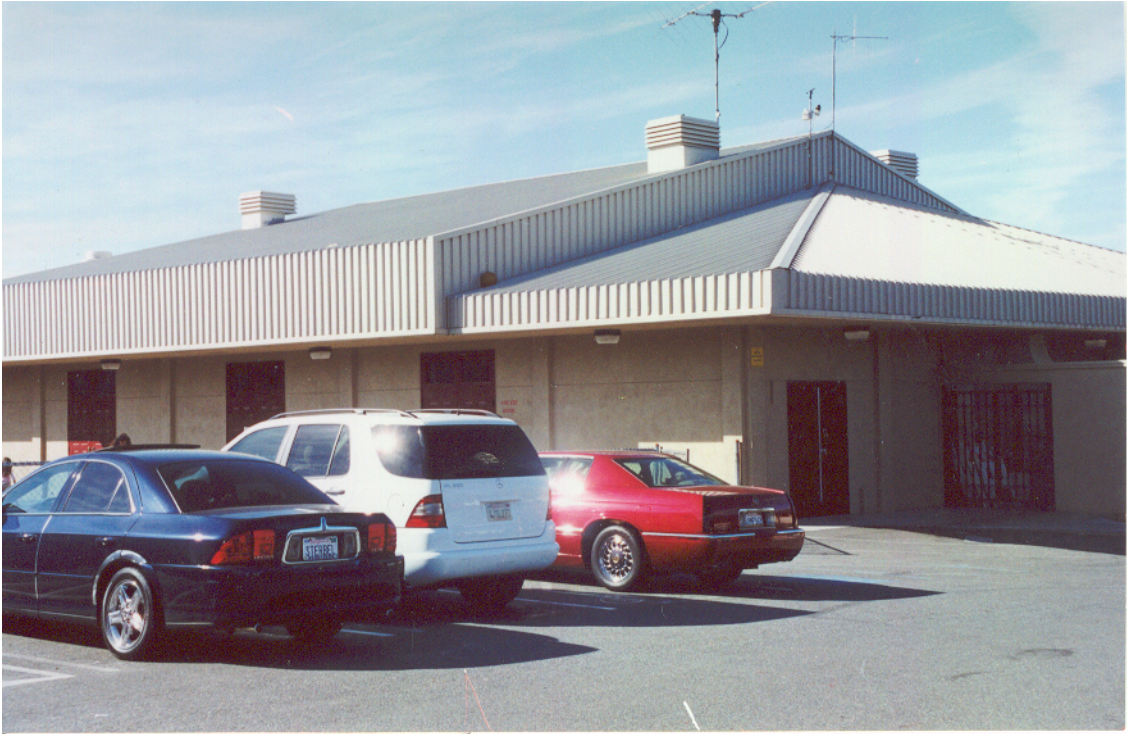
Figure 8: Multi-Purpose Building

The multi-purpose building (similar to the one at Hercules elementary school-see figure 8) has a plywood sheathed roof supported by 2x10 joists at 16" on center that span about 15' between 6x12 beams and the exterior stud walls. The 6x12 beams span about 16'-6" between 6x6 posts. These posts rest on 10 3/4"x27" Glu-Lam beams at the ceiling level, which span 60' between posts at the exterior of the building. The 2x10 ceiling framing, spaced at 48" on center, are also supported by the Glu-Lam beams. Both the roof and ceiling plywood sheathing is fully blocked, and the pony wall at the vertical discontinuity in the roof has structural plywood sheathing. Blocking and strapping have been provided at the ceiling level to create sub-diaphragms to resist out-of-plane wall loads. The Glu-Lam beams are supported on built-up columns made of seven 2x6 members bolted together. These rest on 2'-6" square spread footings. The interior and exterior walls are supported on 12 wide strip footings. It appears that the connections are generally well detailed and adequate collectors have been provided. The existing sheet metal roofing at the multi-purpose building is about 10 years old and appears to be in good condition.

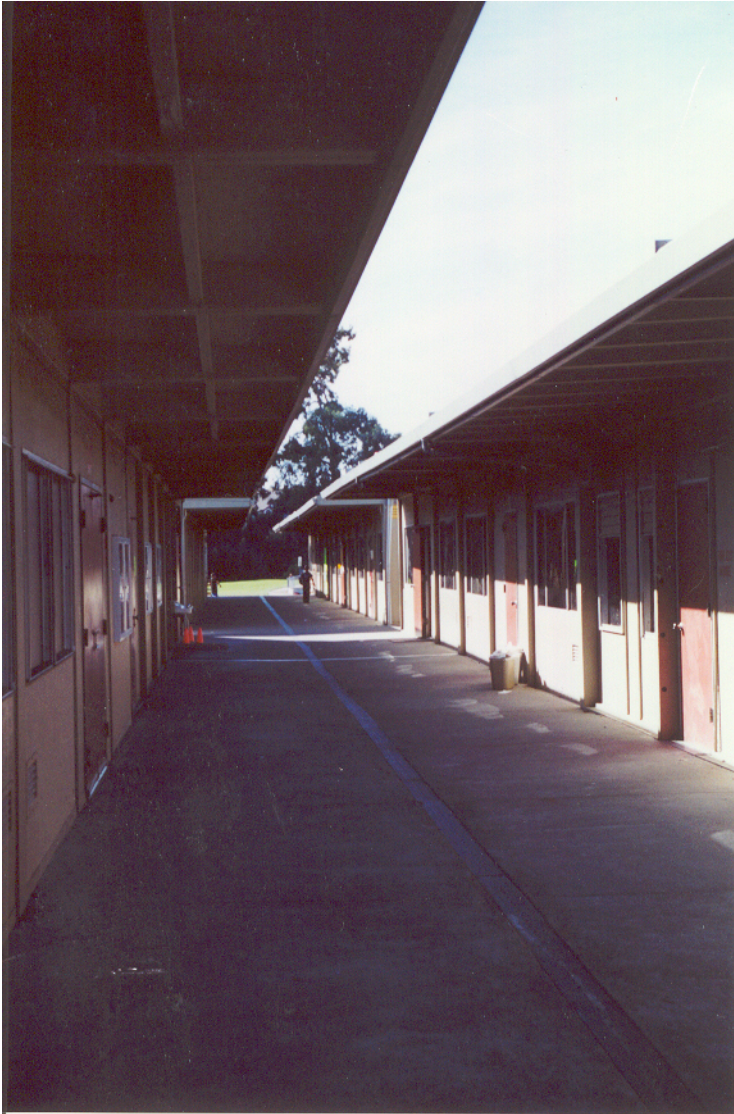
Figure 9: Front Entrance of Classroom numbers 7 to 10 & 11 to 14

All the buildings on this campus are portable buildings except the Multi-Purpose building. The original classroom buildings (built in 1965 & 1966) have numerous openings (long and narrow slit window) on the rear longitudinal wall (see figure 3). This results in a lack of mechanism to transfer seismic forces from the roof diaphragm to the longitudinal shear wall. Some leakage of roof was reported during the site visit. There is a 5 foot roof overhang on front and back side of the portable units. There are two window openings and a big door opening at the front of each of these portable units (see figure 9) resulting in inadequate length of shear wall to resist seismic forces.
