STRUCTURAL EVALUATION OF

OLINDA ELEMENTARY SCHOOL

WEST CONTRA COSTA UNIFIED SCHOOL DISTRICT
(WCCUSD)

April 30, 2002

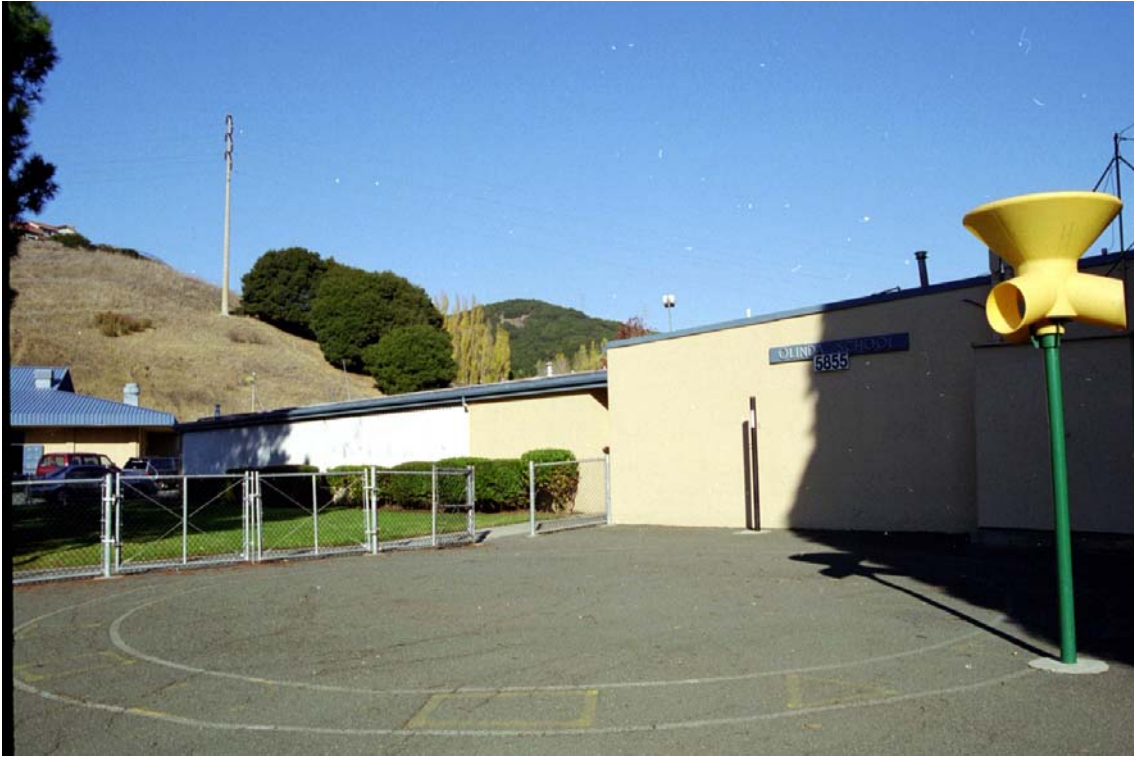
Figure 2: West Face of Main Building

2.	The west face of the computer room wing of the main building has excessive window openings, resulting in a lack of adequate length of shear wall.
3.	The east face of the computer room wing of the main building has clerestory windows, resulting in a lack of adequate length of shear wall.

Item	Recommended Remediation	Priority	Figure Number
1.	Verify existing shear wall nailing and add new wall nailing as required.	1.7	9
2.	Infill some windows with plywood shear wall. Strengthen existing collectors and add new holdowns as required.	1.3	2, 8

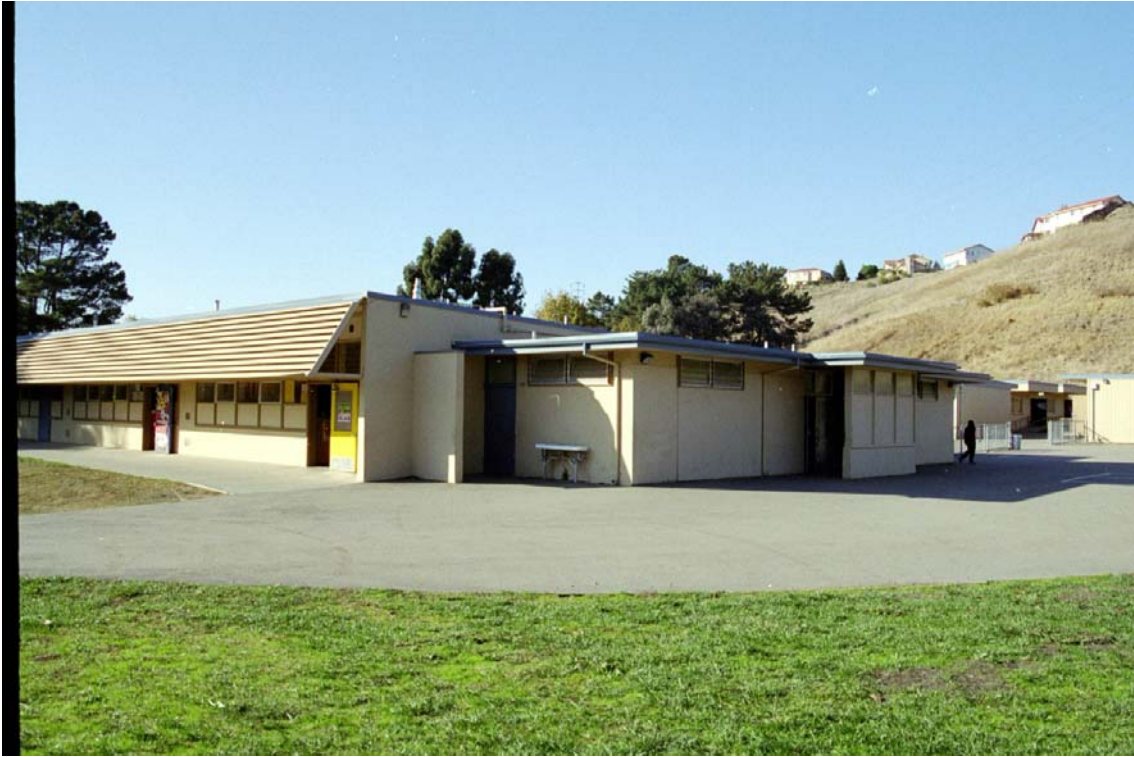
Figure 4: Southeast Corner of Main Building

The main building is an L-shaped building with classrooms on both sides of a central longitudinal corridor (see figure 1). The exterior finish is stucco. The main portion of the building, which houses the classrooms, has windows along the exterior longitudinal walls (see figures 3 and 5). The transverse walls between classrooms do not have any openings. There are long sections of shear wall along the central corridor (see figure 9). At the administration and computer room wing, there are windows with a vertically slotted sunshade along most of the west wall (see figures 2 and 8). The east wall of the computer room has clerestory windows above an exterior covered walkway (see figures 6 and 8). The roof is supported by open-web steel joists spaced at about 5 ft o.c. that rest on 4x8 posts (see figure 10). The ceiling has acoustical tiles attached directly to the underside of the roof. There are skylights in the corridor spaced every 10 feet (see figure 9) and there are long sections of skylight that penetrate the roof diaphragm on both sides of the corridor at the classrooms. The presence of these skylights significantly decreases the ability of the diaphragm to transfer forces to the corridor walls. This is of particular concern because the corridor walls are the main lateral force resisting elements in the east-west direction. At the east end of the corridor, there are restrooms that have a low roof

(see figure 4). This low roof is connected into the side of the adjacent transverse wall, most likely by a ledger connection. There is also a discontinuity in roof height at the corridor that divides the classroom wing of the main building from the area that houses the computer room, offices, and kindergarten (see figure 6).

6.	The connection of the low roof at the restrooms to the adjacent wall may be a ledger connection that is susceptible to damage leading to partial collapse of the structure.

5.	Infill some skylights with new plywood. Add additional nailing and straps at roof diaphragm	1.1	N/A
6.	Verify details of existing connection. Provide strapping from the low roof diaphragm to the wall studs if required.	1.5	4, 5

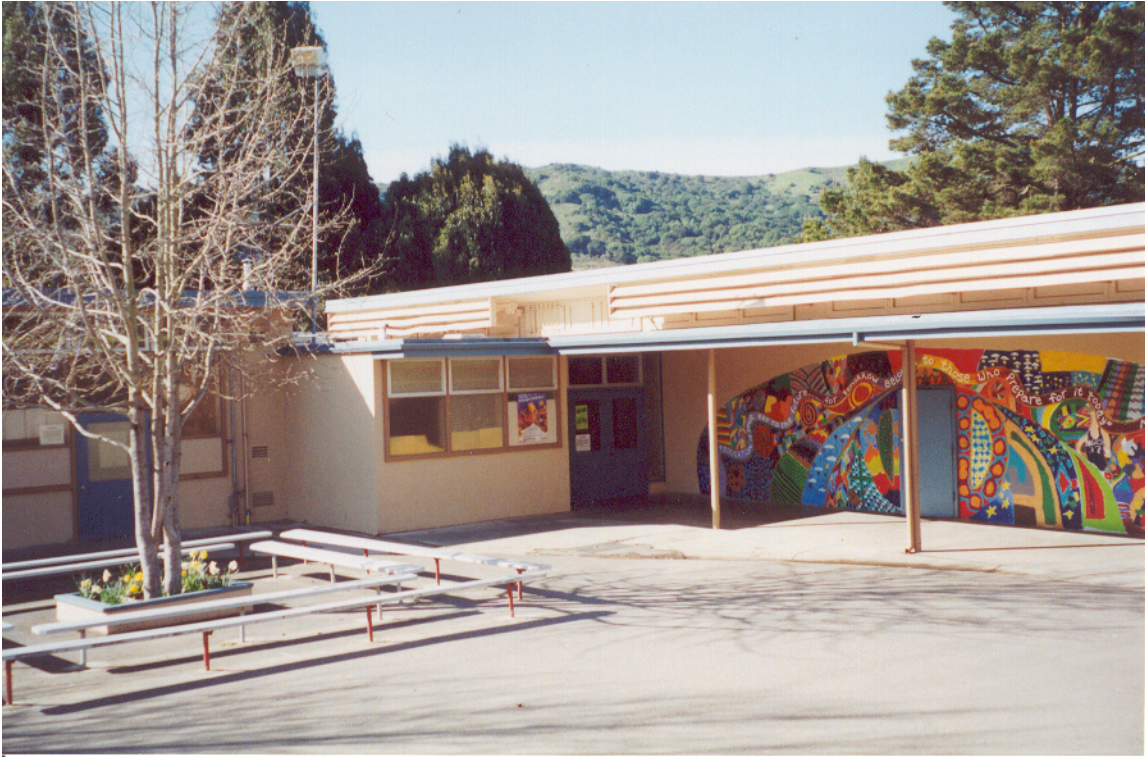
Figure 6: Re-entrant Corner at Main Building

4.	The main building has a re-entrant corner where the computer room wing meets the rest of the building. There is no information about the connection between portions of the building at this location, but the roof collectors, if present, may be overstressed.

3.	Infill some windows with plywood shear wall. Strengthen existing collectors and add new holdowns as required.	1.3	6-8
4.	Verify presence of collectors at re-entrant corner. Strengthen existing collectors as required.	1.6	6

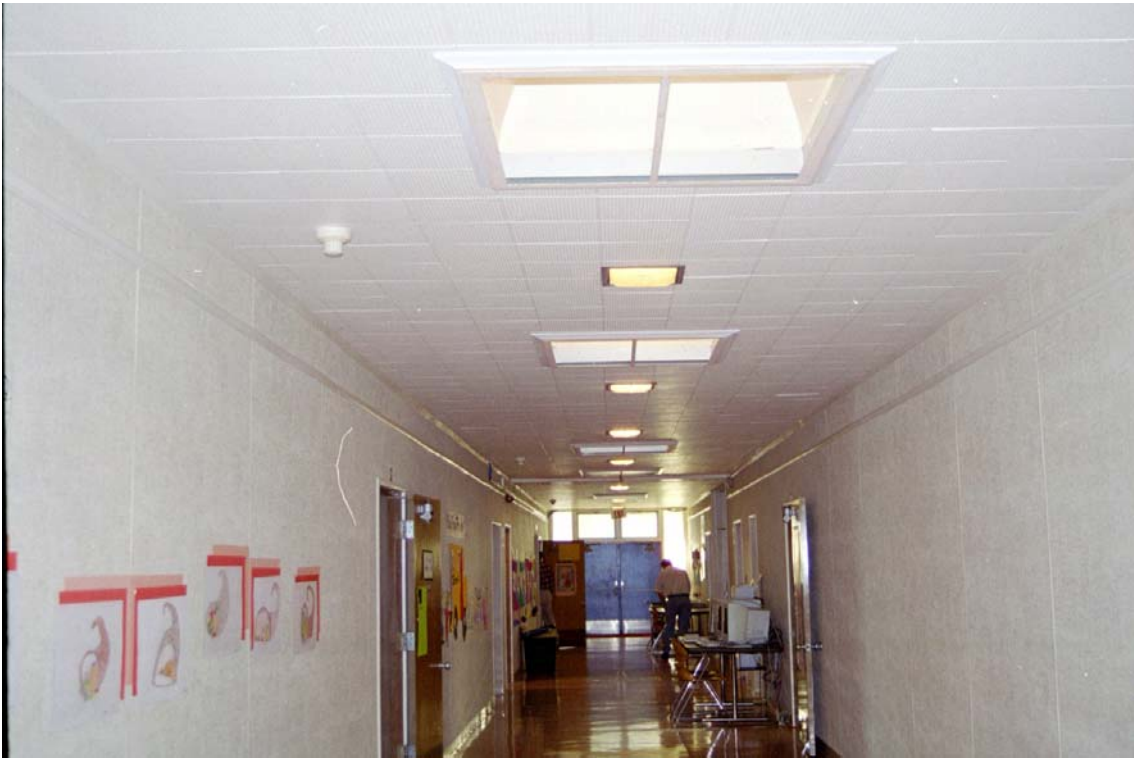
Figure 9: Central Longitudinal Corridor of Main Building

Item	Building Structural Deficiencies
1.	At the main building central corridor, the nailing of the plywood shear walls is unknown and the walls may be overstressed.

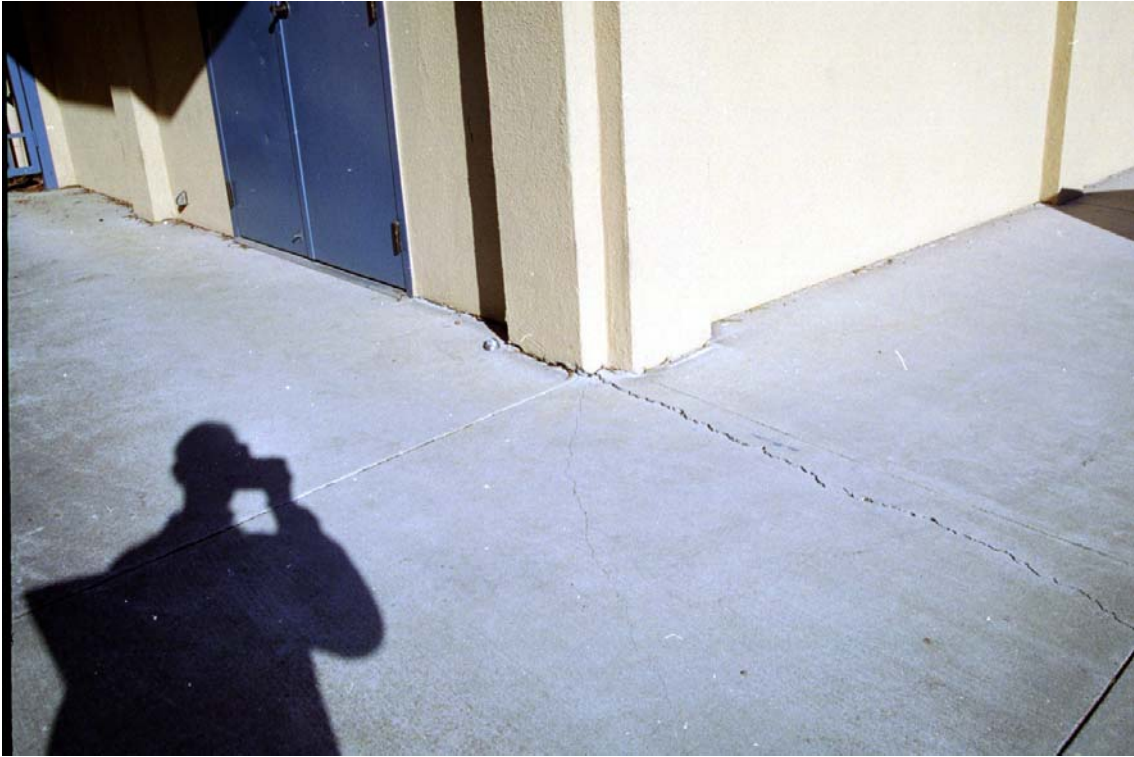
9.	There is minor cracking in the slab outside of the multi-purpose building.

Figure 14: Cracks in Exterior Slab at Main Building

9.	Repair the cracked slab.	3.9	14

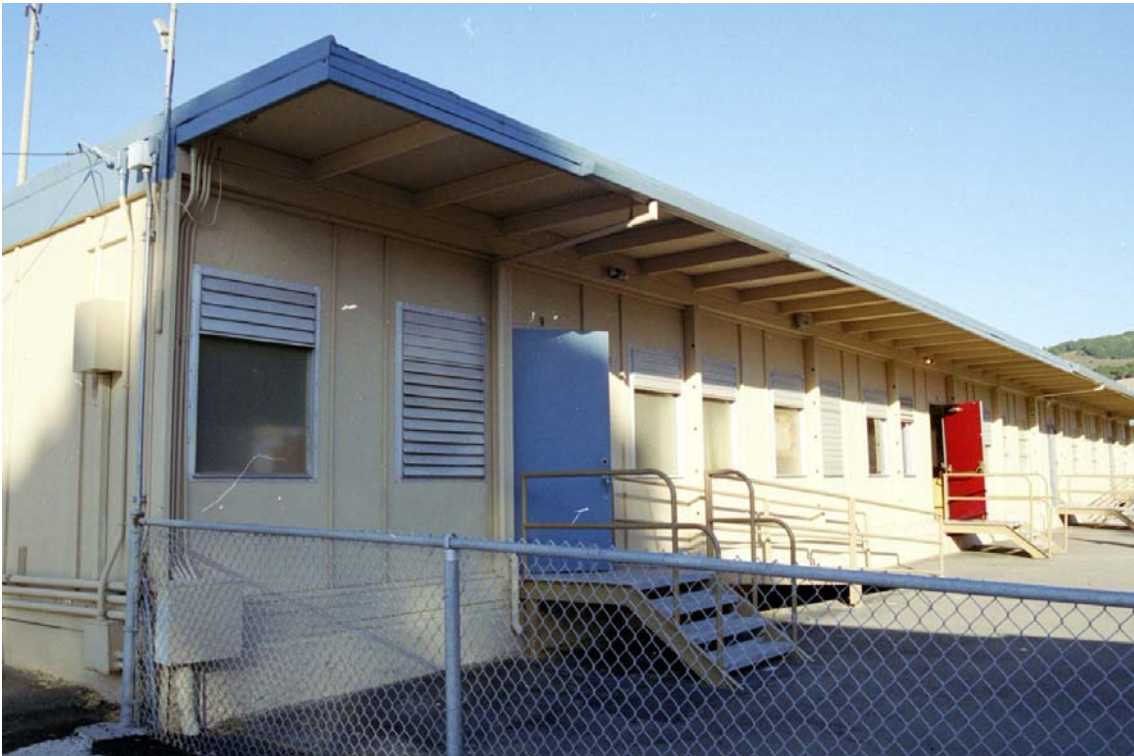
Figure 15: Front of 1960's Portables

The front face of the 1960 portables has excessive openings in the shear wall (see figure 15). Also, there is electrical conduit running between the portable units near the roof level (see figure 16).

7.	The front wall of the 1960’s portables have excessive window openings, resulting in a lack of shear wall.
8.	There is conduit running between the portable units near the roof level. As the buildings move independently, the conduit may get damaged and is a life-safety hazard.

7.	Infill some windows with new plywood shear wall. Strengthen existing collectors and add new holdowns as required.	1.3	15
8.	Provide flexible connection in conduit at building separation.	1.9	16

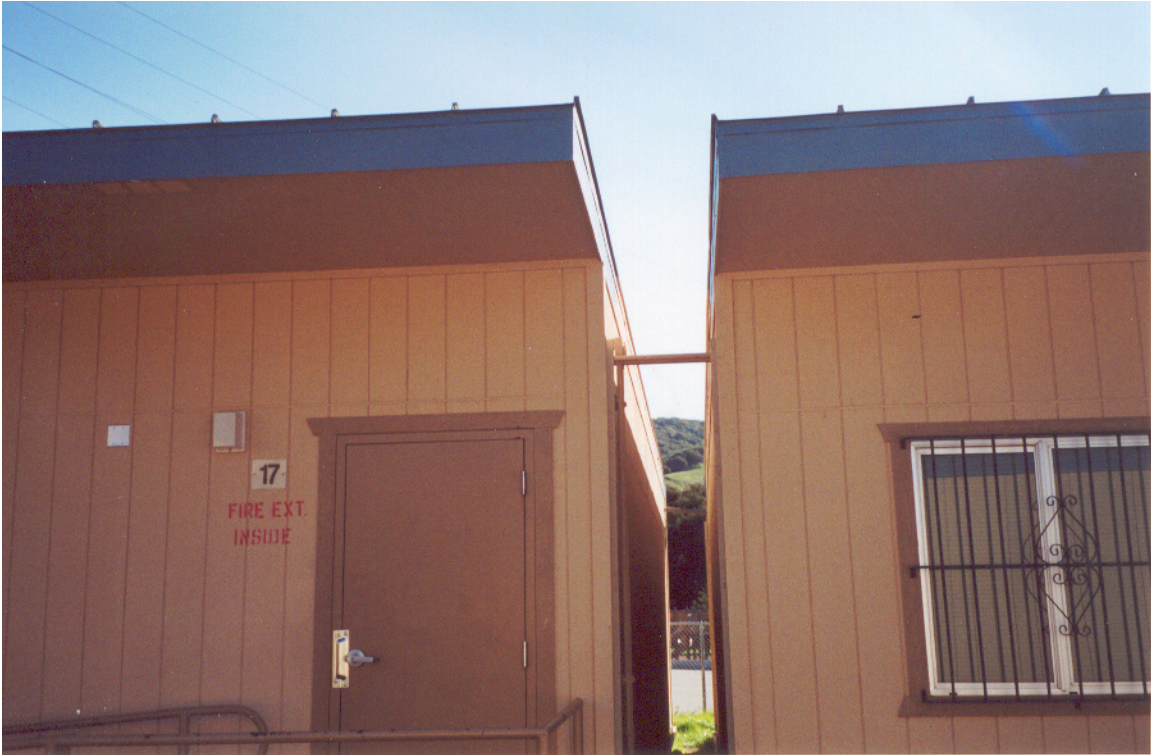
Figure 16: Conduit Running between Portable Units
