STRUCTURAL EVALUATION OF

PERES ELEMENTARY SCHOOL

WEST CONTRA COSTA UNIFIED SCHOOL DISTRICT  
(WCCUSD)

April 30, 2002

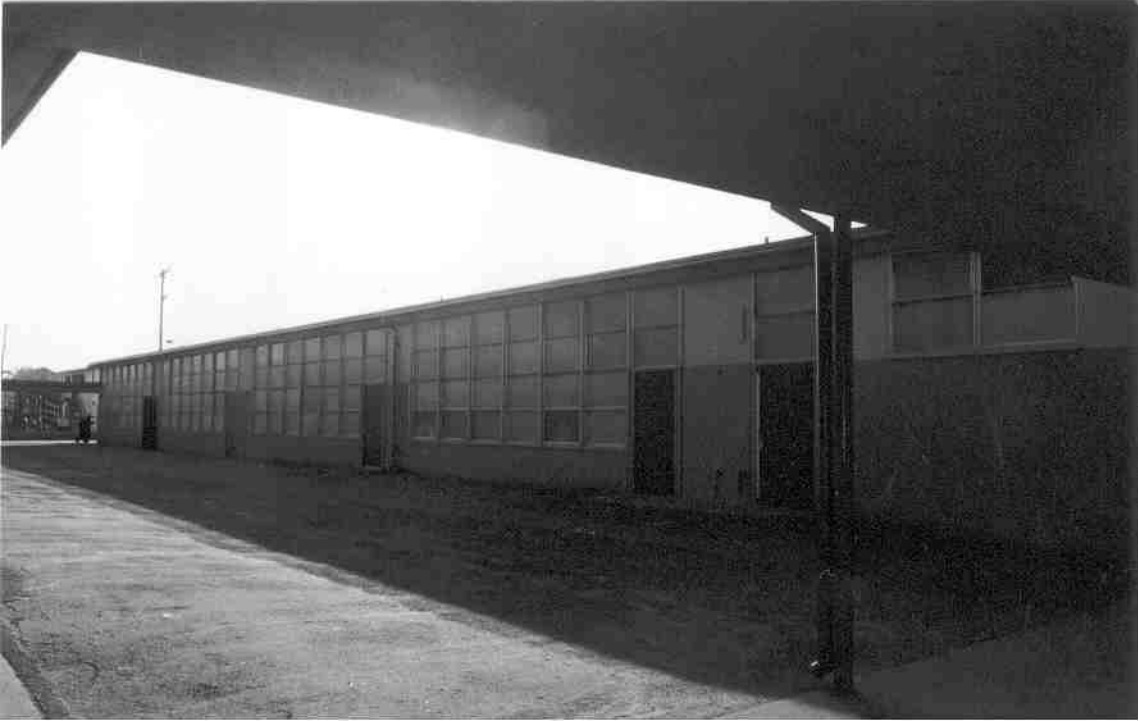
Figure 4: 1948 Classroom Buildings (1 of 3)

Item	Building Structural Deficiencies
1.	Classroom Buildings 1-14 (1948) in the longitudinal direction rely on relatively few four foot long concrete shear walls with remainder of walls being window wall systems or high window walls. These walls do not have adequate shear resistance or collectors or connections to the relatively few concrete shear walls.
2.	Classroom Buildings 1-14 (1948) in the transverse direction rely on classroom

partition walls with few 1x4 let in braces. These walls do not have the capacity to resist calculated seismic demands.
3.	Covered walkways between all classroom buildings do not have seismic separations between buildings and also act as support for main electrical conduits between buildings.
4.	Classroom Building Rooms 25-33 (1954) are inadequate to resist code prescribed seismic loads. The shear walls employ old and outdated construction methods and the foundation system is not adequate to support the building should a major earthquake and ground motion occur at this site.
5.	Brick incinerator is a falling hazard.

Item	Recommended Remediation	Priority	Figure Number
1.	Add adequate plywood shear walls to Classroom building Rooms 1-14 around the perimeters, at the corridor walls and at the classroom partition walls. Provide new collectors and hold downs as required.	1.2	4,5

2.	Add complete lateral bracing to covered walkways. Provide secondary gravity support to walkways at buildings. Add seismic joints in covered walkways between buildings and provide emergency shut-offs and flexible connections for electrical conduits traveling through walkway roofs and across seismic joints.	1.9	4,5,7

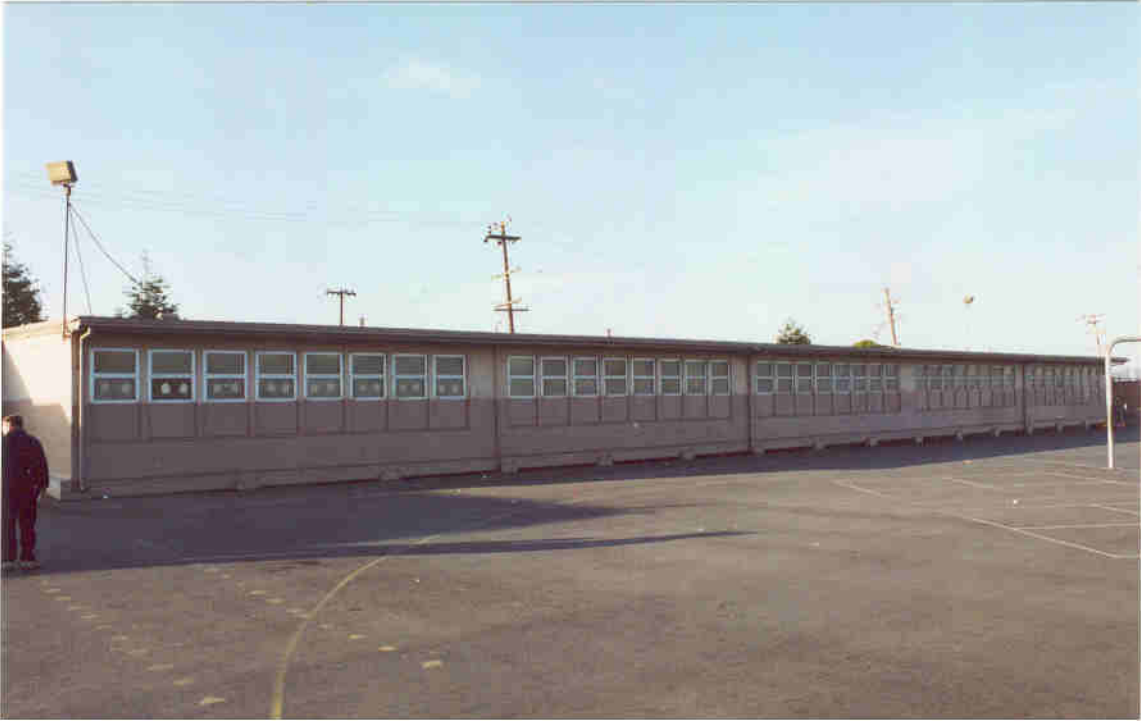
In 1954, five units of a re-locatable building were brought in and placed on a drilled pier foundation system without interconnecting grade beams. This building is located at the south-west portion of the site. The building construction for this building is not clear on drawings. Transverse walls appear to have diagonal let in braces as their shear resisting elements. Exterior

walls appear to have plaster finish over plyscord sheathing. The roof diaphragm has diagonal sheathing. The building is layed out with a central corridor and classrooms on each side.

Figure 6: Classroom Building at south-west of site (1954) with intermittent foundations

3.	Remove brick incinerator.	1.5	8
4.	Classroom Building 25-33 requires infill of intermittent pier foundation system with continuous grade beams under shear walls located around the perimeter, at the corridor walls and at the classroom partition walls. Wall sheathing should be added for shear resisting walls located at the exterior walls, corridor walls and classroom partition walls. Chords and collectors should be added as necessary.  Alternately, this building should be demolished and replaced for a similar cost as strengthening.	1.3	6

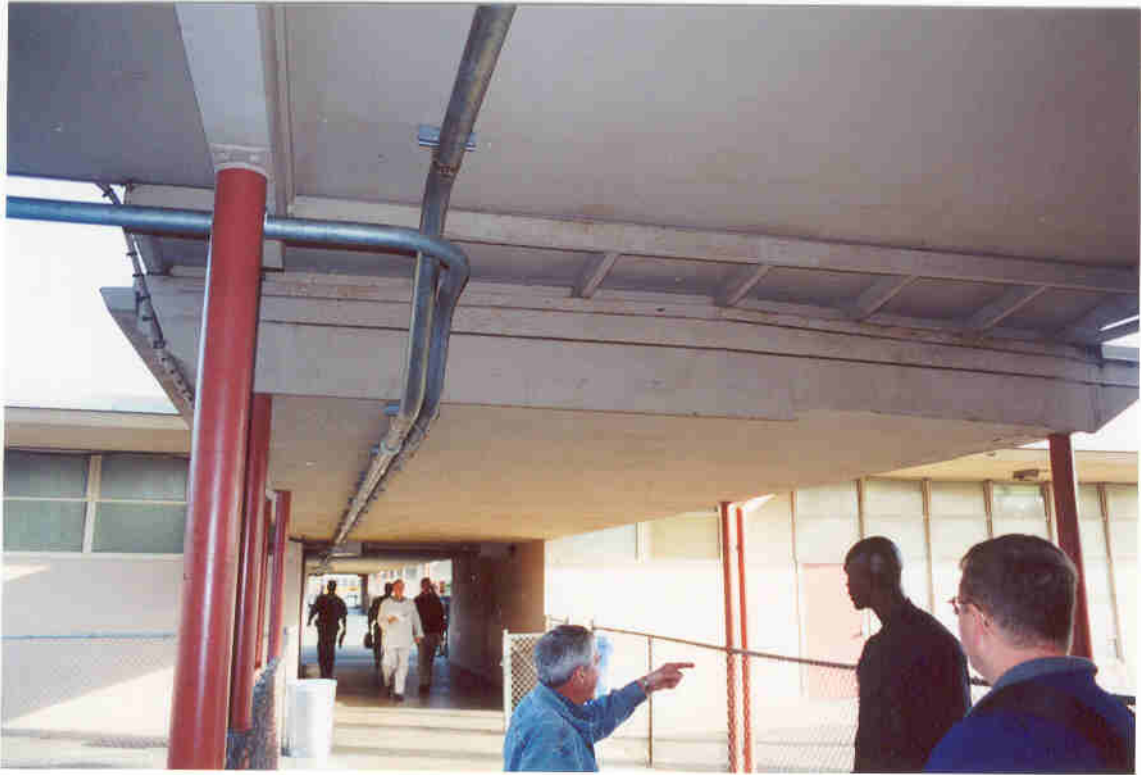
Figure 7: Electrical Conduits passing through covered walkways

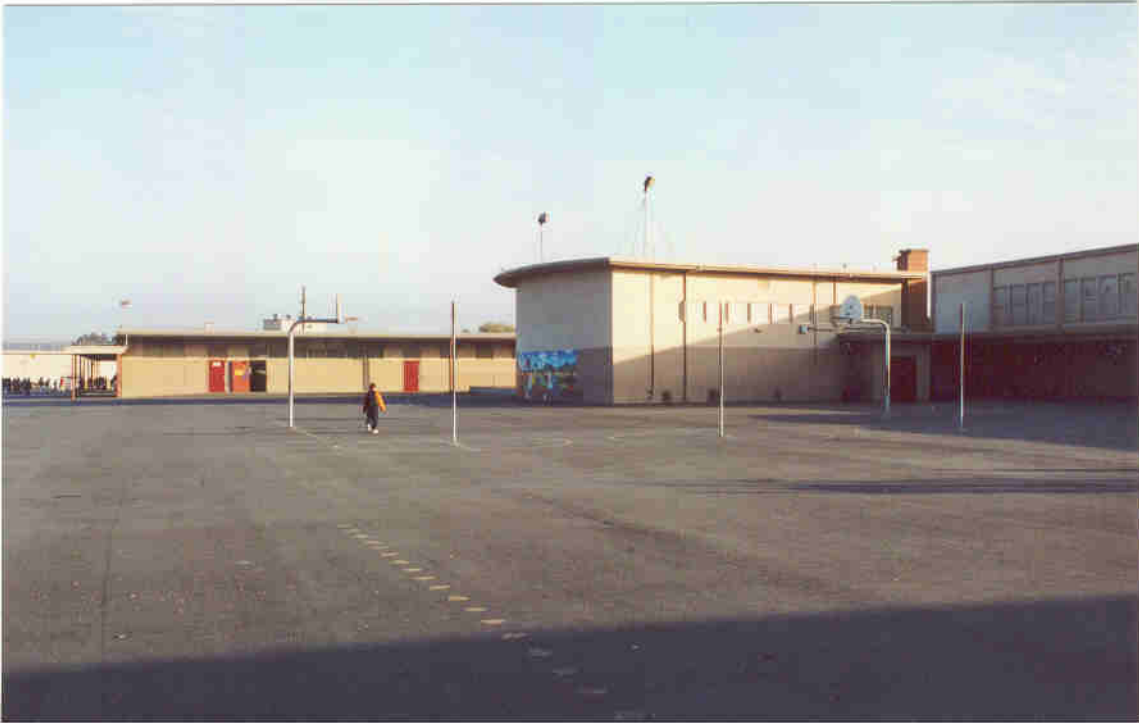
Figure 8: Playground looking north, Library in center

An old incinerator is located between the Multipurpose Room and the Library, and is a tall unreinforced masonry structure.
