STRUCTURAL EVALUATION OF  
SHANNON ELEMENTARY SCHOOL  
WEST CONTRA COSTA UNIFIED SCHOOL DISTRICT  
(WCCUSD)

April 30, 2002

DASSE Design Project No. 01B300

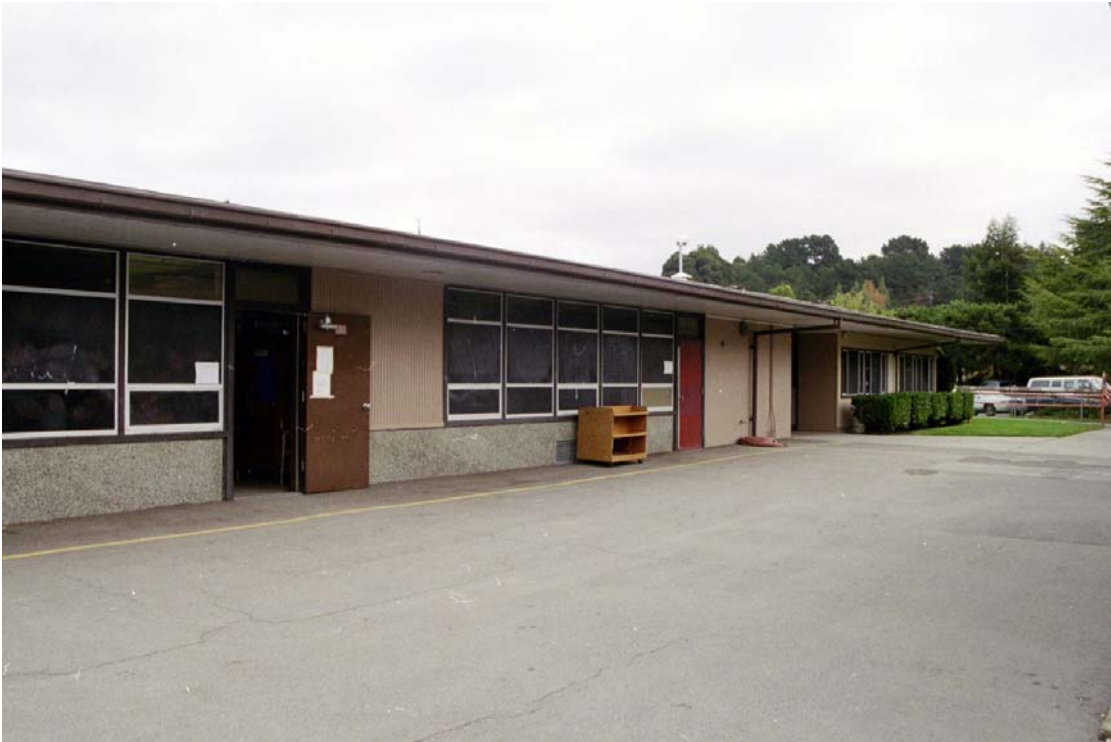
Figure 3: South Classroom Building, south face

Item	Building Structural Deficiencies
1.	Classroom Buildings: Strength of plywood shear walls at the exterior longitudinal walls is inadequate to resist prescribed forces.
2.	Classroom Buildings: Strength of chord/collector splices is inadequate to resist prescribed forces at the interior and exterior longitudinal walls.
3.	Classroom Buildings: Positive connection of shear walls to foundation is lacking at critical locations in the exterior longitudinal walls.
4.	Enclosed Hallway: Structure is tied to two adjacent buildings with no provision to accommodate differential movement.
5.	Enclosed Hallway/Portable Buildings: Electrical conduits are connected to adjacent buildings with no provision to accommodate differential movement.
6.	Lunchroom Portable: Rust observed on steel roof beams.

Item	Recommended Remediation	Priority	Figure Number
1.	Remove some windows and replace with new stud framing and plywood sheathing. Provide new holdowns at new shear wall locations.	1.1	3, 4
2.	Provide new strapping at inadequate locations.	1.5	N/A
3.	Provide new holddown anchors into existing foundation at lacking locations.	1.5	N/A
4.	Provide new beams and columns to support the hallway framing near each classroom building.	1.9	5

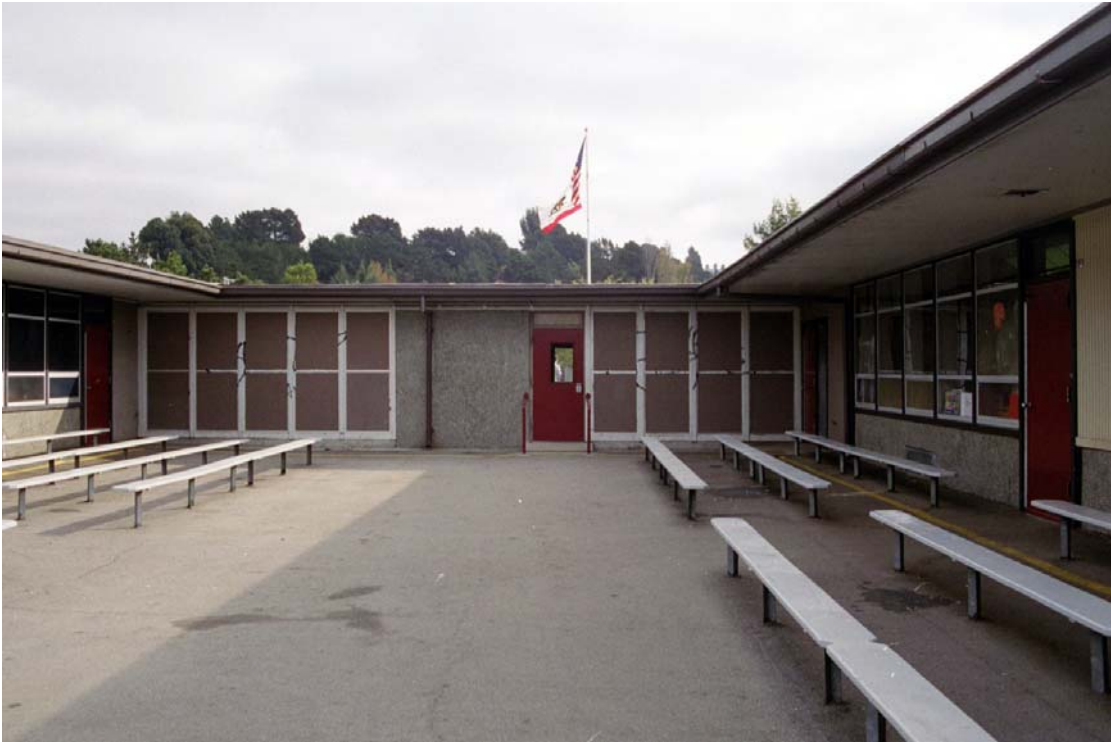
Figure 5: Enclosed Hallway, west face

The main classroom buildings are single story structures (see figures 2 - 8). The exterior longitudinal classroom walls have large lengths of window openings, below which are short concrete walls to the sill of the windows. These large windows leave little room for shear resistance in the shear walls at these lines. Elsewhere the exterior walls are finished with stucco or wood siding. The interior walls in the corridors and in the transverse direction between classrooms are continuous with minimal wall openings. A suspended T-bar ceiling with acoustical tiles is found in the classrooms and corridors. Additionally skylights occur periodically in the corridor. The enclosed hallway between the two classroom buildings (see figure 5) is supported by both buildings, which could result in significant damage and a life safety hazard should the two classroom buildings be subjected to differential displacements

during a seismic event. Additionally, hard electrical conduits were observed to pass between buildings at this location without provision for these opposing movements. This also represents a life safety concern. At the portable lunchroom building, rust was observed on steel roof beams at the rear roof eave. This type of deterioration represents a life safety hazard. Furthermore, electrical conduits were observed passing between various portable buildings without the capacity to withstand differential movements.
