STRUCTURAL EVALUATION OF
SHELDON ELEMENTARY SCHOOL
WEST CONTRA COSTA UNIFIED SCHOOL DISTRICT
(WCCUSD)

WLC Architects
Kaiser Building
1300 Potrero Avenue
Richmond, CA 94804

DASSE Design, Inc.
33 New Montgomery Street #850
San Francisco, CA 94105
(415) 243-8400

April 30, 2002

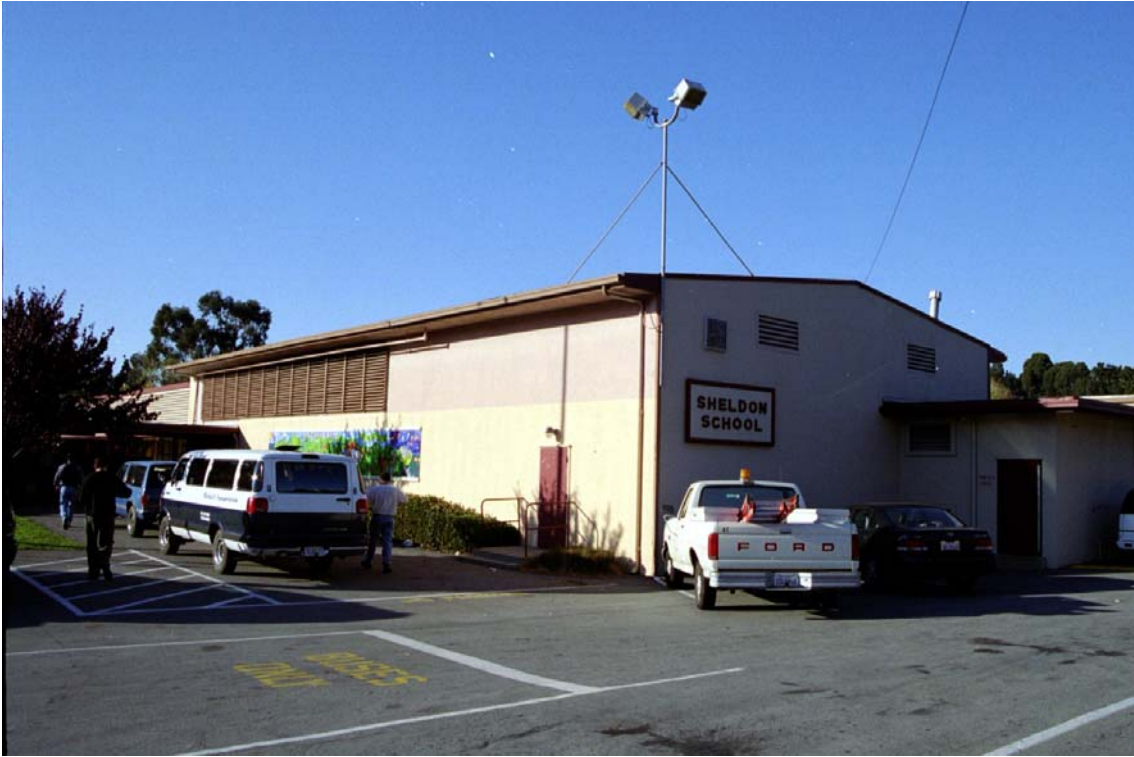
Figure 2: Multi-Purpose Building

8.	There are continuous high windows near the west end of the exterior longitudinal walls of the multi-purpose building. The shear wall and collectors may be overstressed at these locations.

7.	Provide new blocking and metal straps from the low roof to the wall.	1.9	9, 10, 12
8.	Infill some existing windows with new plywood and framing. Strengthen existing collectors and add new holdowns as required.	1.9	2, 3

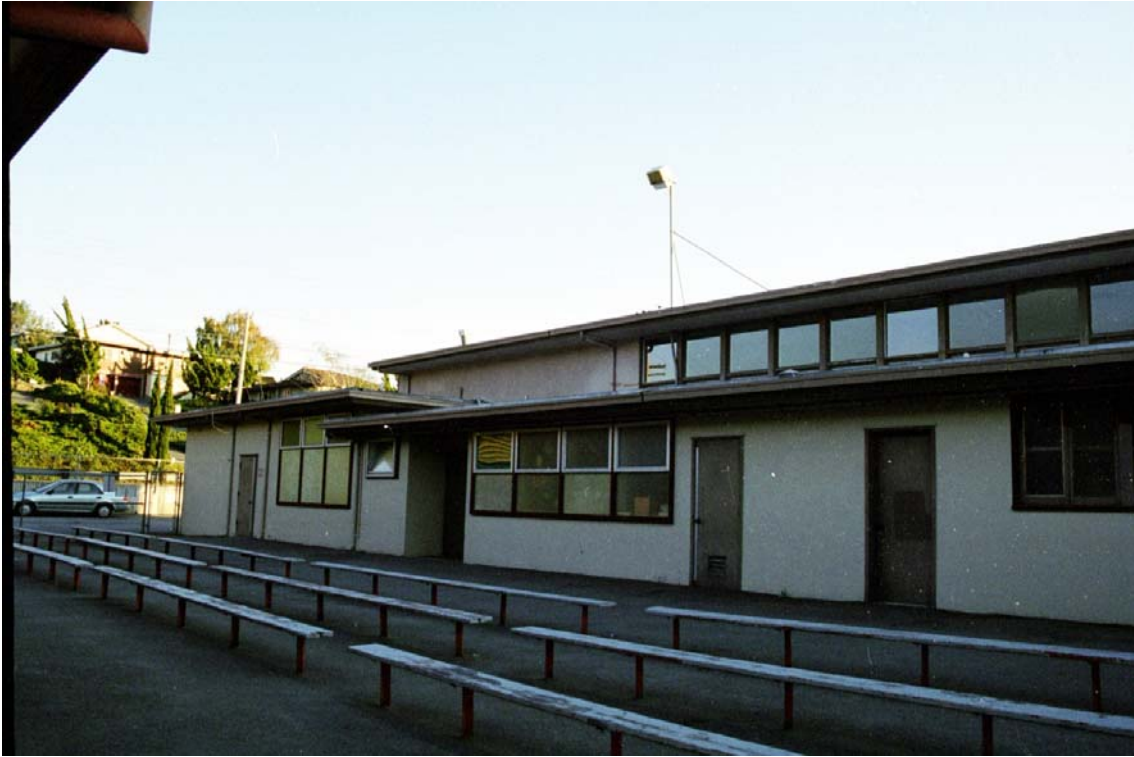
The classroom buildings are all of similar construction. There are high windows along most of the length of the back face of the buildings (see figures 10 and 12). On the front face of the buildings, there is a covered walkway with clerestory windows above (see figure 11). Consequently, the longitudinal walls lack adequate length of shear wall. The roof slopes down from the clerestory windows toward the back of the buildings. The classroom buildings have a stucco finish on their front and back walls, as well as on the side facing the administration building. At the west end of the buildings, there is wood panel siding. The covered walkways near classrooms #1 through #8 have exposed diagonal sheathing, whereas the covered walkways at the main entrance and other classrooms have a cement plaster soffit. Some of the classrooms have acoustical tile ceilings and others have suspended T-bar ceilings. There is some deterioration of the wood at the exterior of the building near classroom number 15 (see figure 14). The administration building has a low flat roof and multiple window openings facing the front of the school. The rear wall of the administration building, adjacent to the corridor, has long segments of shear wall. The multi-purpose building has a large open cafeteria space with and acoustic tile ceiling and high windows that run along about one half of the length of the building (see figures 2 and 4). Because the windows are all grouped together, there appears to be adequate shear wall but collector forces will be high. At the north side of the cafeteria space, there is a low area with some classrooms and service areas. This area has a large number of window and door openings at the exterior (see figure 3).

9.	The shear walls at the north side of the multi-purpose building may be overstressed.
10.	There is a change in roof height between the kitchen and room number 43 of the multi-purpose building. There is a lack of continuity in the collectors at this location.

9.	Infill some existing windows with new plywood and framing. Strengthen existing collectors and add new holdowns as required.	1.8	3
10.	Provide new blocking and metal straps from the low roof to the wall.	1.9	3

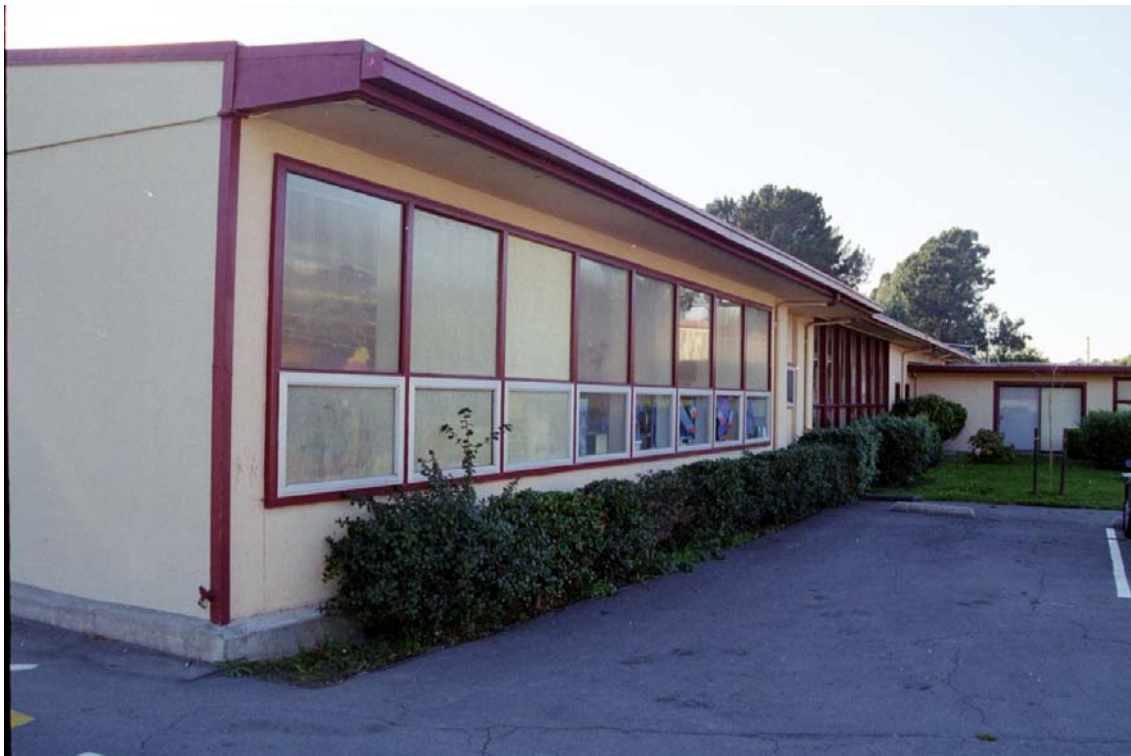
Figure 5: Classrooms #1 and #2 and Administration

Item	Building Structural Deficiencies
1.	The classroom buildings have high windows or other large openings along the back longitudinal wall and clerestory windows along the front longitudinal wall. There is a lack of shear wall at these areas.

6.	At the intersection of the administration wing and classroom number 2, there is a change in roof height. There is a lack of continuity in the collectors at this location. This is further compounded by the presence of the re-entrant corner at this location.

Item	Recommended Remediation	Priority	Figure Number
1.	Infill some existing windows with new plywood and framing. Strengthen existing collectors and add new holdowns as required.	1.2	5, 10, 11, 12

4.	Provide lateral bracing of covered walkway	1.9	13
5.	Provide a flexible conduit connection at the seismic joint	2.5	13
6.	Provide new blocking and metal straps from the low roof to the wall.	1.9	5

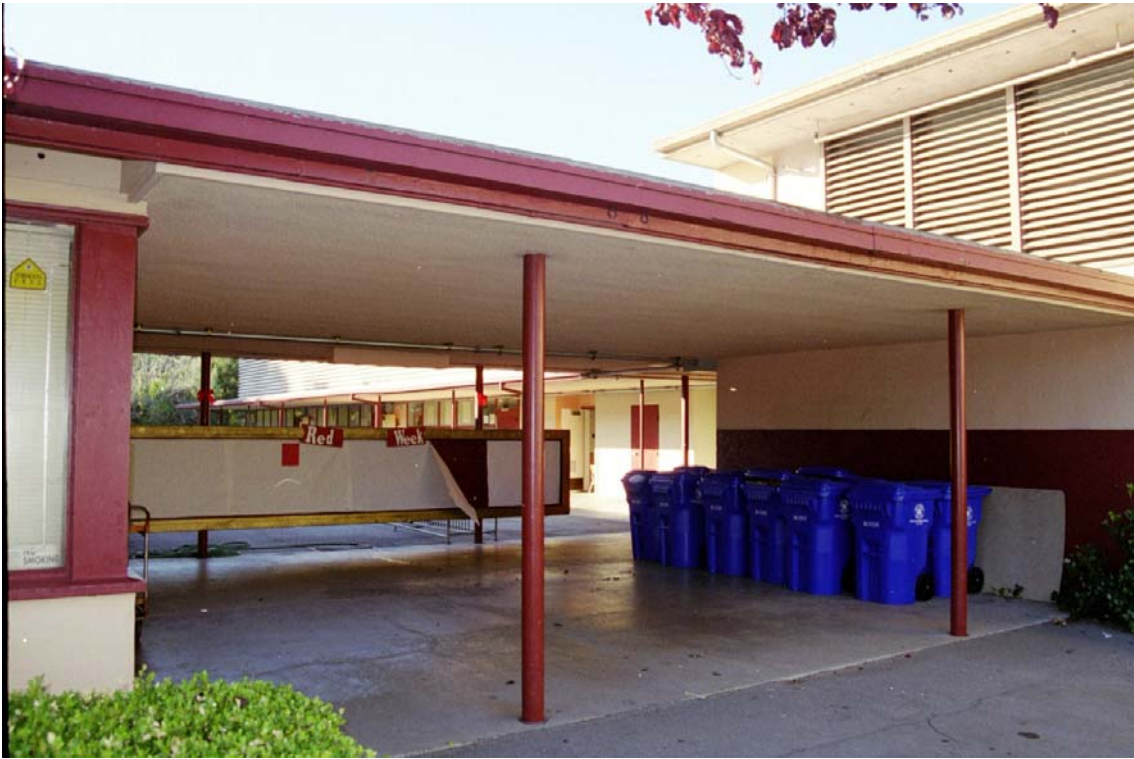
Figure 7: Main Entrance, between Administration and Multi-Purpose Buildings

There are existing seismic joints in the between buildings 1 and 2, 5 and 6 (see figure 9), 7 and 8, and at the covered walkway separating buildings 7 and 8 from the rest of the buildings (see figure 13). There are covered walkways that connect building 2 to buildings 3, 4, and 5. These covered walkways do not have their own independent gravity systems and are supported by the aforementioned buildings connected buildings (see figures 7 and 8).

3.	The covered walkways are attached to multiple buildings. They may lose gravity support and collapse as the buildings move independently of each other.

2.	Verify presence of adequate nailing at original skylight locations and re-nail diaphragm if required	1.2	N/A
3.	Provide new seismic joints. Add new beams, columns, footings, and lateral bracing at covered walkway. Provide flexible connections in conduit at seismic joints.	1.4	7, 8

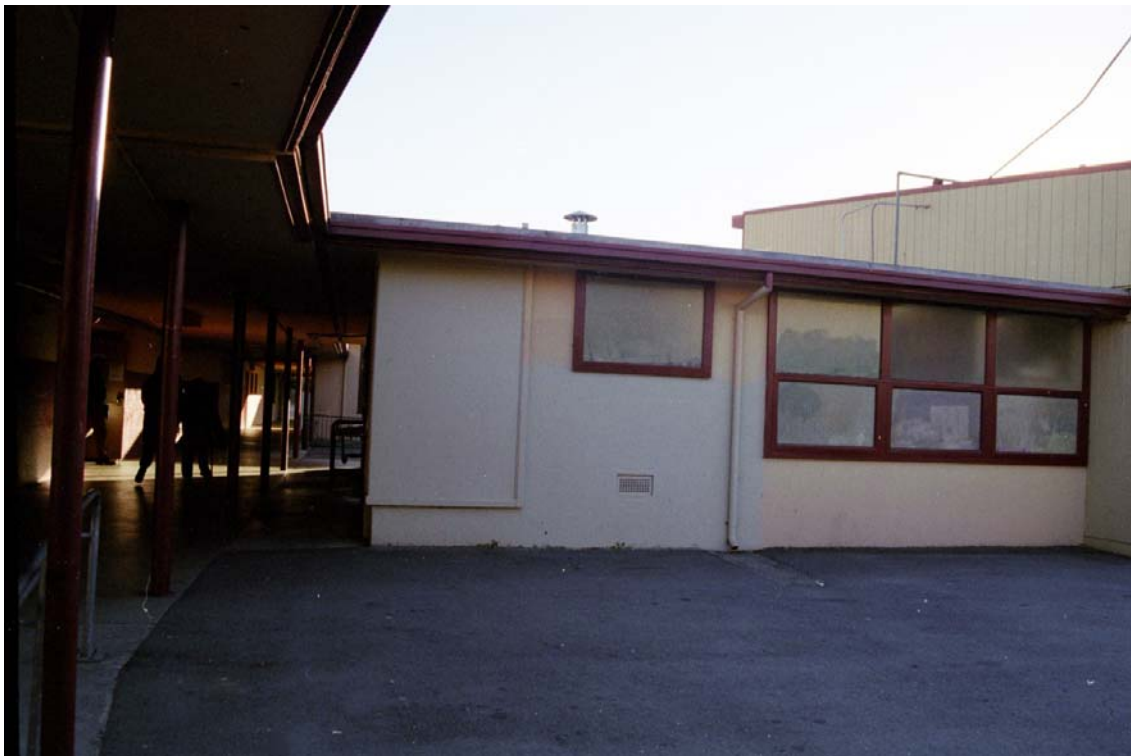
Figure 9: Bathrooms East of Library; Seismic Joint between Classrooms and Corridor

7.	At the classroom buildings, there is a change in roof height where the bathrooms are located. There is a lack of continuity in the collectors at these locations.

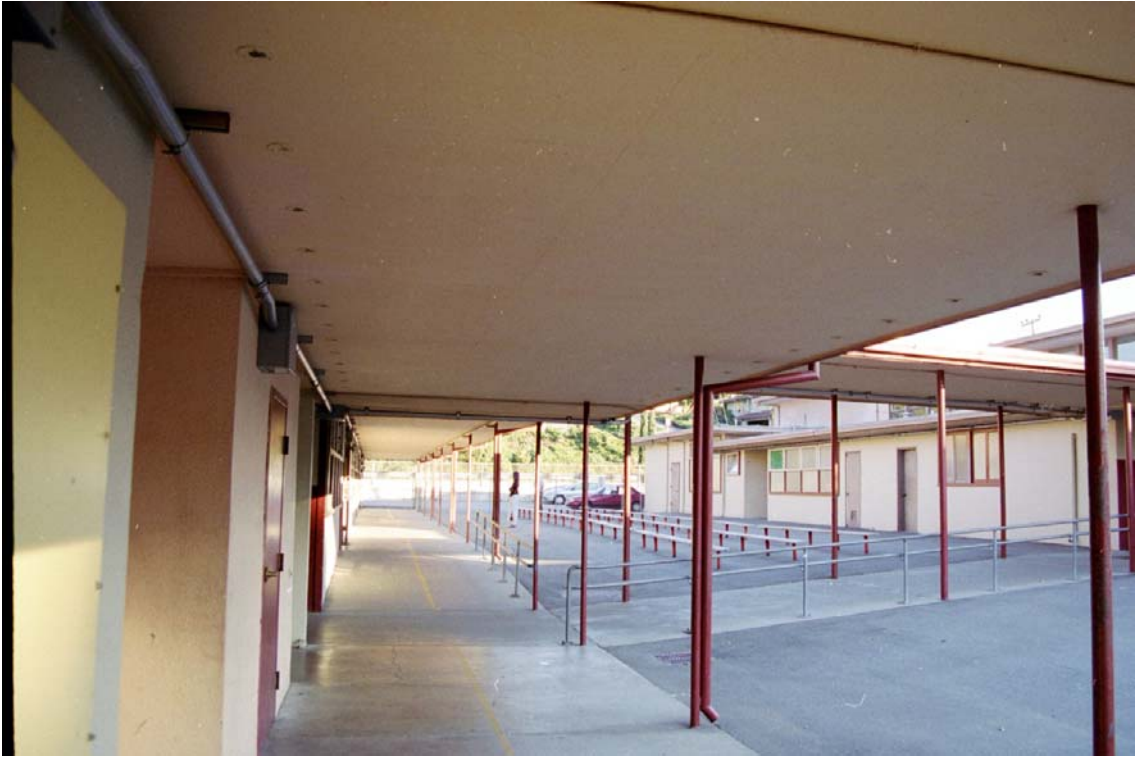
Figure 13: Covered Walkway between Multi-Purpose Building and Classroom #15

4.	The covered walkway from the multi-purpose building to near classroom number 5 lacks adequate lateral bracing.
5.	There is an existing seismic joint at the covered walkway from the multi-purpose building to near classroom number 5. The electrical conduit crossing the existing seismic joint may be damaged and fall as the buildings move.

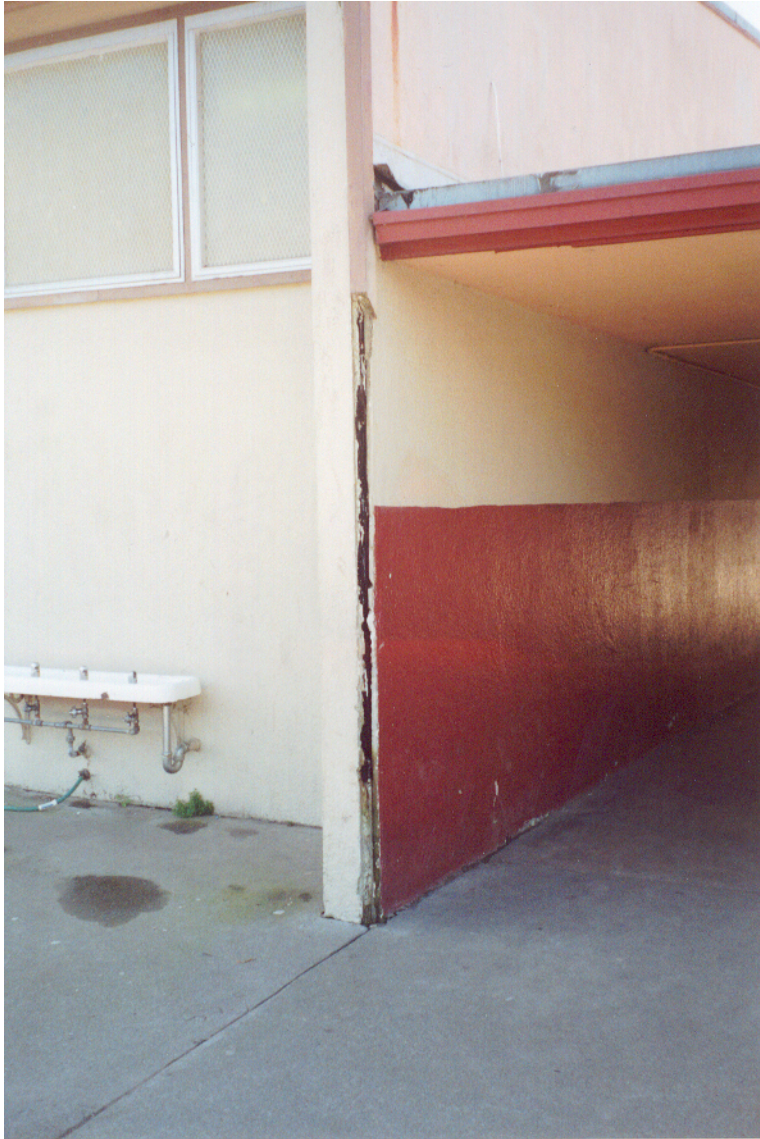
13.	There is some deterioration of the wood in the exterior wall near classroom number 15.

Figure 14: Deterioration of Wood near Classroom Number 15

13.	Remove and replace damaged wood. Repair stucco finish.	1.9	14
