STRUCTURAL EVALUATION OF  
TARA HILLS ELEMENTARY SCHOOL  
WEST CONTRA COSTA UNIFIED SCHOOL DISTRICT  
(WCCUSD)

April 30, 2002

DASSE Design Project No. 01B300

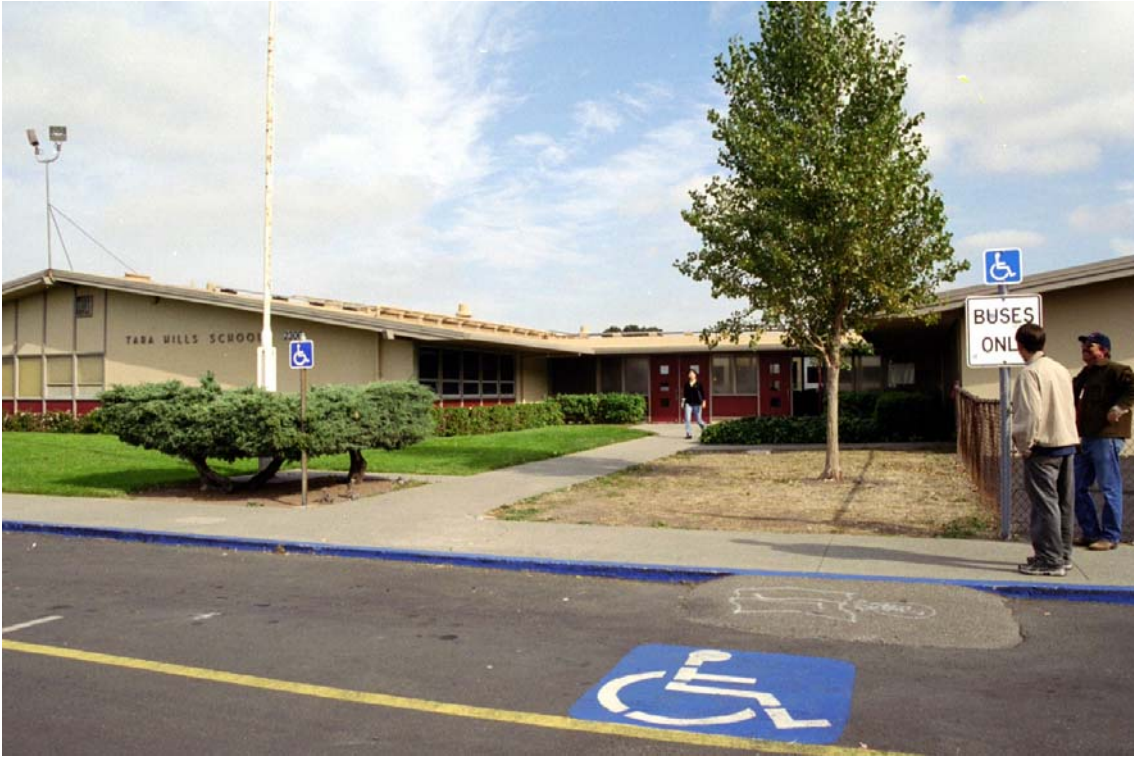
Figure 2: Main Entrance

5.	The connecting corridors are attached to multiple buildings and may be damaged as the buildings move independently. At the corridor roof intersection with the classroom building and multi-purpose building roofs, some local tearing may be expected. At the corridor interface with the kindergarten / library building, the corridor roof frames into the side of a wall. At this location there could be a partial collapse of the corridor roof.

shear transfer to the wall		
3.	Add new plywood sheathing. Strengthen existing collectors and add new holdowns as required.	1.5	5
4.	Provide new blocking and straps at roof	1.9	7, 11, 12
5.	At the typical intersecting roof condition, the potential tearing does not present a significant threat to life safety and does not need to be modified. At the corridor to kindergarten / library building interface, add new posts and beams to provide a secondary means of support for the roof and prevent partial collapse.	1.2	2, 4, 6, 8, 9
6.	Replace the damaged wood and re-paint.	1.9	15

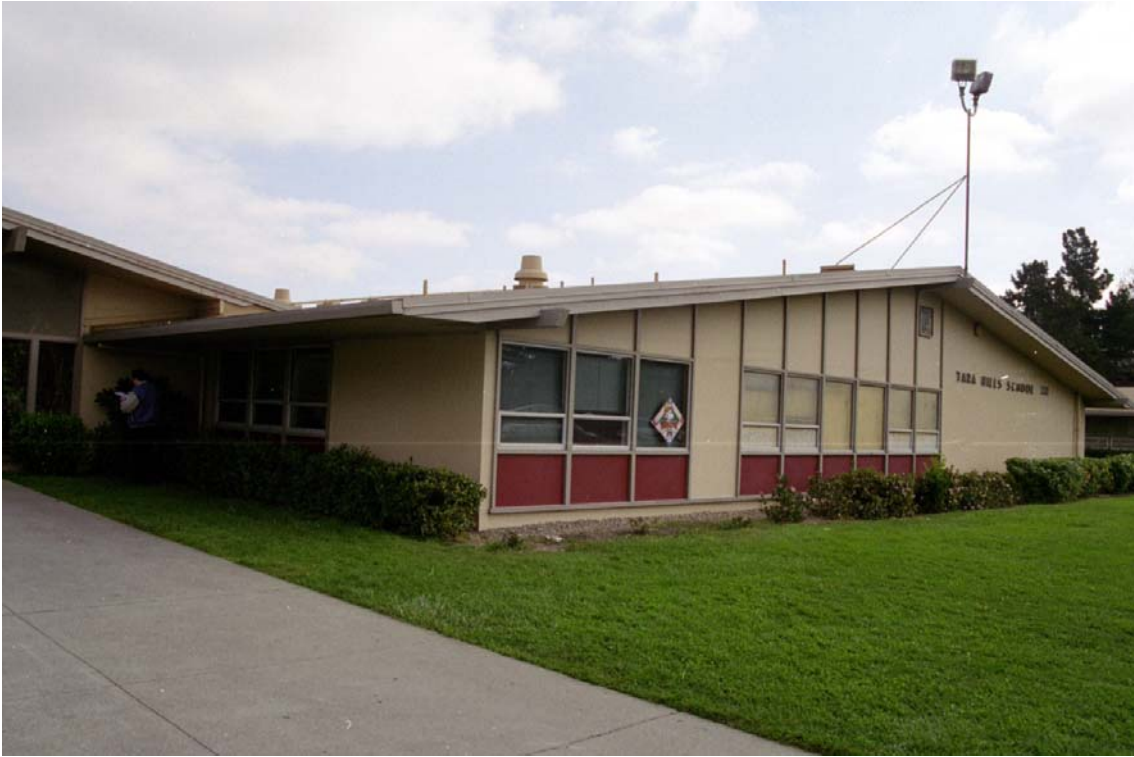
Figure 3: West Corner of Administration Area

2.	At the end wall of the classroom building near the office, all of the window openings are at one end of the wall. This results in high collector forces, and the existing collector elements and connections may be overstressed.

Item	Recommended Remediation	Priority	Figure Number
1.	Add new nailing at existing shear wall panels. Strengthen existing collectors and add new holdowns as required.	1.5	6-9, 11, 14
2.	Provide new continuous strap at roof and new clip angles for	1.5	3

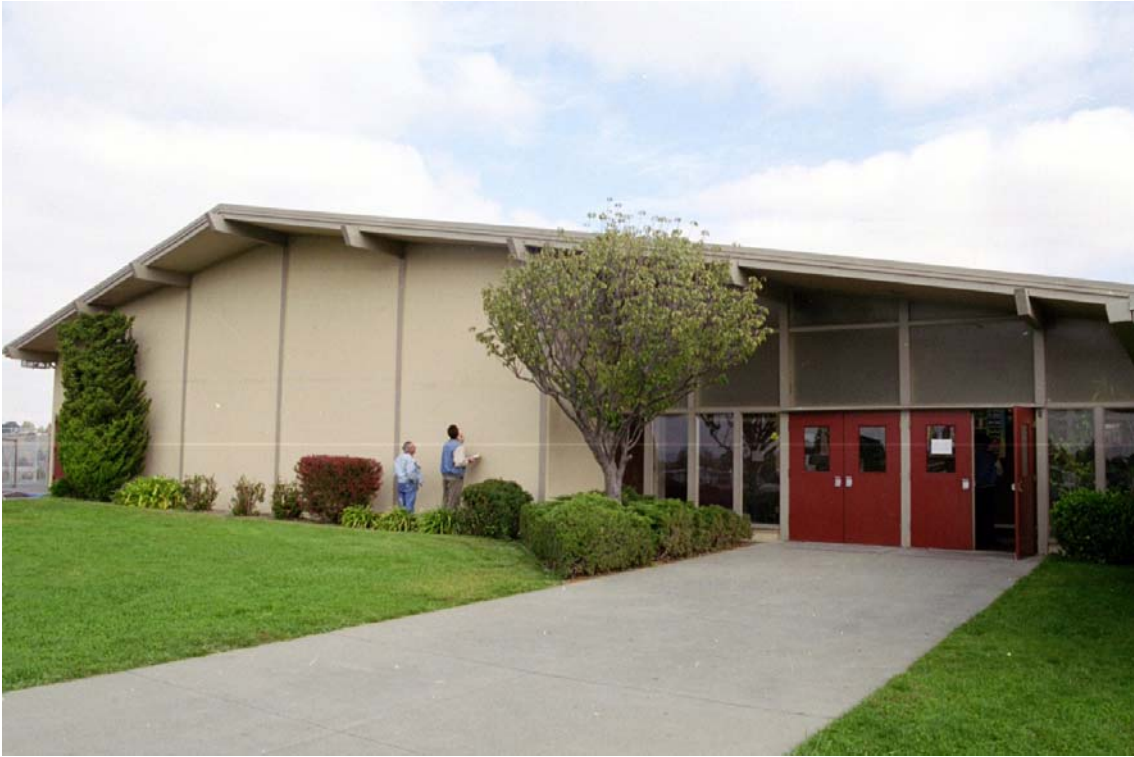
Figure 4: Front of Multi-Purpose Building

The multi-purpose building (see figures 4 through 6) has a high, open main area and a shorter ancillary area at the northwest side. The roof of the main area appears to be supported by lumber framing over glu-lam beams that span across the width of the building. There are some minor cracks in one of these glu-lam beams that appear to be due to checking. The roof above the main

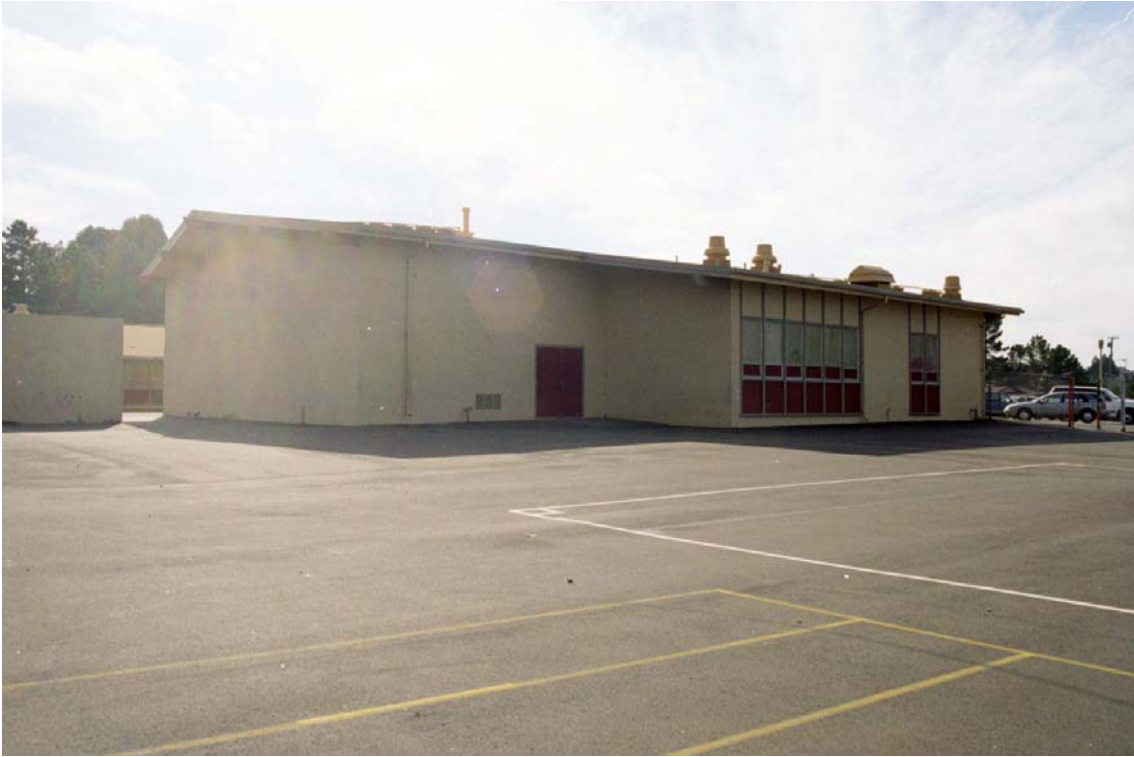
Figure 5: North Corner of Multi-Purpose Building

3.	At the multi-purpose building, the transverse shear wall at the re-entrant corner (the end of the ancillary area) may be overstressed due to its short length and long tributary area. The collector on that line may be inadequate.

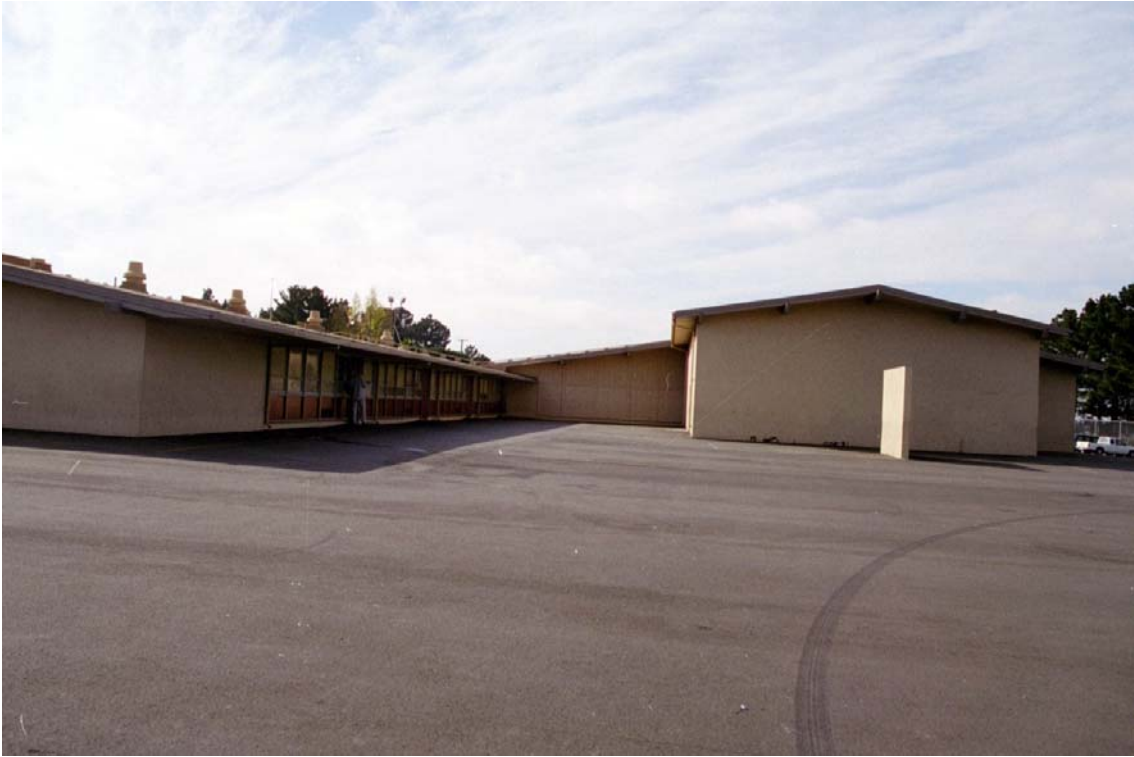
Figure 6: Rear of Multi-Purpose Building and Northwest Classroom Building

There are enclosed corridors linking the buildings together. Except at the kindergarten / library building, these corridors have roofs that are continuously framed with the roofs of the adjoining buildings (see figure 8). Some localized tearing of the roof diaphragm can be expected at the intersection of the corridor and building roofs. At the kindergarten / library building, the corridor roof frames into the end wall of the building (see figure 9). The corridors generally have windows along their entire length on both sides, although the corridor to the multi-purpose building has wood siding on the rear face (see figure 6). There is conduit running over the corridor roofs between buildings.

Item	Building Structural Deficiencies
1.	The classroom buildings and the kindergarten / library building have large window walls at the exterior longitudinal walls. Therefore, the buildings must be supported laterally by the shear walls along the interior corridor. These shear walls and their connection to the diaphragm may be slightly overstressed.

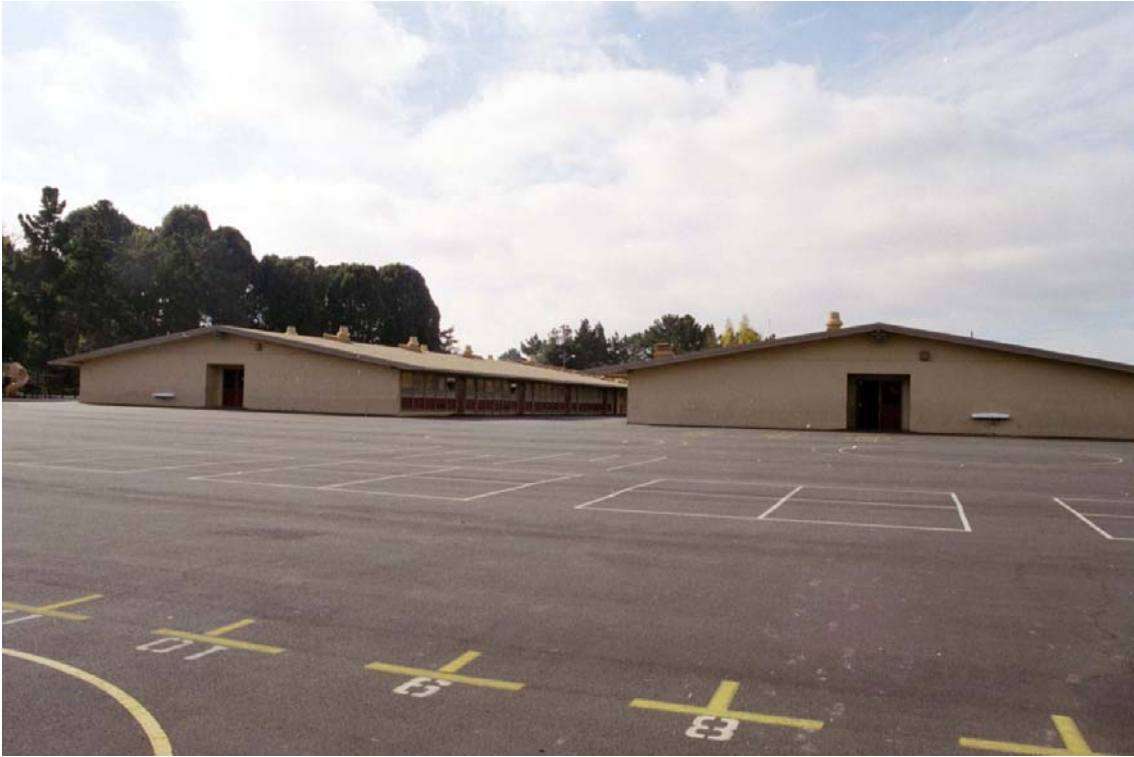
Figure 7: Northeast End of Classroom Buildings

4.	There is a discontinuity in the roof of the southeast classroom building near classrooms #12 and #15. The collectors at the discontinuity may be overstressed.

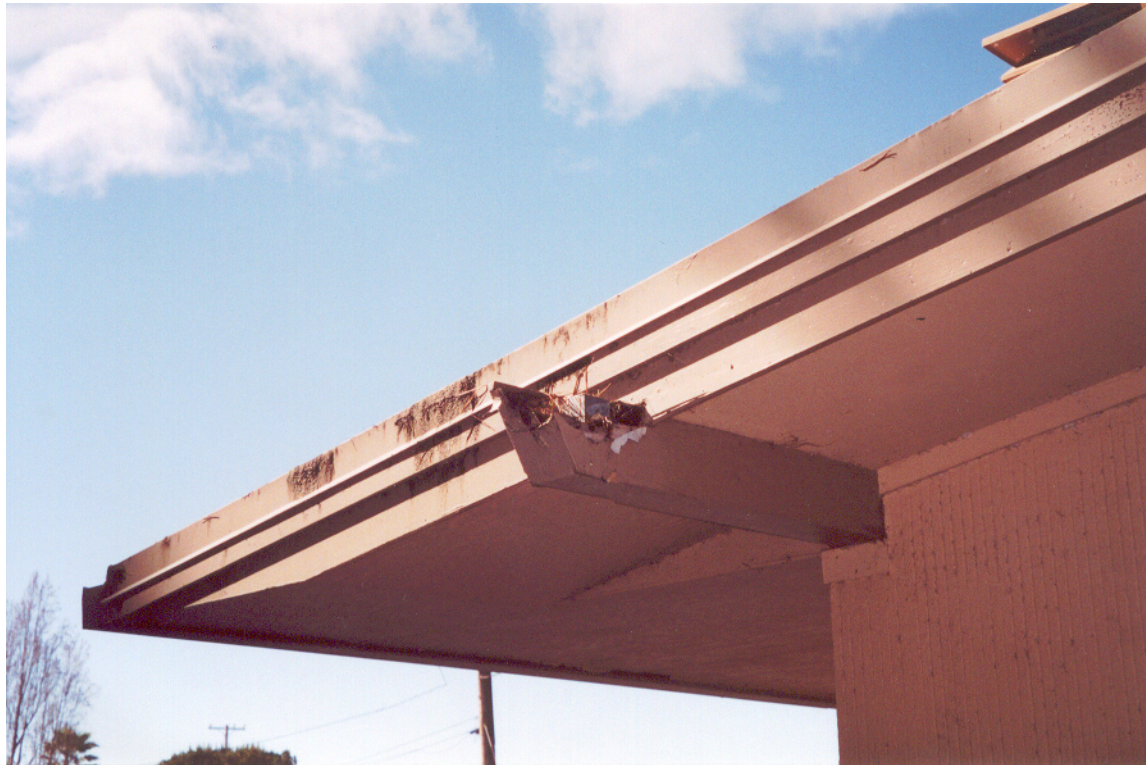
The four permanent buildings are all one-story wood-framed structures with stucco finish (see figures 2 through 12). The roofs are not exposed and the roof overhangs have plaster soffits. The classroom and kindergarten / library buildings are all of similar construction. In these buildings, there are classrooms on both sides of a central corridor. The exterior longitudinal walls have windows along most of the length (see figure 8) and the interior corridor walls appear to have shear wall panels (see figure 14). For lateral forces, the roof diaphragm is cantilevered out from these walls to the exterior of the building. In the transverse direction, there appear to be shear walls between the classrooms and the end walls have significant lengths of shear wall. There is some deterioration of an exposed roof beam at the kindergarten building.

6.	There is some deterioration at an exposed roof beam at the kindergarten building.

Figure 15: Deterioration of Roof Beam at Kindergarten Building
