STRUCTURAL EVALUATION OF
VALLEY VIEW ELEMENTARY SCHOOL
WEST CONTRA COSTA UNIFIED SCHOOL DISTRICT
(WCCUSD)

DASSE Design, Inc.
33 New Montgomery Street #850
San Francisco, CA 94105
(415) 243-8400

April 30, 2002

DASSE Design Project No. 01B300

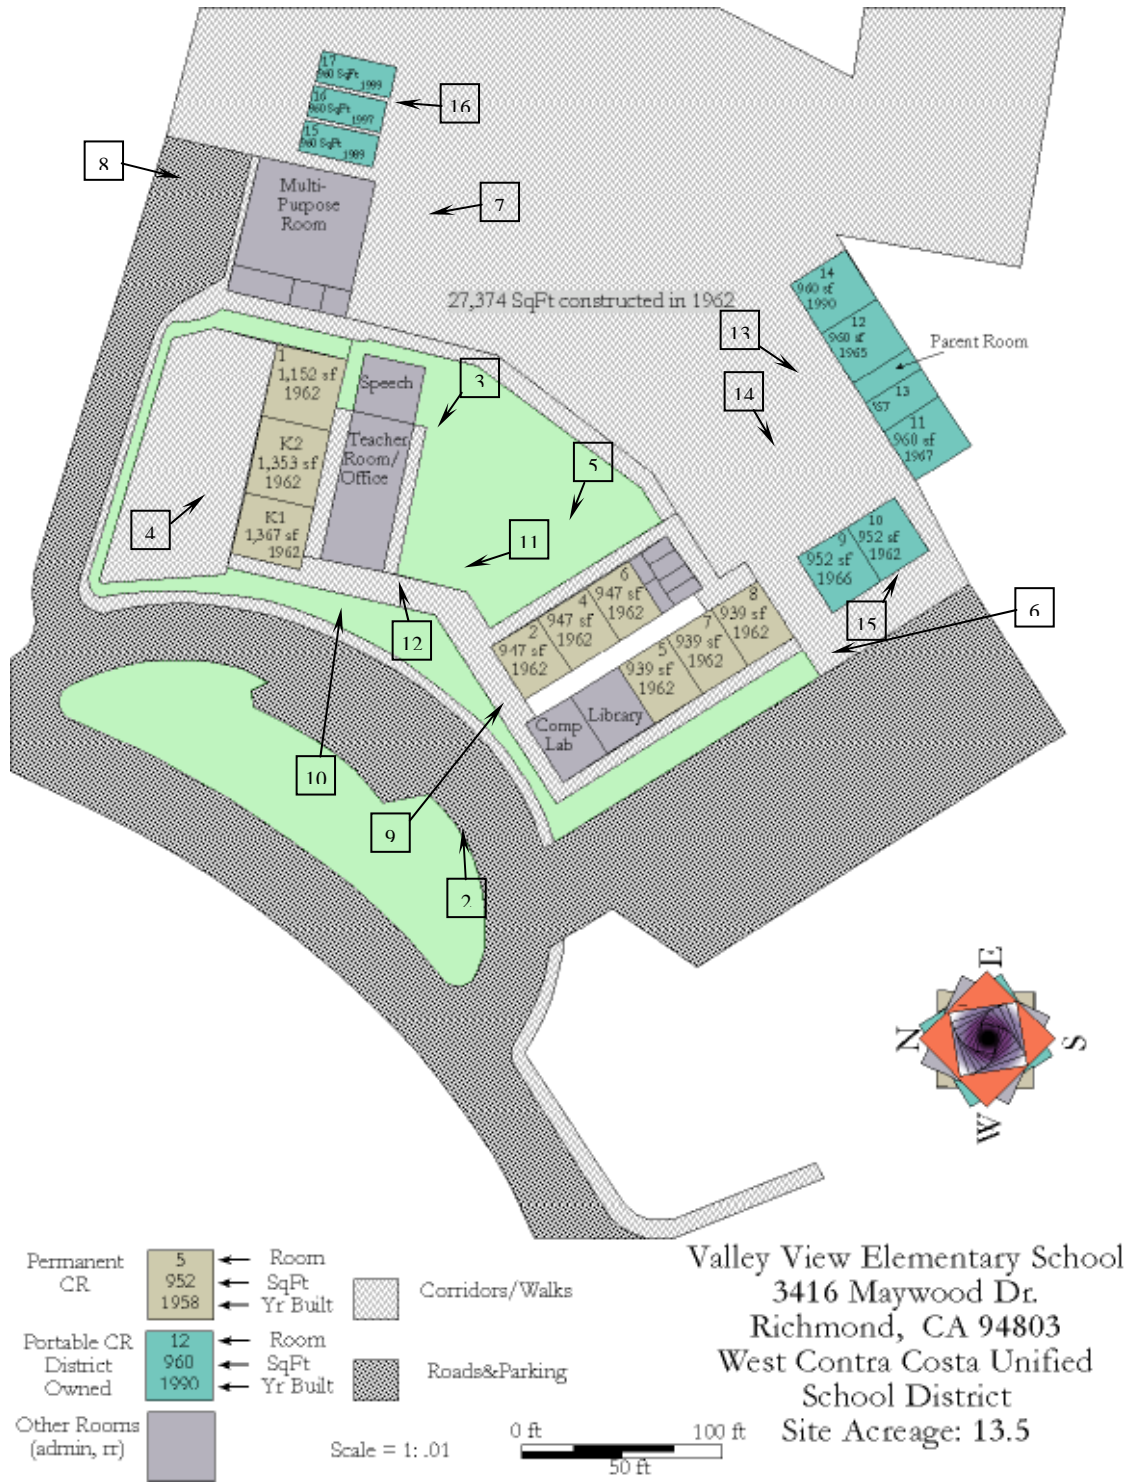
Figure 1: School Layout Plan

The school was built in 1962. There are three main buildings (permanent structures) and nine portable buildings (see figure 1). The original buildings are two one-story wood- and steel-framed structures with some CMU walls. A one-story wood- and steel-framed structure (multi-purpose building) was constructed in 1985. There is one 1962 portable, one 1965 portable, one 1966 portable, two 1967 portables, one 1989 portable, one 1990 portable, one 1997 portable, and one 1999 portable. The total square footage of the permanent structures is about 27,100 square feet.

There are two permanent classroom buildings. Classroom wing A has the offices and rooms K1, K2, and 1. Classroom wing B has classrooms 2 through 8, the computer lab, and the library (see figure 1). The main classroom buildings are two one-story wood-framed structures with transverse CMU shear walls at the front and back end of classroom wing A and at the front end

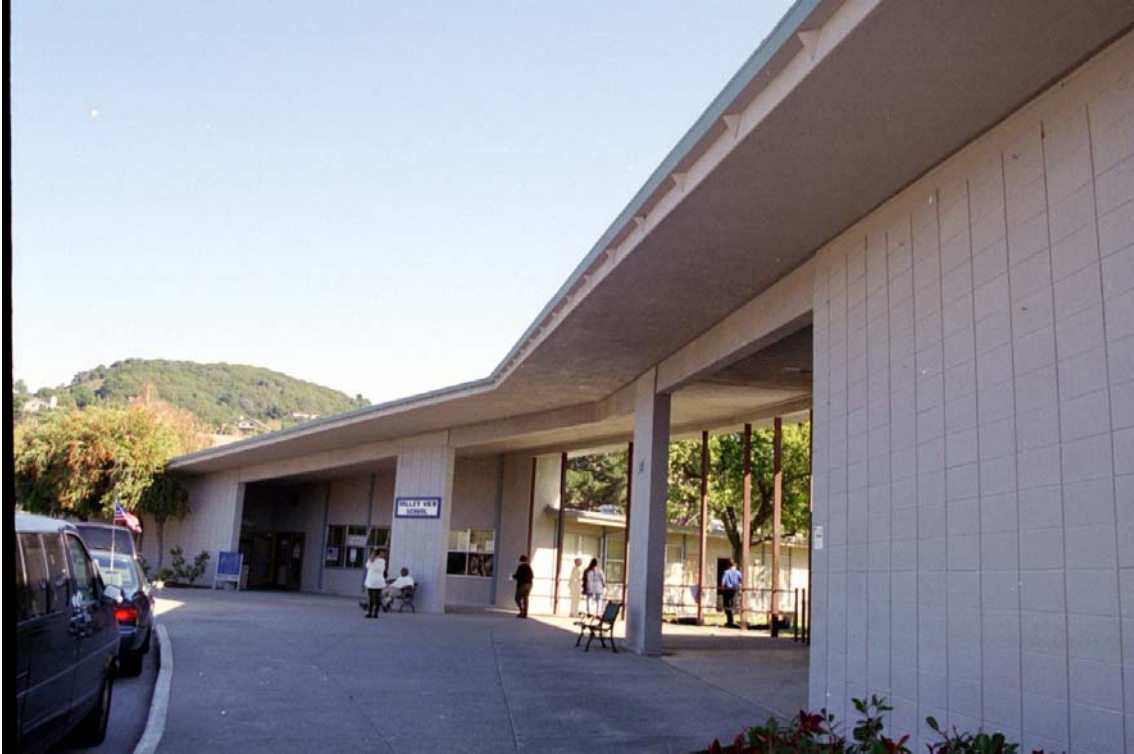
Figure 2: Front Entrance

At the front entrance of the school, there is a high covered walkway area running between the classroom wings (see figures 2 and 3). There is a plaster ceiling on the underside of the walkway. The covered walkway roof slopes up from the ridgelines of the classroom buildings to a high point near the middle of the main entryway. This covered walkway is supported by CMU walls and pilasters at the front and by steel tube columns at the rear side. There is significant cracking of the CMU walls at the ends of the covered walkway where the walkway beam bears on the wall (see figures 9 and 10). Where the covered walkway meets the classroom buildings at its rear edge, there is also some cracking of the stucco soffit and beam furring (see figure 12). There is also some minor cracking at the top of one of the concrete pilasters that support the front edge of the canopy that appears to be due to out-of-plane bending.

The covered walkway that runs between the classroom buildings have a plywood roof diaphragm over 2x10 joists that span between steel wide-flange beams. At the front face, these steel beams span between the CMU end walls of the classroom buildings and the 6 ft. wide CMU pilasters at the front entrance (see figure 2). The beam is attached to the end walls by 2 bolts where it bears on the CMU wall. There are 3" diameter standard pipe columns embedded at each end of the CMU pilasters, and there is a bolted connection from the steel beam to these columns at the top. At the rear, the steel beams span between TS6x4x1/4 columns that sit on a strip footing. These slender tube steel columns do not appear to have adequate lateral bracing at the roof level (see figure 11). The roof diaphragm is about 24 ft wide and has a double 2x10 chord member at each edge. At its high point, the roof is approximately 19 ft. tall, and there is a re-entrant corner at this location. The diaphragm chords are connected to each other at this corner with steel clip angles. Where the covered walkway meets the classroom buildings, the roof is framed continuously and there is no seismic joint in the covered walkway to separate it from either of the classroom buildings (see figure 3). The covered walkway does not have its own lateral force resisting system, and therefore it spans about 110 ft between the two classroom buildings.

3.	The covered walkway’s roof diaphragm aspect ratio is very slender. This will lead to large lateral deflections in the transverse direction.
4.	The covered walkway roof is connected to both classroom buildings. As the buildings move toward or away from each other, it will cause large forces at the re-entrant corner.

6.	Out-of-plane lateral support for CMU pilasters at the main entrance is provided by 3” diameter pipe columns embedded in them. The columns may be inadequate to carry the out-of-plane load of the pilaster. This may cause collapse of the walkway.

2.	Provide new lateral bracing beams at top of existing columns.	1.5	11
3.	Provide seismic bracing or moment frame in transverse direction at covered walkway columns	2.5	2

6.	Provide a positive connection at the top of the CMU pilasters to the covered walkway roof diaphragm.	1.0	2
7.	Provide new wall out-of-plane connection and cross-ties.	1.0	2, 3

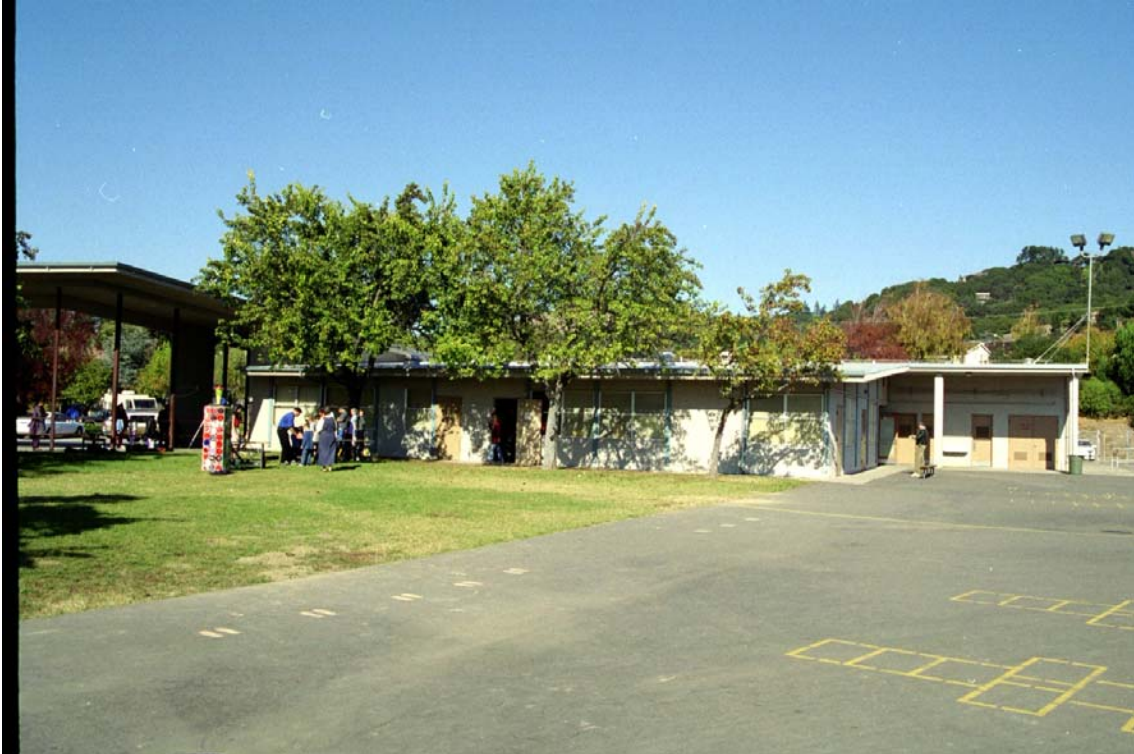
Figure 3: Wing A Classrooms (front)

At the rear end of classroom wing A, there appears to be a deviation between the original construction documents and the existing conditions observed during the site visit. The original drawings show the roof overhang spanning 8 ft. between the rear wall of the building and a steel channel over a row of pipe columns. The existing condition however is a much shorter overhang that is cantilevered over the rear wall of the building (see figure 3).

7.	The CMU shear walls at the front of the classroom buildings and at the rear of classroom wing A do not have positive connection to the roof diaphragm for resisting out-of-plane forces. Additionally, buildings with masonry walls and flexible diaphragms require cross-ties which are not provided in the longitudinal direction.

8.	The splices in the roof diaphragm chords at the wood end walls of the classroom buildings are overstressed.
9.	At the classroom buildings, the interior longitudinal and transverse shear walls are overstressed.

8.	Provide new straps above the plywood at the roof.	1.3	3
9.	Provide new plywood sheathing at the unsheathed face of the wall. Strengthen existing collectors and add holdowns as required.	1.3	N/A

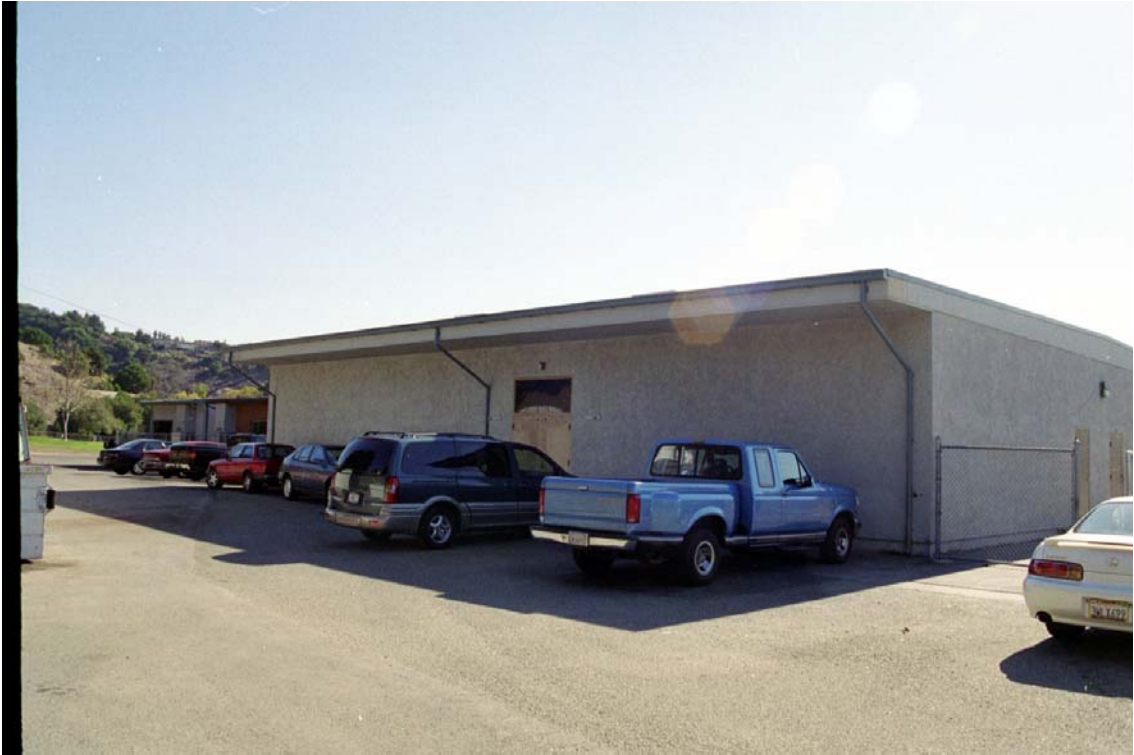
Figure 8: Multi-Purpose Building (rear)

10.	The shear wall at the west side of the multi-purpose building is overstressed.
11.	The front wall of the portable units (classrooms 9 to 14) has multiple window openings and the shear wall may be overstressed.

10.	Provide new plywood sheathing at the unsheathed face of the wall, or re-nail existing plywood at exterior. Strengthen existing collectors and add holdowns as required.	1.3	8

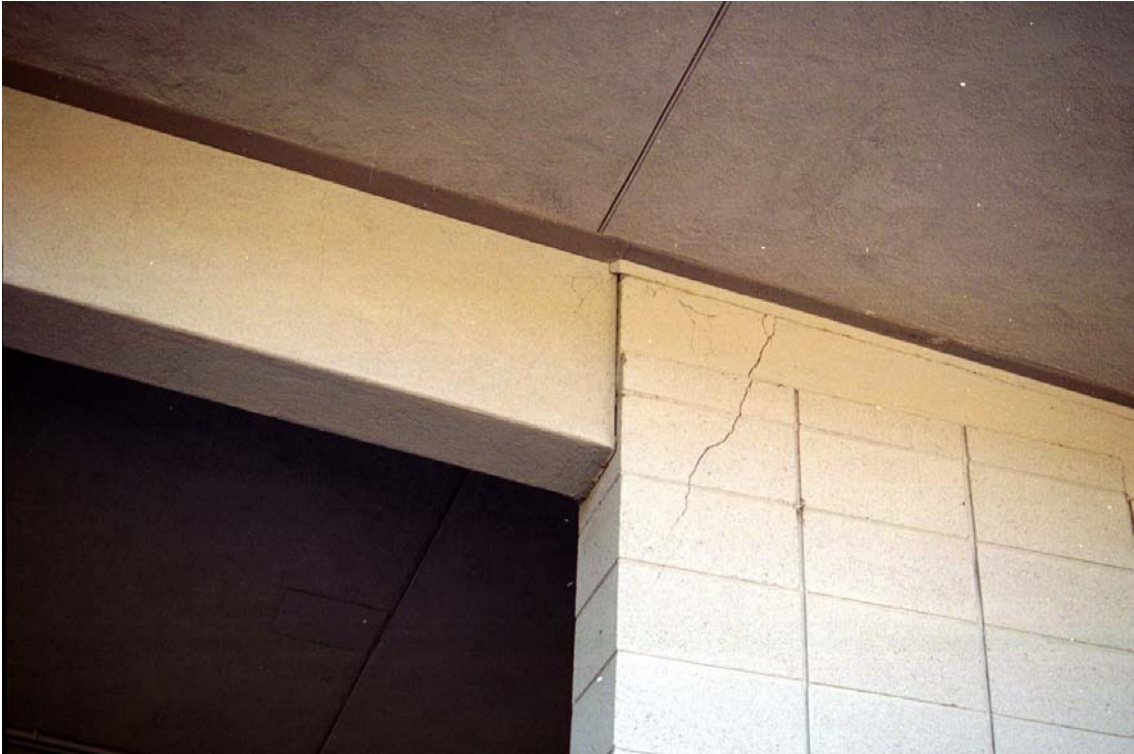
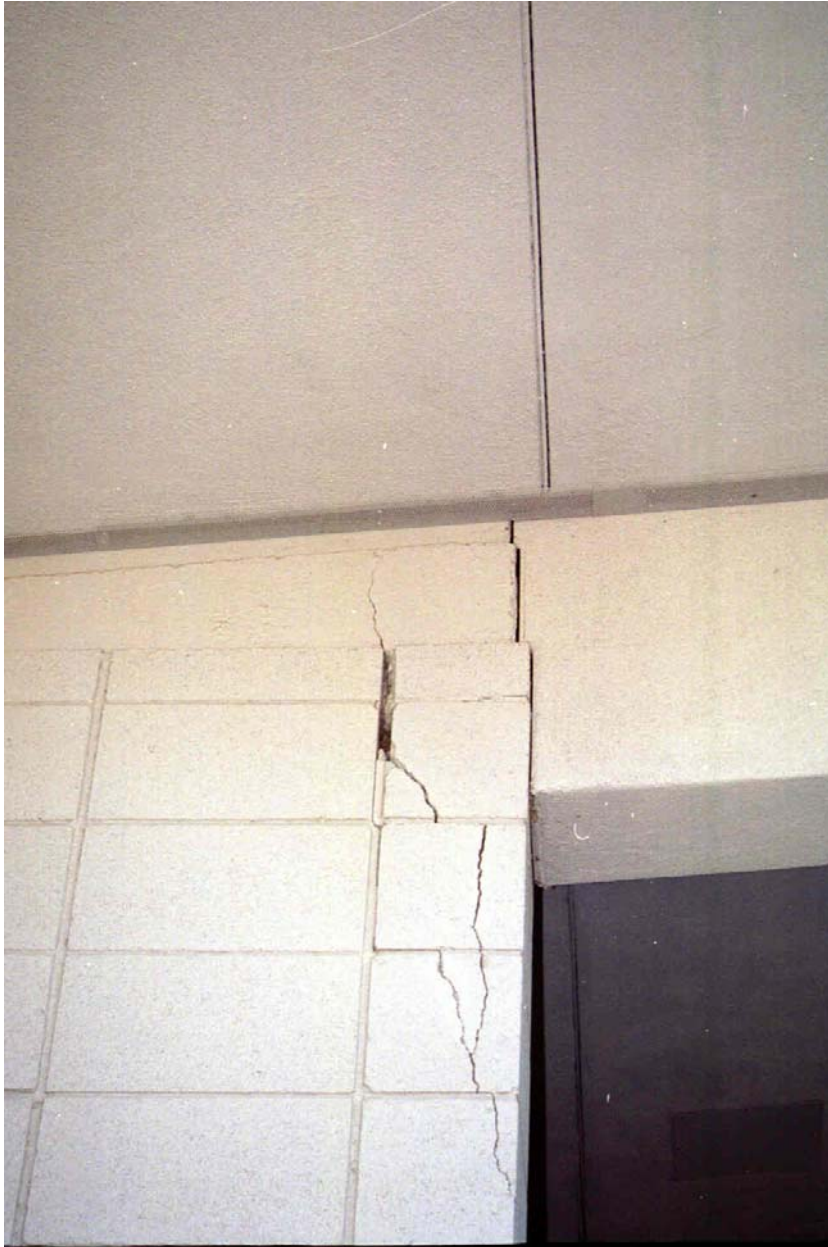
Item	Building Structural Deficiencies
1.	There are cracks in the CMU wall at the main entrance where covered walkway beam is supported.
2.	There is a lack of lateral bracing at the top of TS columns at covered walkway.

Figure 9: Cracking at Entrance Canopy

Figure 10: Cracking at Entrance Canopy

Item	Recommended Remediation	Priority	Figure Number
1.	Provide a new steel column at end of CMU wall to prevent collapse. Provide new straps at roof above collector.	1.1	9,10

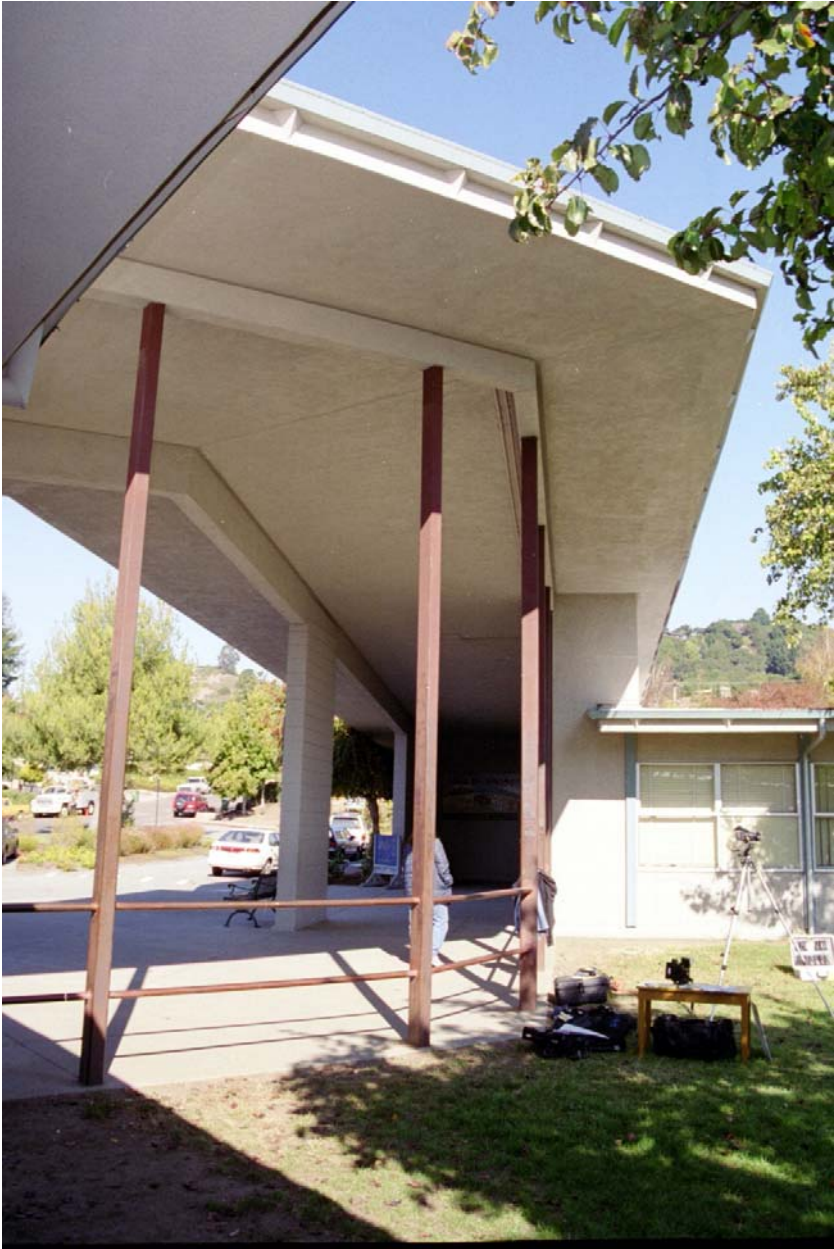
5.	There is a discontinuity in the roof diaphragm where the covered walkway and classroom building roofs intersect. As they move differently, there may be some damage to the roof at these locations.

Figure 11: Columns at Entrance Canopy

4.	Provide new straps and blocking as collectors at the re-entrant corner	1.5	11
5.	Provide new straps and blocking as collectors at the Diaphragm discontinuity.	1.7	11

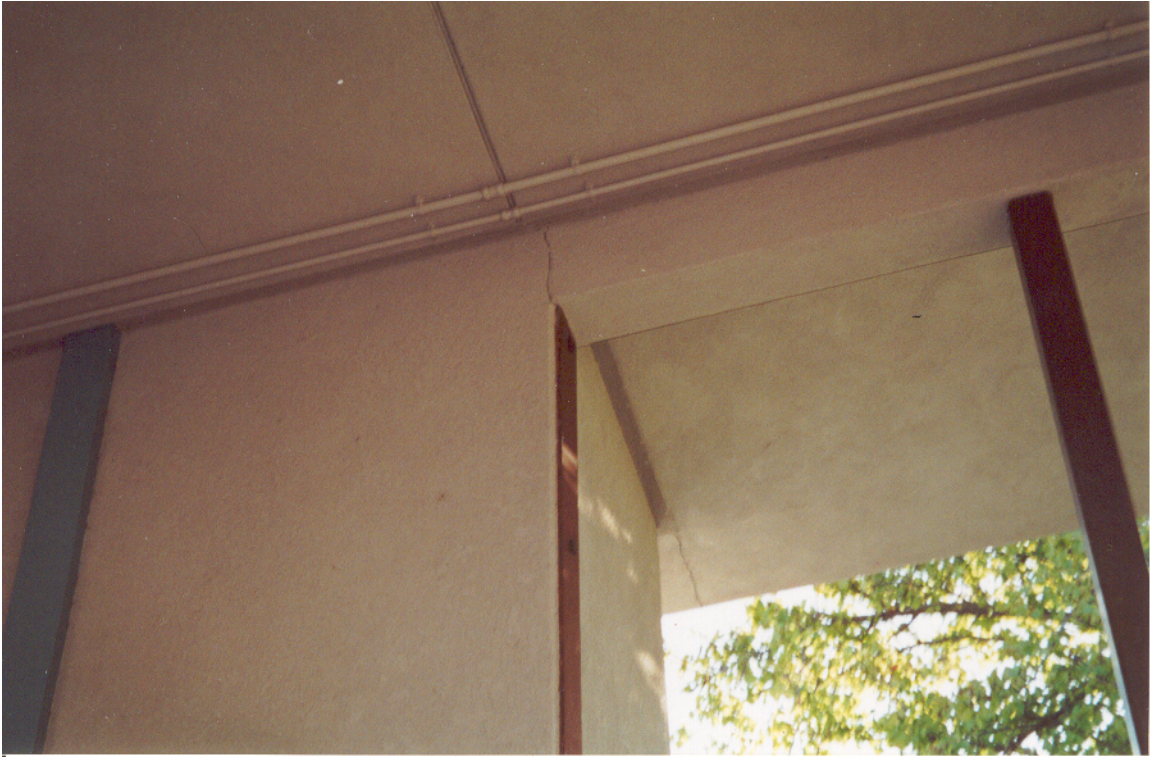
Figure 12: Cracks at Rear Side of Entrance Canopy at Building

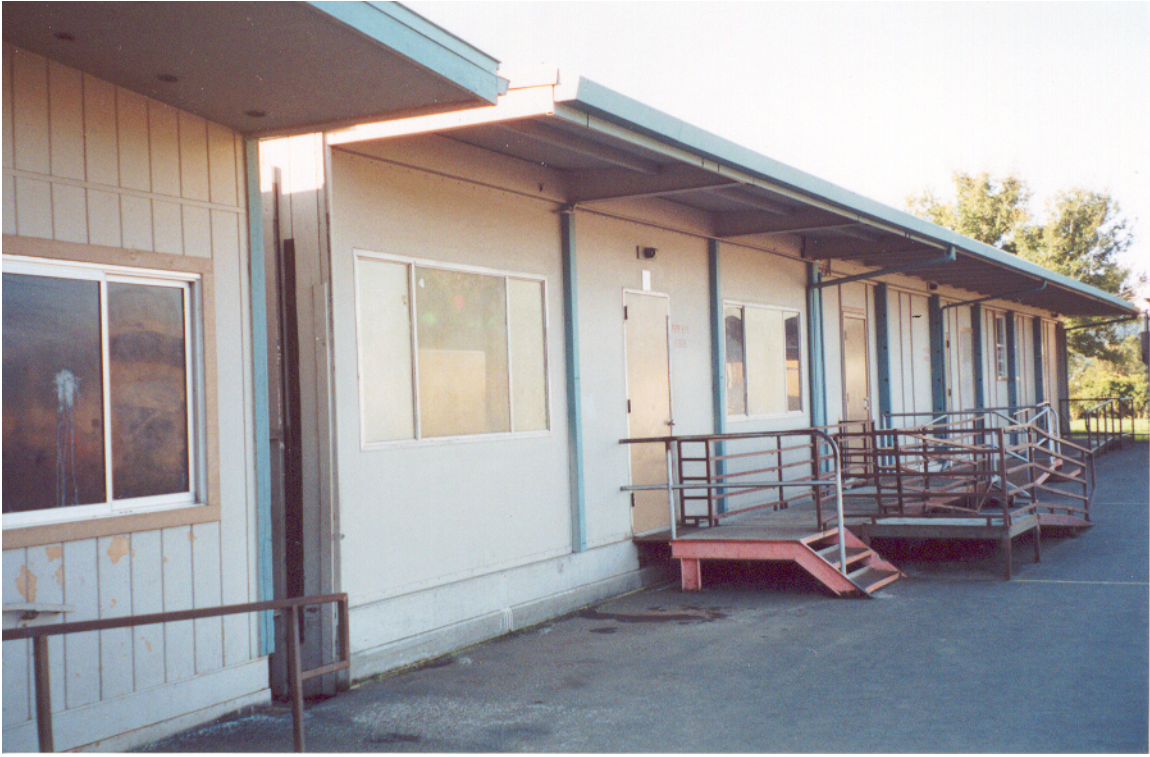
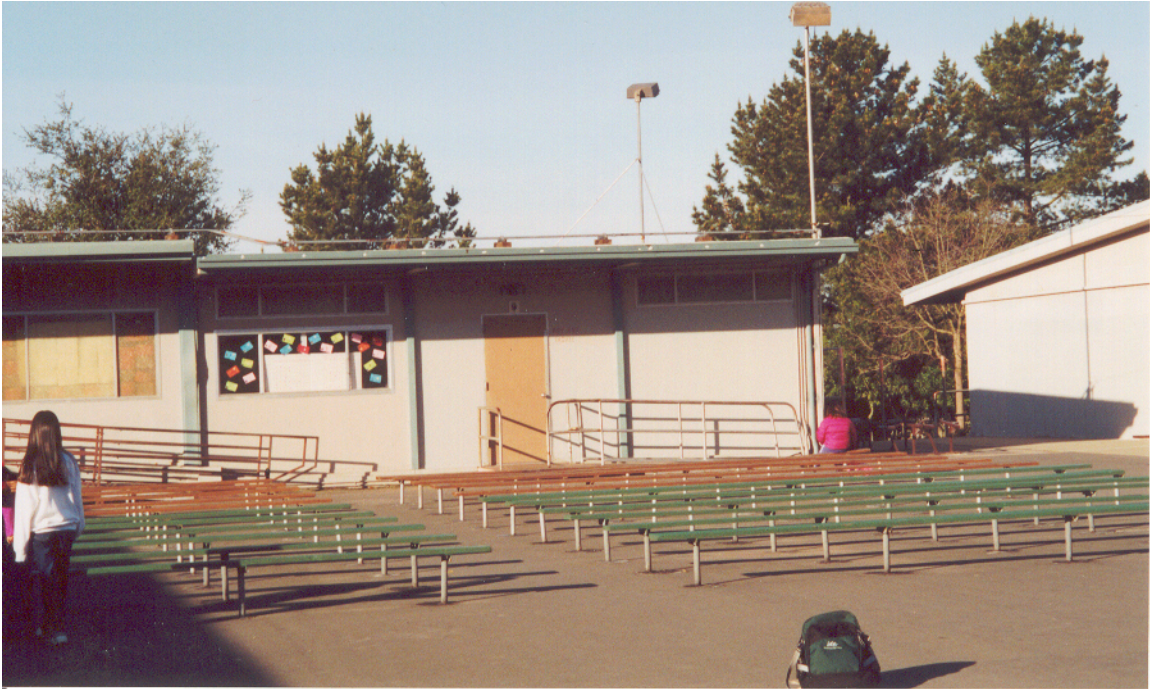
The main group of portables (classrooms 9 to 14) have multiple window openings on their front face (see figures 13 and 14). There is some rusting of the metal frames at the base of these portables (see figure 15). These portables and the newer portables (classrooms 15 to 17) have electrical conduit running between them above the roof and near the roof level, respectively (see figures 14 and 16). The conduit does not have flexible connections.

Figure 13: Portable Classrooms

Figure 14: Portable Classrooms

11.	Infill some windows with new framing and plywood. Strengthen existing collectors and add holdowns as required.	1.6	13, 14
12.	Repair as necessary and re-paint.	1.9	15

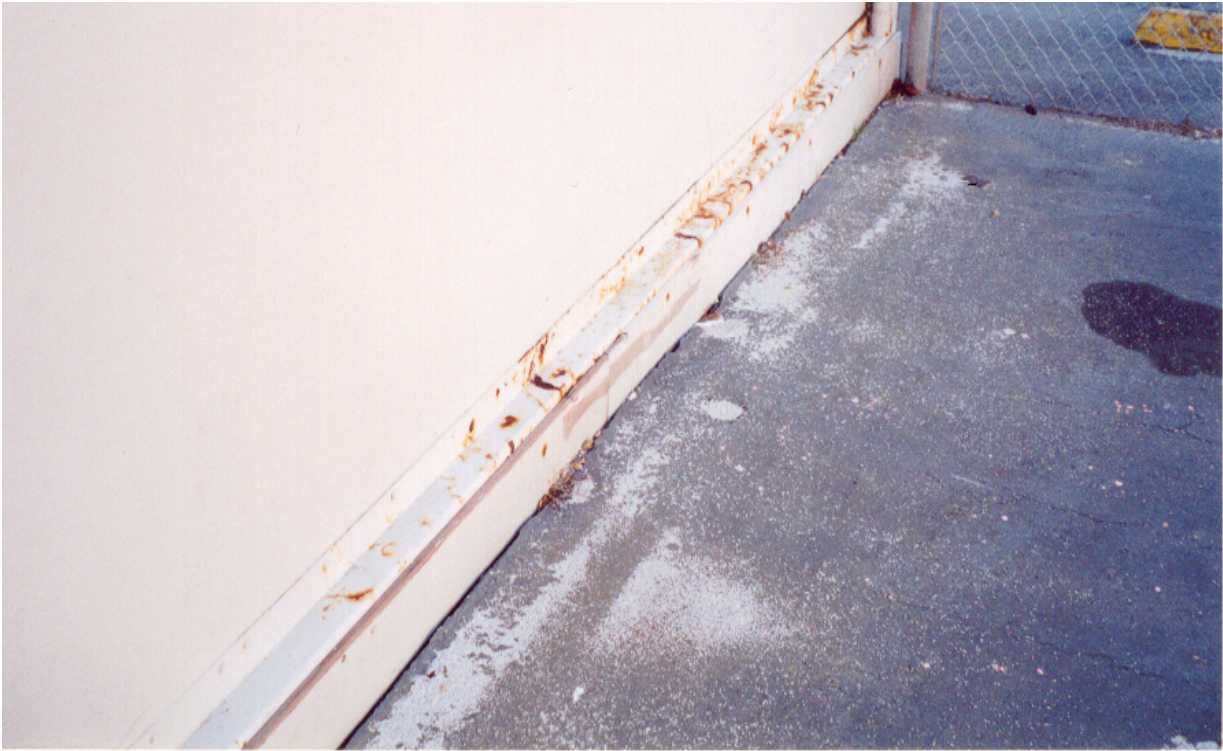
12.	There is some rusting at the base frame of the portable units at classrooms 9 to 14.
13.	Conduit crossing the seismic joints between portable units may get damaged as the buildings move independently and is a life-safety hazard.

Figure 15: Rust at Base Frame of Portable Unit

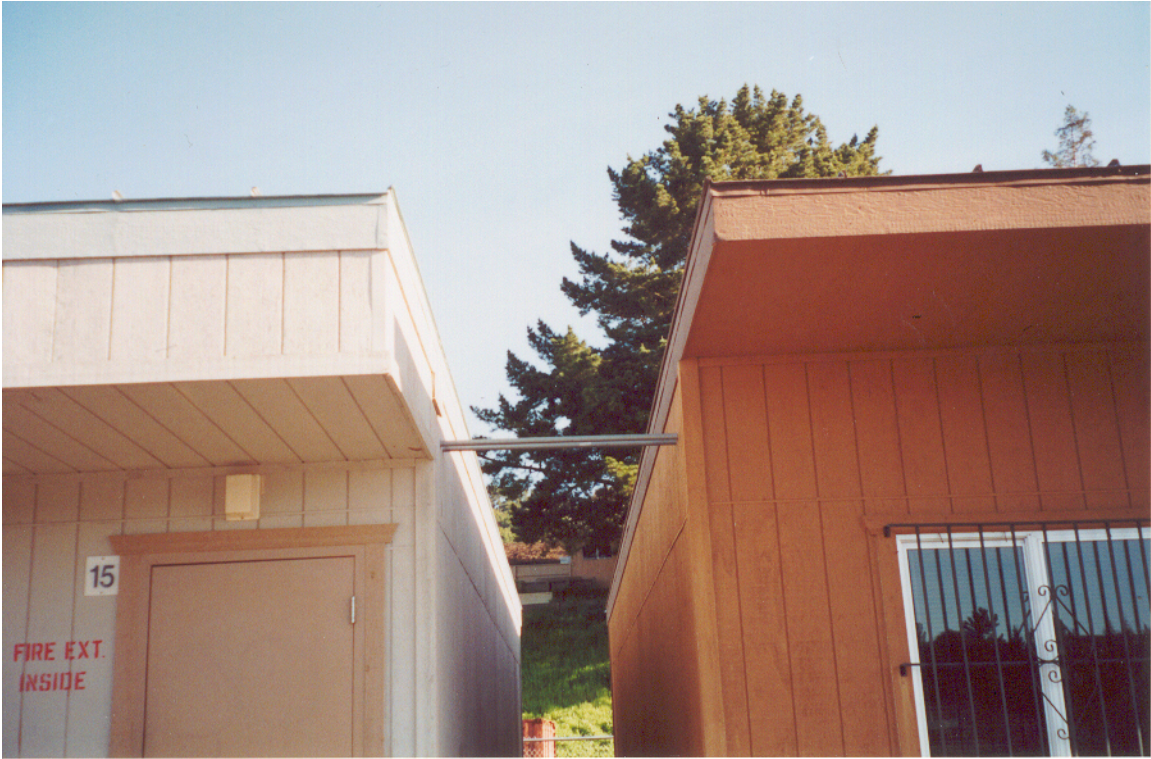
Figure 16: Conduit Running between Portables

13.	Provide flexible connections in conduit at seismic joints.	1.9	16
