STRUCTURAL EVALUATION OF
VISTA HILLS STAFF DEVELOPMENT CENTER
WEST CONTRA COSTA UNIFIED SCHOOL DISTRICT
(WCCUSD)

April 30, 2002

DASSE Design Project No. 01B300

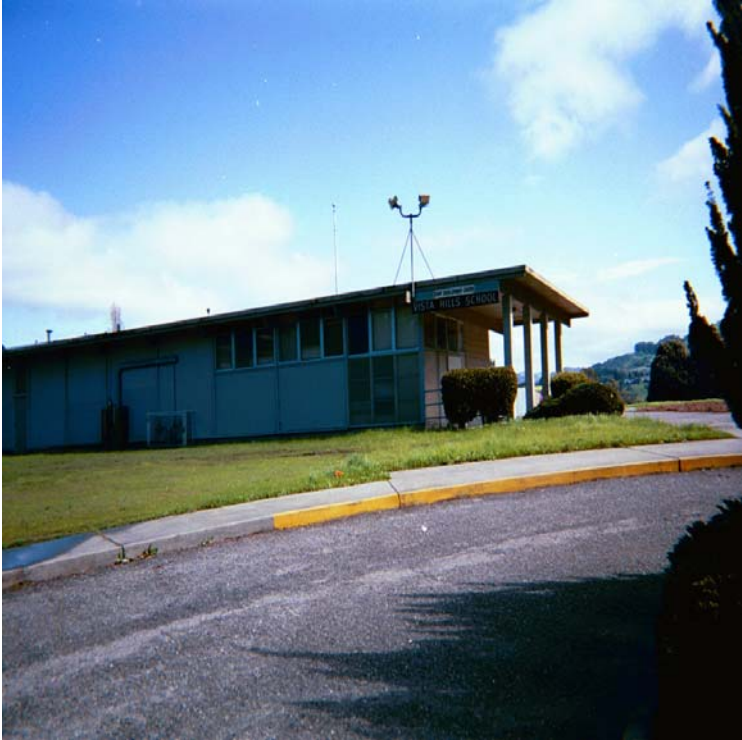
Figure 2: Front Entrance

1.	Exterior walls where masonry does not extend to the roof have limited capacity to resist out of plane forces.
2.	Main Building entrance canopy has tall CMU pilasters which do not appear to be adequately anchored to the roof.
3.	Concern about the adequacy of the connection of roof drags and collectors to the masonry shear walls.
4.	Top of beam extending from the North-West wall appears to have some decay.

Item	Recommended Remediation	Priority	Figure Number
1.	Where the masonry walls do not extend to the roof, provide pilasters on face of wall extending from slab-on-grade to roof.	1.5	4, 5
2.	Provide additional lateral bracing between the top of the entry canopy CMU pilasters and the roof.	1.1	2, 3, 10
3.	Strengthen the anchorage of roof drags into the masonry shear walls.	1.9	N/A
4.	Eliminate cause of decay and repair damage.	3.5	N/A

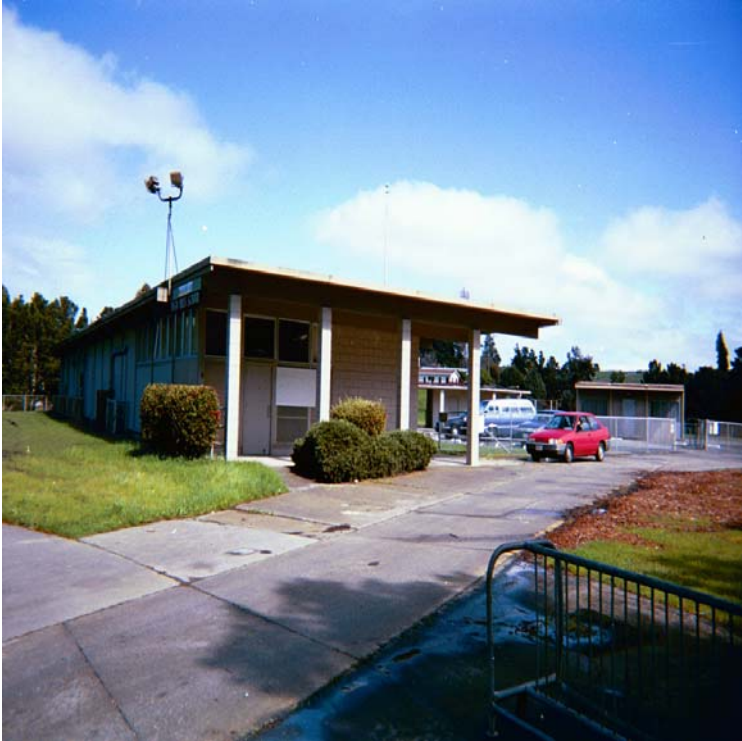
Figure 3: Front Entrance

There were several tall CMU columns (Figures 3 & 10) near the campus entrance that had Glu-Laminated beams resting on them and no bracing or blocking between the bottom of the beams and the roof diaphragm.

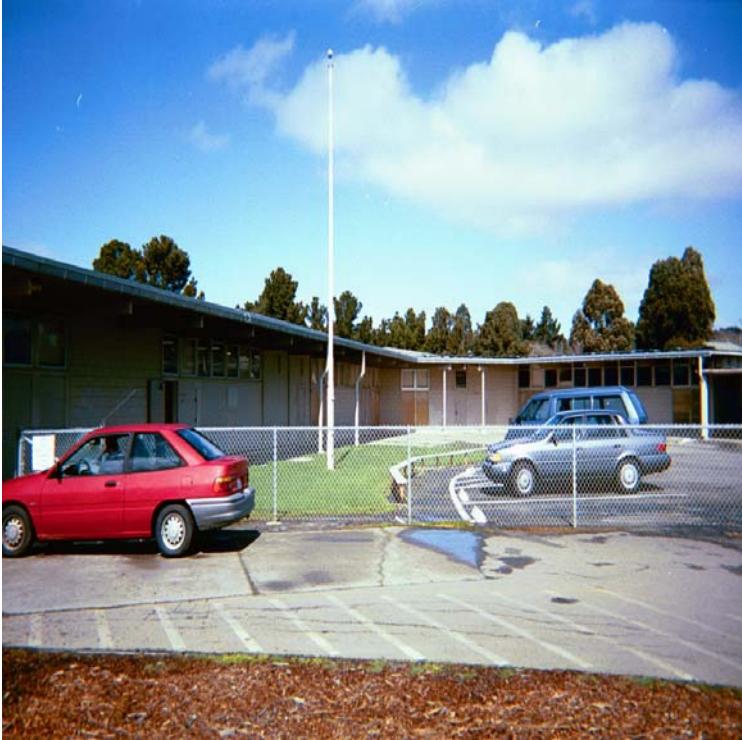
Figure 4: Courtyard

During the visit it was observed that the roof structure consisted of straight sheathing supported by Glu-lam beams. The exterior walls were either stucco over wood or CMU (Figures 4, 5, & 7).

At the inner corridor wall there are continuous windows over CMU walls (Figures 4, 5).

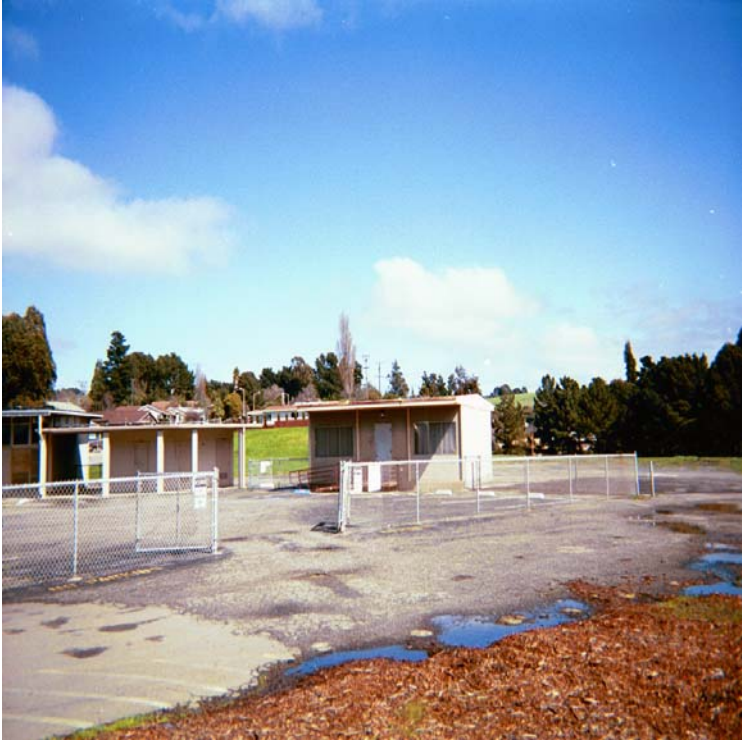
Figure 6: Portable Building

In past earthquakes, the predominant damage displayed by portable buildings has been associated with the buildings moving off of their foundations and suffering damage as a result. The portables observed during our site visits tend to have the floor levels close to the ground, thus the damage resulting from buildings coming off of their foundation is expected to be minimal. The life safety risk of occupants would be posed from the potential of falling 3 feet to the existing grade levels during strong earthquake ground shaking. Falling hazards from tall cabinets or bookshelves could pose a greater life safety hazard than building movement. The foundation piers supporting the portable buildings tend to be short; thus the damage due to the supports punching up through the floor if the portable were to come off of its foundation is not expected to be excessive.

Because of their light frame wood construction and the fact that they were constructed to be transported, the portable classrooms are not in general expected to be life safety collapse hazards. In some cases the portables rest directly on the ground and though not anchored to the ground or a foundation system could only slide a small amount. In these instances the building could slide horizontally, but we do not expect excessive damage or life safety hazards posed by structural collapse of roofs.
