STRUCTURAL EVALUATION OF
WOODROW WILSON ELEMENTARY SCHOOL
WEST CONTRA COSTA UNIFIED SCHOOL DISTRICT
(WCCUSD)

DASSE Design, Inc.
33 New Montgomery Street #850
San Francisco, CA 94105
(415) 243-8400

April 30, 2002

DASSE Design Project No. 01B300

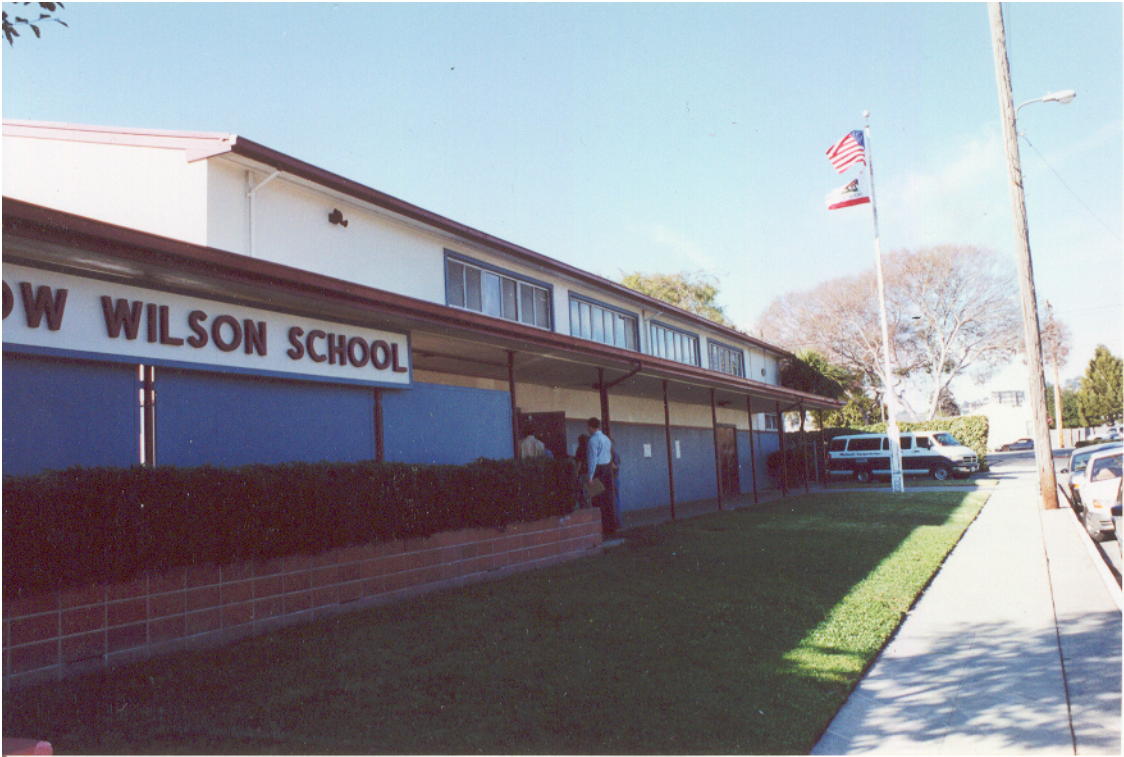
8.	The covered walkway at the east face of the multi-purpose building and at the ends of the classroom buildings is attached to the wall using a ledger connection. This ledger is stressed in cross-grain bending for out-of-plane lateral forces.

Figure 3: East Face of Multi-Purpose Building

7.	Provide new straps at roof and clip angles from blocking to top plates.	1.3	2, 8, 9
8.	Provide a direct connection from the covered walkway to wall for lateral forces	2.8	3, 10, 11

9.	Provide new straps at roof and clip angles from blocking to top plates	1.3	3
10.	Add new additional nailing at the existing top plate splices.	1.8	5
11.	Provide new seismic joints to separate the connecting walkways from the buildings. Add lateral bracing.	1.9	10

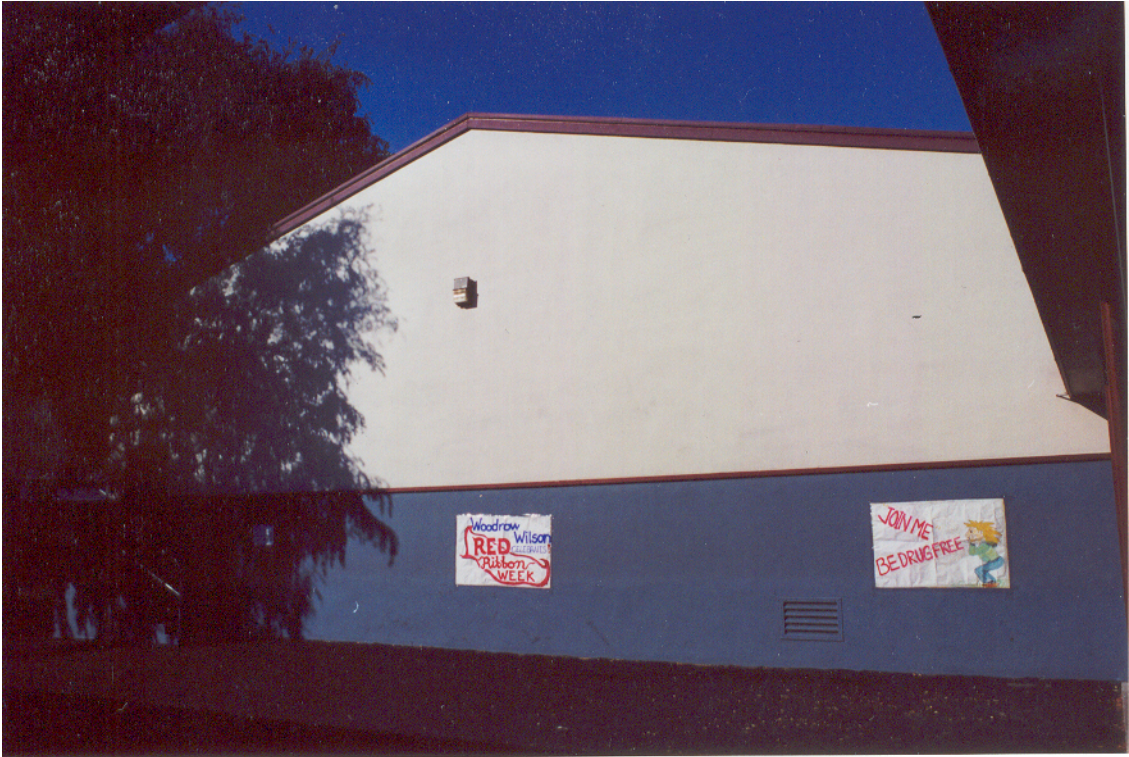
Figure 5: South Face of Multi-Purpose Building

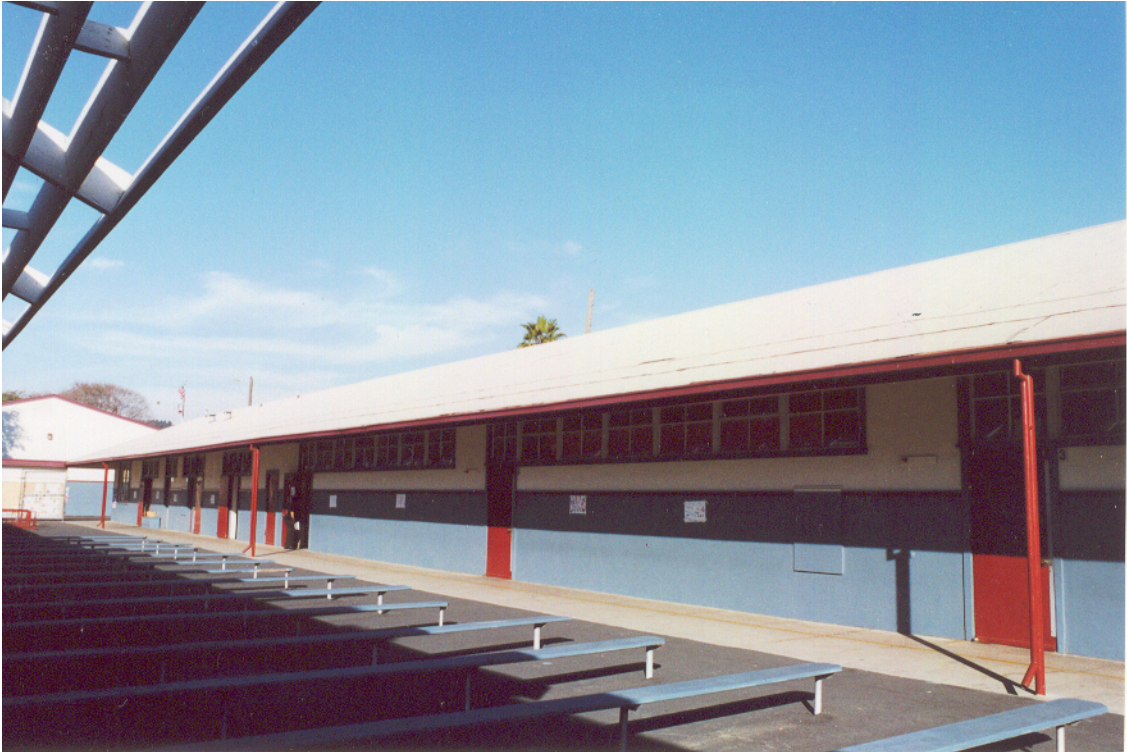
2.	The west exterior longitudinal walls of the classroom buildings have bands of high windows, resulting in a lack of shear wall. The wall below the high windows has straight sheathing.

Figure 8: West Longitudinal Wall of Classroom Building (Typical)

2.	Infill some windows with new framing. Add new full-height plywood sheathing to the interior of the wall. Strengthen collectors and add new holdowns as required.	1.1	8

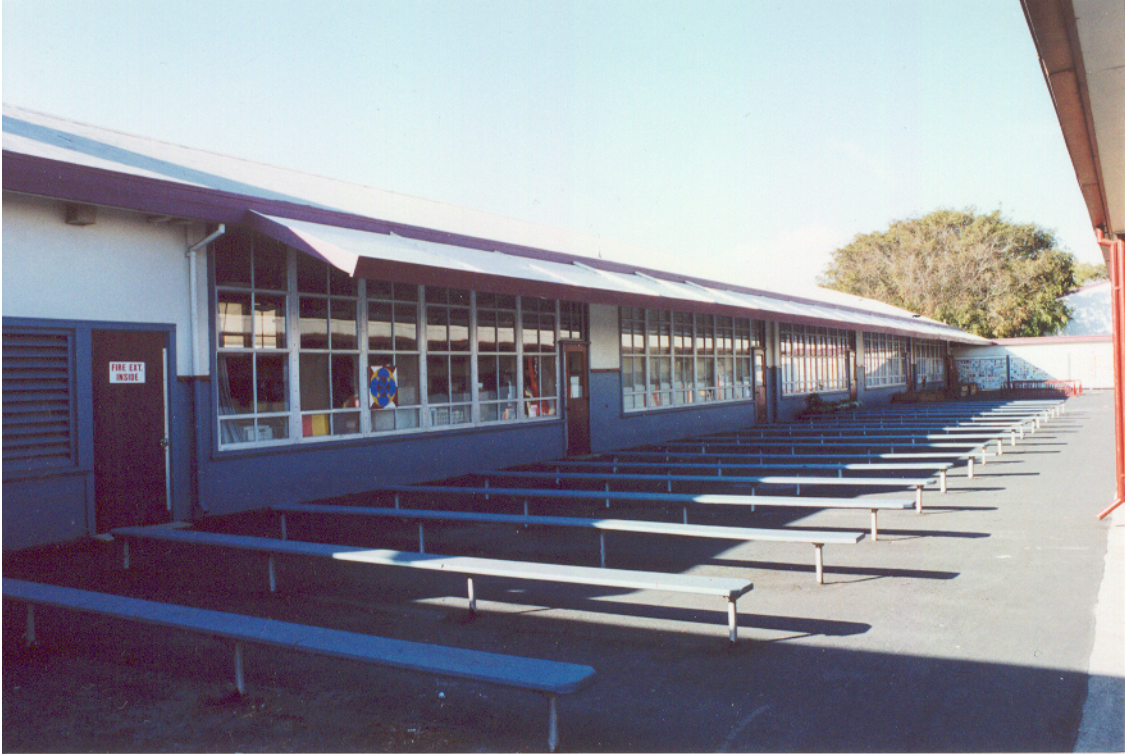
Item	Building Structural Deficiencies
1.	The east exterior longitudinal walls of the classroom buildings have excessive window openings, resulting in a lack of shear wall

Figure 9: East Longitudinal Wall of Classroom Building (Typical)

Item	Recommended Remediation	Priority	Figure Number
1.	Infill some windows with new plywood shear wall and framing. Strengthen collectors and add new holdowns as required.	1.1	9

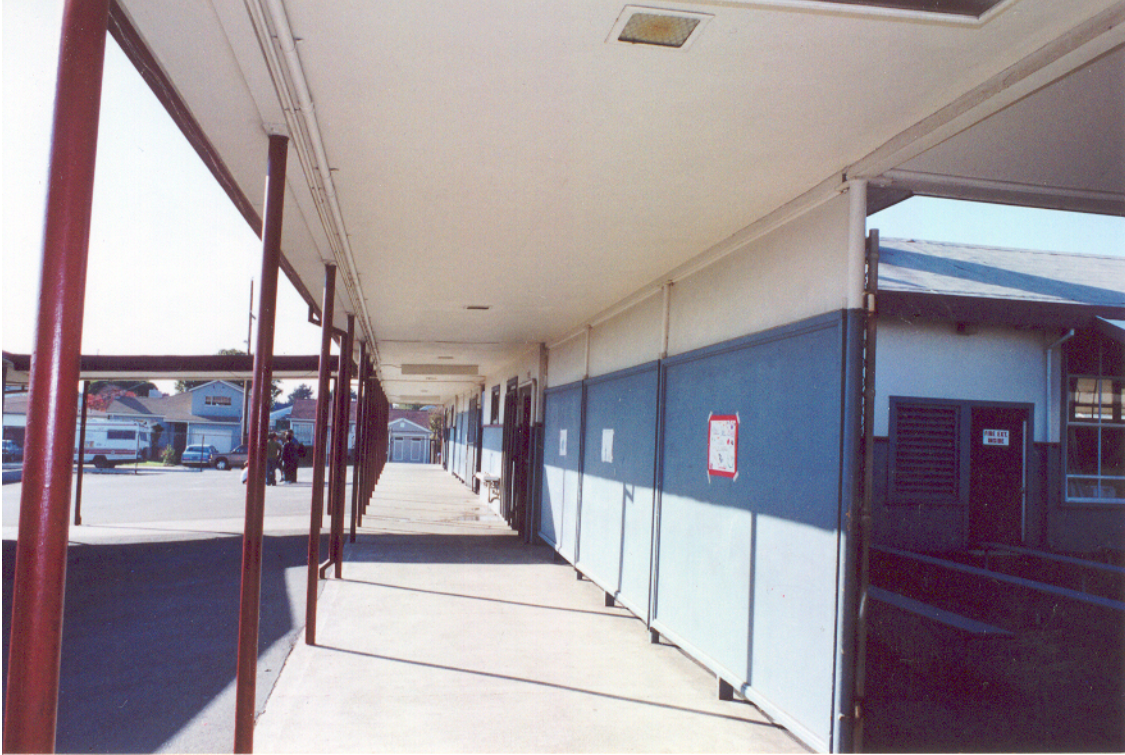
11.	The covered walkways are attached to multiple buildings. As the buildings move independently, the covered walkways may be damaged or partially collapse.

12.	The covered walkways lack adequate lateral bracing at segments connecting the buildings to each other.
13.	There are continuous bands of high windows at the west walls of the permanent portables, resulting in a lack of shear wall.

Figure 10: South End of Classroom Buildings and Covered Walkway

12.	Add lateral bracing.	1.5	10
13.	Infill some windows with new plywood shear wall and framing. Strengthen collectors and add new holdowns as required.	1.1	13

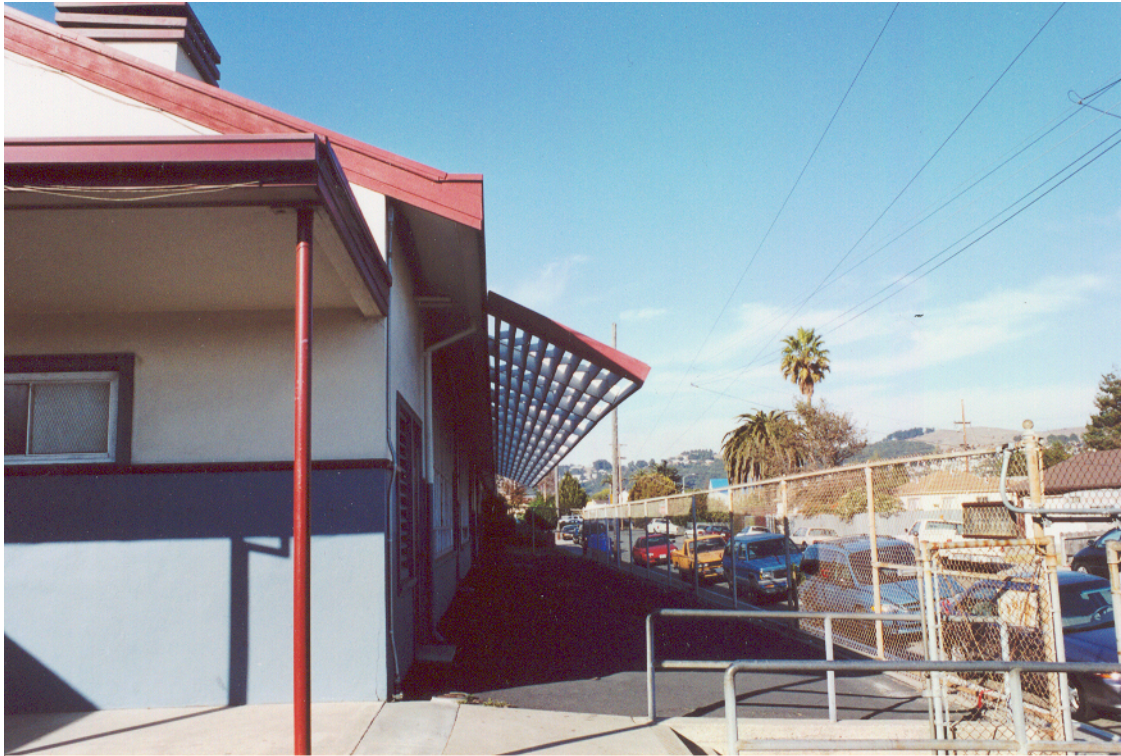
rigid connection. As the buildings move independently, the conduit may be damaged and is a life safety hazard.
19.	The trellis at the east face of the classroom and kindergarten buildings is in imminent danger of falling. There is a lack of adequate support at the cantilever for gravity forces.

Figure 11: Trellis at East Face of Easternmost Classroom Building

15.	Verify existing conditions. Provide steel strap anchors across the ridge to connect the frames for axial forces	1.2	15
16.	Provide new holdowns through the existing floor system to the foundation at the ends of shear panels. Add new sill plate nailing if required.	1.1	15
17.	Remove and replace members with dry rot.	1.9	17
18.	Provide new flexible joint in conduit at building separations	1.9	20
19.	Provide new posts at 16 ft spacing to support the exterior edge of the trellis per detail provided to the school district on November 5, 2001.	1.0	11, 12

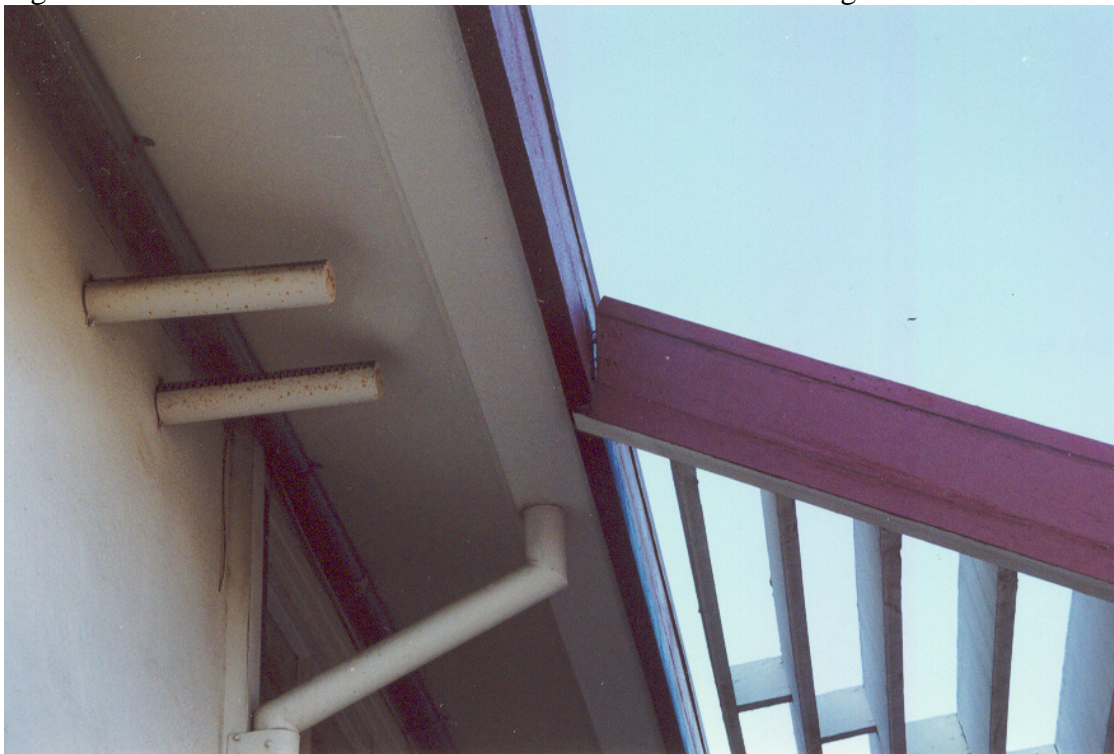
The existing trellis on the eastern face of the kindergarten and classroom buildings does not appear to be built in accordance with the original construction drawings. The original drawings call for a joist that is lapped with the roof joist and cantilevers out to support the trellis. The existing construction has the trellis cantilevering out from the fascia board, held up by nails in withdrawal that are back-nailed through the fascia into the end-grain of the beam (see figure 12).

Figure 12: Trellis at East Face of Easternmost Classroom Building

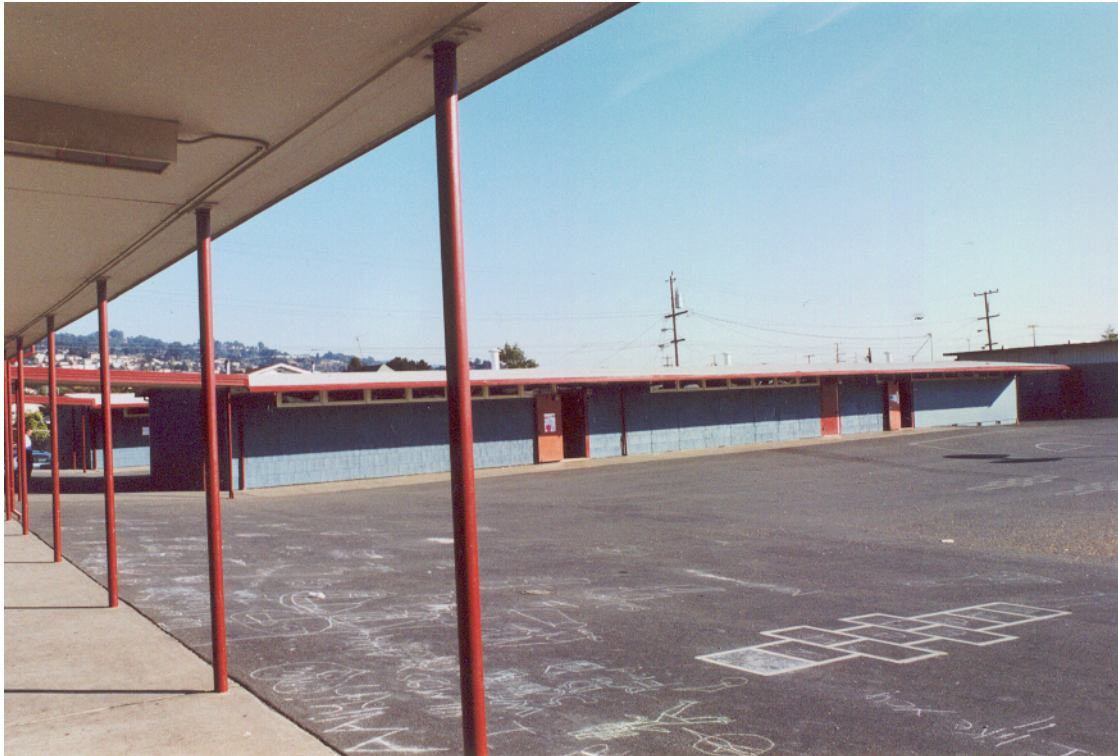
Figure 13: West Face of Permanent Portable Building (Typical)

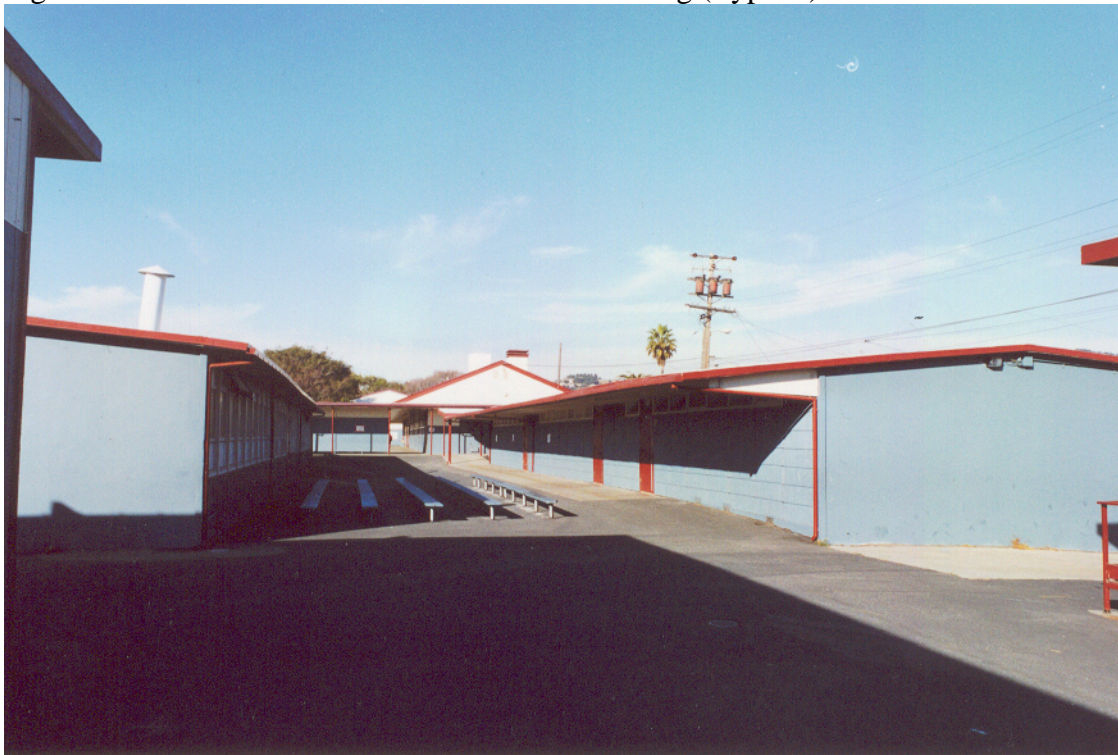
14.	There are excessive window openings at the east walls of the permanent portables, resulting in a lack of shear wall.
15.	At the permanent portables, there may be a lack of cross-tie continuity at the ridge. It appears that there is no positive connection between the two halves of the glulam arch to transfer axial forces.

Figure 14: Longitudinal Walls of Permanent Portable Buildings (Typical)

14.	Infill some windows with new plywood shear wall and framing. Strengthen collectors and add new holdowns as required.	1.1	14

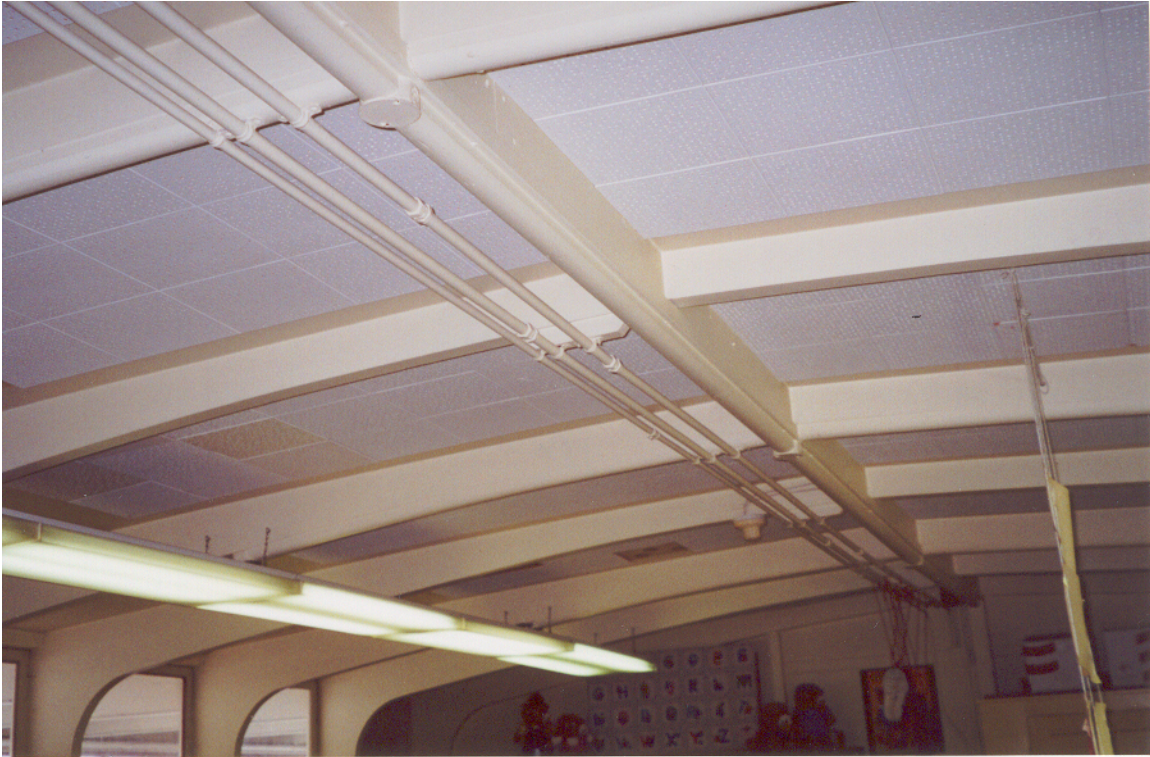
Figure 15: Interior of Permanent Portable Building

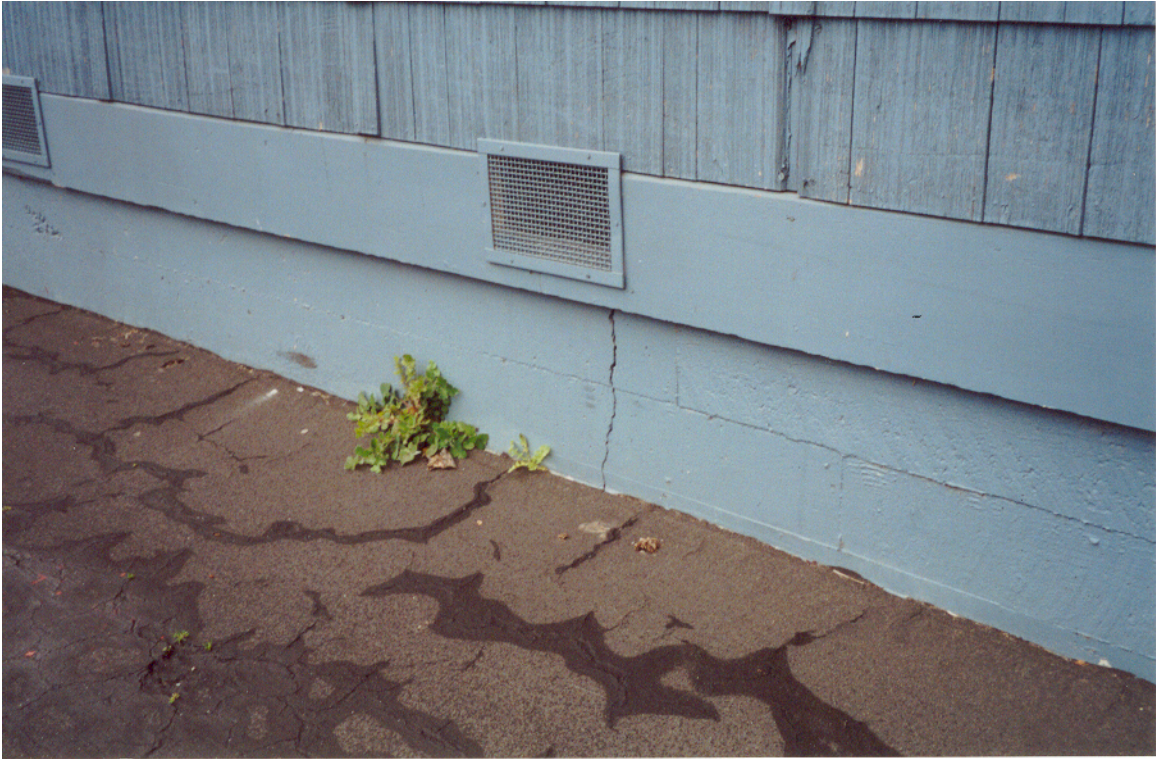
Figure 16: Cracking at Foundation of Permanent Portable Building

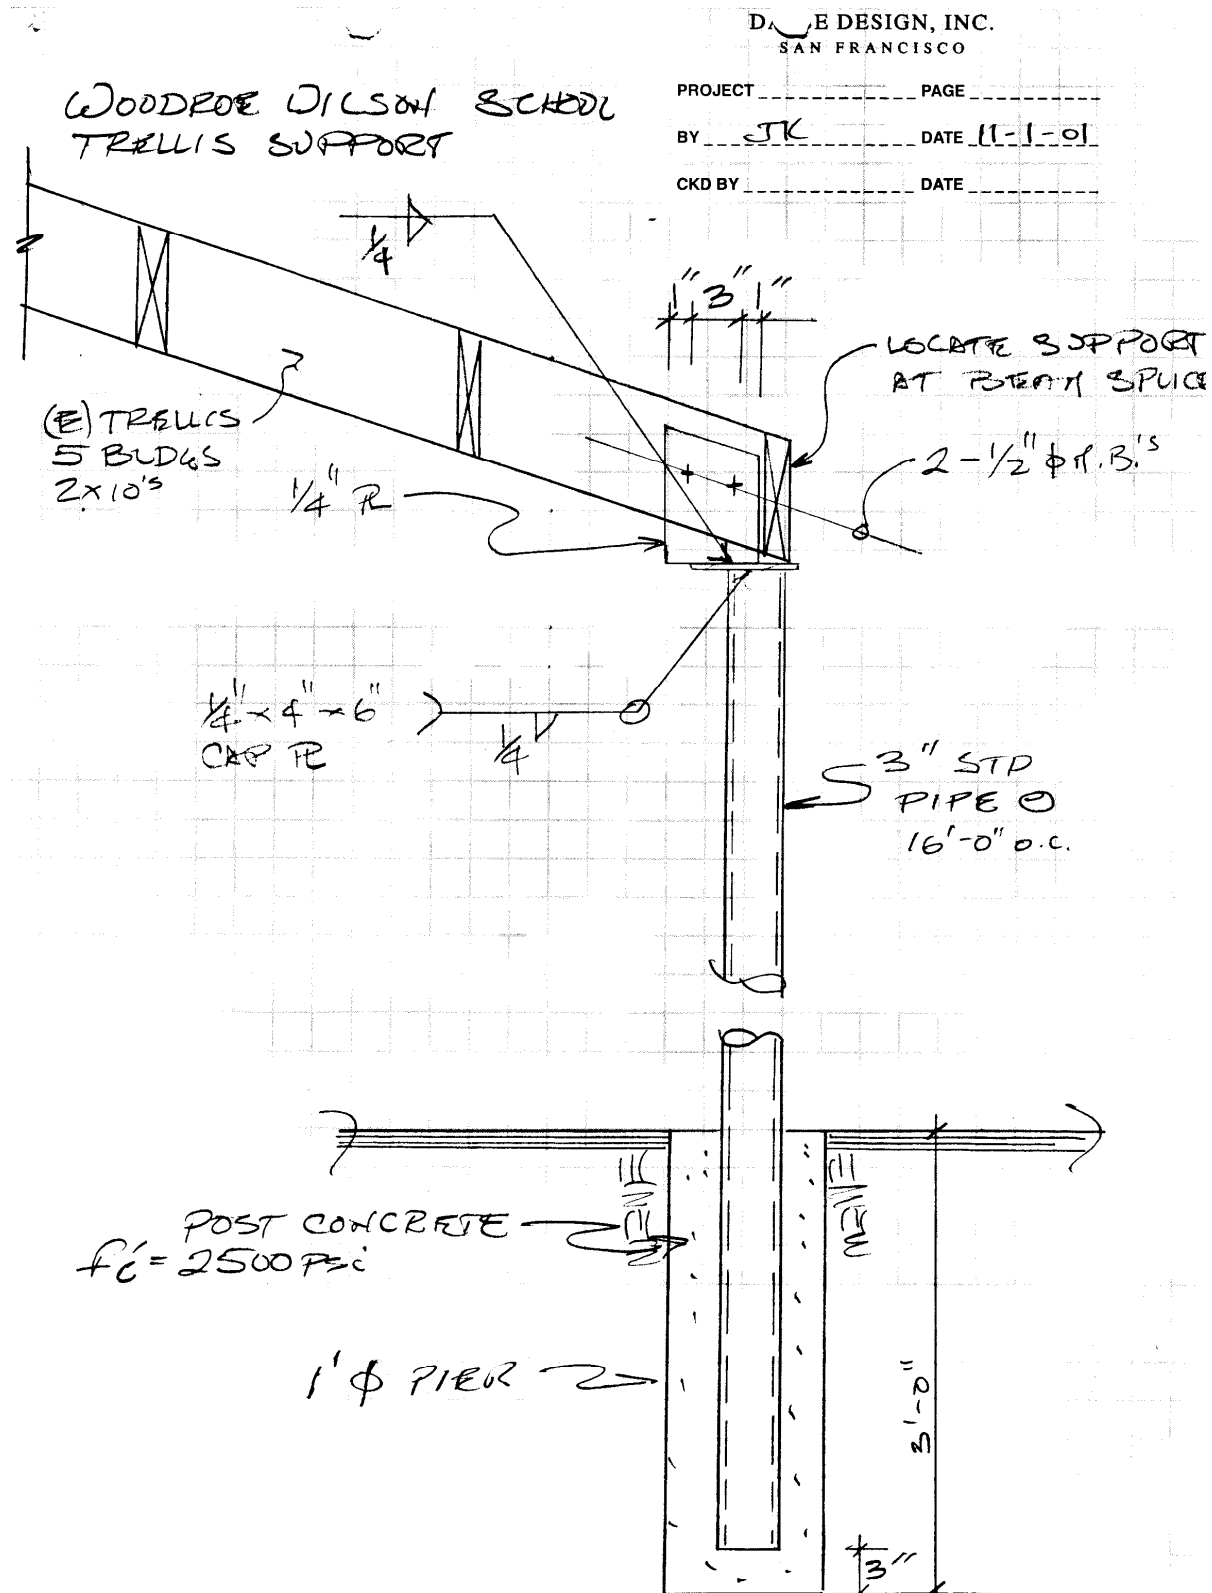
Figure 21: Proposed Retrofit Sketch for Trellis
