STRUCTURAL EVALUATION OF  
CRESPI MIDDLE SCHOOL  
WEST CONTRA COSTA UNIFIED SCHOOL DISTRICT  
(WCCUSD)

WLC Architects  
Kaiser Building  
1300 Potrero Avenue  
Richmond, CA 94804

DASSE Design, Inc.  
33 New Montgomery Street #850  
San Francisco, CA 94105  
(415) 243-8400

October 17, 2002

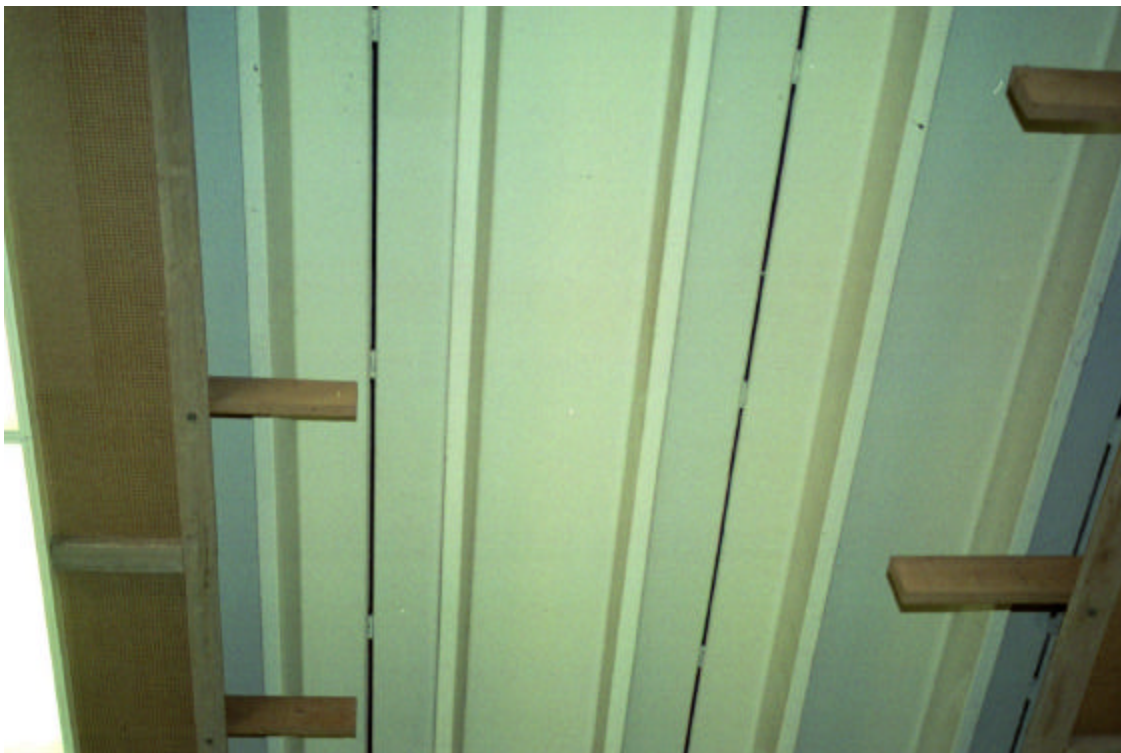
Figure 13: Cafeteria/music Building (Unit 5), interior pre-cast joist flange splice

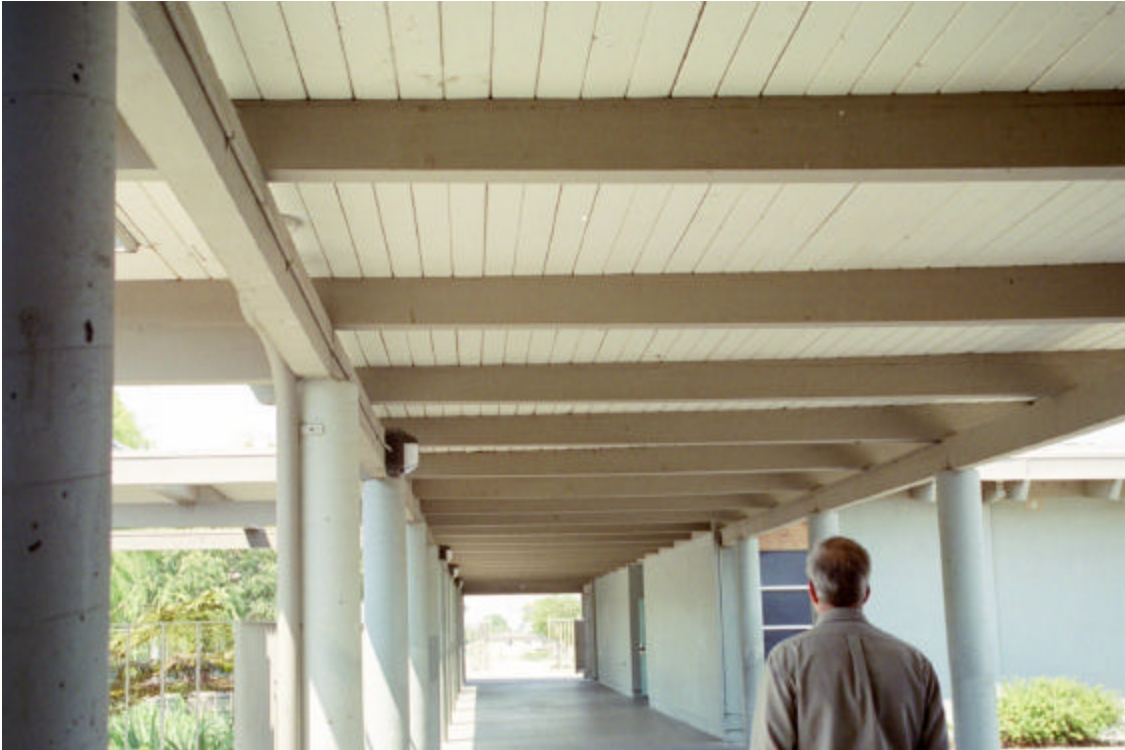
20.	Unit 8: Wood shear walls lack a positive connection to the foundation for the resistance of overturning forces at critical locations.
21.	Campus: Covered walkway structures are connected to multiple buildings and lack the capacity to withstand differential building displacements.

Figure 18: Covered Walkway, typical

21.	Provide new beam, columns, and footing to provide a secondary support of gravity loads at each connection of the covered walkway structure to an adjacent building.	1.9	2, 4, 6, 8, 9, 13, 15

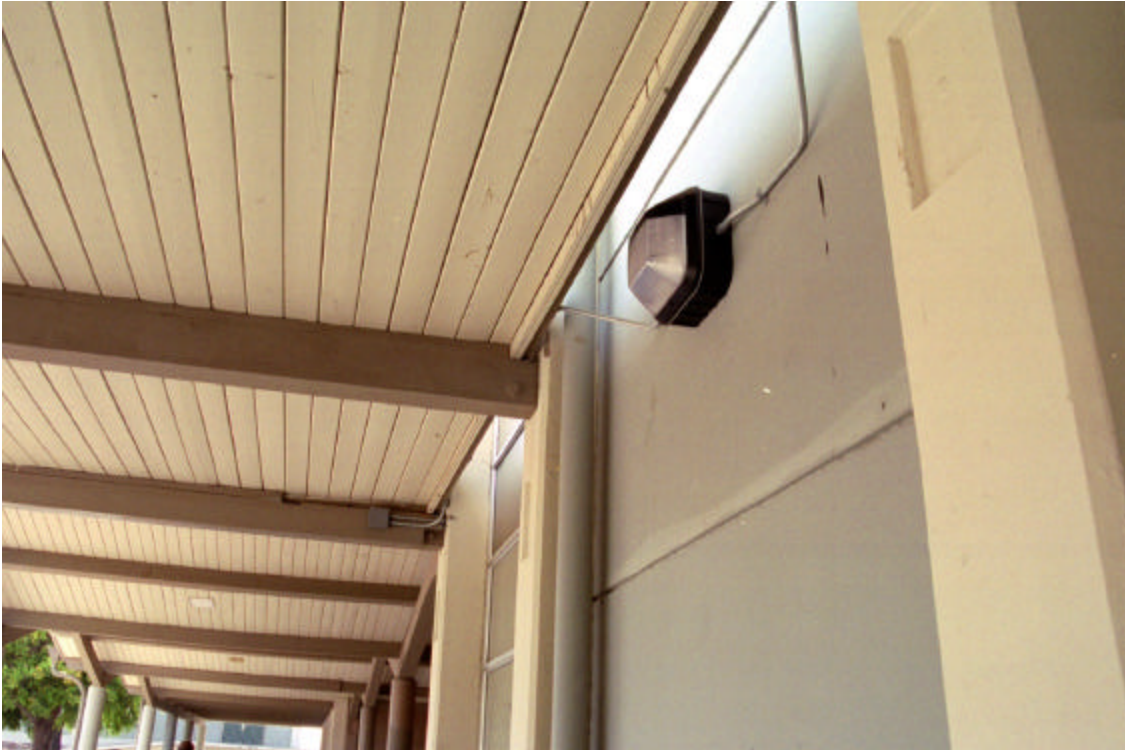
22.	Campus: Hard conduits connect multiple structures and lack the capacity to withstand differential building displacements.

Figure 19: Covered Walkway, hard conduit

22.	Provide new flexible conduit connections across seismic separation joints.	1.9	N.A.

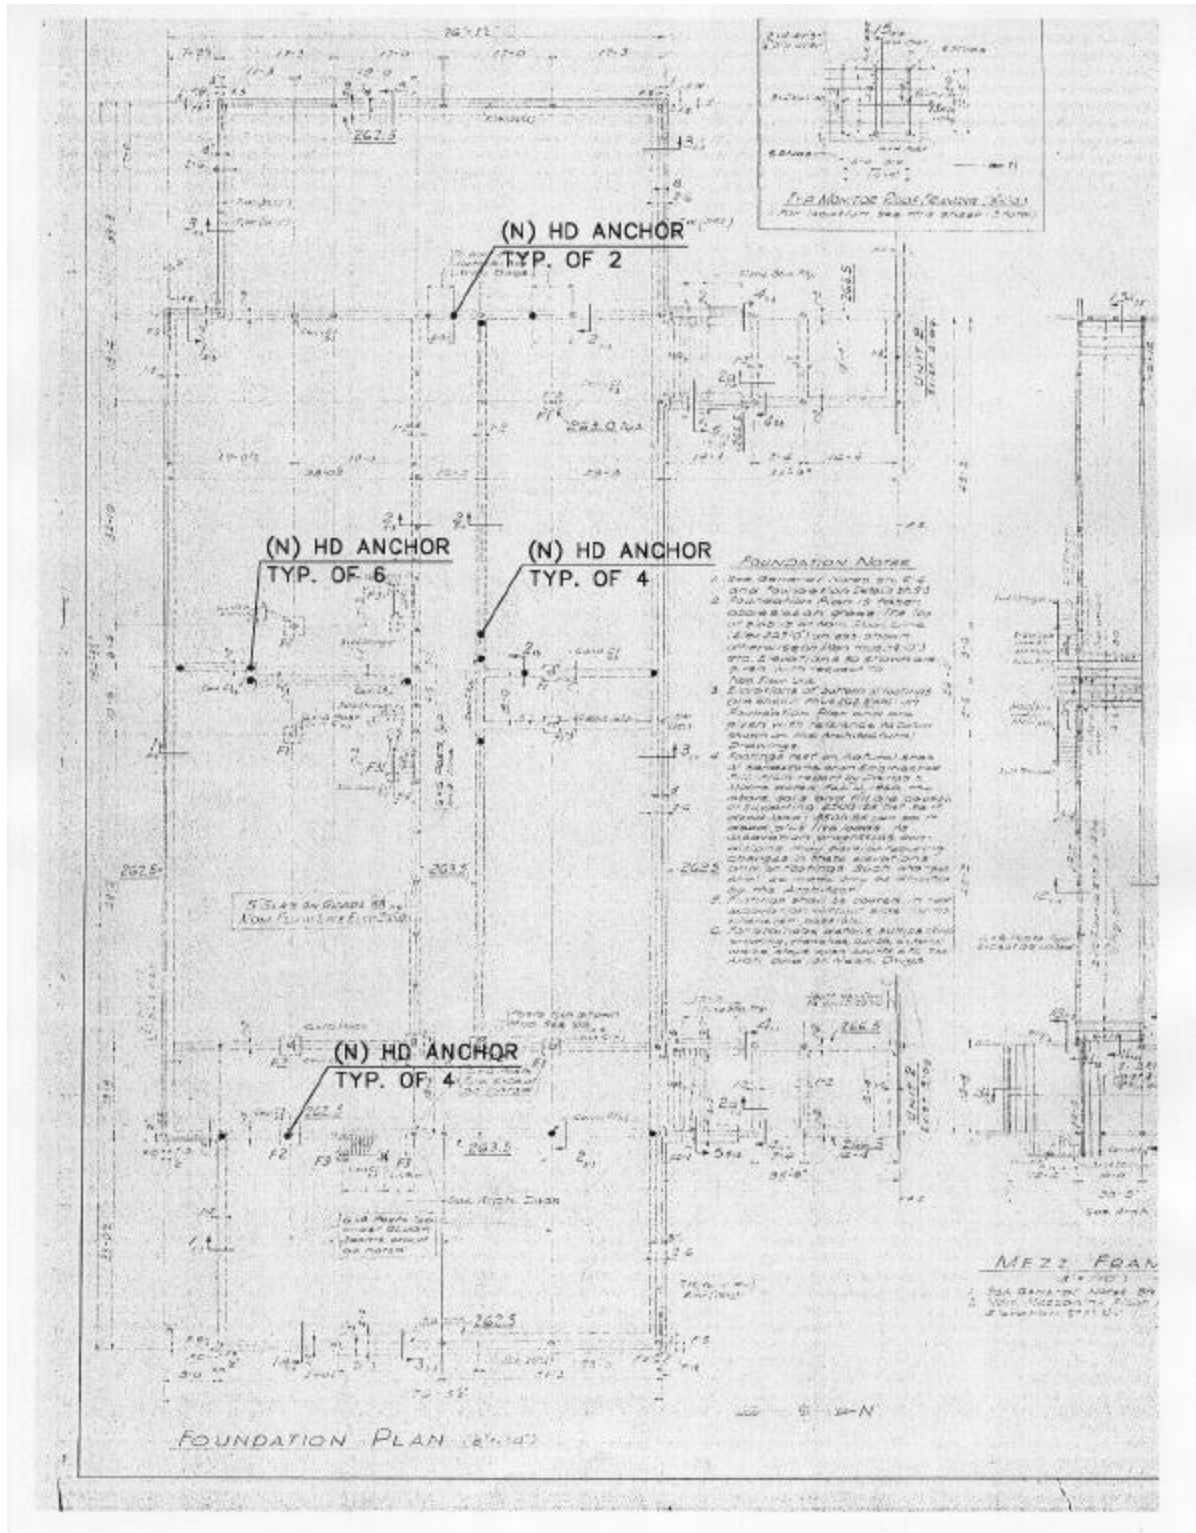
Drawing 1: Unit 1, Foundation Plan

2.	Unit 1: Wood shear walls lack a positive connection to the foundation for the resistance of overturning forces at critical locations.
3.	Unit 2: Wood collector elements and/or connections lack adequate strength to resist the expected seismic forces at critical locations.

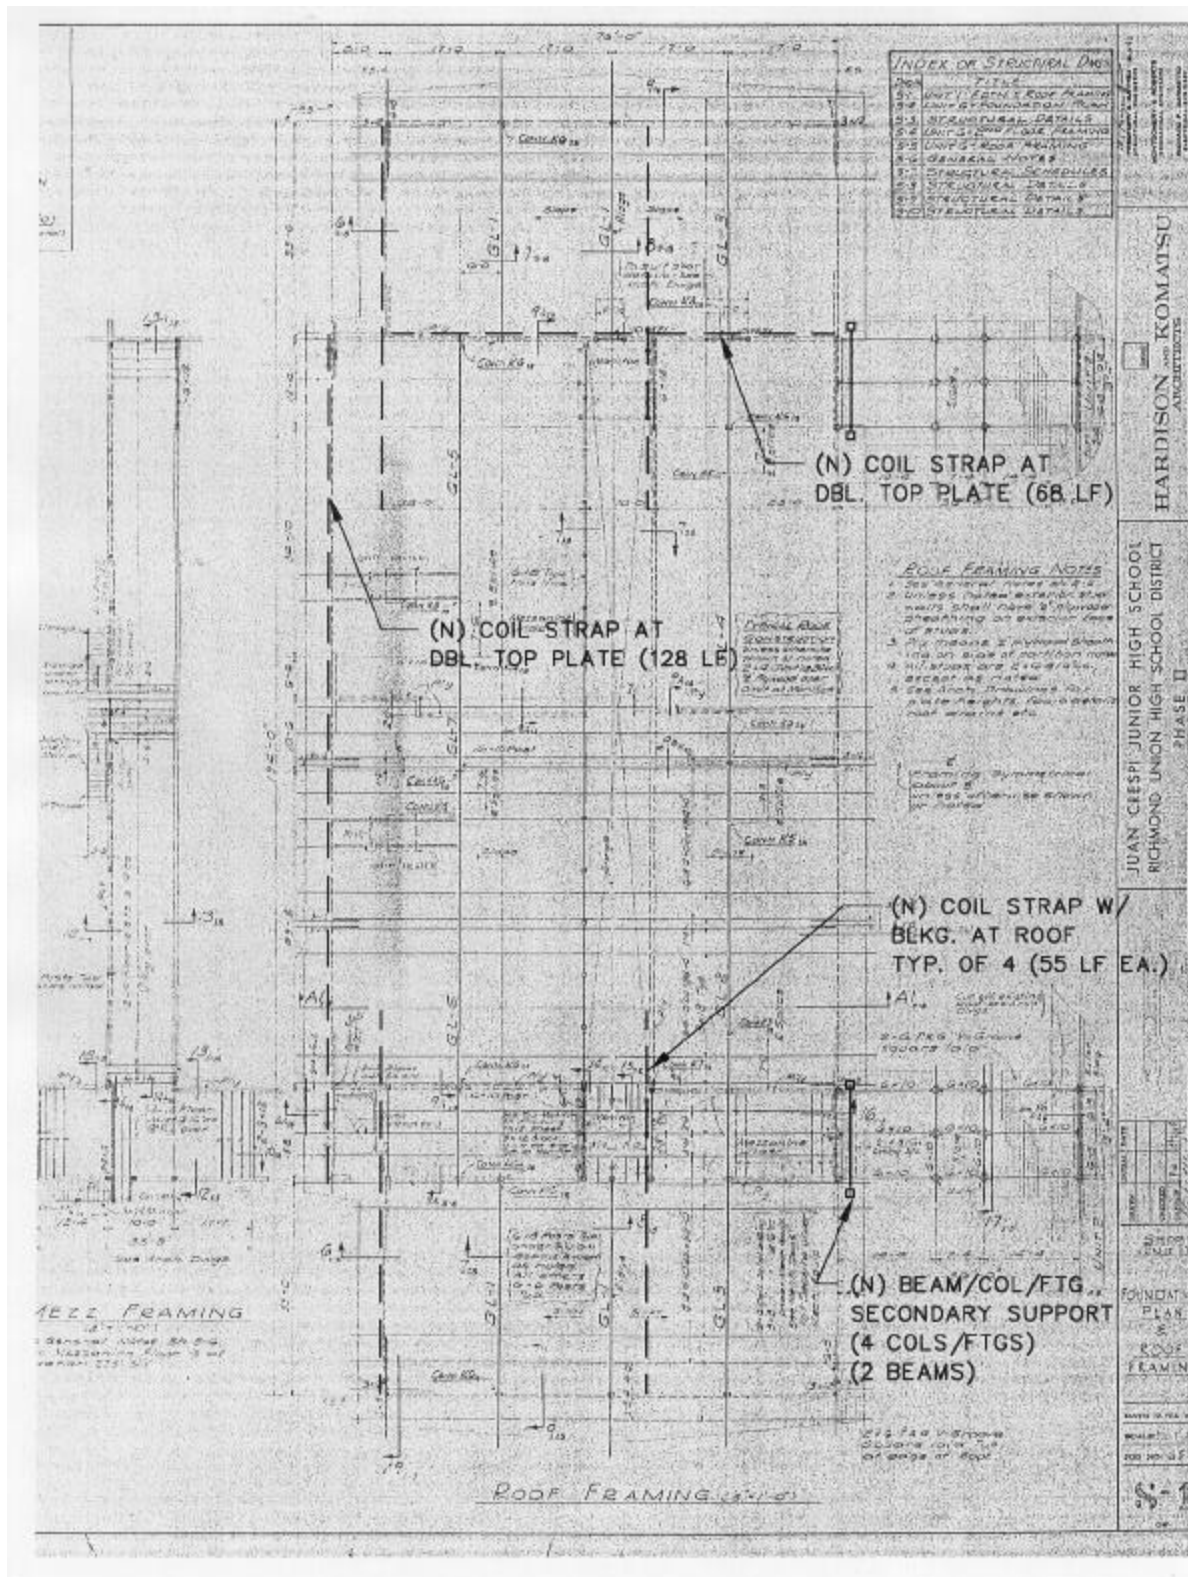
Drawing 2: Unit 1, Roof Framing Plan

Item	Building Structural Deficiencies
1.	Unit 1: Wood collector elements and/or connections lack adequate strength to resist the expected seismic forces at critical locations.

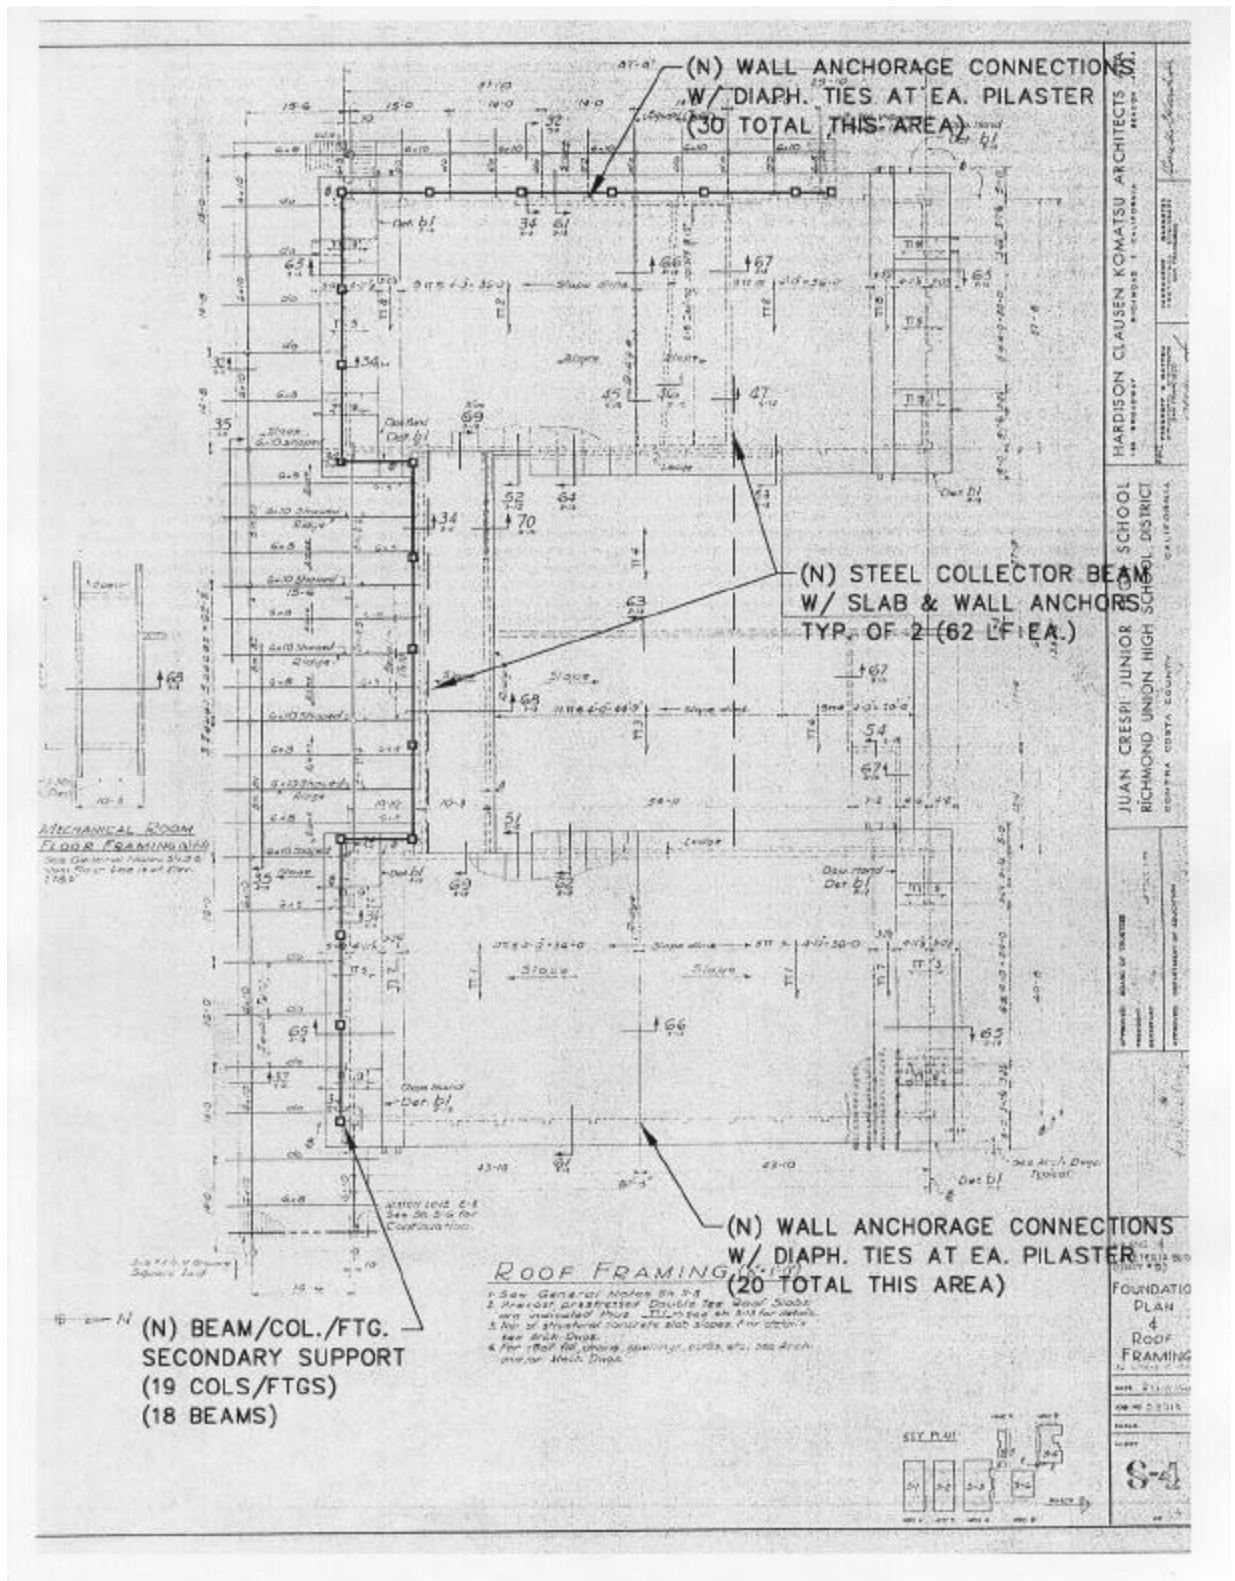
Drawing 9: Unit 5, Roof Framing Plan

10.	Unit 5: Chord/collector elements lack adequate strength to resist the expected seismic forces.
11.	Unit 5: Concrete wall anchorage connection lacks strength to transfer the expected out-of-plane seismic forces.

10.	Provide new steel chord/collector member with new anchors into shear walls and diaphragm.	1.2	9
11.	Strengthen concrete wall anchorage connection with new wall anchors and new diaphragm ties.	1.1	9

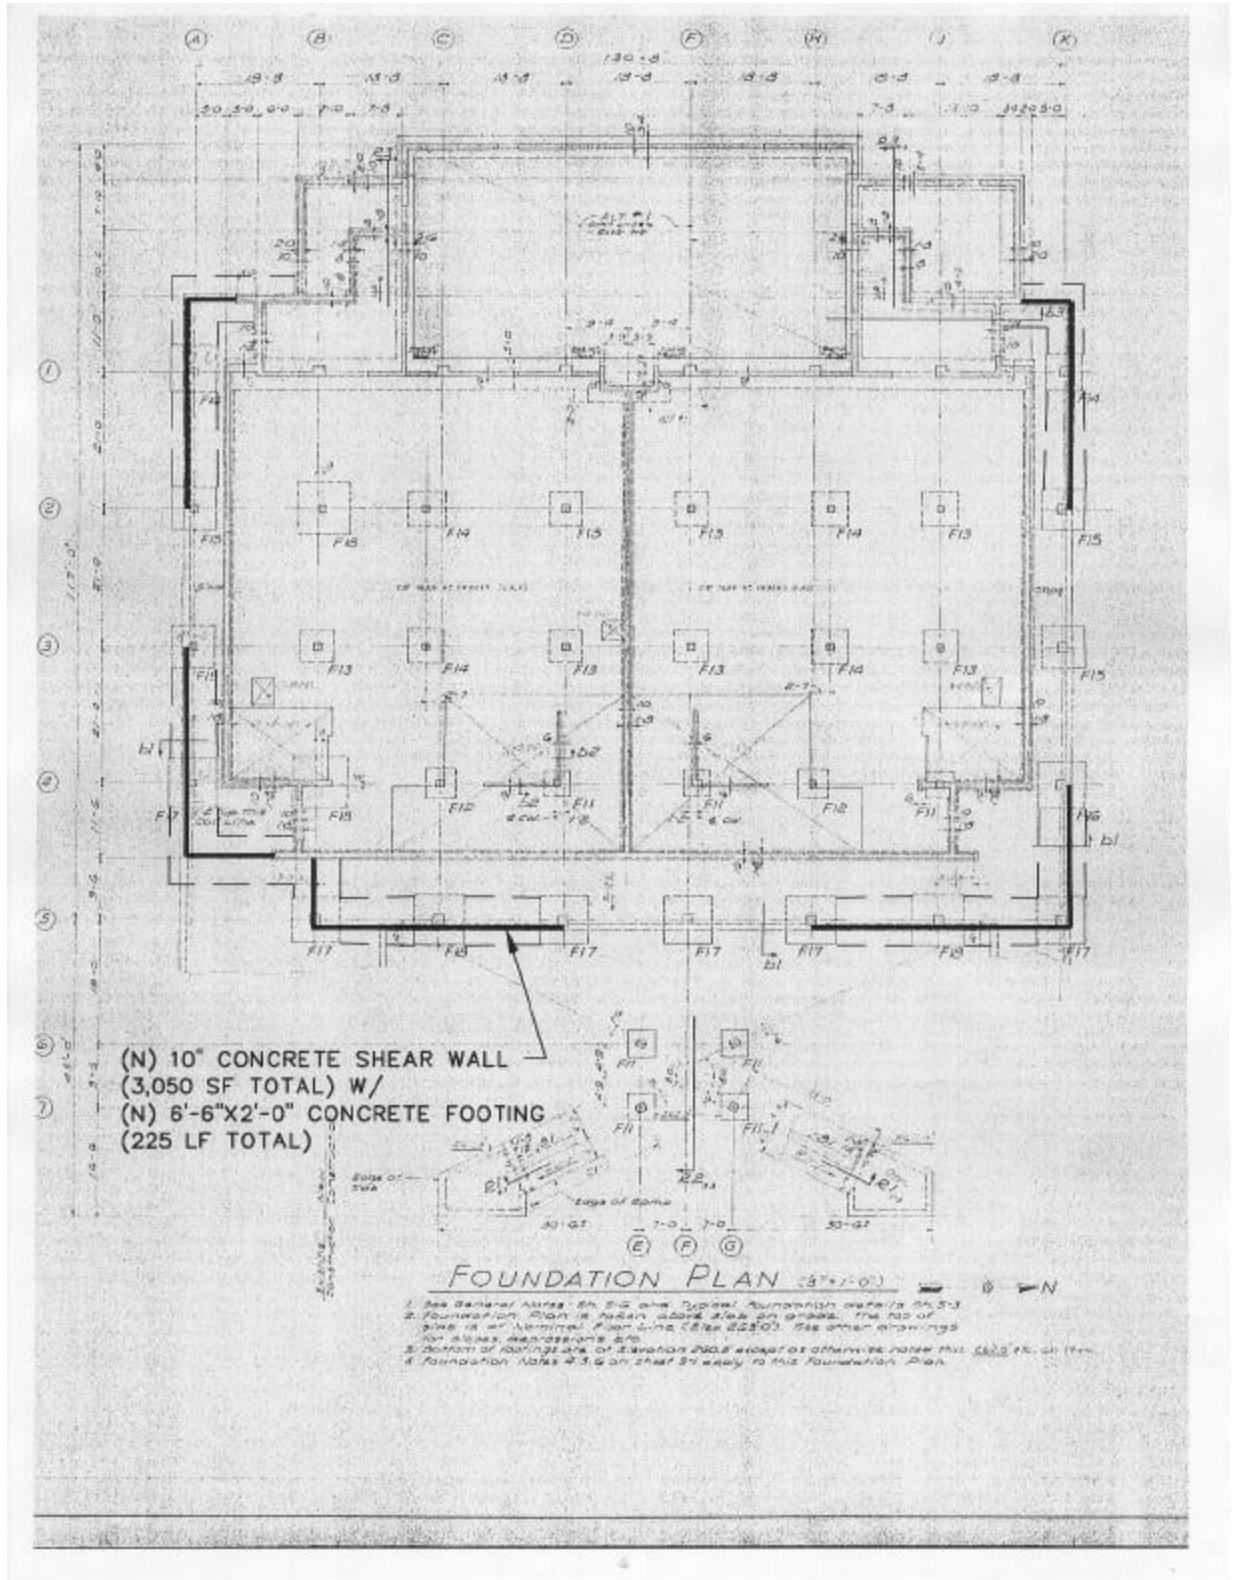
Drawing 10: Unit 6, Foundation Plan

12.	Unit 6: Out-of-plane offset in concrete shear walls creates a vertical discontinuity in the primary lateral force resisting system.

12.	Provide new concrete wall in-fill between existing columns at locations below the shear wall discontinuity. Provide new dowels into the existing concrete columns and wall above. Provide new concrete footings.	1.1	10

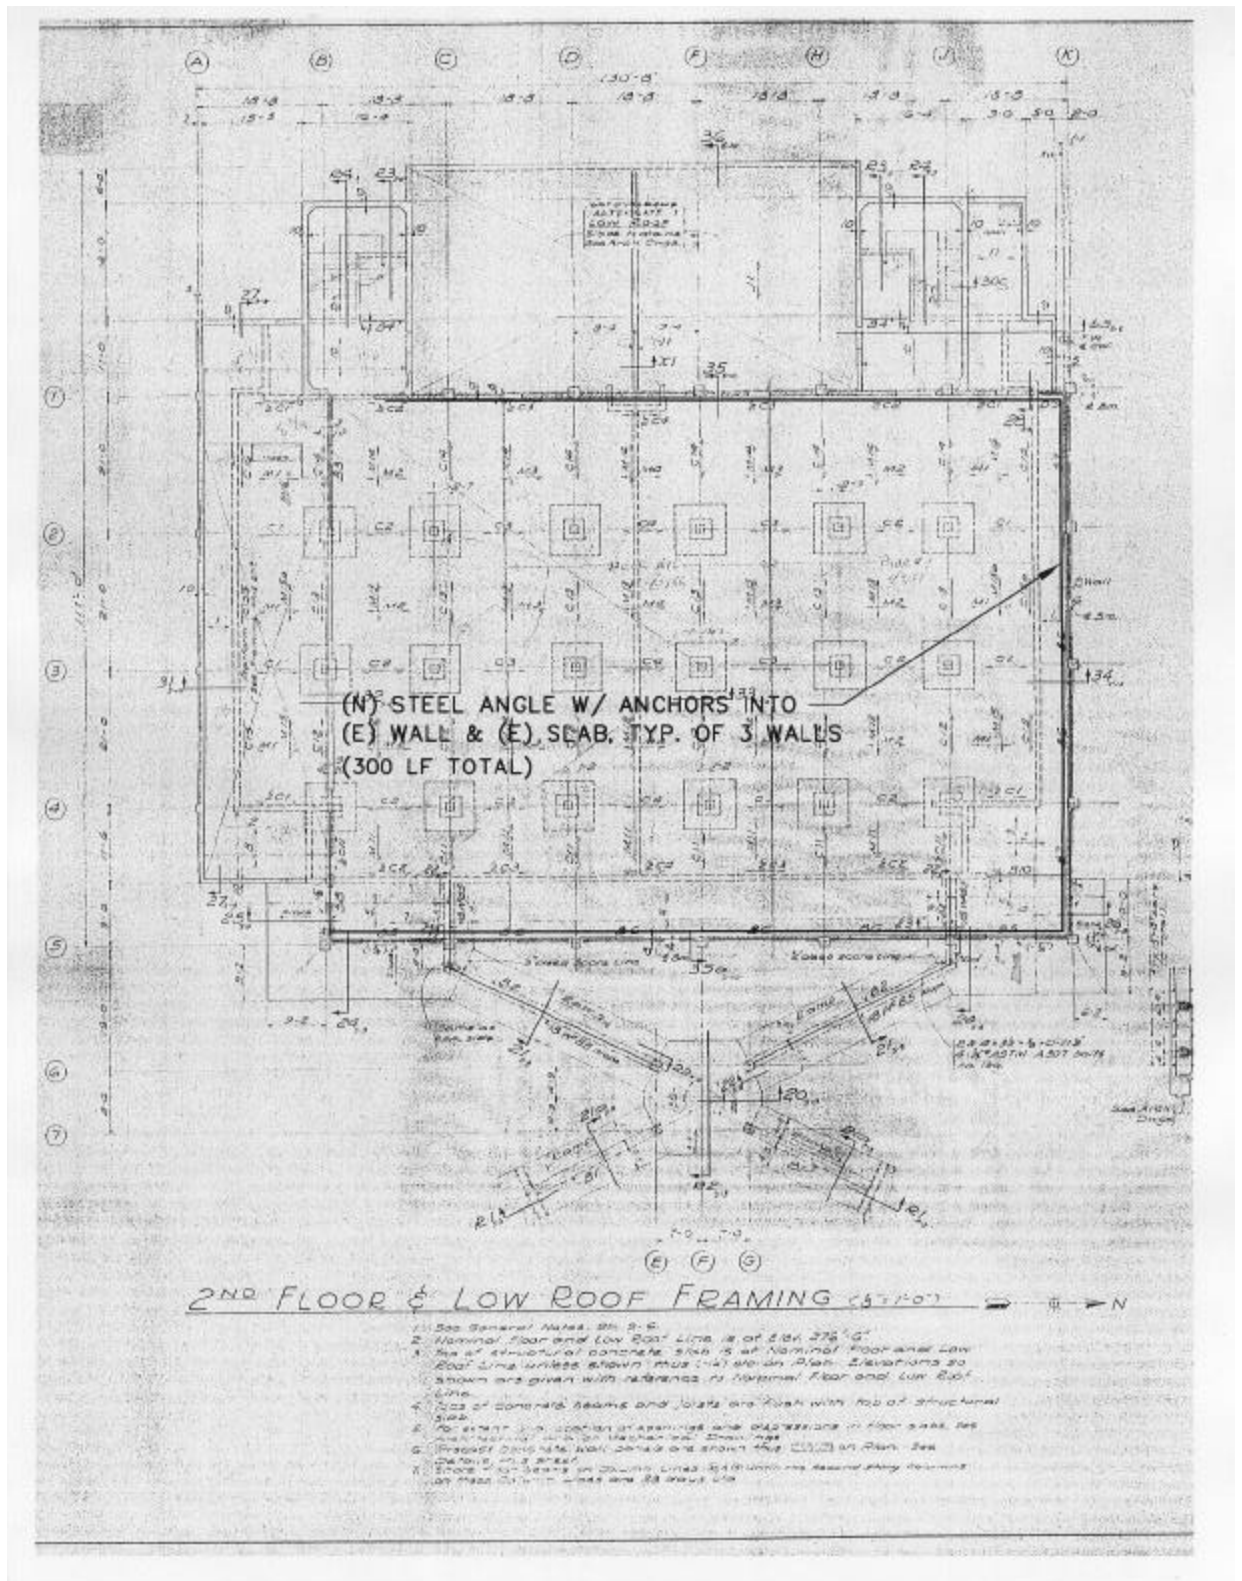
Drawing 11: Unit 6, Floor Framing Plan

Item	Building Structural Deficiencies
13.	Unit 6: Tilt-up concrete walls lack adequate load path for the transfer of seismic shear forces into the diaphragm or wall below.

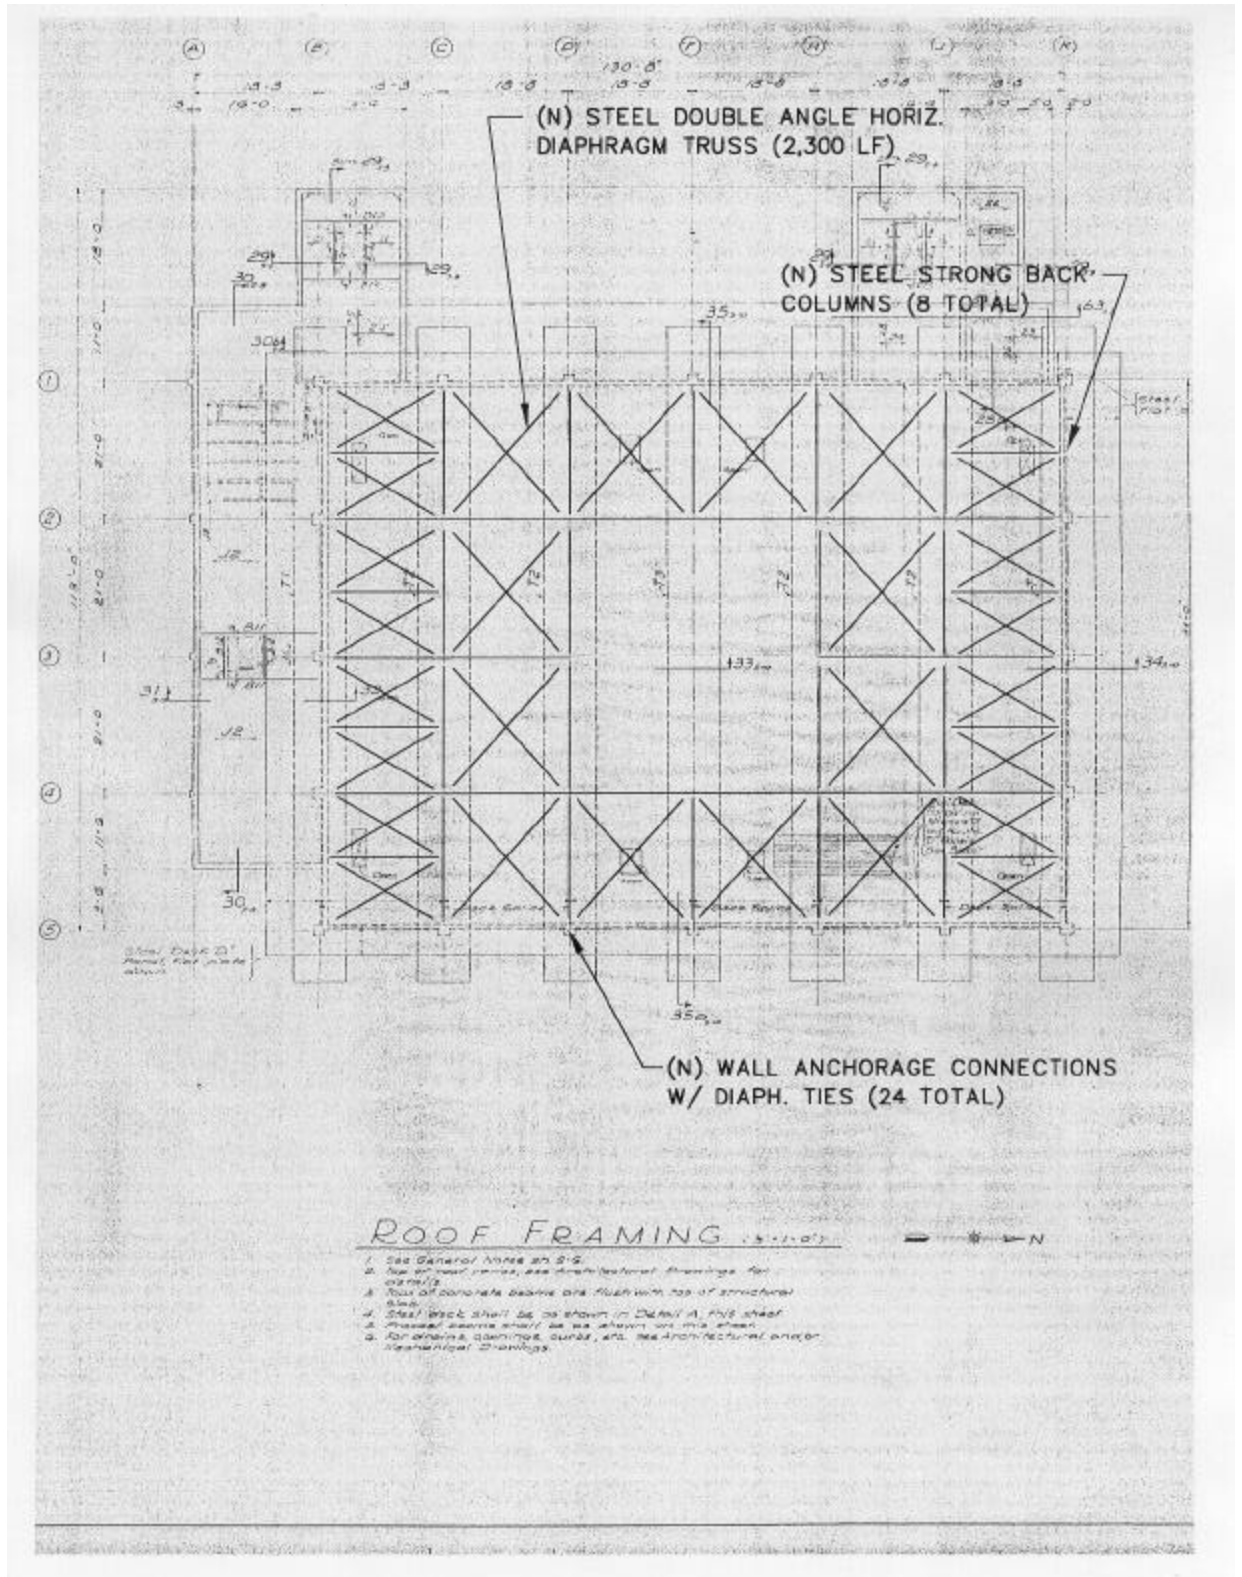
Drawing 12: Unit 6, Roof Framing Plan

14.	Unit 6: Metal deck diaphragm lacks adequate strength to resist the expected seismic forces.
15.	Unit 6: Concrete wall anchorage connection lacks strength to transfer the expected out-of-plane seismic forces.

16.	Unit 6: Concrete walls lack flexural strength to resist the expected out-of-plane seismic forces.
17.	Unit 7: Wood collector elements and/or connections lack adequate strength to resist the expected seismic forces at critical locations.

15.	Strengthen concrete wall anchorage connection with new wall anchors and new diaphragm ties.	1.1	12
16.	Provide new steel "strong backs" from the floor to roof diaphragm with anchors into existing concrete walls.	1.5	12

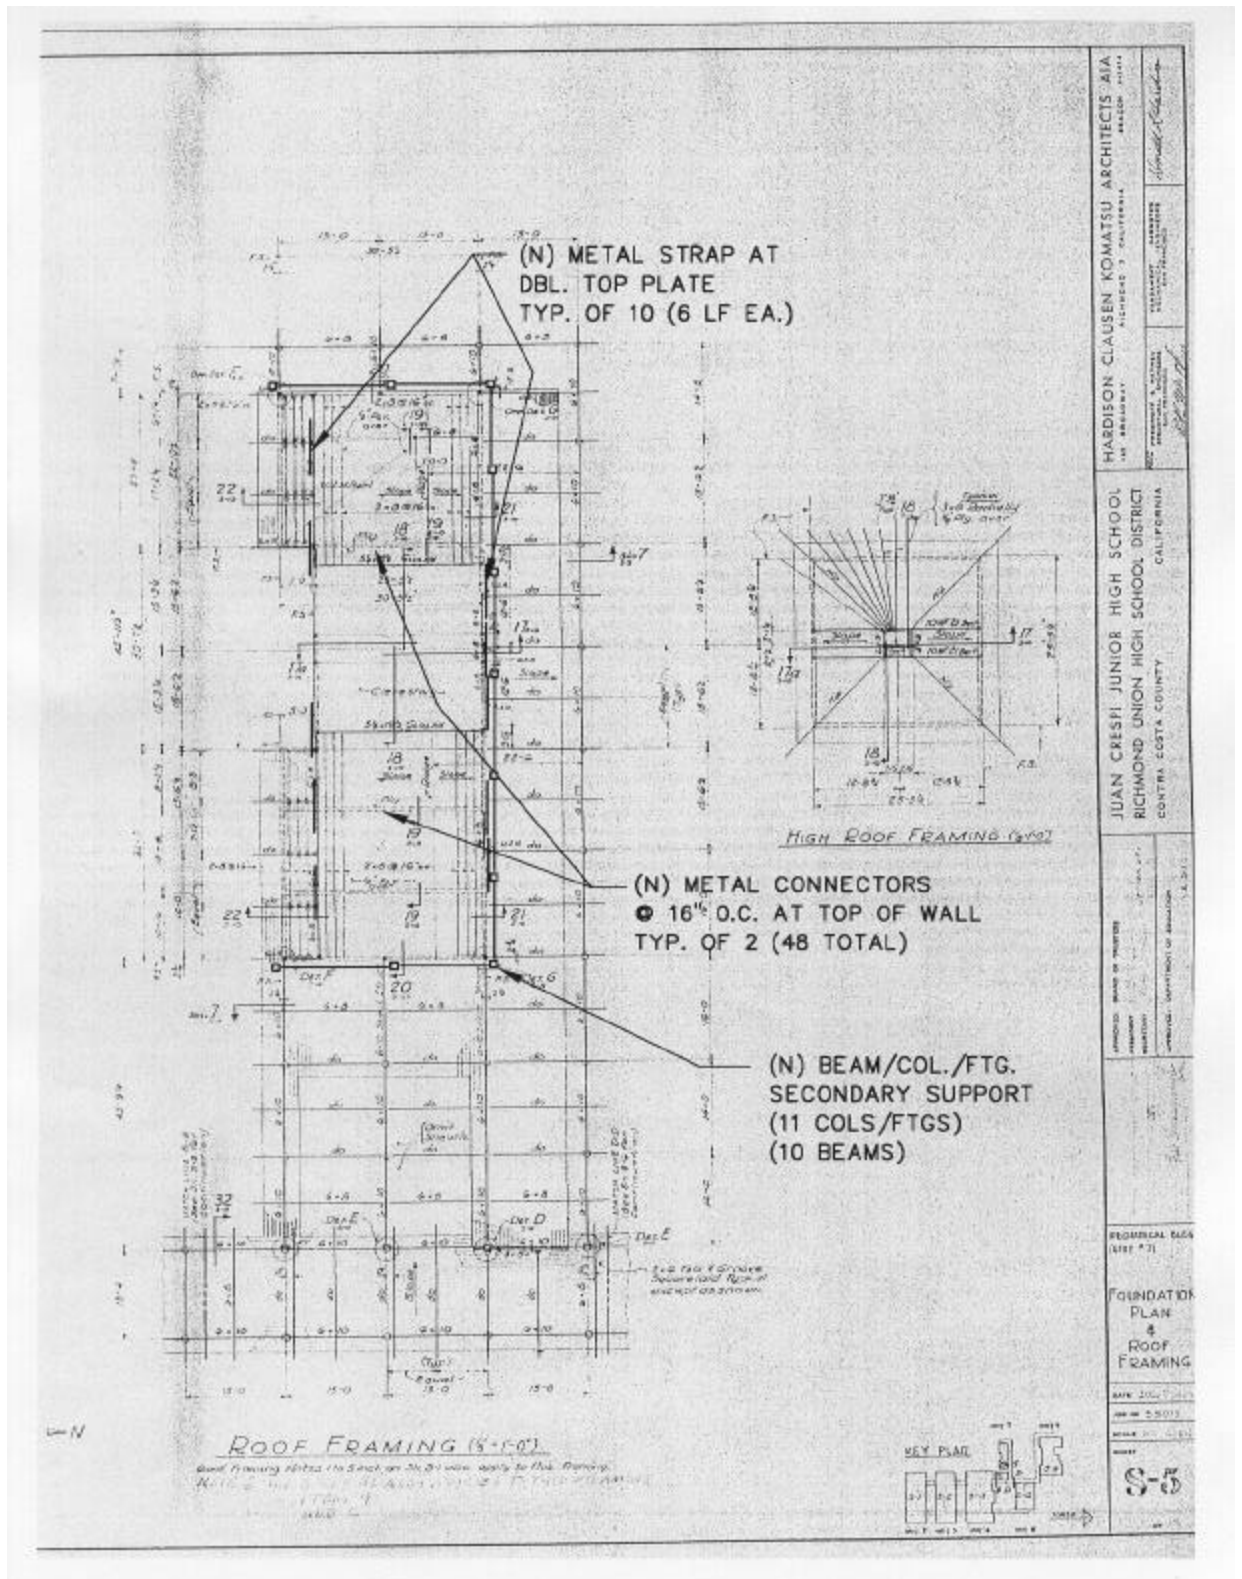
Drawing 13: Unit 7, Roof Framing Plan

18.	Unit 7: Diaphragm to shear wall connection lacks a complete load path or adequate strength to transfer the expected seismic forces.
19.	Unit 8: Wood chord elements and/or connections lack adequate strength to resist the expected seismic forces at critical locations.

17.	Provide new metal strapping, blocking, and/or collector beam at critical locations.	1.5	13
18.	Provide new metal connectors at inadequate connections.	1.5	13
