STRUCTURAL EVALUATION OF
DE ANZA HIGH SCHOOL
WEST CONTRA COSTA UNIFIED SCHOOL DISTRICT
(WCCUSD)

WLC Architects
Kaiser Building
1300 Potrero Avenue
Richmond, CA 94804

DASSE Design, Inc.
33 New Montgomery Street #850
San Francisco, CA 94105
(415) 243-8400

October 17, 2002

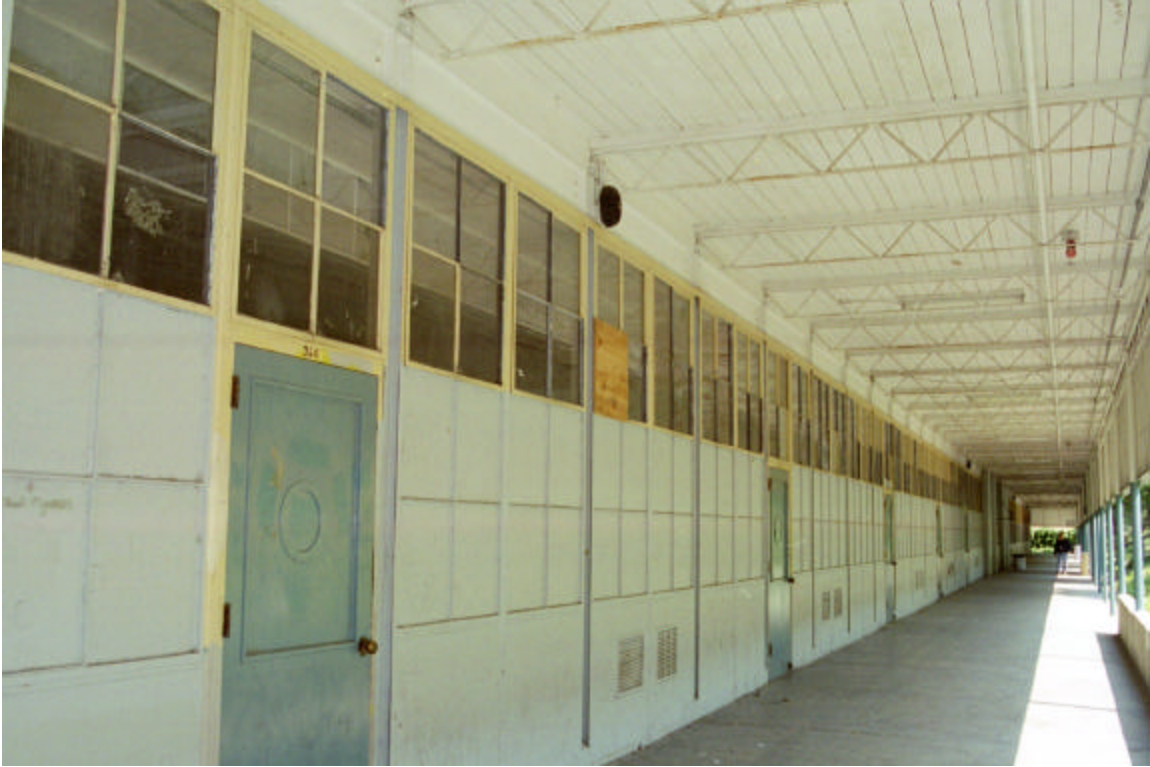
Figure 4: Side view of Classroom Building

of the building, there is a 12 ft wide covered walkway that is framed with open-web joists spanning between steel columns and open-web truss girders. These open-web joists have small bars as a bottom chord member and do not have any bridging to provide lateral stability (see figure 4).

9.	There is no lateral bracing of the bottom chords of the trusses at the attached covered walkways of the classroom buildings. This is a potentially unstable condition that could result in roof collapse.

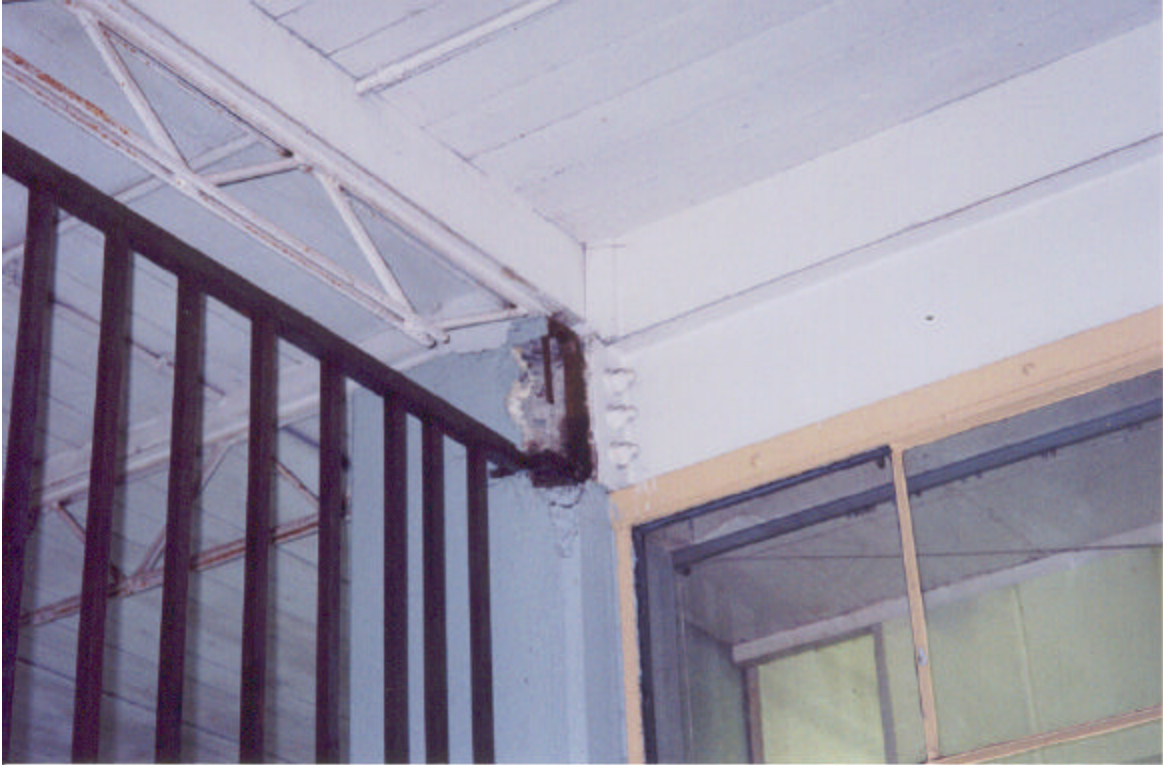
11.	At the classroom buildings, there are no collector elements at the corners of the courtyard area openings. This will result in tearing and possible collapse of a truss. There is some existing cracking of the pilasters supporting the trusses at the corners of the courtyard openings.

Figure 5: Cracking at truss support pilaster at Classroom Building, typical

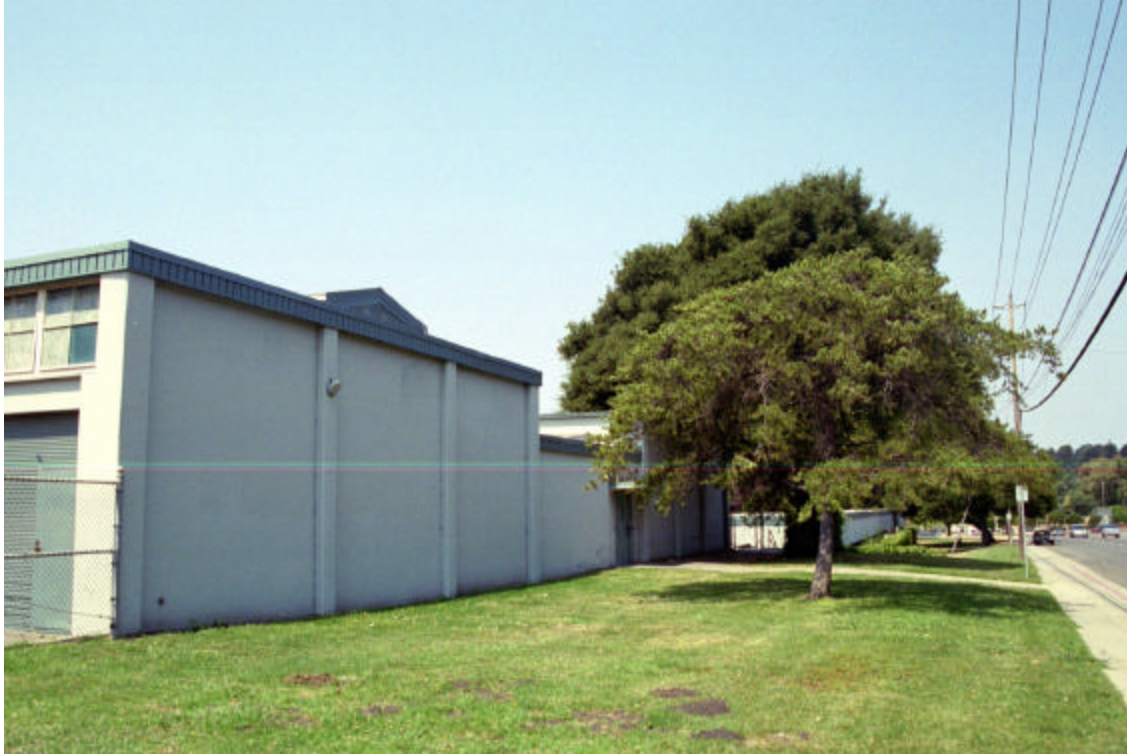
Figure 8: East end of Shop Building

The shop building has a multi-level roof profile. The outer sections of the roof are higher than the low area that runs longitudinally down the center of the building over the corridor (see figure 8). At one end of the building, the transverse shear wall is concrete and at the other end there is a wood-sheathed shear wall. There are visible cracks in the concrete end wall and pilasters and cracks in the stucco at the wood wall (see figures 9 and 10). Their locations at the change in roof height indicate that there may be some differential movement occurring between the high and low roof levels.

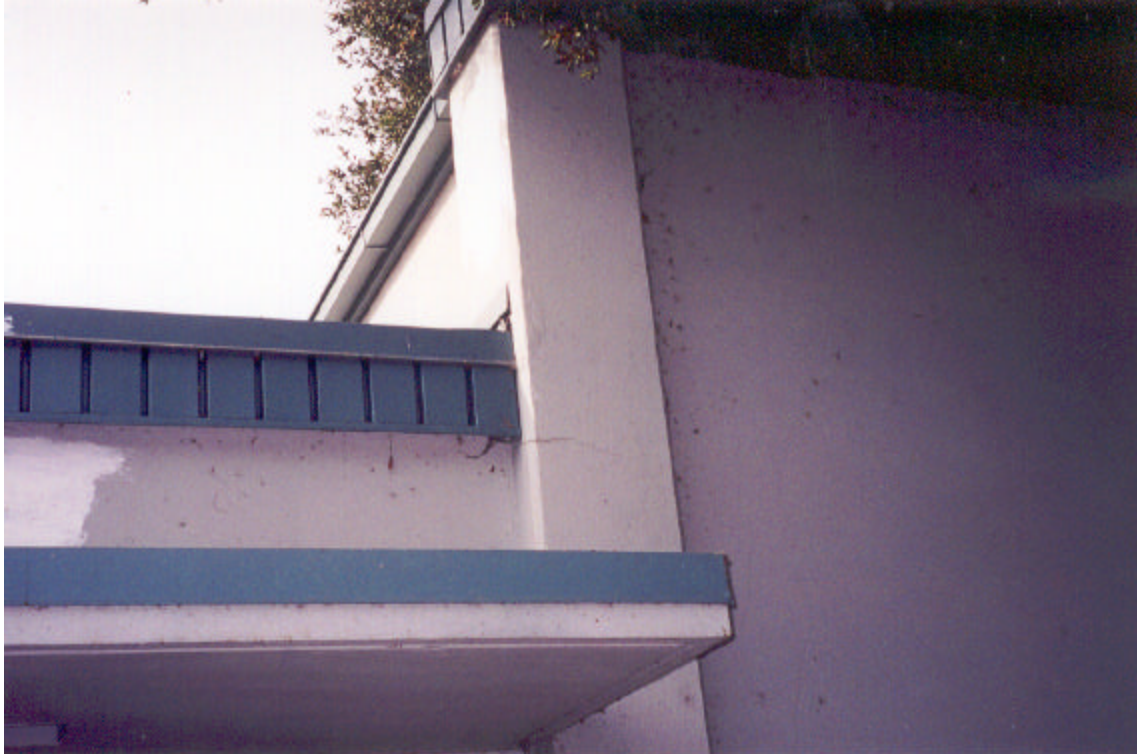
Figure 9: Cracks in the east concrete end wall of the Shop Building

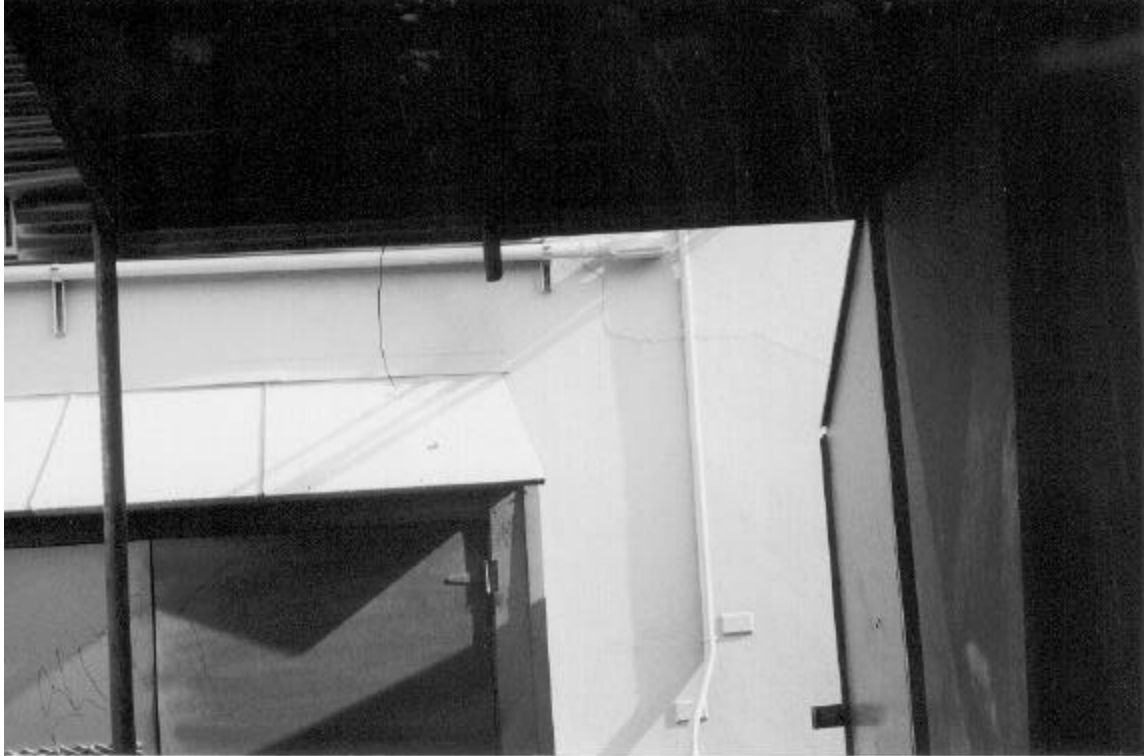
Figure 10: Cracks in the west wood-framed end wall of the Shop Building

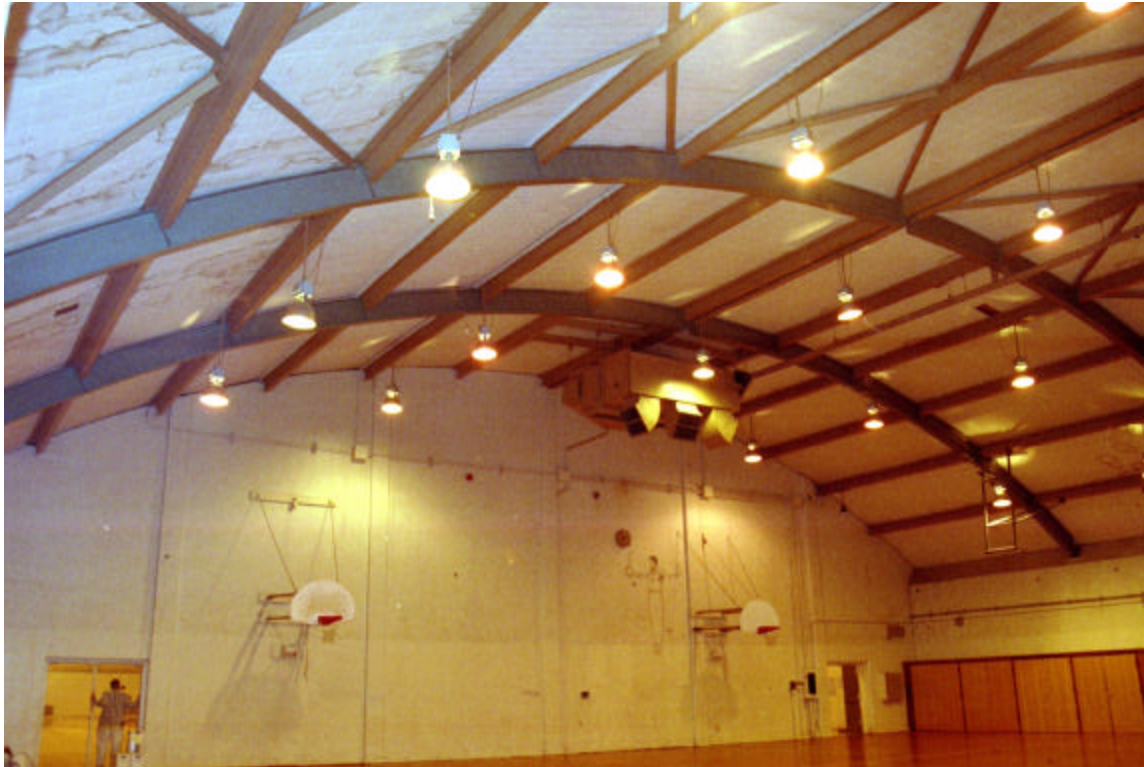
Figure 18: Vaulted ceiling in the Gymnasium

The gymnasium has a large barrel-vaulted open space with a wood roof and steel framing. The long skylight openings in the gymnasium roof have been infilled with straight sheathing over their entire length (see figure 18). The acoustical tile on the ceiling of the gymnasium shows evidence of water damage, primarily along the south side but also at the north side as well (see figure 19). The locker rooms have concrete shear walls and concrete roof diaphragms (see figure 20). There are some minor vertical shrinkage cracks and diagonal cracks near the corners of wall openings in the locker room and gymnasium concrete walls (see figure 22). Some of the skylight openings in the locker room areas have been infilled with plywood sheathing.

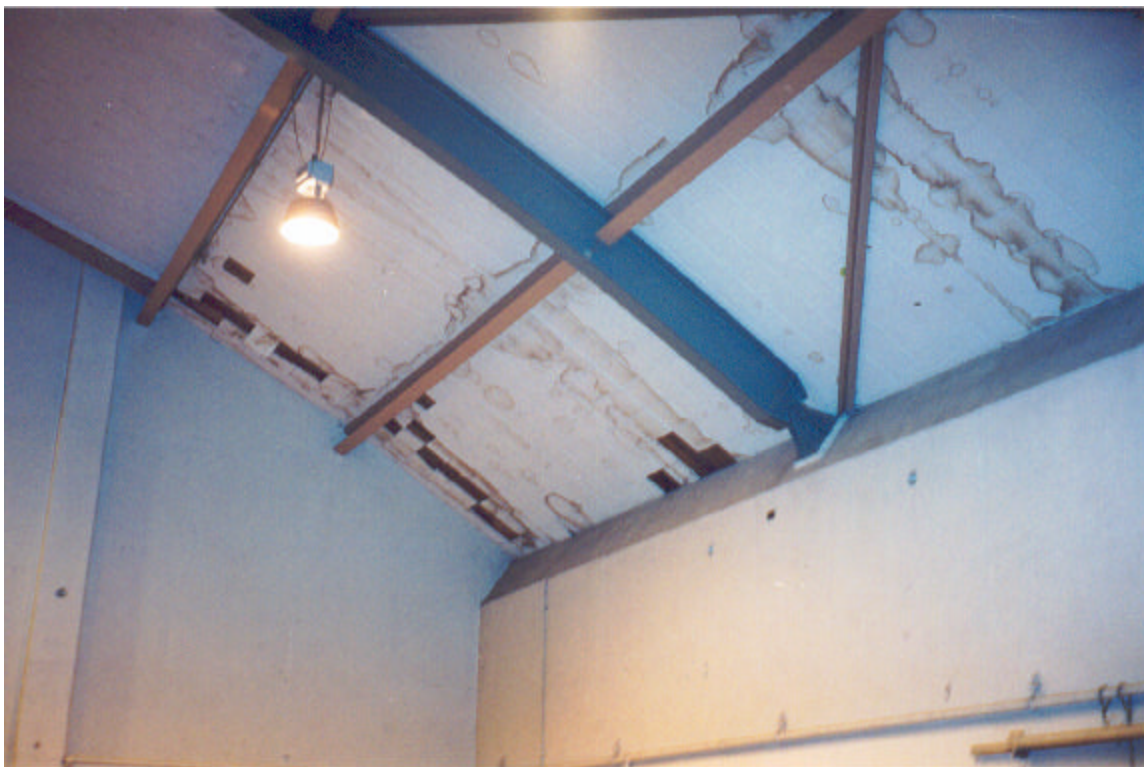
38.	There is water damage to the acoustical tile ceiling in the gymnasium. This may indicate damage to the roof sheathing as well. Deterioration of the support members may result if not attended to.

Figure 19: Water damage at the vaulted ceiling in the Gymnasium

38.	Repair the leaking roof and replace any deteriorated roof sheathing.	3.0	10
39.	Provide new secondary support columns and beam to prevent loss of vertical support.	1.3	10

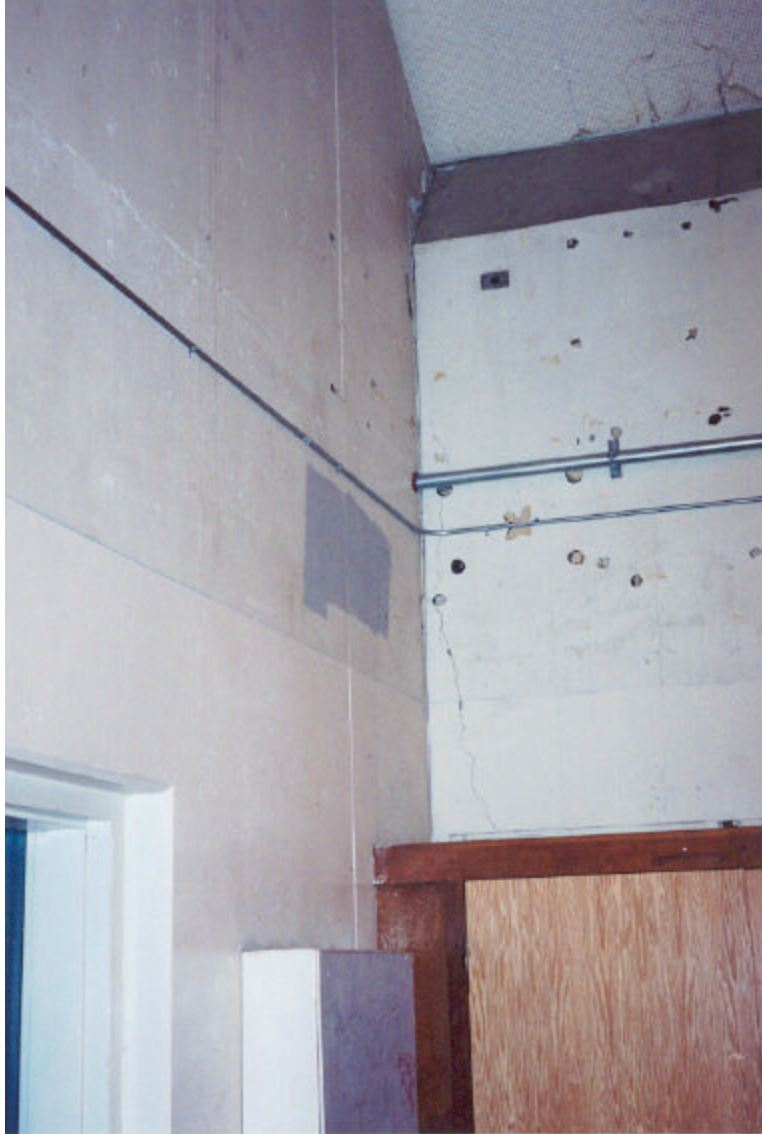
Figure 22: Cracks in the Gymnasium walls, typical

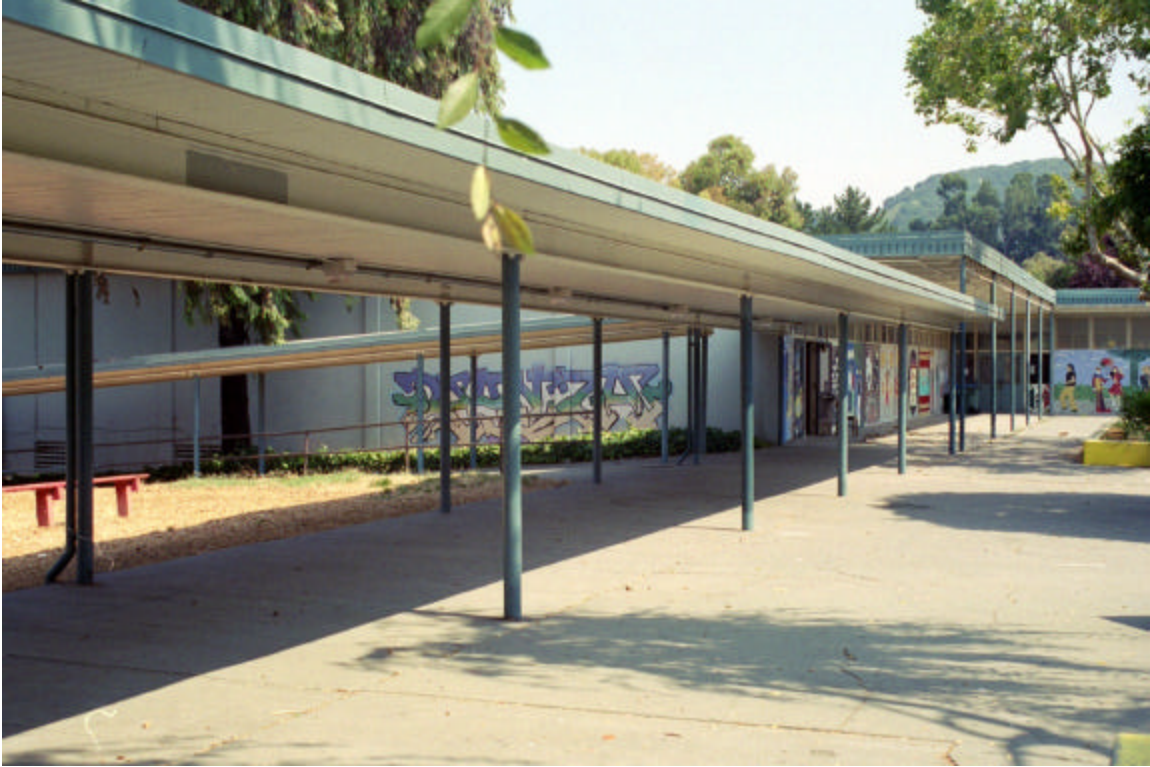
Figure 23: Covered walkway, typical

There are covered walkways attached to the buildings that interconnect all of the main buildings, as well as some freestanding covered walkways as well (see figures 21 and 23). The attached walkways are contiguous with the building roof framing at the gymnasium, classroom, and administration and library buildings. There are seismic separations between the covered walkway and the shops building and cafeteria. At the locker rooms, the covered walkway relies on a ledger connection for gravity support (see figure 24). The original construction drawings call for the covered walkway to be supported by a steel beam and two columns at each location where the existing ledger connections exist. This represents a life safety hazard because wood ledgers may fail due to cross-grain tension and the a section of the covered walkway might collapse.

Item	Building Structural Deficiencies
1.	Throughout the campus, the covered walkways are connected at each end to buildings. As the buildings move independently, the walkway may tear away and collapse.

Item	Recommended Remediation	Priority	Drawing Number
1.	Provide supplemental supports adjacent to each building so that damage will not lead to the collapse of the walkway. Reroute conduits and piping so that it is not supported by covered walkways or provide flexible connections.	1.2	None

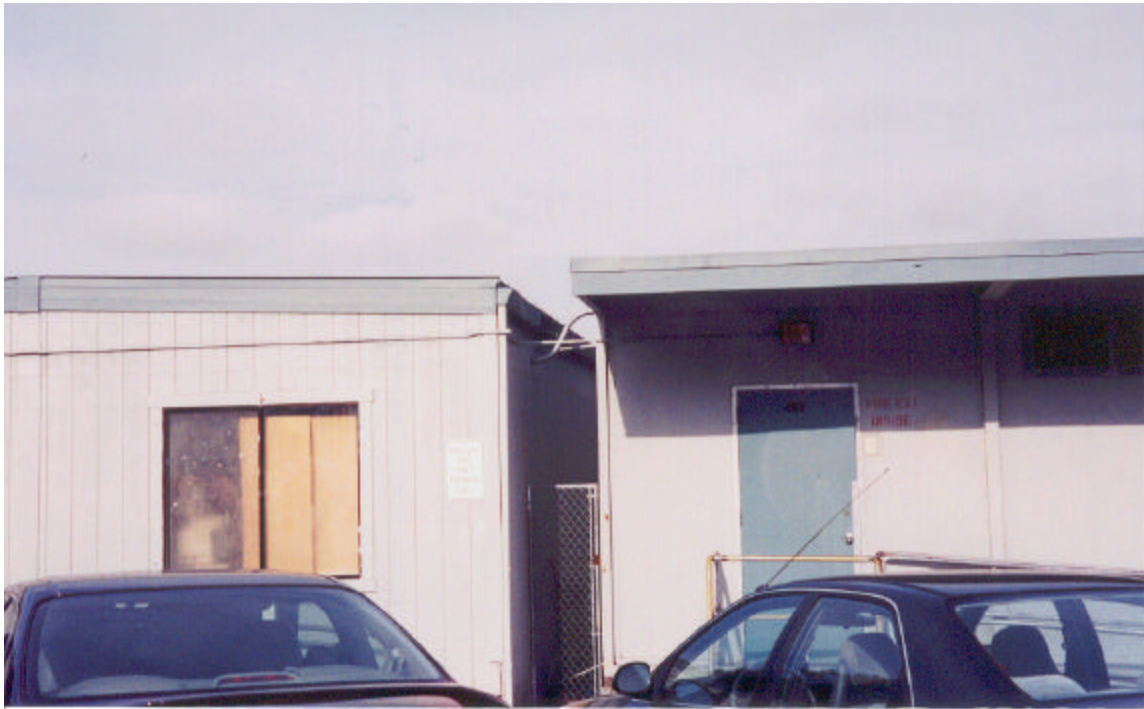
Figure 27: Conduit running between portable classrooms, typical
