STRUCTURAL EVALUATION OF
HELMS MIDDLE SCHOOL
WEST CONTRA COSTA UNIFIED SCHOOL DISTRICT
(WCCUSD)

DRAFT
October 17, 2002

DASSE Design Project No. 01B300x2

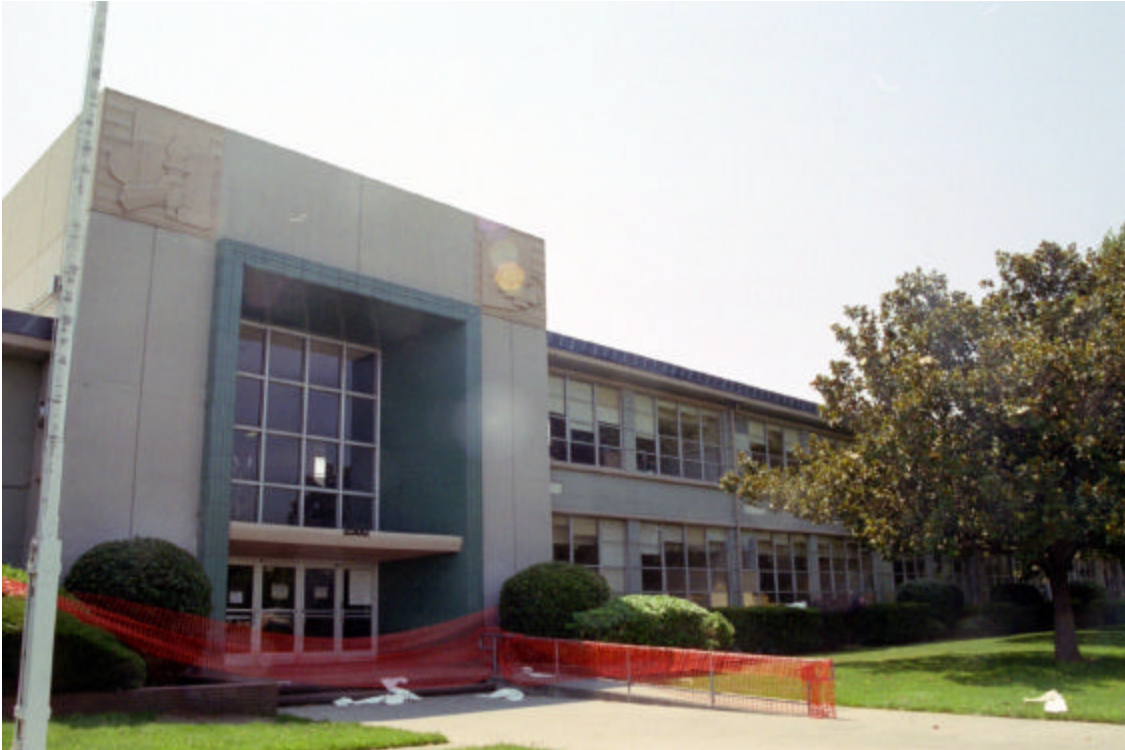
Figure 3: Main Building, wing 1, exterior north wall

direction at both the exterior and corridor walls. The typical classroom configuration has tall windows at the exterior wall and high windows over lockers at the corridor wall. At the second level, these high windows open to the outside over the lower corridor, while at the lower level the high windows open into the corridor. The classroom corridors have glass block windows at the lower level, and smaller window openings at the second level. At the corridors connecting the various rooms, large windows are found facing into the courtyards, while the outside walls tend to have more solid wall. The interiors typically have a suspended T-bar ceiling in the classrooms, and an acoustical tile ceiling in the corridors. No seismic joints were observed in the corridors, and hard conduits run the length of these corridors without compensation for the potential differential movement of the various building wings. This condition is considered a life safety hazard. The excessive lengths of windows found at the longitudinal walls of the classroom wings of the main building, indicate a severe deficiency in the strength of the structure to resist the expected lateral forces, and are also perceived to be life safety hazards. The classroom wings of the main building are shown in figures 3, 4, 5, 10, and 11.

Item	Building Structural Deficiencies
1.	Main Building, Wing 1: Concrete frames lack adequate shear strength and ductility to resist the expected seismic forces.

Item	Recommended Remediation	Priority	Figure Number
1.	Provide new concrete shear walls with dowels into the	1.0	3, 10, 11

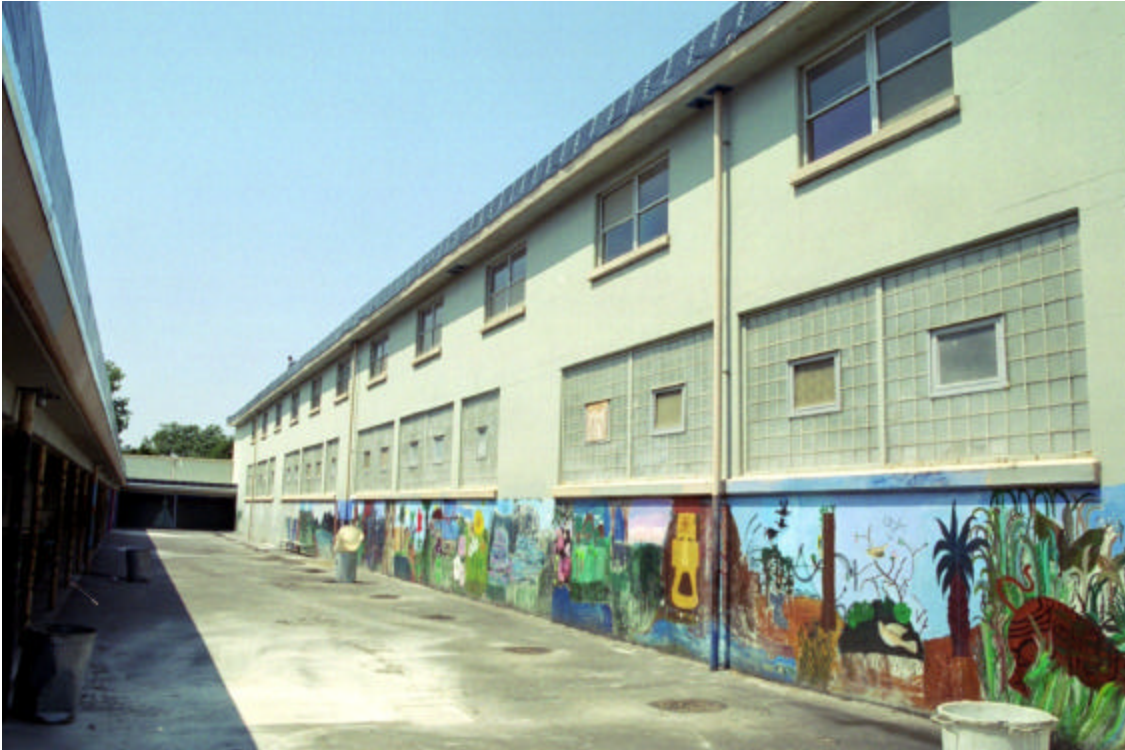
Figure 5: Main Building, wing 4, exterior south wall

6.	Main Building, Wing 3: Chord/collector reinforcing and/or splices lack adequate tensile strength to resist the expected seismic forces.
7.	Main Building, Wing 4: Concrete frames lack adequate shear strength and ductility to resist the expected seismic forces.

6.	Provide new steel chord/collector member with new anchors into shear walls and diaphragm.	1.2	N.A.
7.	Provide new concrete shear walls with dowels into the existing concrete columns and beams. Provide new concrete strip footings at the foundation.	1.0	5, 10, 11

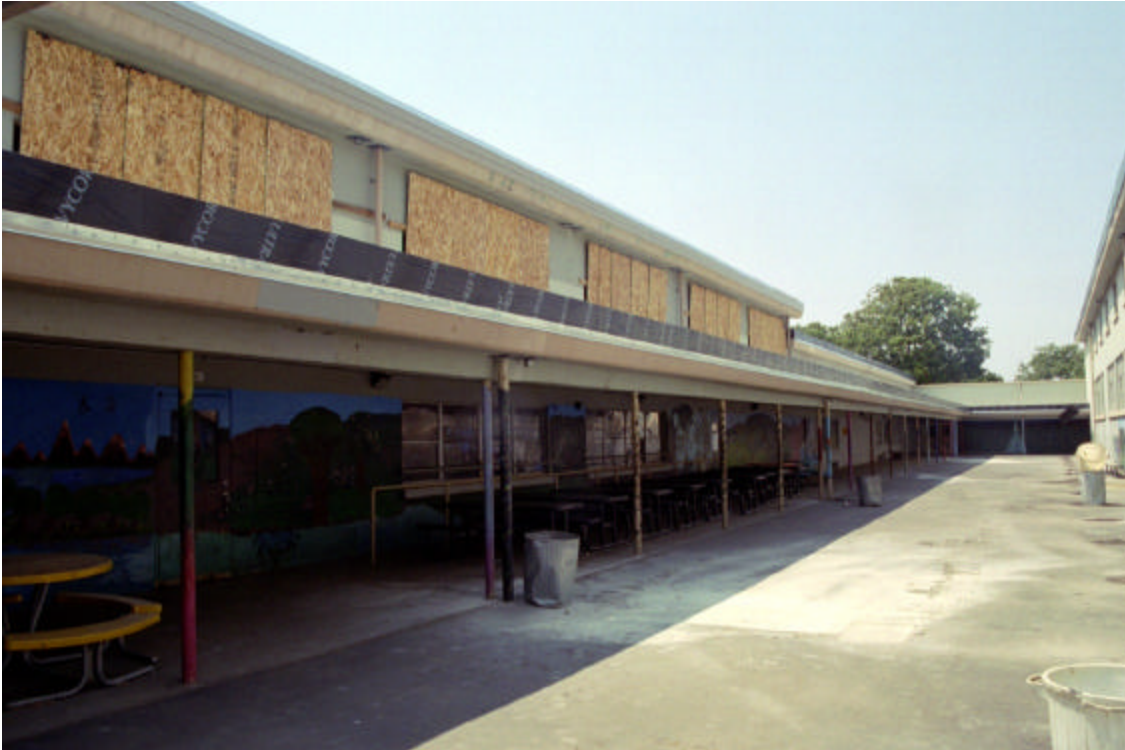
Figure 7: Main Building, wing 5, exterior north wall

Also part of the main building, the cafeteria wing is a single story with a covered walkway supported by steel pipe columns on the north side. The large cafeteria room has a plaster ceiling, and the walls have an interior plaster finish. An additional dining area to the east of the large room is also supported by steel pipe columns that have been infilled with windows, masonry, and concrete. At the time of the initial site observation, the re-roofing of the main building's roof was in progress. In the time between the two site visits, this roofing work was completed, new windows were installed at some locations in the cafeteria wing, and a large canopy structure was constructed to provide an additional outdoor eating area. The cafeteria wing of the main building is shown in figures 6, 7, 12, 13, and 25.

12.	Main Building, Wing 5: Chord/collector reinforcing and/or splices lack adequate tensile strength to resist the expected seismic forces.
13.	Main Building, Wing 5: Concrete walls with extensive window openings lack adequate shear strength to resist the expected seismic forces.

12.	Provide new steel chord/collector member with new anchors into shear walls and diaphragm.	1.2	N.A.
13.	Provide new concrete wall in-fill at existing window locations with dowels into the existing concrete walls. Provide new concrete strip footings at foundation where absent.	1.1	7

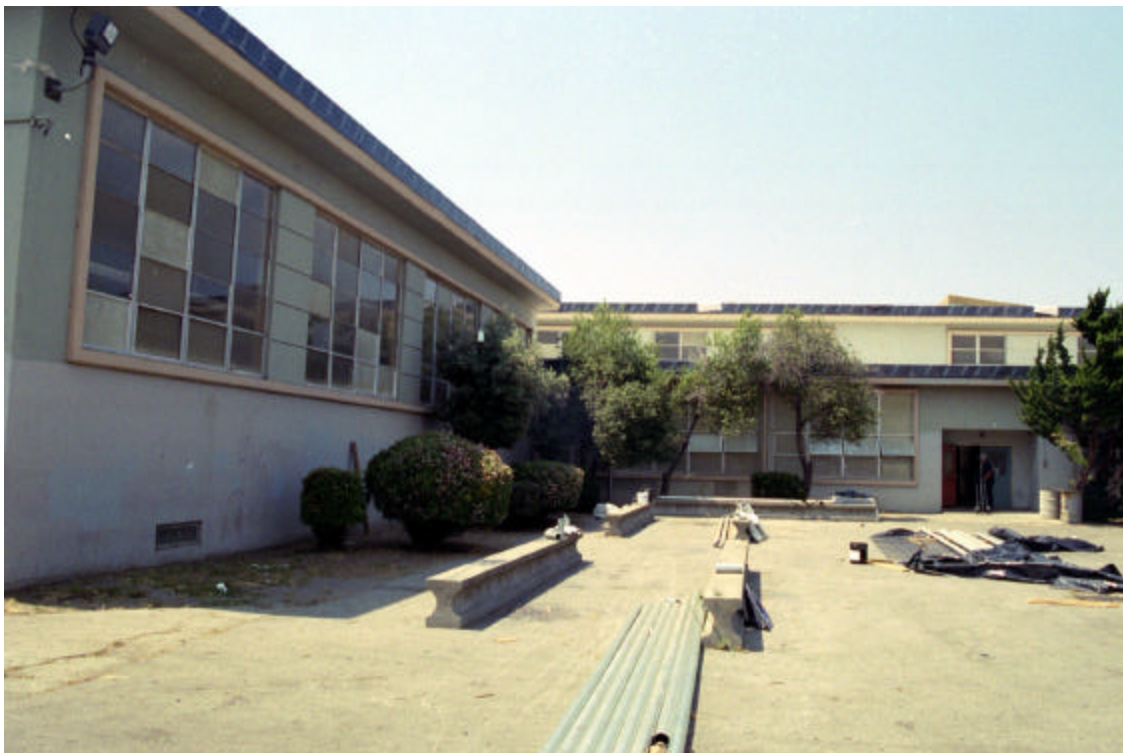
Figure 9: Main Building, library wing, exterior north wall

The remaining portion of the main building is comprised of the library wing, the administration wing, and various other rooms. The library wing is a larger structure, approximately 20' tall. The library has a plaster ceiling, and the adjacent hallway has a large skylight. Adjacent to the library, large wall height louvers occur in the exterior wall of the mechanical room. Overhead in the same area, a tall chimney extends above the roof level. Extensive window openings were observed at most of the exterior walls throughout the library wing, administration wing, and adjacent areas. While interior shear walls may exist in some of these areas, the excessive window openings indicate a deficiency in the strength of the structure to resist the expected lateral forces, and is consequently perceived to be a life safety hazard. The library wing, administration wing, and adjacent areas of the main building are shown in figures 2, 8, and 9.

14.	Main Building, Library Wing: Concrete walls with extensive window openings lack adequate shear strength to resist the expected seismic forces.

14.	Provide new concrete wall in-fill at existing window locations with dowels into the existing concrete walls. Provide new concrete strip footings at foundation where absent.	1.1	9

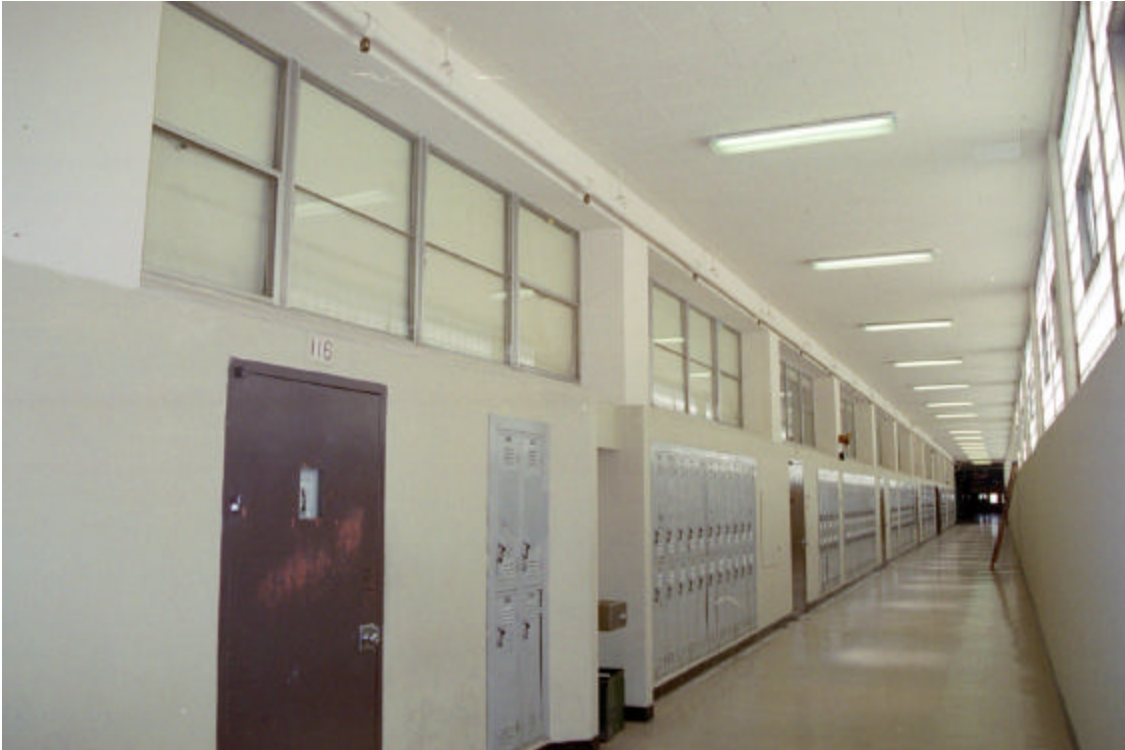
Figure 10: Main Building, classroom wings, interior at corridor

run the longitudinal length of each wing at the north wall and between the classrooms and corridor. A third beam/column line with similar sections runs along the south side to support the remainder of the corridor framing. The combination of concrete slabs at both levels provides a rigid diaphragm. At some upper level locations, the columns of the south wall are actually wider wall piers; however, like the other two concrete frames, the strength of these lines is limited by the concrete columns below. Although they are not well reinforced for this purpose, it appears that the concrete frames were intended to resist lateral forces in the longitudinal direction as moment frames. These concrete moment frames are very flexible and have deficient reinforcement details that are likely to cause a brittle, non-ductile behavior during a large seismic event. In the transverse direction, lateral forces are resisted by concrete shear walls at each end and at one intermediate location. Collector forces are transferred by horizontal beam reinforcing; however, the splices of these bars limit their strength to transfer the expected seismic forces. The structure is founded on spread footings at the columns and a 1'-8" wide strip footing at the north wall. The inadequate strength and ductility of the concrete moment frames and the inadequate strength of the collector reinforcement represent severe life safety hazards in the classroom wings.

3.	Provide new concrete shear walls with dowels into the existing concrete columns and beams. Provide new concrete strip footings at the foundation.	1.0	10, 11

4.	Provide new steel chord/collector member with new anchors into shear walls and diaphragm.	1.2	N.A.
5.	Provide new concrete shear walls with dowels into the existing concrete columns and beams. Provide new concrete strip footings at the foundation.	1.0	10, 11

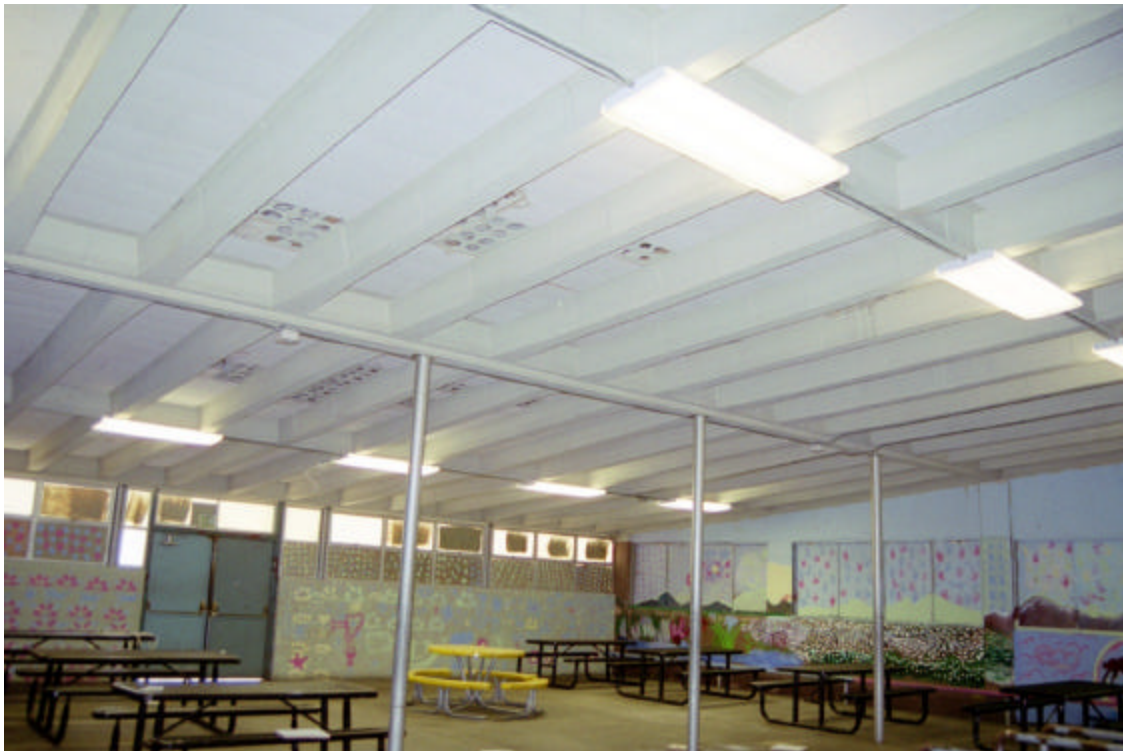
Figure 13: Main Building, wing 5, interior at additional dining area

20.	Main Building, miscellaneous: Concrete shear walls lacking at some locations.
21.	Main Building, miscellaneous: Corridor structures are connected to multiple building wings and lack the capacity to withstand differential displacements of these wings.

19.	Provide new steel chord/collector member with new anchors into shear walls and diaphragm.	1.2	N.A.
20.	Provide new concrete shear walls with dowels into the existing diaphragm. Provide new concrete strip footings at the foundation.	1.1	13

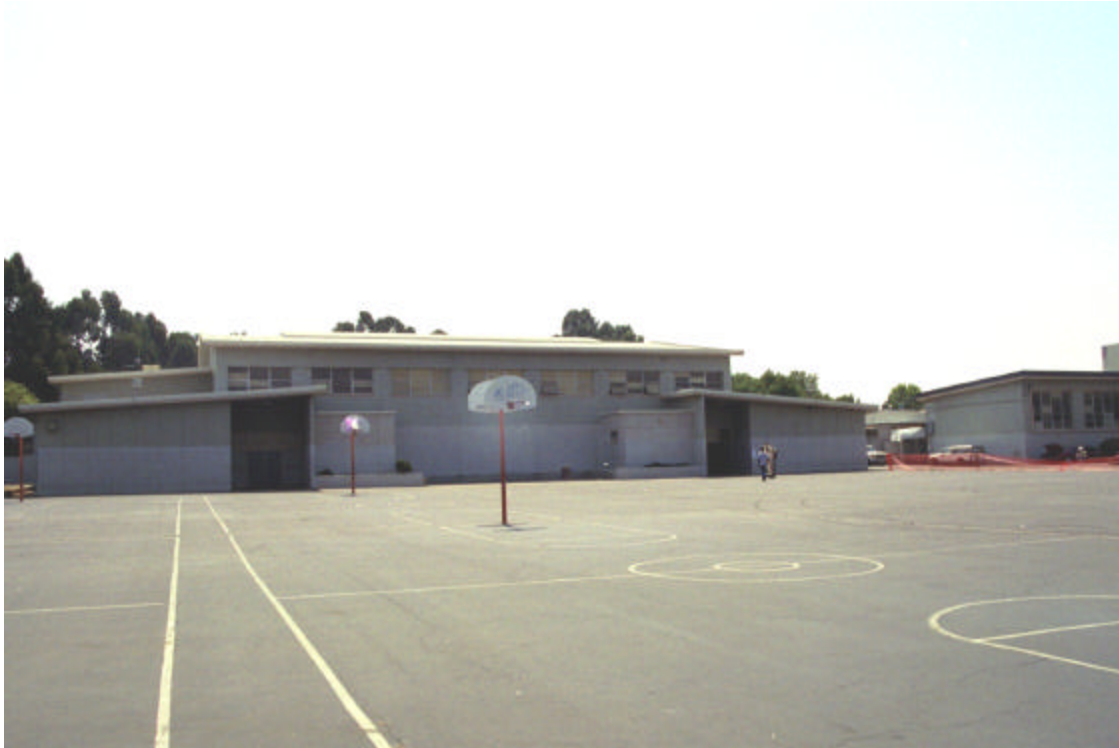
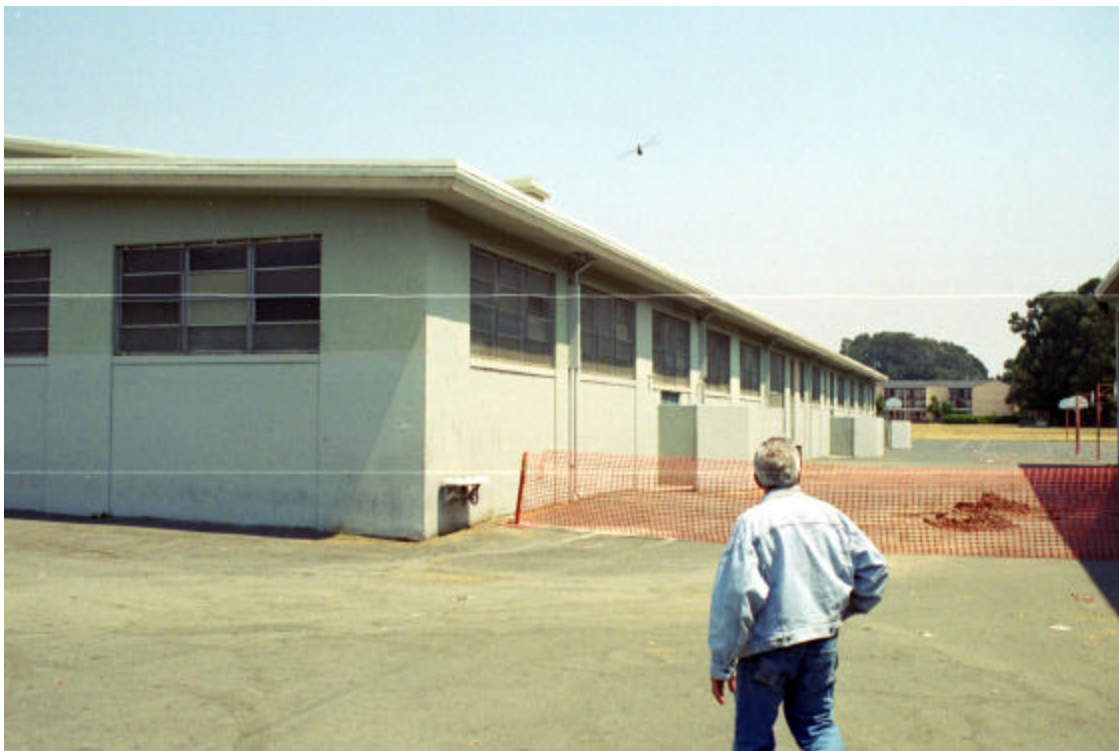
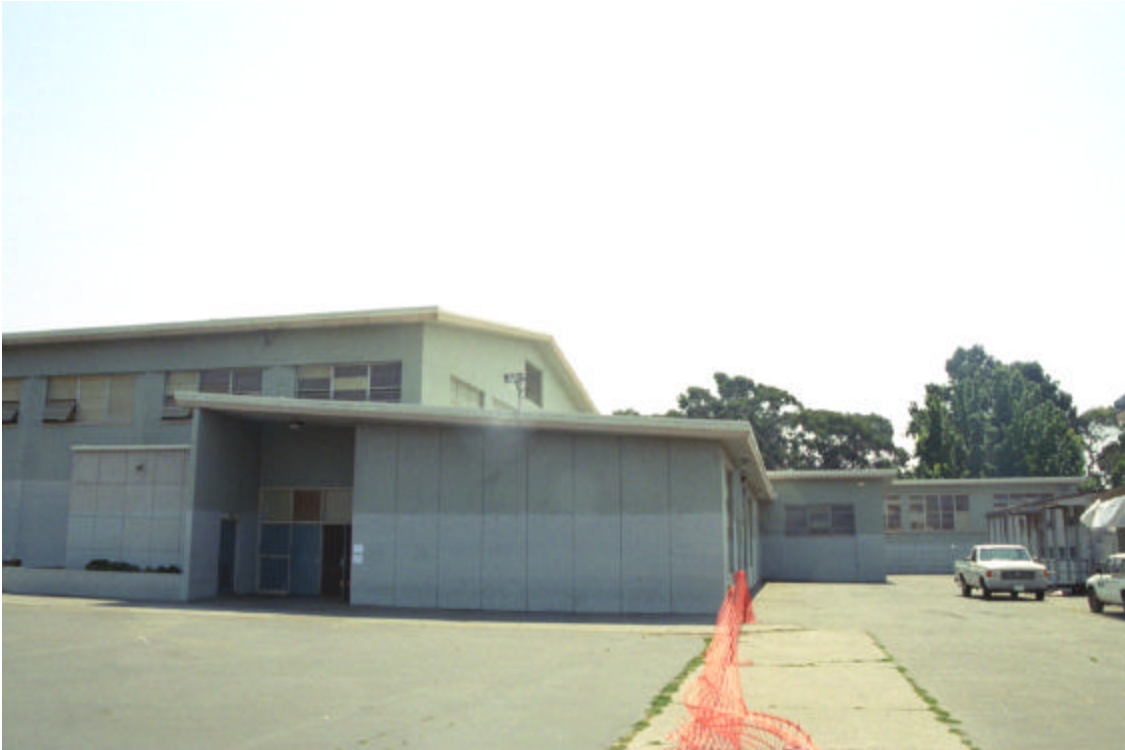
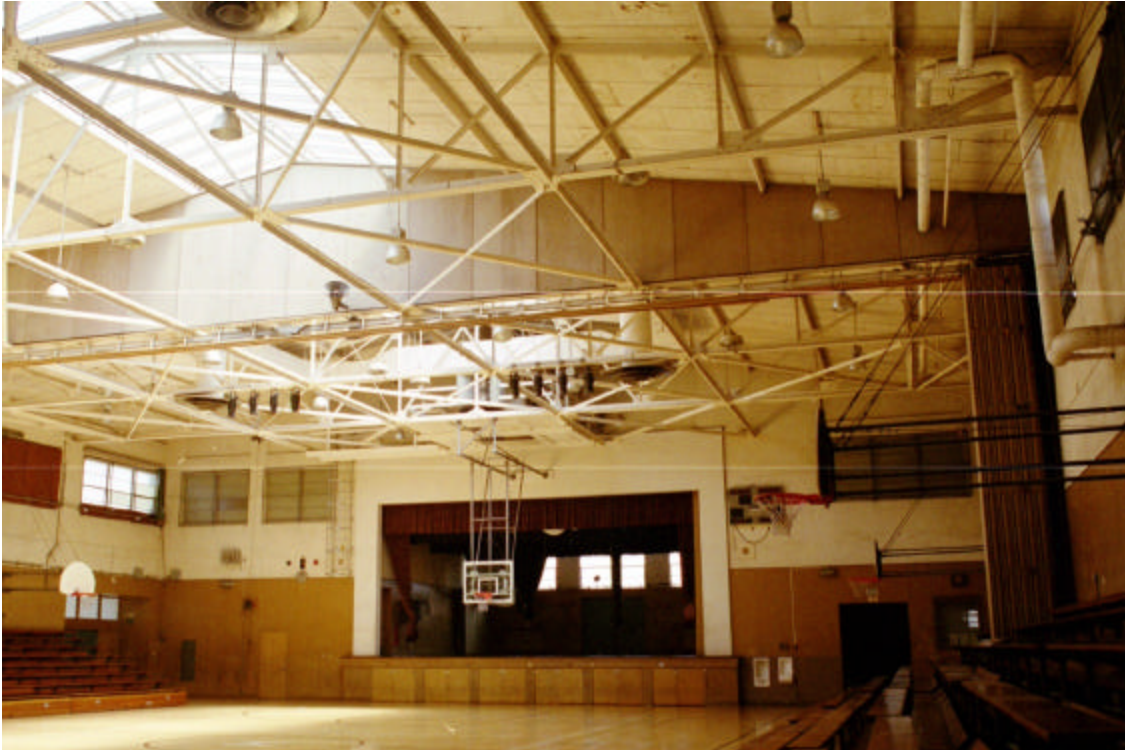
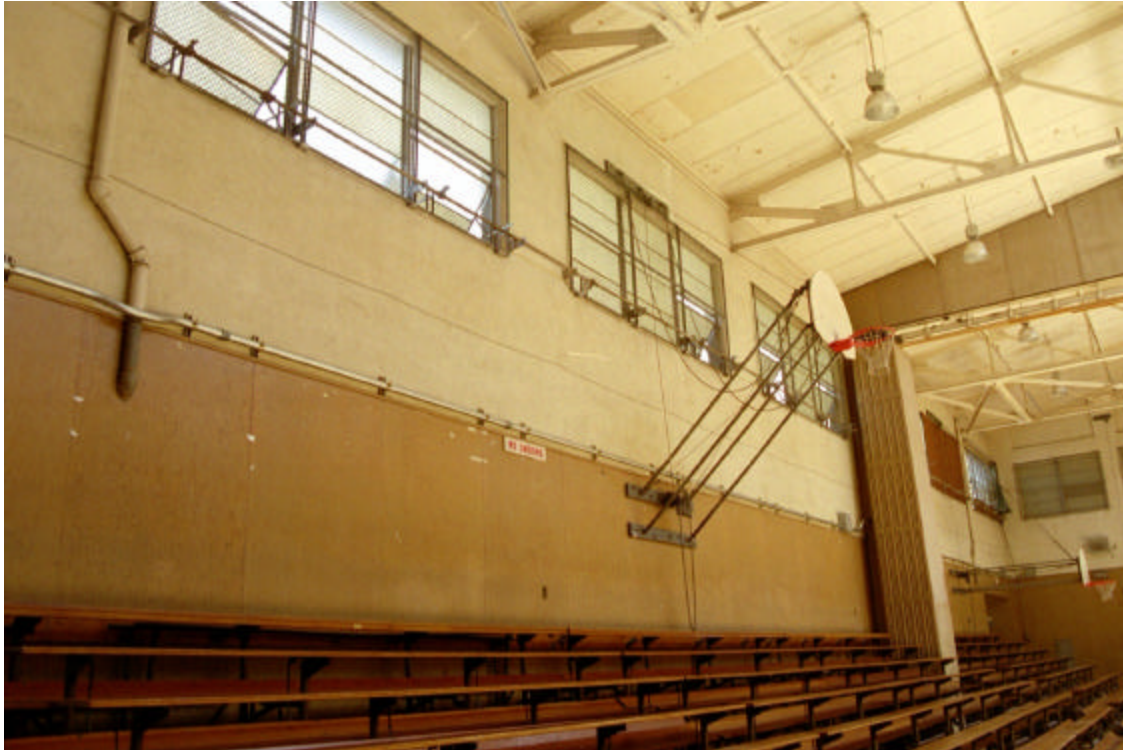
A single story structure, the gymnasium building has a high roof (approximately 35' tall) at the gym area and a more typical roof height at the surrounding classroom areas. The high roof is framed with exposed steel trusses, and a large skylight is centered over the court. Around the main gym area, the longitudinal walls have numerous high, clerestory type windows. At the lower roof areas the framing consists of a concrete slab and beam system supported by concrete bearing walls. These shorter exterior walls also have many window openings. The limited strength of the concrete shear walls caused by the window openings at both the exterior and the gym area, appears to constitute a life safety hazard. The gymnasium building is shown below in figures 14, 15, 16, 17, and 18.

Designed along with the main building, the gymnasium building employs many of the same framing techniques previously discussed. The building is composed of the main gym area with a high roof, and the surrounding ancillary areas that have a lower roof. The lower roof is framed with concrete pan joists with a typical total depth of 8-1/2" including a 2-1/2" thick continuous slab. The joists span between steel wide flange beams (typically W21x62 and W24x76) that are encased in concrete and spaced at an average of 16'-6" on center. The steel beams are supported by concrete bearing walls. At the high roof, the framing is quite similar to the cafeteria room of the main building. Six large steel roof trusses span the 86'-6" width of the gymnasium, while a system of purlins (spaced at 7'-3" on center) and subpurlins (spaced at 2'-9" on center) fill in the remainder of the framing. Similar to the cafeteria, the roof itself is composed of 2-1/2" thick gypsum concrete fill set over a 1" sonotherm product. The inadequacy of this roof system as a diaphragm as previously discussed, is accounted for by a horizontal diaphragm truss composed of steel angles located at the bottom chord of the main roof trusses. However, the diaphragm truss lacks adequate strength. As with the lower roof, the high roof framing is supported by concrete bearing walls. The anchorage connection of these walls at the high roof level is inadequate to resist the out of plane wall forces, and at some locations the flexural strength of these walls is also insufficient. These concrete shear walls provide the lateral force resisting system in the structure. Due to an extensive amount of window openings at the exterior walls both at the lower and upper locations, these walls lack adequate strength in comparison to the expected seismic forces. As seen elsewhere, the horizontal reinforcing intended to transfer seismic forces is inadequate when compared to the expected forces. Strip footings of various widths provide foundation support. At the gymnasium building life safety hazards are identified

in the inadequate concrete walls (out-of-plane) and anchorage connections at the high roof, the inadequate strength of the high roof diaphragm truss, the inadequate collector strength, and the inadequate shear wall strength.

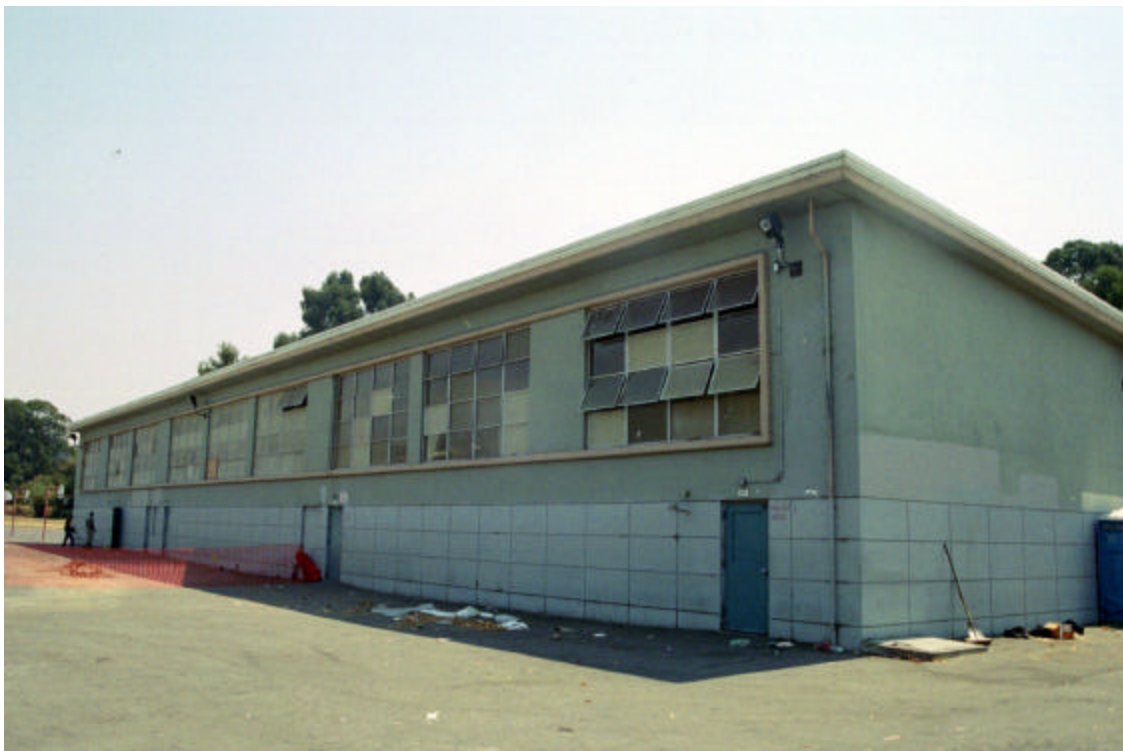
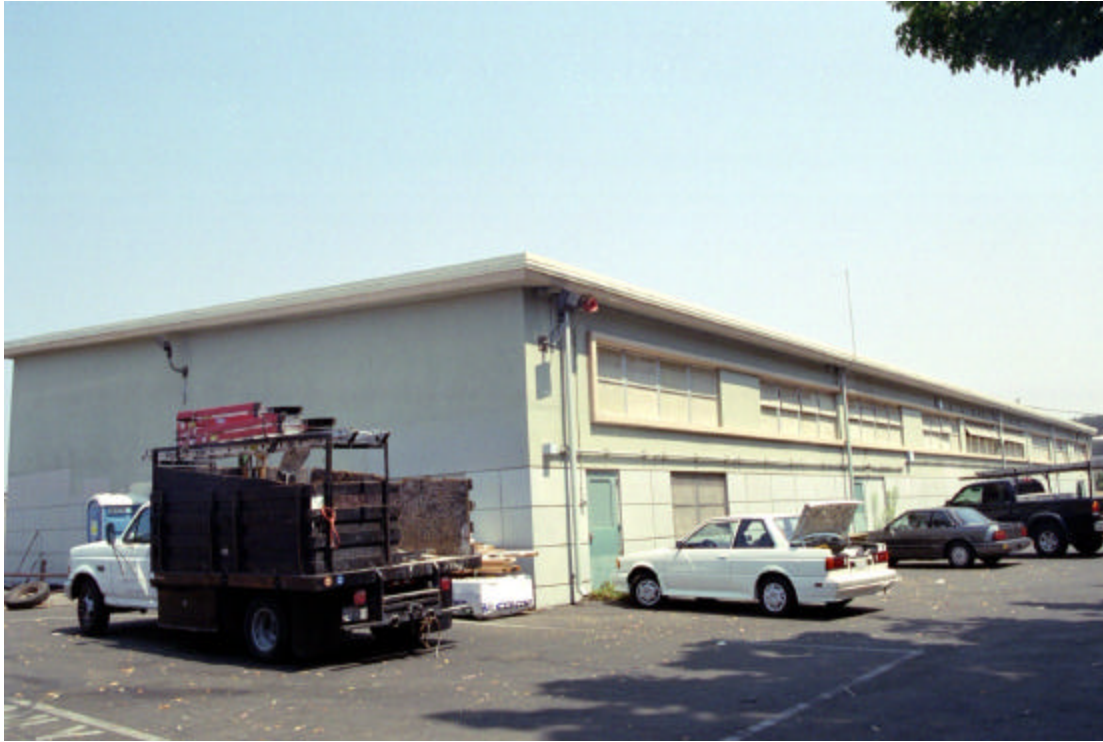
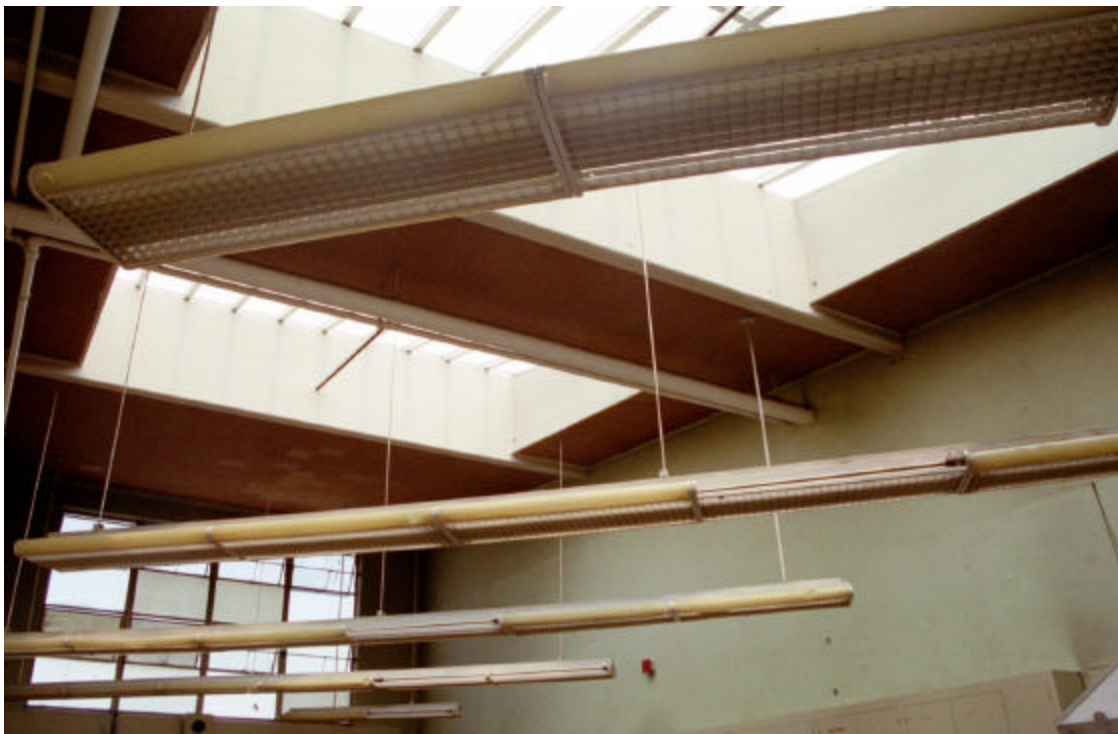
Located just south of the gymnasium is the shop building, another single story structure. This building has a rectangular plan shape and is 18' to 20' tall. The longitudinal walls have nearly continuous windows that are located in a band over the doorways. Inside the building, pairs of skylights are observed straddling the longitudinal centerline of the building. Light fixtures are hung from the high ceiling above. Near the east end of the building, a mezzanine was observed. The mezzanine space has hard wood floors, and appears to be used predominately for storage. The continuous window openings at the longitudinal walls, inhibit the shear wall strength to the point that a life safety hazard is perceived. The shop building is shown below in figures 19, 20, and 21.

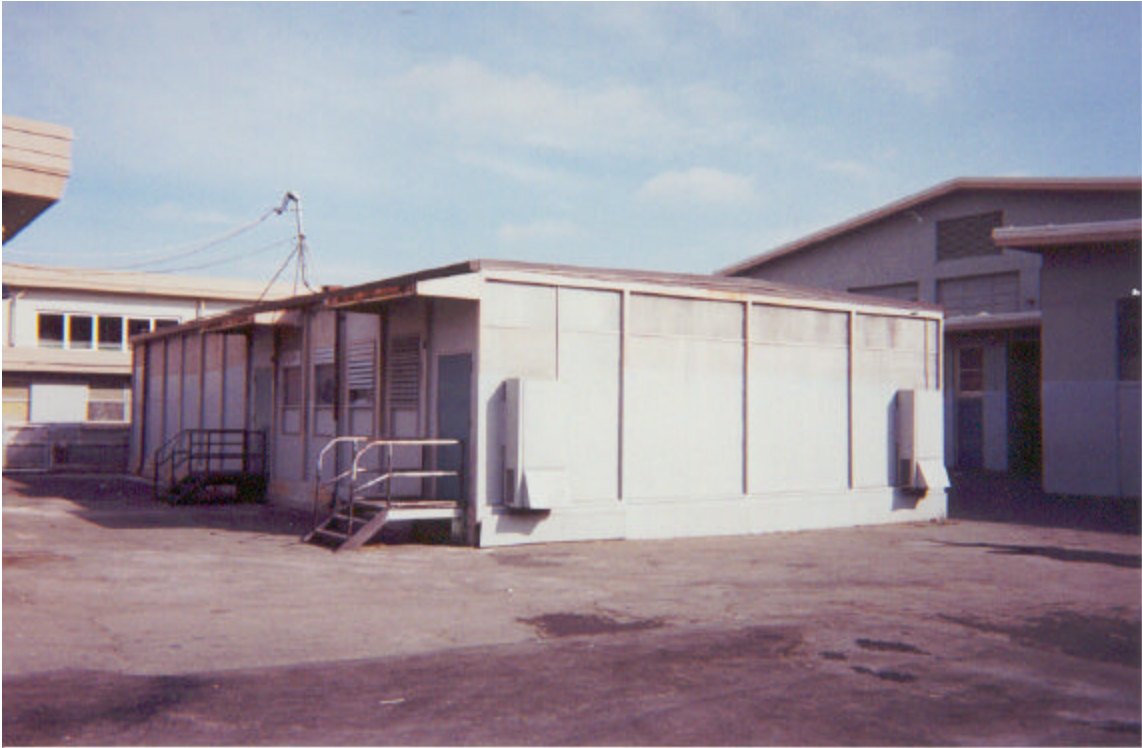
Figure 24: Portable Building, exterior

Of the portable structures, two are located closely together between the main building and gymnasium building, while the other six are located opposite the playground area. The former appear older than the others and are in a poorer condition (some rusting was observed in the awnings). At the newer portable buildings, some hard conduit was observed running between separate structures. The inability of these conduits to withstand the differential displacement of the separate structures is recognized as a life safety hazard. The older portable buildings are shown in figure 24.
