STRUCTURAL EVALUATION OF
NORTH CAMPUS/TLC/VISTA CONTINUATION HIGH SCHOOL
WEST CONTRA COSTA UNIFIED SCHOOL DISTRICT
(WCCUSD)

WLC Architects
Kaiser Building
1300 Potrero Avenue
Richmond, CA 94804

DASSE Design, Inc.
33 New Montgomery Street #850
San Francisco, CA 94105
(415) 243-8400

October 17, 2002

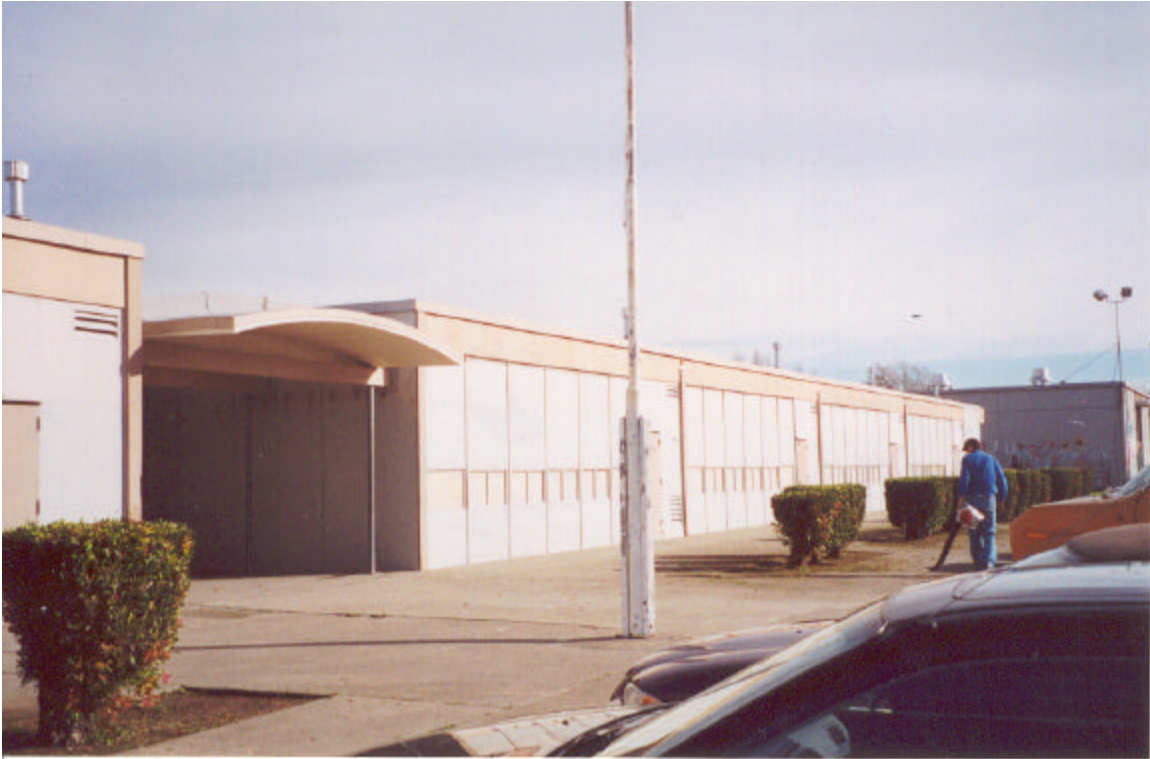
Figure 2: South Longitudinal Wall of Main Building (East Half)

The main building is a one-story wood-framed structure with a plaster exterior finish and a large number of windows, particularly in the longitudinal walls (see figures 2 and 6 through 9). The building is shaped like an "8", having two interior courtyards (see figure 1). Interior corridors are located along the courtyards in the longitudinal direction. The corridors and adjacent classrooms have windows that look into the courtyards, but there appear to be long segments of shear walls on the interior sides of the corridors (see figure 10). The corridors have acoustical tile ceilings and skylights are placed in the areas that are not adjacent to the central courtyards. Classrooms and administration areas have suspended T-bar ceilings. The transverse walls at the classrooms have no openings in them. The main entrance has a canopy above it that is attached to the building along the rear edge and is lower than the main roof diaphragm (see figures 2 and 15).

Since the exterior longitudinal walls do not have any shear panels (see figures 7 and 9), the roof diaphragm will cantilever horizontally outward from the corridor to the exterior of the building. The chord forces that could result from this cantilever action exceed the capacity of the 8-16d top plate splices.

Item	Building Structural Deficiencies
1.	At the main building, there are no shear walls at longitudinal exterior faces of building. This forces the roof diaphragm to act as a horizontal cantilever along those sides of the building. The top plate splices are overstressed due to chord forces.

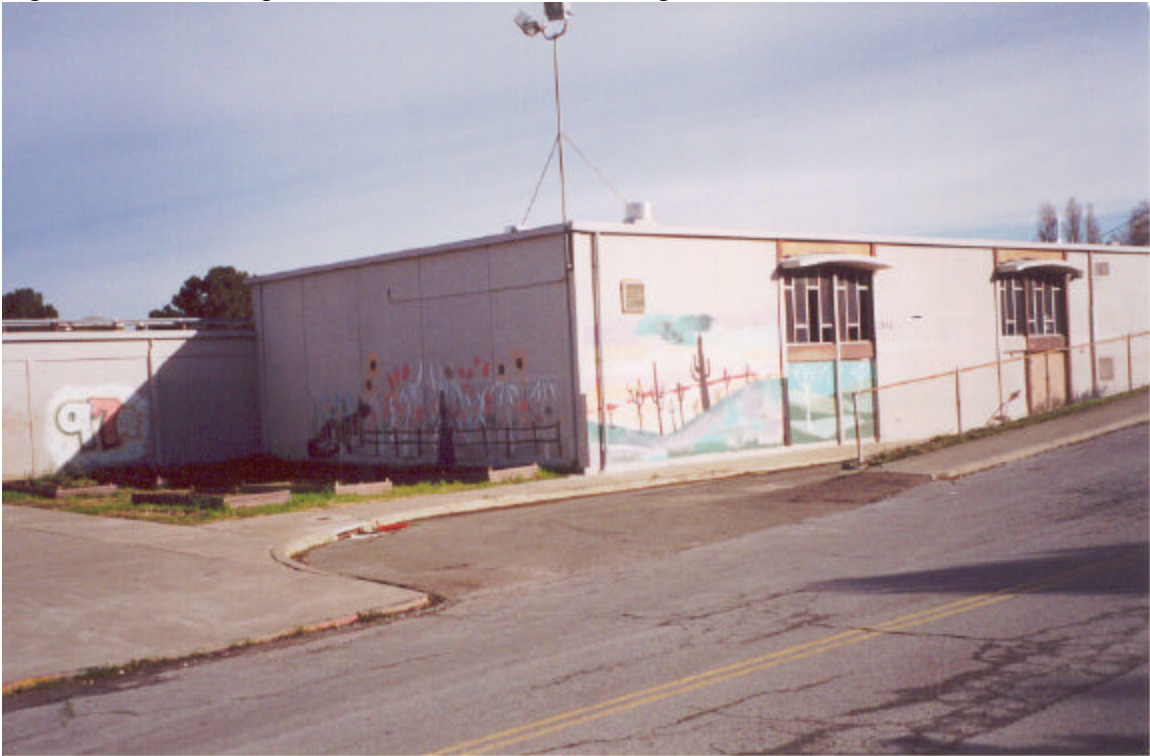
Figure 3: South Face of Multi-Purpose Building

The multi-purpose building is a wood-framed structure with a plaster exterior finish and a split-level roof (see figure 3 through 5). The multi-purpose building has two main areas: the cafeteria / auditorium and the kitchen. The cafeteria / auditorium area has some windows in the front longitudinal wall and has a high roof that spans about 45 ft between longitudinal walls (see figure 11). The kitchen area has a lower roof and has multiple window openings along the exterior longitudinal wall. The transverse walls of the multi-purpose building have only minor

openings. The cafeteria / auditorium has an acoustical tile ceiling and the kitchen area has a plaster ceiling. There is also a connecting corridor between the main and multi-purpose buildings that is attached to the multi-purpose building at the roof diaphragm level (see figure 3).

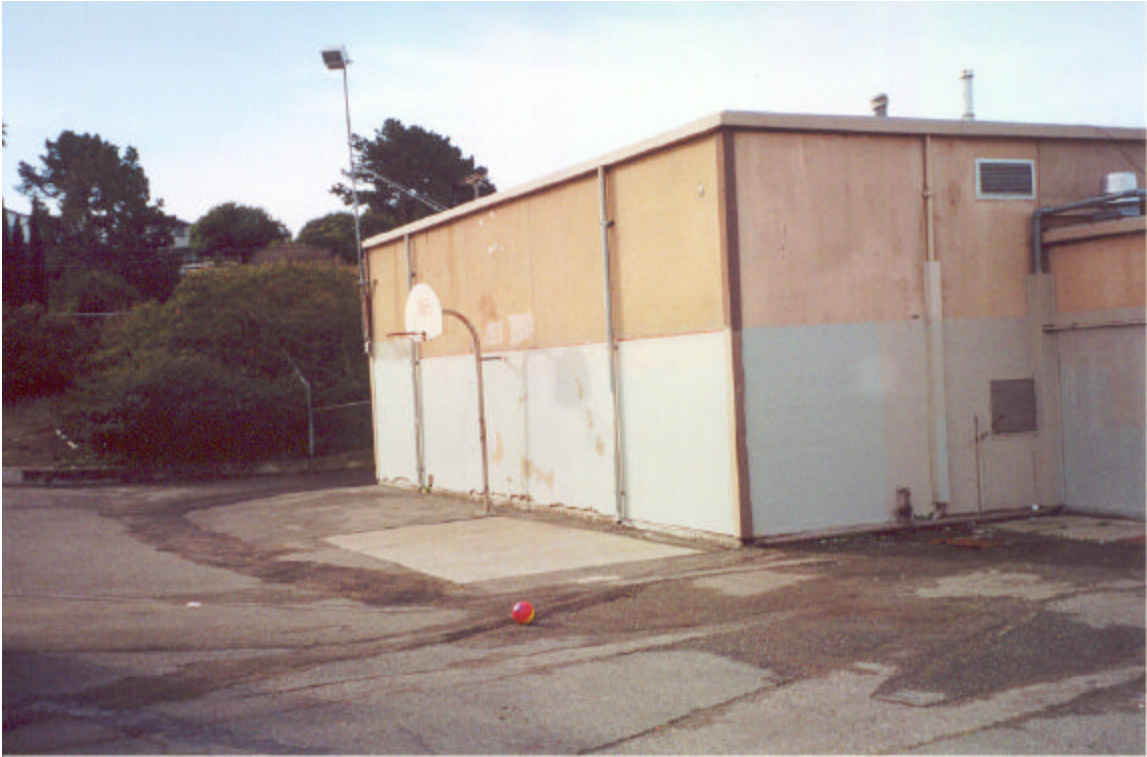
Figure 4: East Face of Multi-Purpose Building

Where the east and west ends of the low roof frame into the wall of the high roof area, there are re-entrant corners that cause stiffness discontinuities (see figures 4 and 5). Some minor damage to the walls may occur at these locations. However, it does not appear to be a significant threat to life safety because the positive connection of the low roof to the wall will prevent loss of gravity support for the low roof framing.

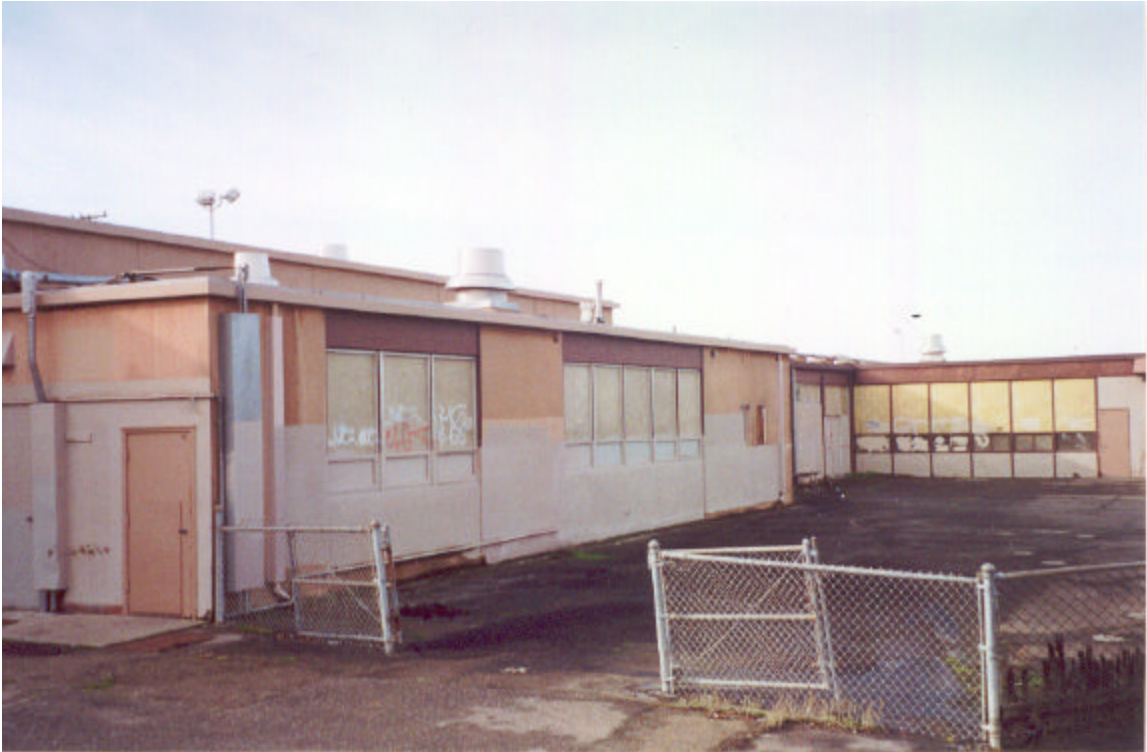
Figure 5: North Face of Multi-Purpose Building at Kitchen Area

A short corridor connects the main building and the multi-purpose building. A seismic separation joint is located at the end adjacent to the main building (see figures 6 and 16). Windows are located along the entire north wall of the corridor (see figure 5). Light moment frames with steel 5I10 beams and columns are spaced every 10 feet along the length of the corridor and provide lateral support in the transverse direction. The beams are located in the space between the roof and the ceiling of the corridor. In the longitudinal direction, collector straps connect the walkway back into the roof framing of the multi-purpose room.

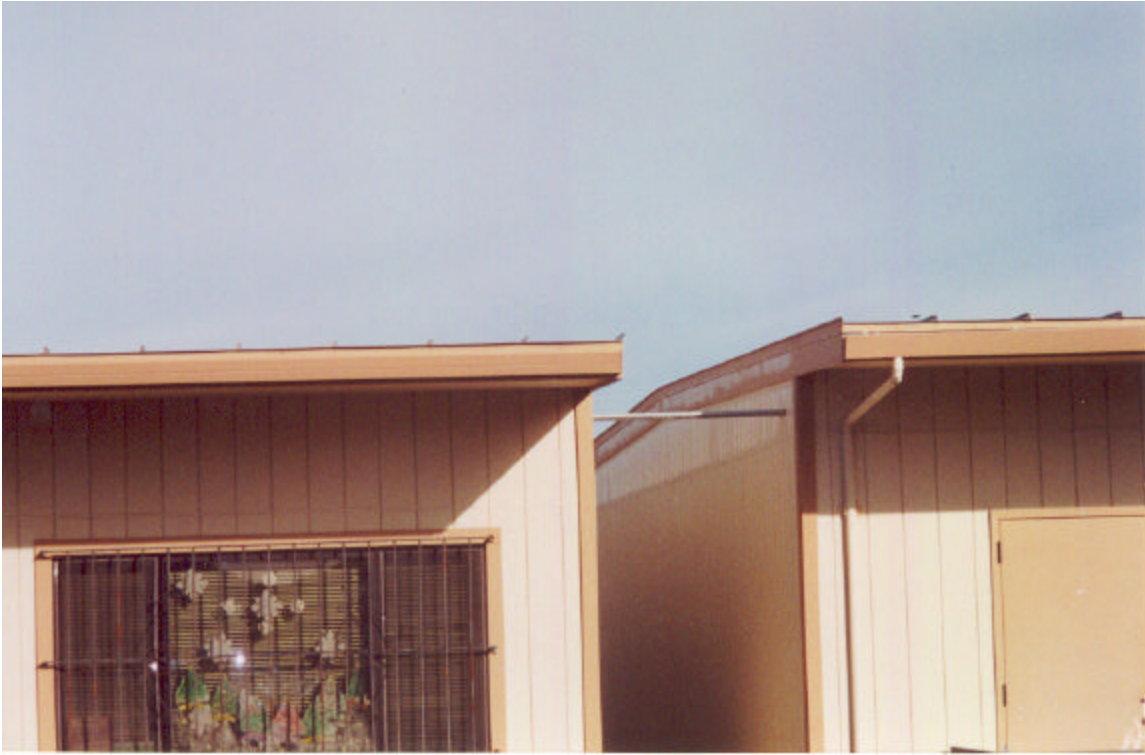
Figure 14: Conduit Running between Portable Classrooms

At the portable classrooms, there is electrical conduit running between the classroom units near the roof level (see figure 14). There are no flexible connections to allow for relative movement of the units. During an earthquake these conduits may be damaged and pose a threat to life safety.

6.	There is electrical conduit running between the portable units at the roof level without flexible connections. As the buildings move relative to each other during an earthquake, the conduit may be damaged, causing a potential life safety hazard.

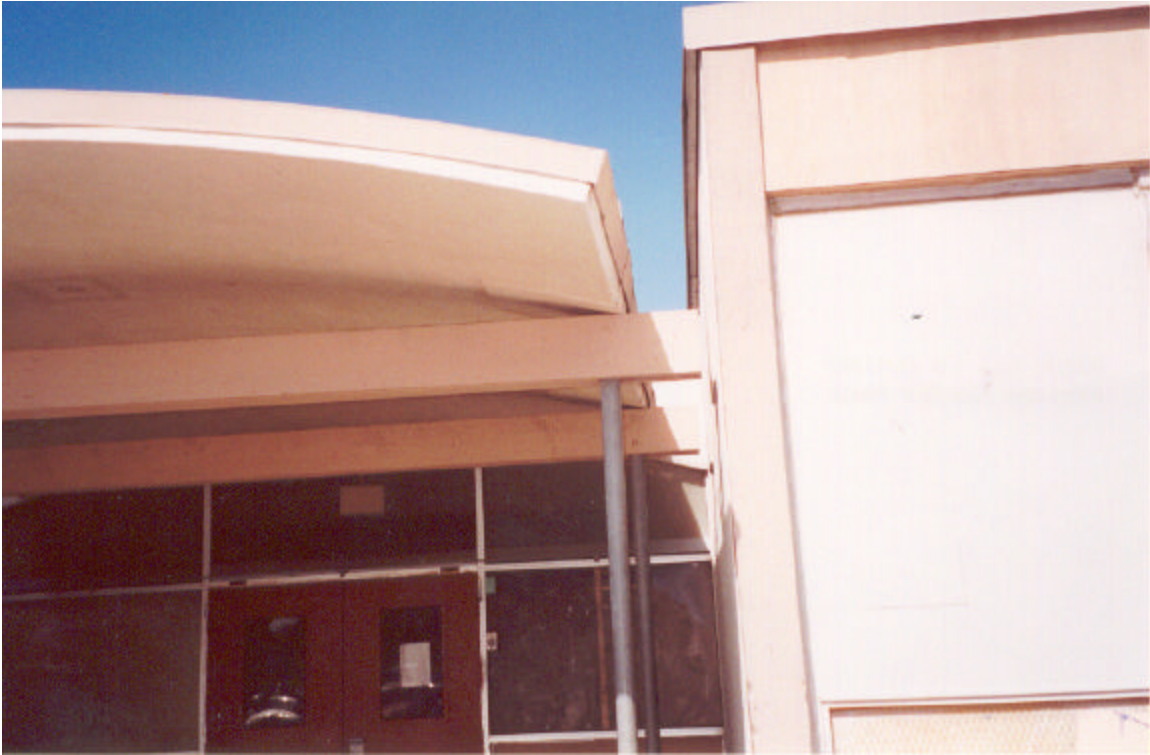
Figure 15: Entrance Canopy at Main Building

The main building entrance canopy was not built in accordance with the original construction documents. The 3x4 canopy joists, spaced at 16" centers, are supported by three 7" x 9³/₄" glue-laminated beams. The existing drawings show the beams framing into the bearing walls on the sides of the entrance area. In the actual construction, however, the front and middle beams are supported by pipe columns at each end. At the rear edge of the canopy, the glue-laminated beam spans between posts in the bearing wall. Except at the rear edge, the canopy structure is not attached to the main building (see figure 15). A short plywood-sheathed shear wall is located above the rear beam to transfer seismic shears up to the roof diaphragm. There does not appear to be a complete lateral force resisting system since the canopy structure is only braced laterally at the back wall and the other three sides are not braced. This element could fall during strong seismic ground motions, posing a life safety hazard at the main entry.

5.	The entrance canopy is connected to the building along its rear edge but not along the sides. At the rear edge, the canopy frames into the wall below the roof level. There is no mechanism to restrain the rotation of the canopy during an earthquake event. This may result in damage to the beam connections and a loss of gravity support for the canopy.

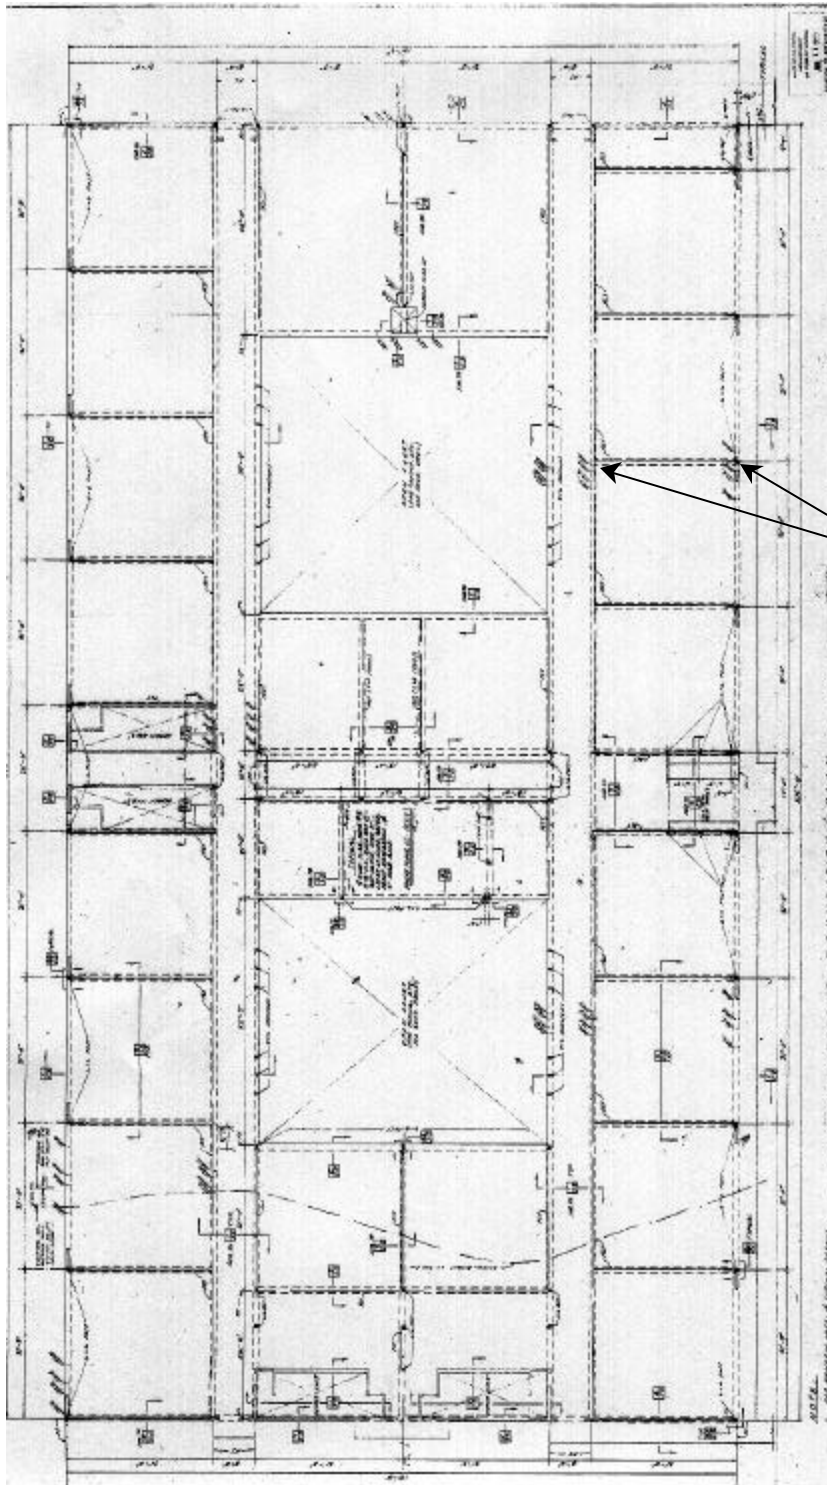
Drawing 1: Main building floor plan

Since the transverse walls run parallel to the roof joists and do not have holdowns at the ends, they will not have adequate overturning resistance during a strong earthquake event. The collector connections along the eastern end of the building are not adequate. As the building moves during an earthquake, the roof at the corners of the courtyard areas may be damaged due to a lack of reinforcement in the transverse direction.

3.	At the east end of the main building, the collector connections are overstressed.
4.	The interior transverse shear walls have neither holdowns nor sufficient weight to resist the seismic overturning forces.

(N) holdowns at the ends of shear walls, typ. at all transverse shear walls.

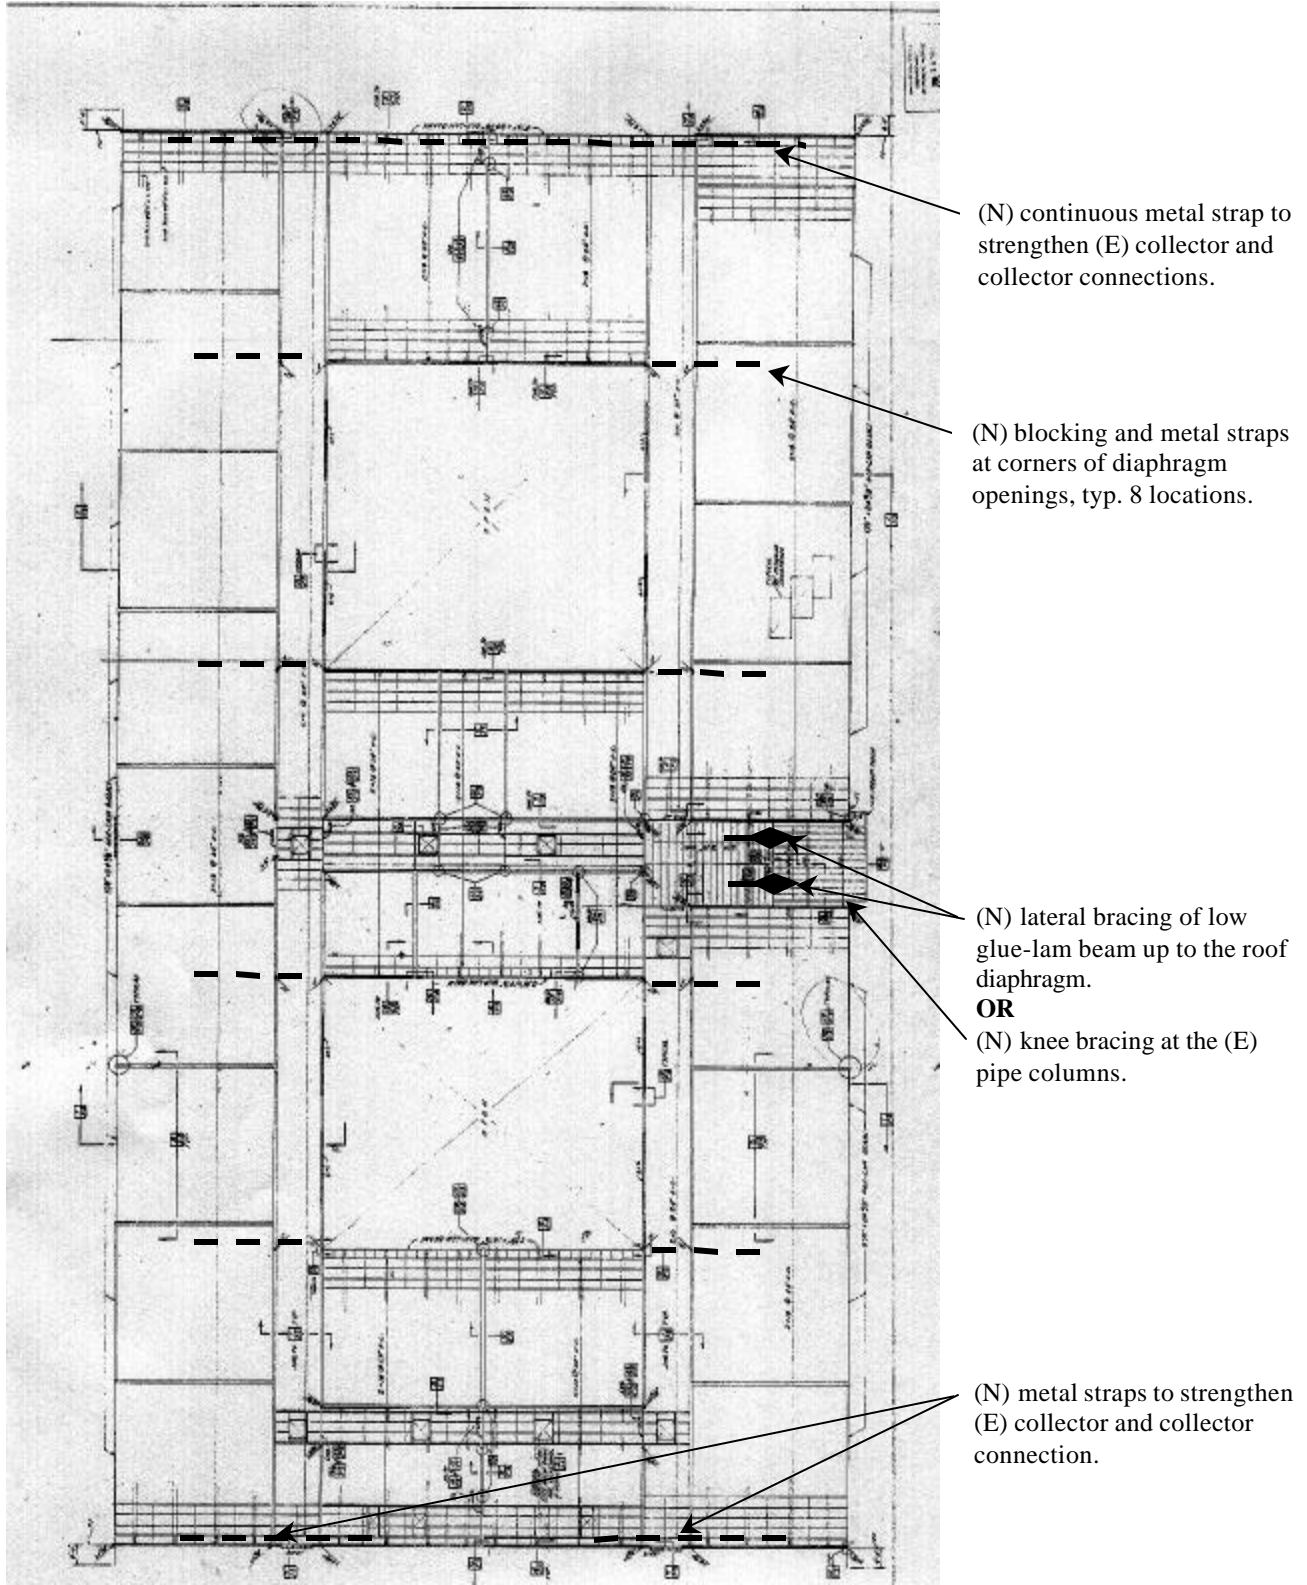
Drawing 2: Main building roof plan

2.	At the main building, there are large interior courtyards. There are no collector elements at the corners of these diaphragm openings in the transverse direction. This may result in damage to the diaphragm at the corners.

Item	Recommended Remediation	Priority	Drawing Number
1.	Provide a new metal collector strap above the plywood roof sheathing along the east and west sides of the building.	1.3	2
2.	Add new collector elements, with metal straps over the plywood roof sheathing at the corners of the openings.	1.5	2
3.	Provide a new continuous metal strap above the plywood roof sheathing.	1.3	2
4.	Provide new holdowns at each end of the existing shear walls	1.2	1
5.	Provide new knee bracing at frame at the front of the entrance canopy, OR provide new lateral bracing of the low beam that supports the rear edge of the canopy. This bracing should be connected up to the main roof level.	1.7	2
6.	Relocate conduit or install flexible connections to accommodate relative movement of the buildings.	1.9	None
