STRUCTURAL EVALUATION OF  
PINOLE MIDDLE SCHOOL  
WEST CONTRA COSTA UNIFIED SCHOOL DISTRICT  
(WCCUSD)

WLC Architects  
Kaiser Building  
1300 Potrero Avenue  
Richmond, CA 94804

DASSE Design, Inc.  
33 New Montgomery Street #850  
San Francisco, CA 94105  
(415) 243-8400

October 17, 2002  
DASSE Design Project No. 01B300x2

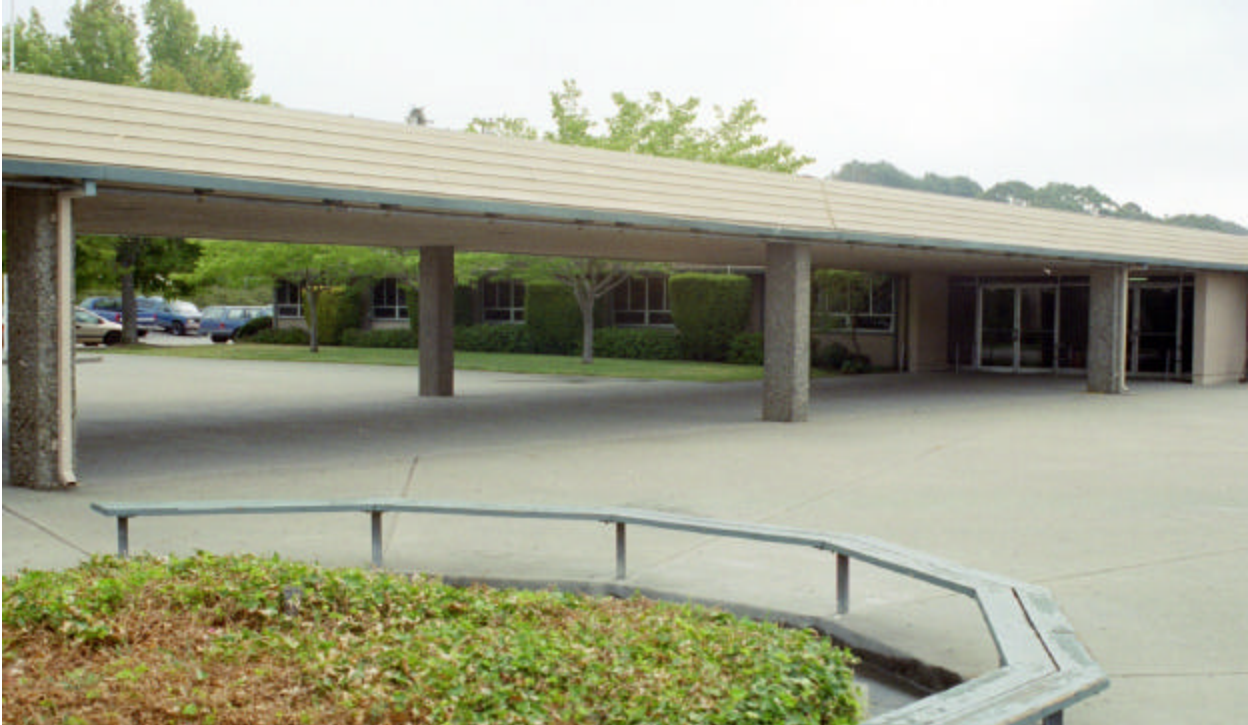
Figure 3: Covered Walkway to Administration Bldg.

A covered walkway connects the administration building and the multi-purpose building. All the covered walkways have electrical conduits suspended below the ceilings. Since the covered

walkways are connected at either ends to different buildings, electrical conduits will be subjected to differential movement between buildings and therefore could be pulled apart, which could pose an electrical line hazard. Therefore, the conduits could pose a life safety hazard.

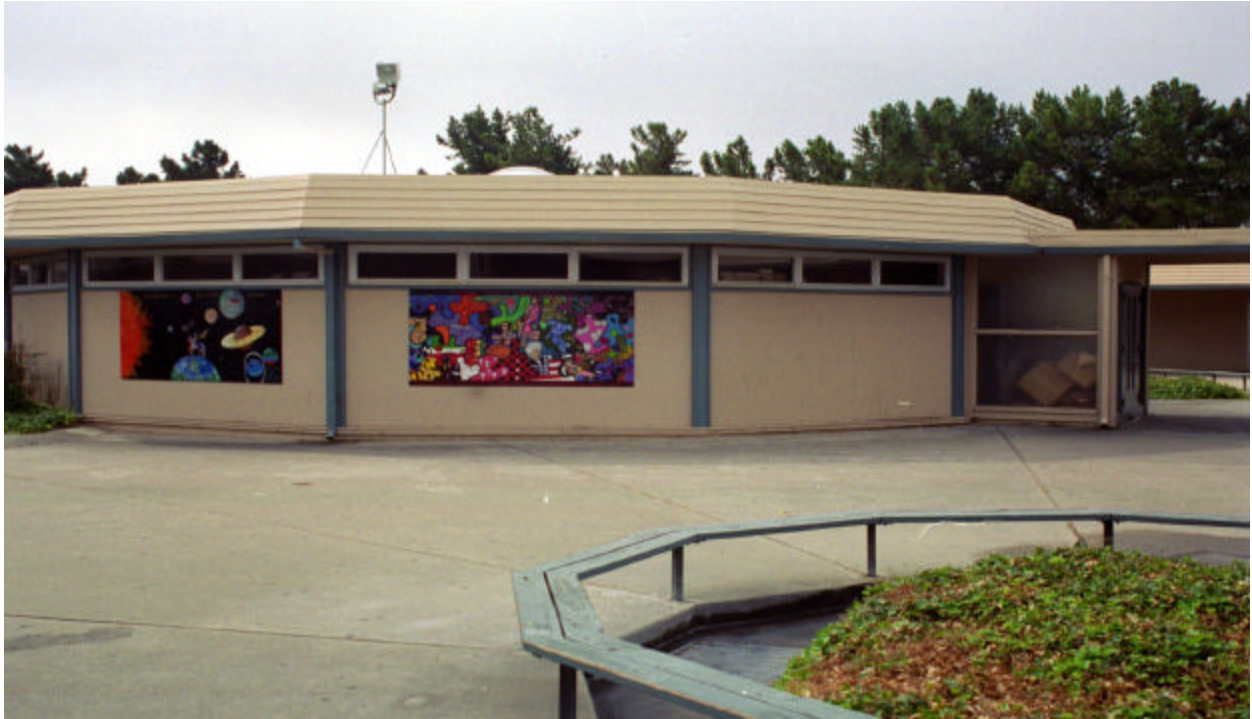
Figure 4: Library Building

The circular library building has continuous window openings just below the roof diaphragm and is connected to the classroom buildings on east and west sides by covered walkways.

The Circular Library Building has 2x6 stud walls framed with a 3/8" plywood sheathing between 5" diameter extra strong pipe columns located on a circle for a total of 12 equal spaced columns. At the roof level, 8WF24 sloped steel beams span radially from the center of the circle towards the perimeter and frame into the 5" diameter pipe columns. At the perimeter of the building, there are 8WF17 steel beams spanning between the pipe columns. Covered walkways frame into the Library building on the east and west sides and there is an expansion joint between the covered walkways and the Library building. The presence of continuous windows along the circumference of the building results in an inadequacy of the building to transfer seismic forces from roof diaphragm to the perimeter shear walls. Some of the windows need to be in-filled to provide a continuous load path to transfer seismic forces into the perimeter shear walls.

8.	Library building has continuous slit window openings just below the roof and thus does not have a load path to transfer prescribed seismic forces to the perimeter shear wall

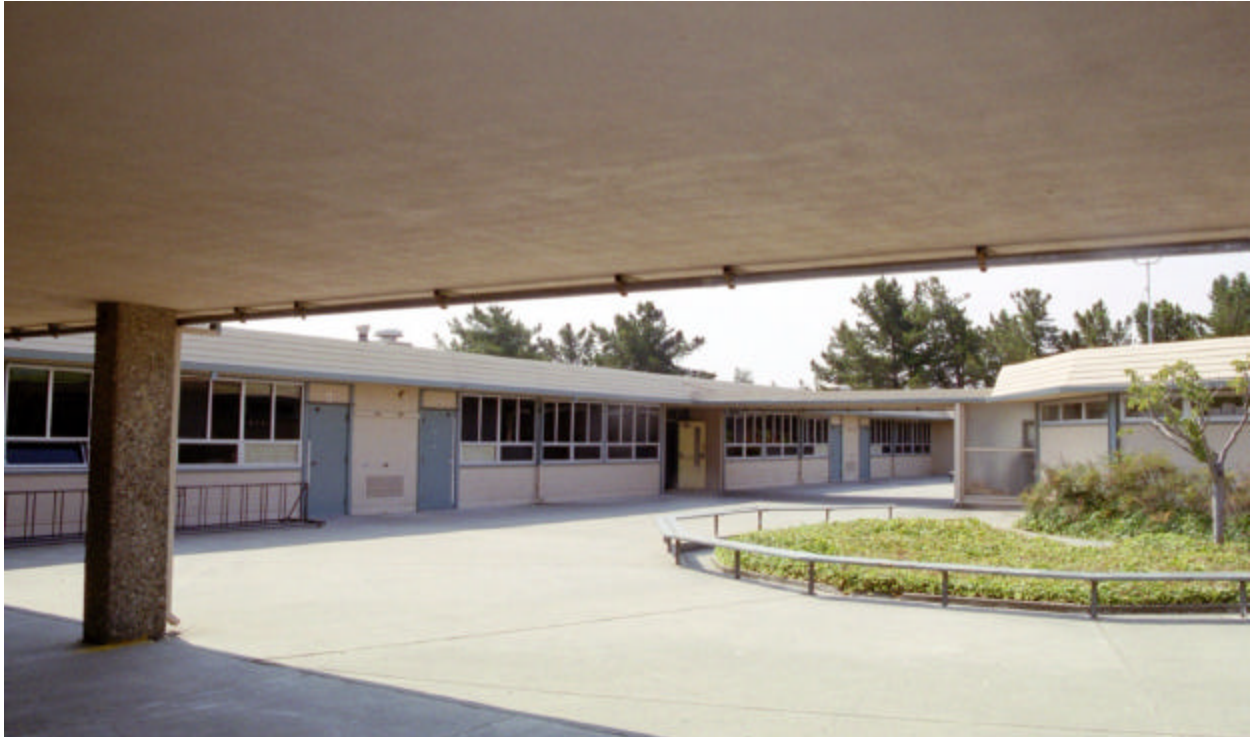
Figure 10: Classroom Bldg. Exterior Wall with window openings

The main building is a one story wood structure (see figures 2). The building exterior typically has a stucco finish. The covered walkways have a plaster finish at ceilings and are connected at their ends to the main buildings. The west face of the administration building has multiple large window openings. The exterior longitudinal walls of classroom buildings (room numbers 1, 2, 3, 5, 7, 9, 11 to 20) have number of window openings (see figure 4).

The lateral system of the classroom wing consists of 1/2” plywood roof sheathing, which acts as a horizontal diaphragm to transfer the seismic loads to 2x6 stud walls acting as shear walls. In the longitudinal direction, the exterior walls have numerous window openings and hence are not adequate shear walls to resist prescribed seismic loads, which poses a life safety hazard. The interior longitudinal corridor walls, with 3/8” plywood sheathing, act as shear walls resisting the lateral forces in the longitudinal (north-south) direction. In the transverse direction, the seismic forces are resisted by transverse shear walls, which have 3/8” plywood sheathing on them. Collector elements to drag the seismic forces to the transverse shear walls are missing and should be provided.

Item	Building Structural Deficiencies
1.	Plywood shear walls at east face of classroom wings (longitudinal walls) lack

adequate shear strength to resist the prescribed seismic forces
2.	Plywood shear walls at west face of classroom wings (longitudinal walls) rooms lack adequate shear strength to resist the prescribed seismic forces

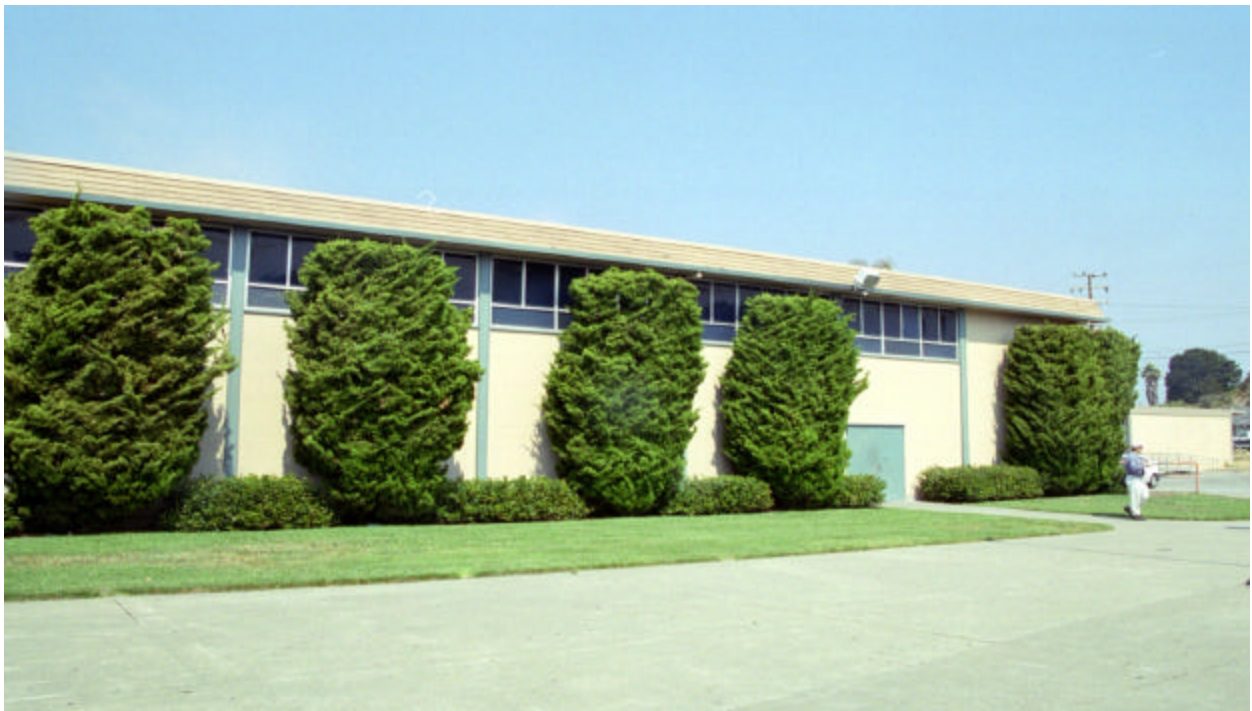
Figure 11: East Wall of Multi-Purpose Room

between the multi-purpose room and the music/shop rooms has few door and window openings and has 1/2" plywood sheathing on one side. Holdowns have been provided at some door openings. The south wall and the east wall of the multi-purpose room consist of 2x8 stud walls at 16" centers with a 3/8" plywood sheathing. These walls have excessive door openings and do not have adequate length of shear wall to resist seismic loads.

4.	Plywood shear walls at east face of multi-purpose room lack adequate shear strength to resist the prescribed seismic forces.
5.	Plywood shear walls at south face of Multi-Purpose Room lack adequate shear strength to resist the prescribed seismic forces
