STRUCTURAL EVALUATION OF
RICHMOND HIGH SCHOOL
WEST CONTRA COSTA UNIFIED SCHOOL DISTRICT
(WCCUSD)

WLC Architects
Kaiser Building
1300 Potrero Avenue
Richmond, CA 94804

DASSE Design, Inc.
33 New Montgomery Street #850
San Francisco, CA 94105
(415) 243-8400

October 17, 2002

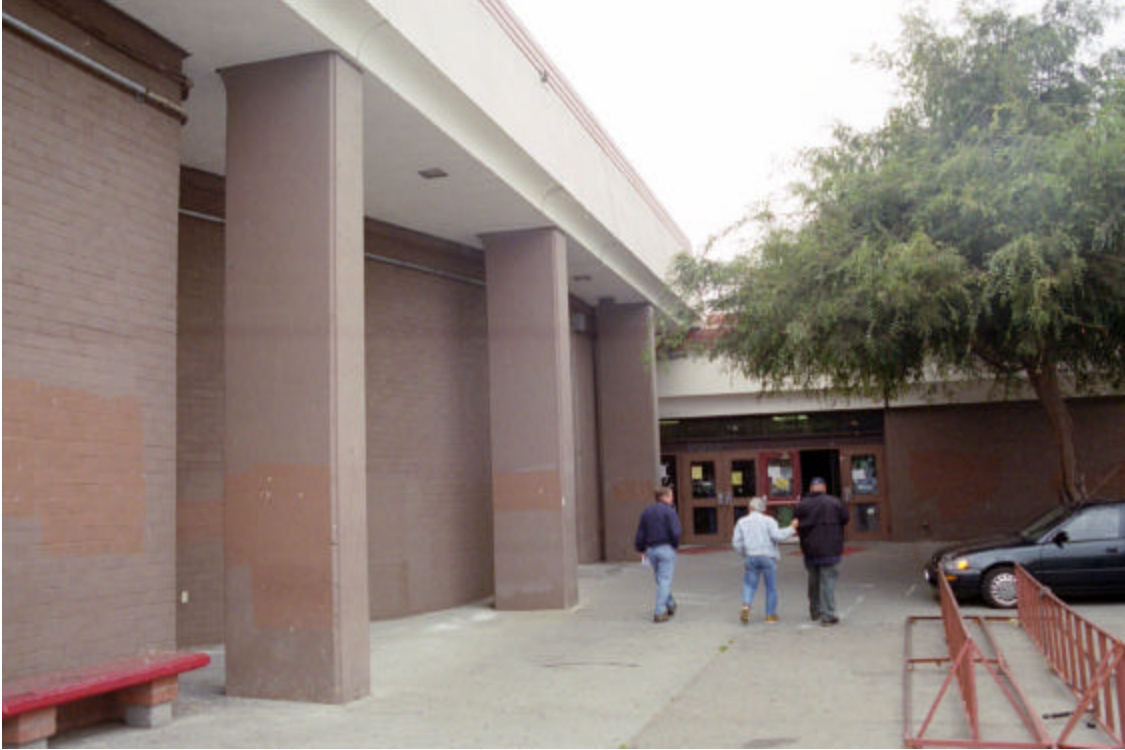
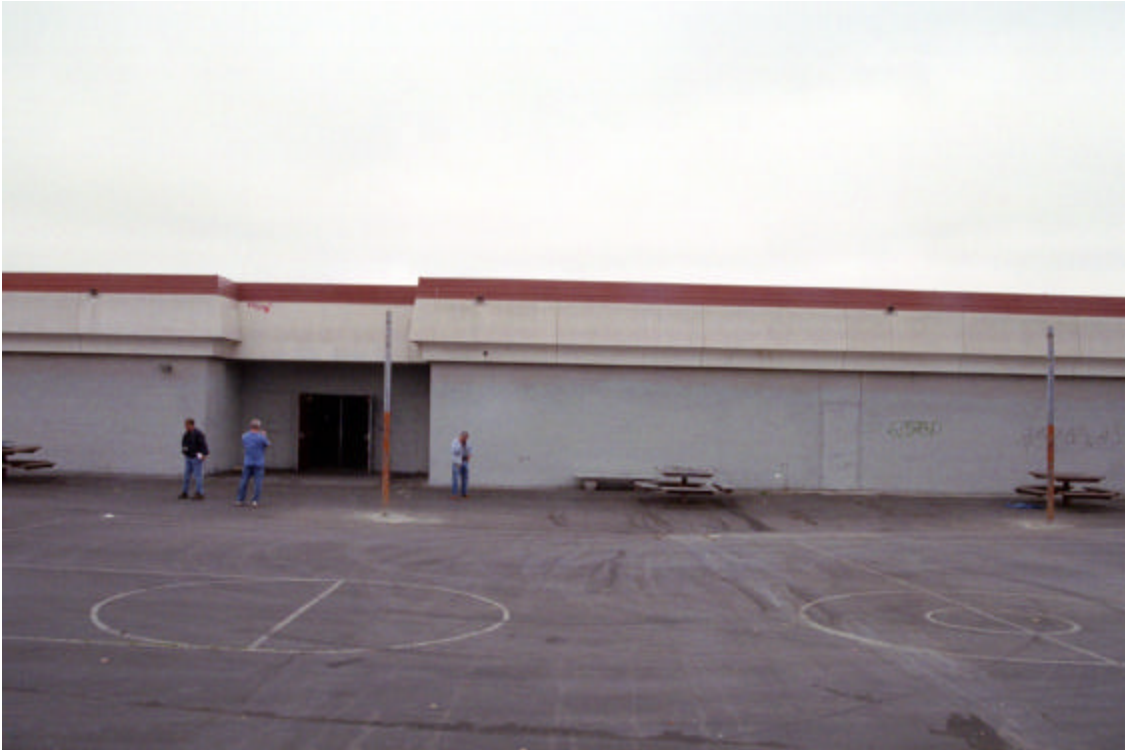
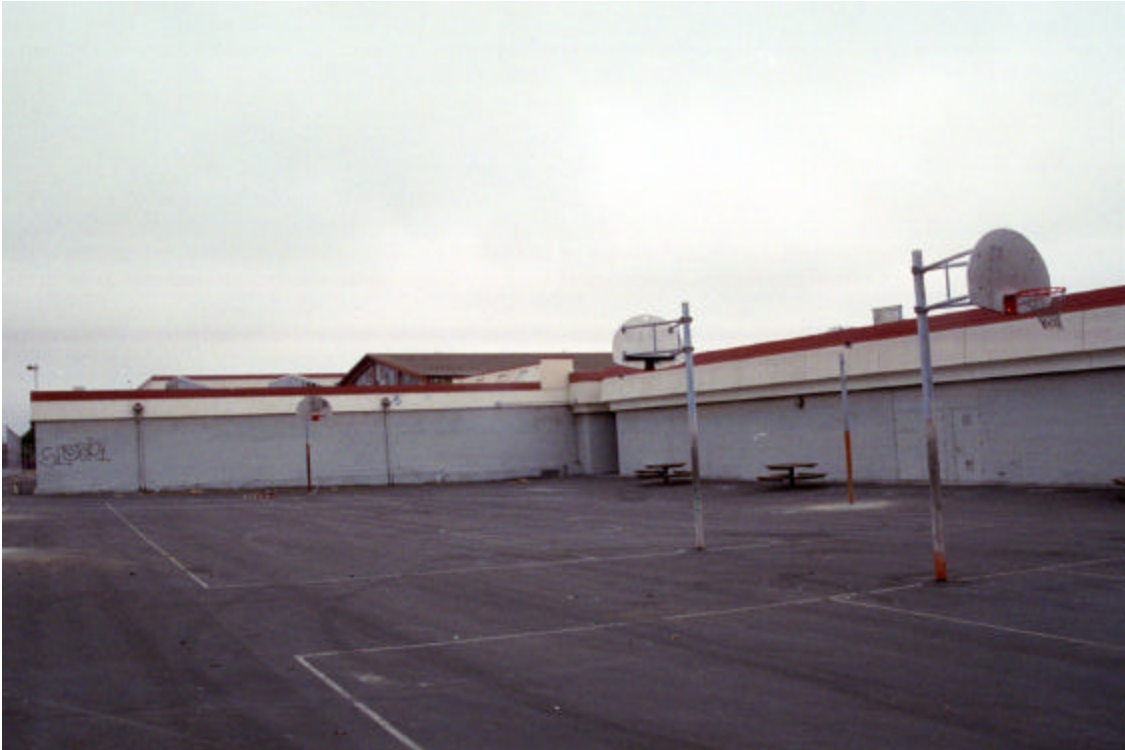
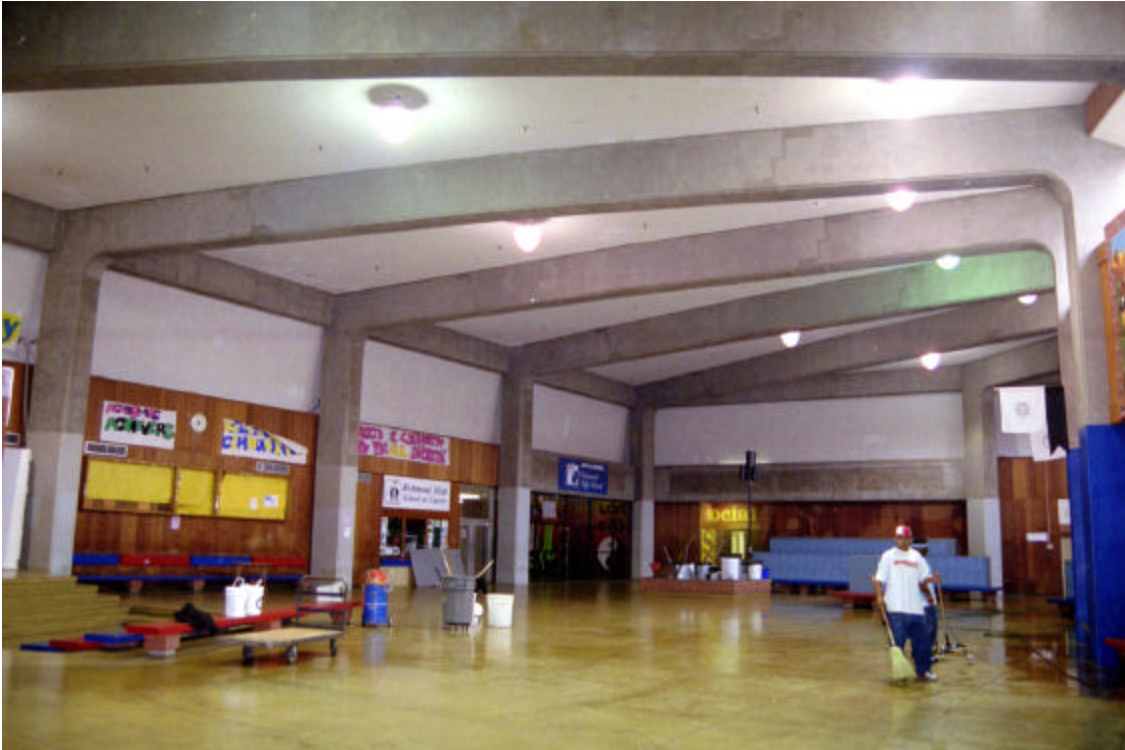
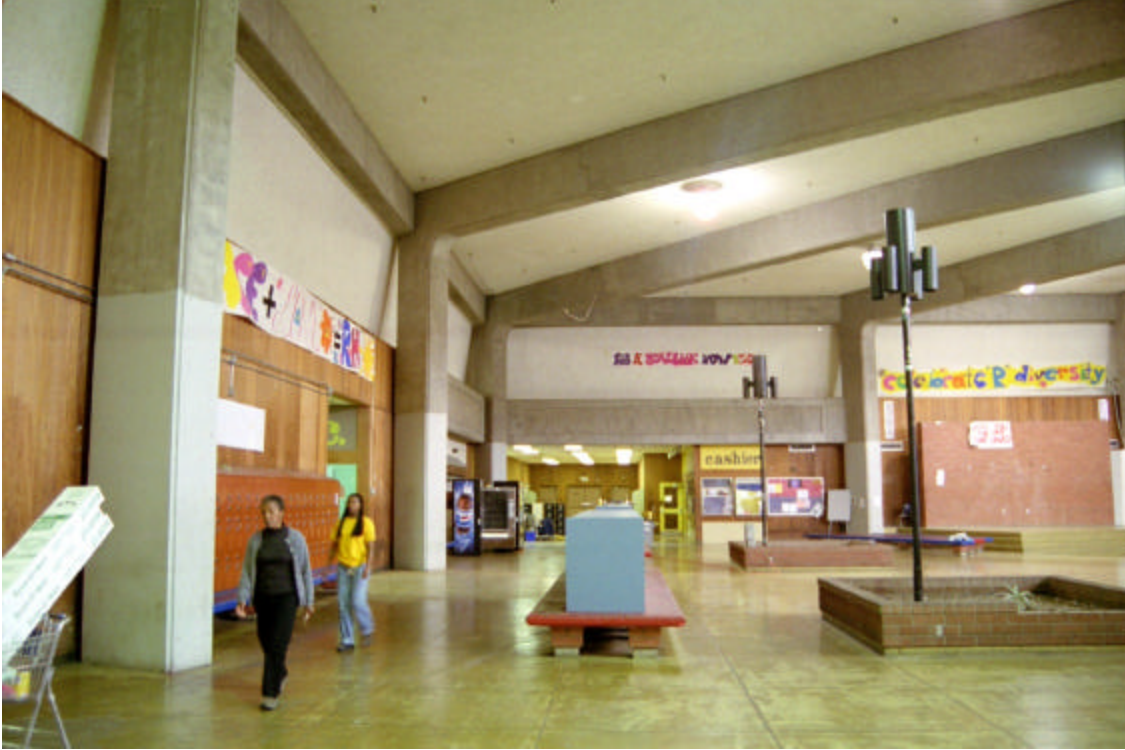
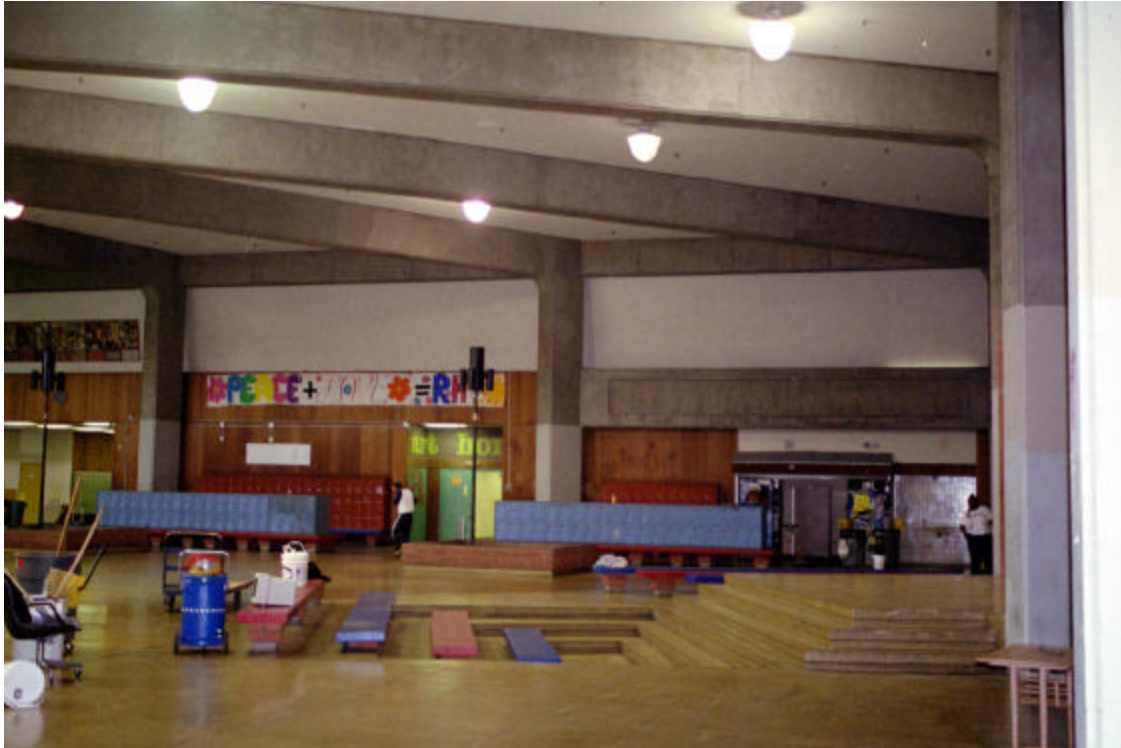
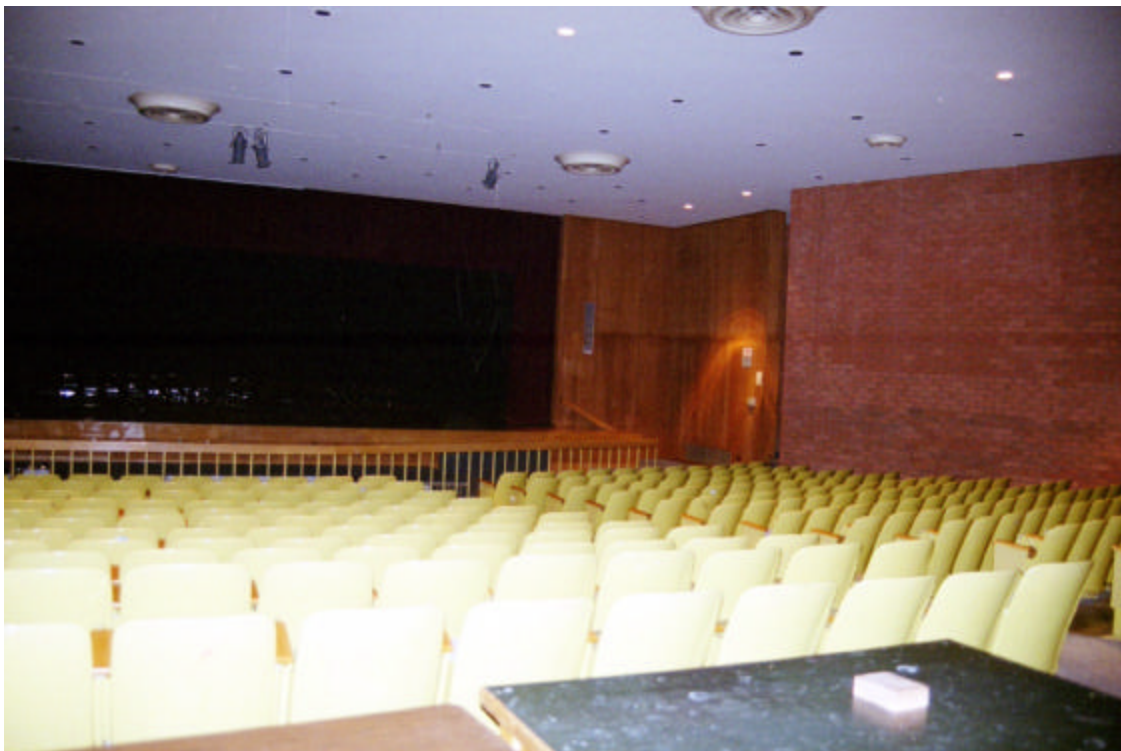
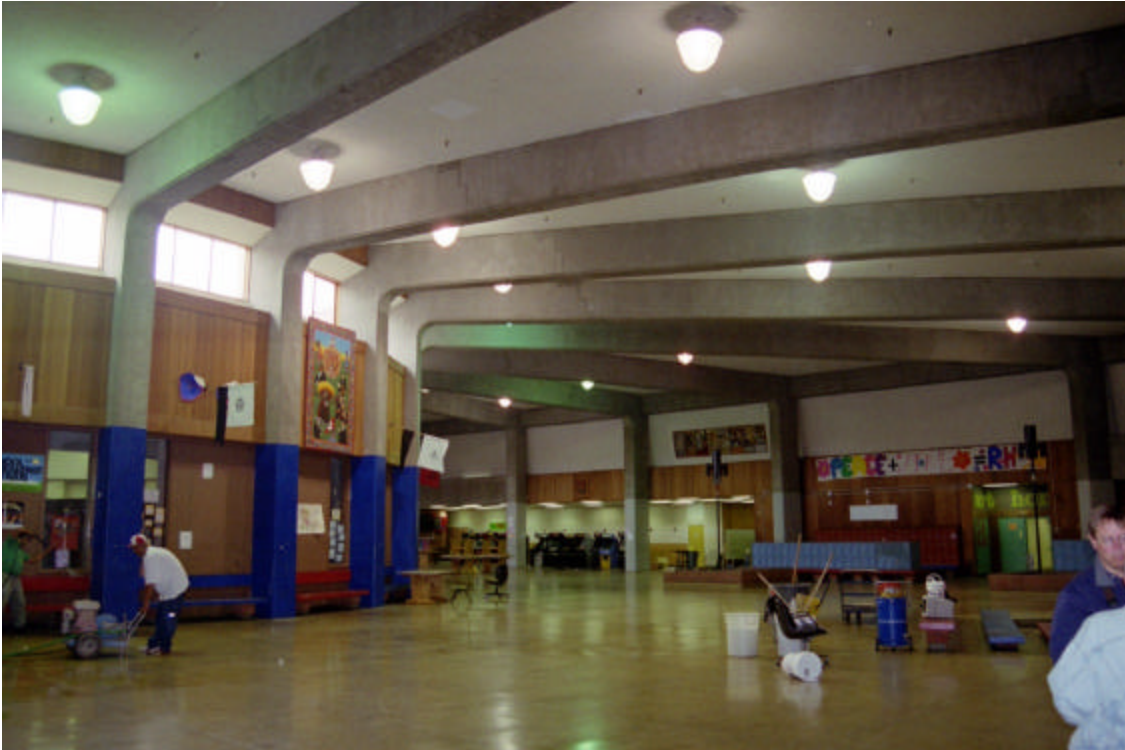
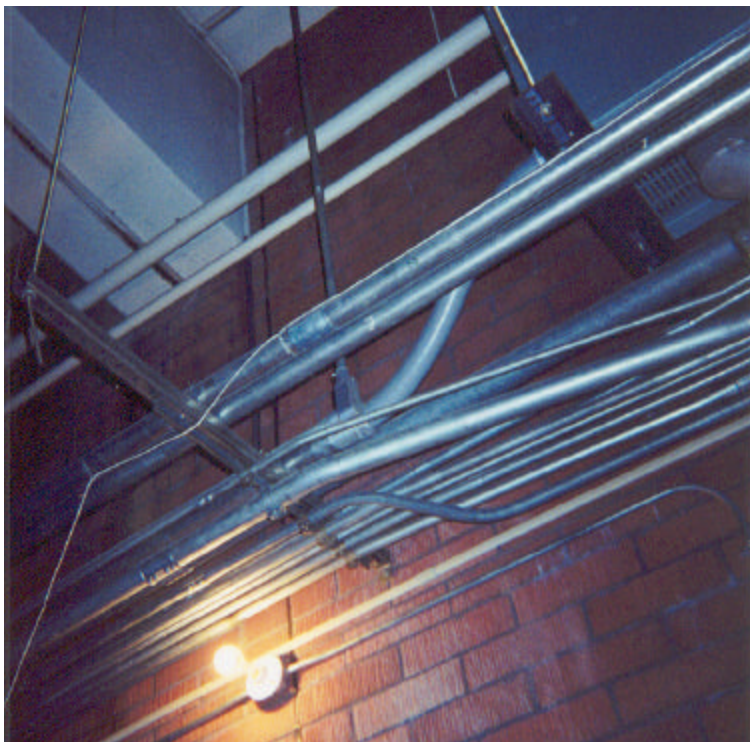
As the largest and most predominant building on campus, Unit D houses a number of functions. In addition to multiple classrooms, the cafeteria, administration offices, theatre, library, and a large commons area can be found in Unit D. The exterior of the building has a full height brick veneer up to an exterior soffit. The building is centered around a large common space with high ceilings. Surrounding this area, shorter classroom areas make up the perimeter, while the theatre wing extend from the south end. From a structural perspective, Unit D is composed of six separate structures, the seismic joints of which are apparent from the exterior of the building. In the classroom areas, the suspended ceiling is observed to be damaged in some areas. The interior walls in this area are drywall. At the central common space, the high roof is supported by concrete frames that extend both oriented both in a radial pattern and at the perimeter lines. Although it is not possible to observe the full detail of the construction, it is noted that concrete moment frame systems from this era traditionally have performed poorly in large seismic events. The hard ceiling in the common area is located at the structure, and the walls have interior wood paneling. The brick veneer that is typical at the exterior also occurs at some interior locations, most notably in the theatre and adjacent entrance area. Surrounded by common area, the circular library has a lower roof than the rest of the central area. High clerestory windows encircle this lower roof area facing into the common area, while additional tall, narrow windows occur between the library and common areas. The combination of these characteristics results in a system with a large diaphragm discontinuity and an unclear load path. Without the proper detailing this system could pose a life safety hazard. Additionally, hard conduits were observed crossing the various seismic separation joints. The inability of this conduit to withstand the differential movements of these separate structures is identified as a life safety hazard. Unit D is shown in figures 3, 4, 5, 6, 7, 8, 9, 10, and 25.

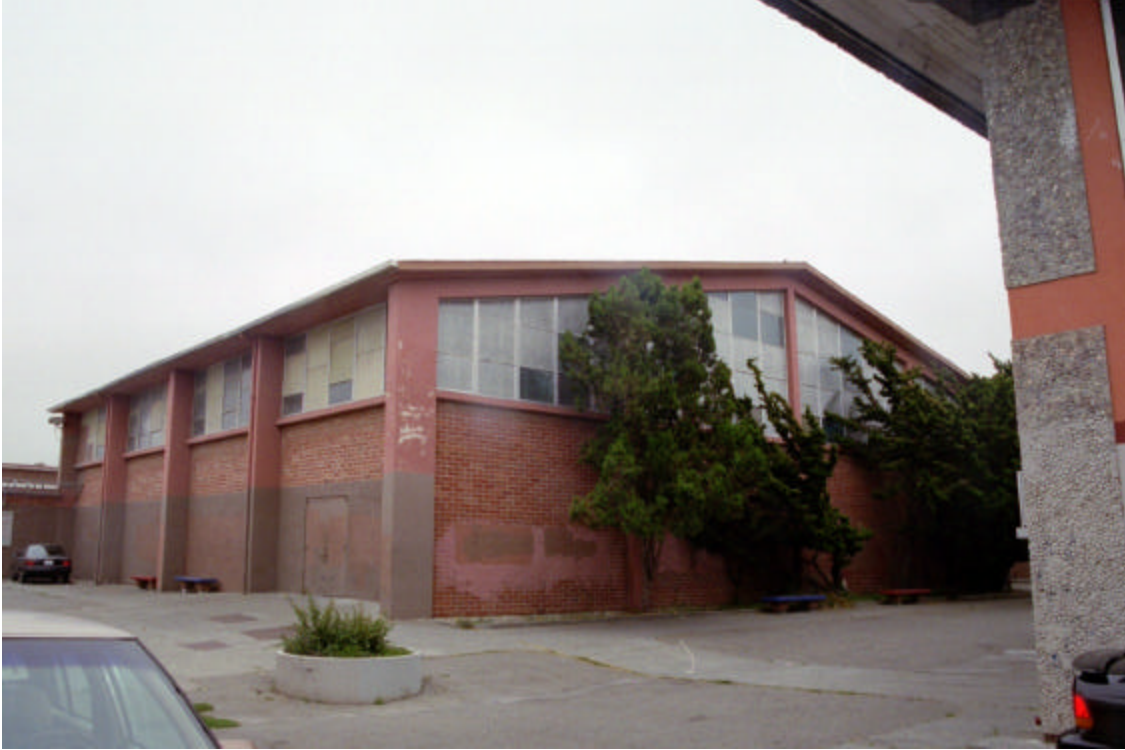
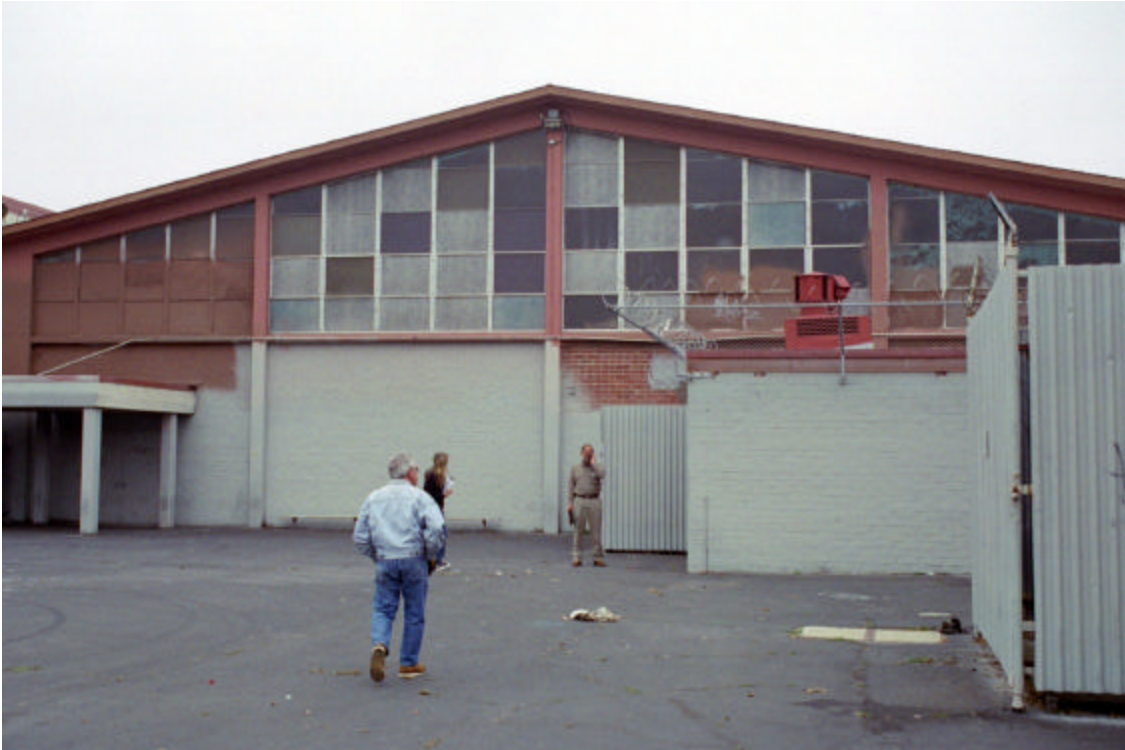
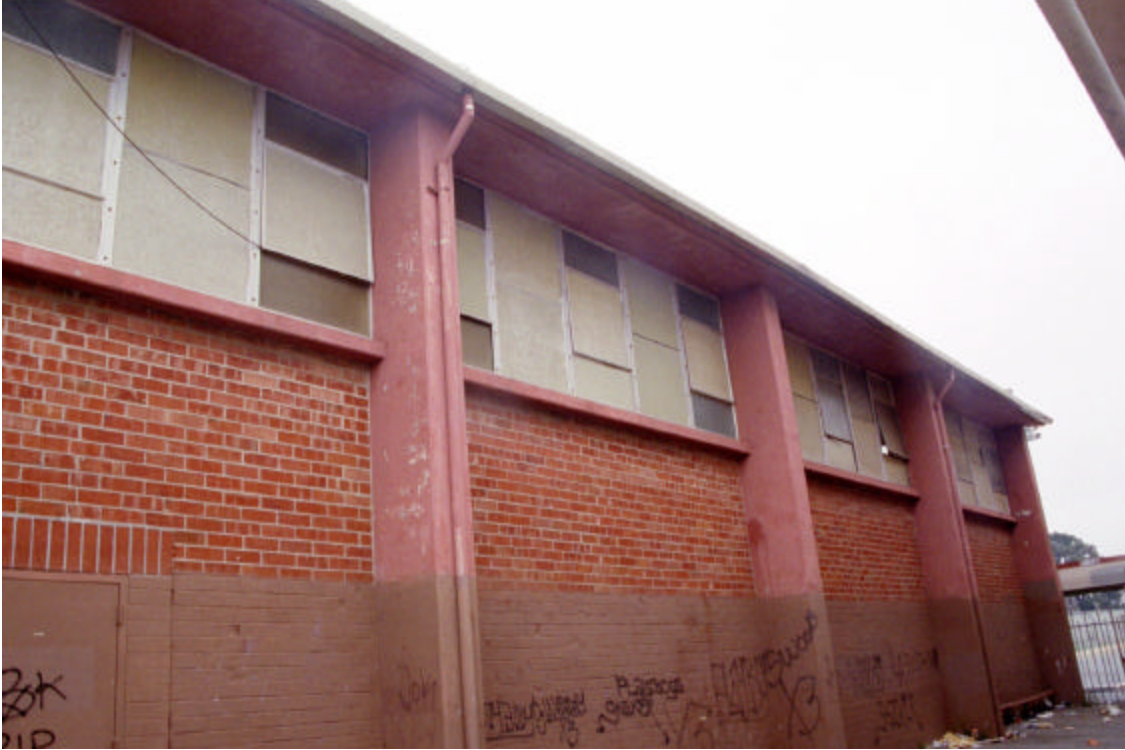
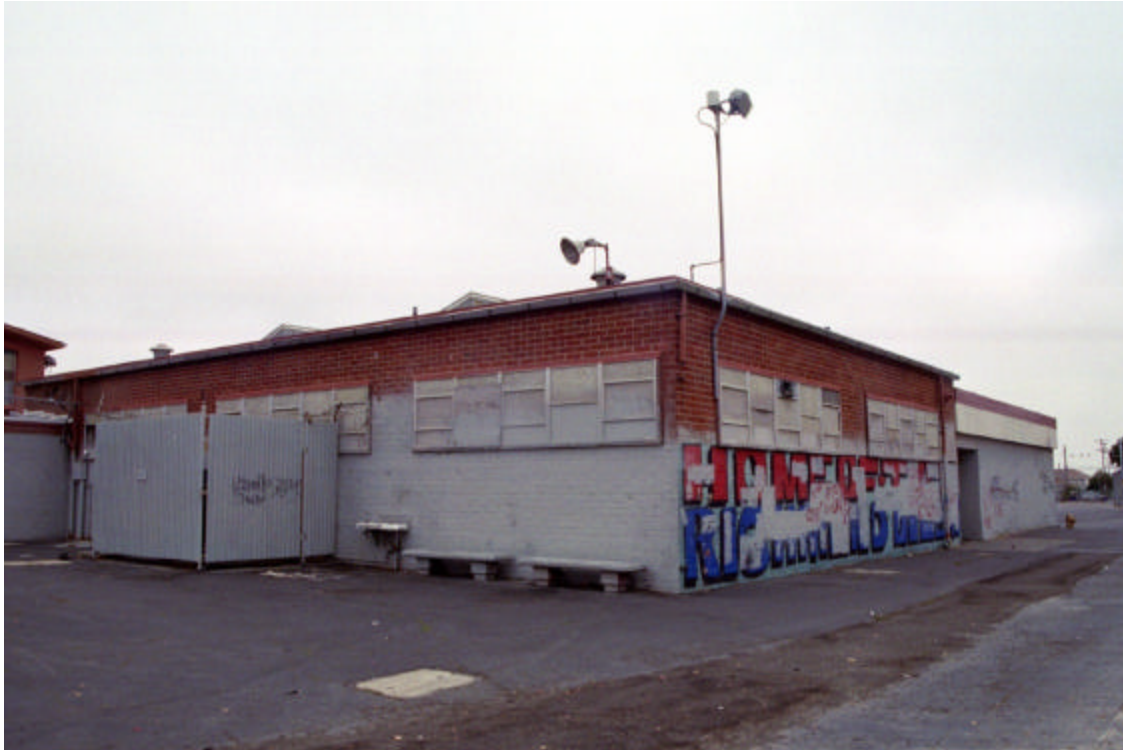
The original gymnasium building, Unit B, is a combination of concrete, steel, and masonry construction. The taller gym area is supported by steel and concrete frames that are infilled with masonry. This masonry stops short of the roof, below continuous high windows that extend around the perimeter gym. This discontinuity forces lateral loads to be transferred solely through both strong and weak axis bending in the columns. Of the remaining locker room portion of the building, half is masonry construction, where further windows similarly inhibit the lateral strength of the building. The other half of the locker room portion differs from the rest of the building by its exterior stucco finish. Although masonry construction may be found beneath the stucco finish it clear that these two parts of the locker room were constructed separately. The

lack of shear strength at the walls with extensive windows appears to constitute a life safety hazard in this building. Unit B is shown in figures 11, 12, 13, and 14.

3.	Unit B: Masonry walls with extensive window openings lack adequate shear strength to resist the prescribed seismic forces.
4.	Unit B: Masonry wall anchorage connection lacks adequate strength to transfer the expected out-of-plane seismic forces.

5.	Unit B: Masonry walls lack adequate flexural strength to resist the expected out-of-plane seismic forces.
6.	Unit B: Horizontal diaphragm truss composed of steel tension rods and metal deck diaphragm lacks adequate strength to resist the expected seismic forces.

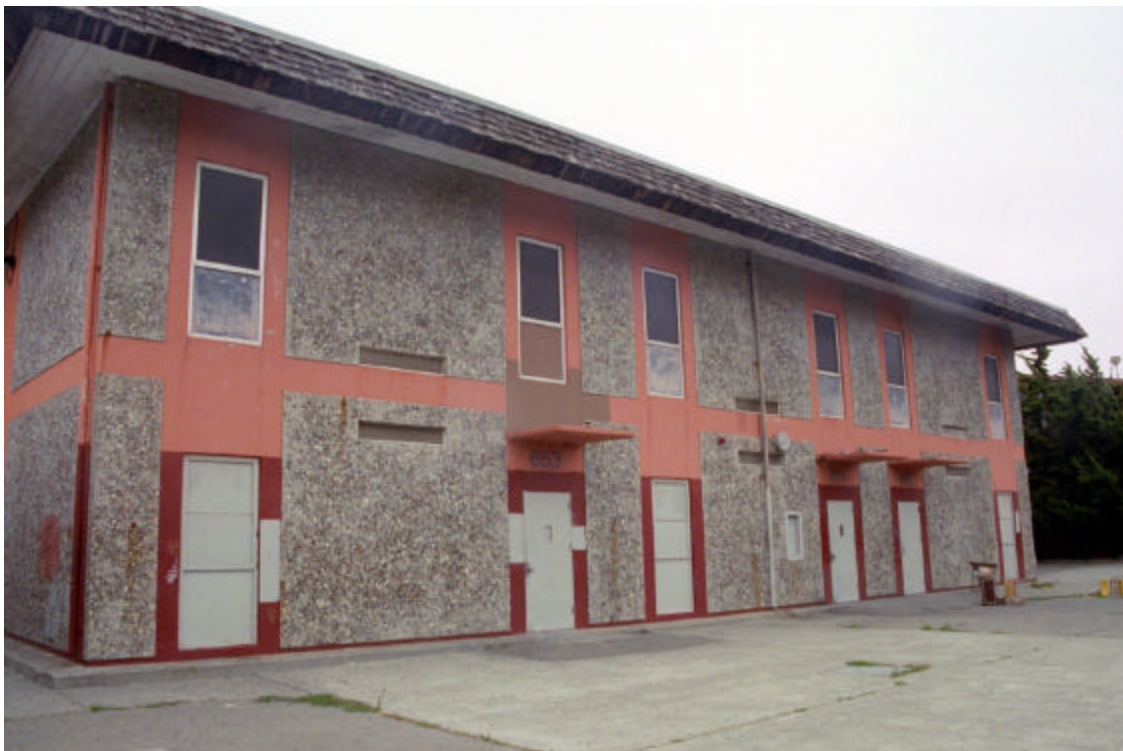
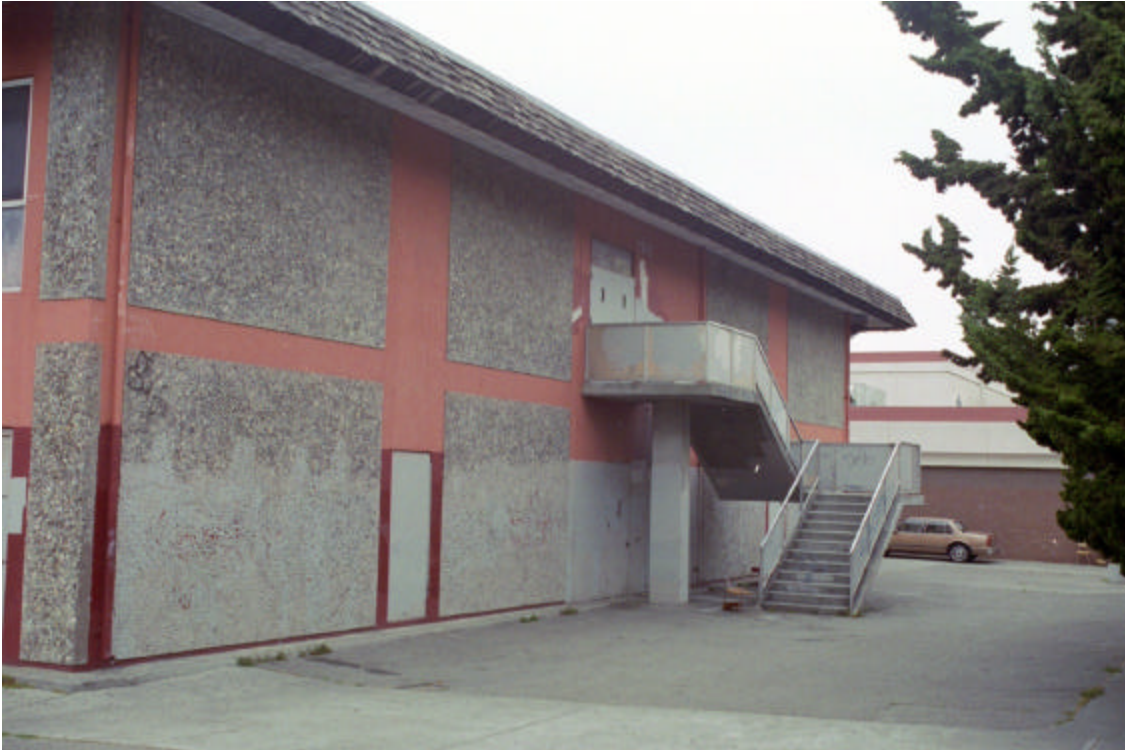
Unit C, the two story building, was built of concrete tilt-up construction with a wood framed roof. A suspended T-bar ceiling was observed in the classrooms. On the exterior a cast-in-place concrete stair provides access to the second floor. Sufficient lengths of concrete wall exist to provide resistance to lateral seismic forces. Although the wall to diaphragm connection was not observable, it is noted that buildings of this type and age typically have insufficient anchorage for the concrete walls under out-of-plane loading. Unit C is shown in figures 15 and 16.

7.	Unit C: Plywood sheathed diaphragm lacks adequate shear strength to resist the expected seismic forces.
8.	Unit C: Concrete wall anchorage connection lacks adequate strength to transfer the expected out-of-plane seismic forces.

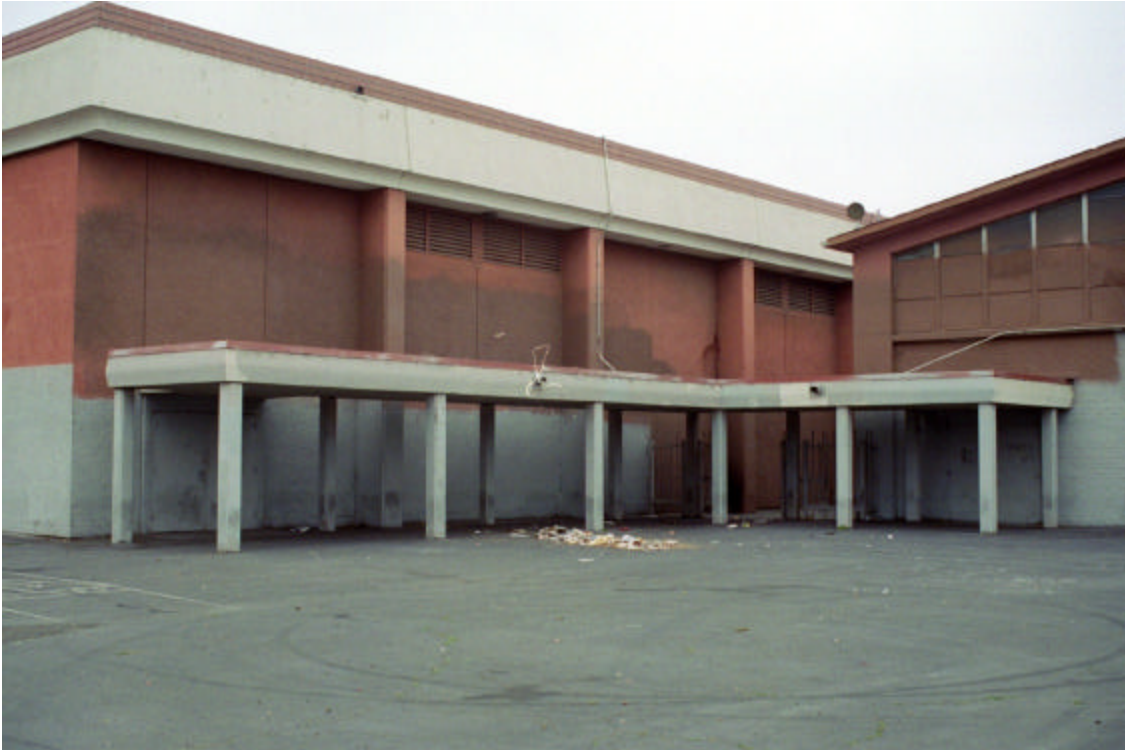
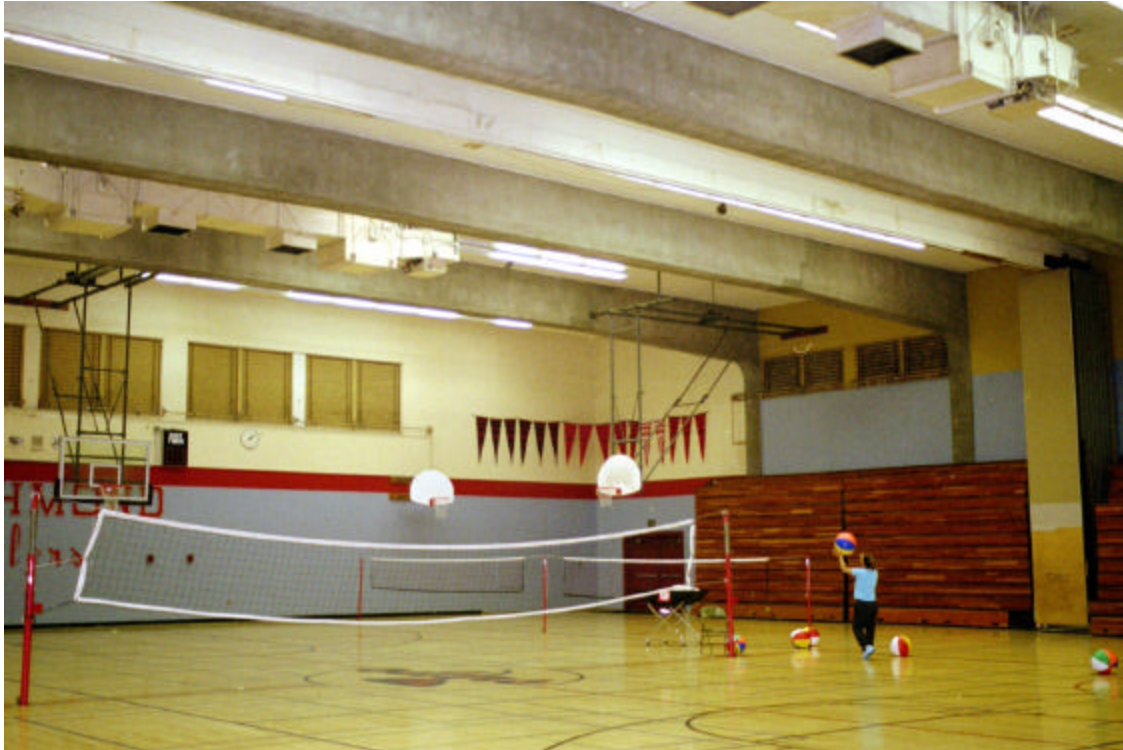
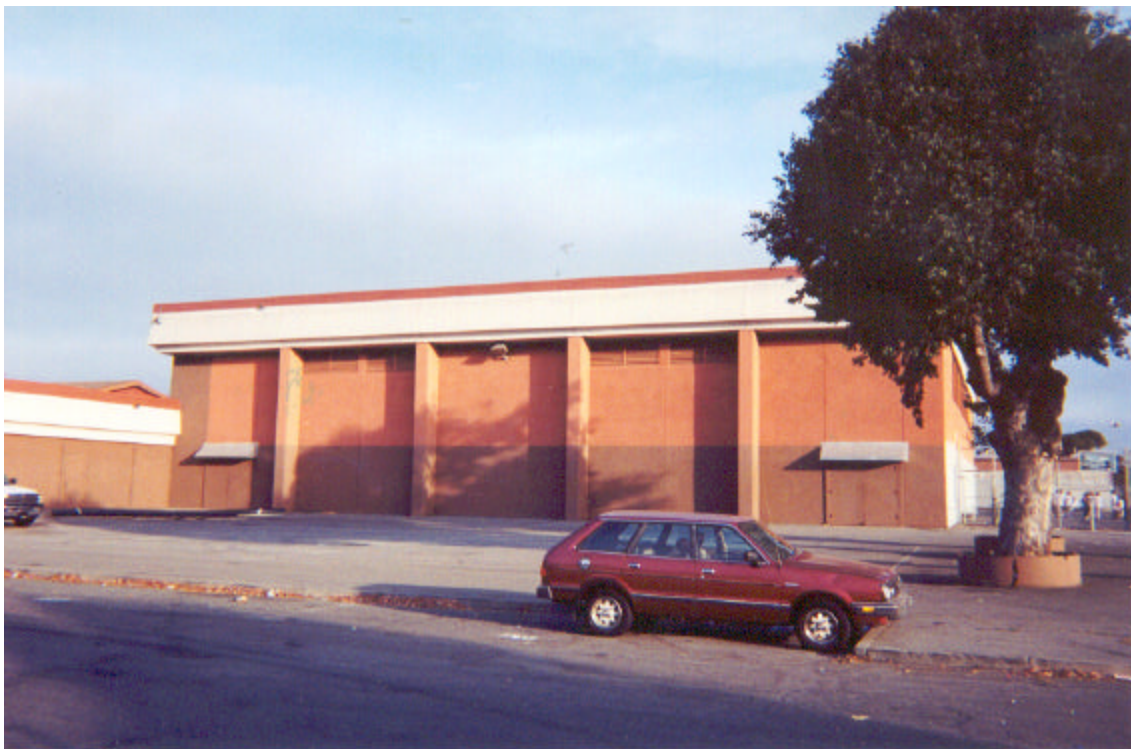
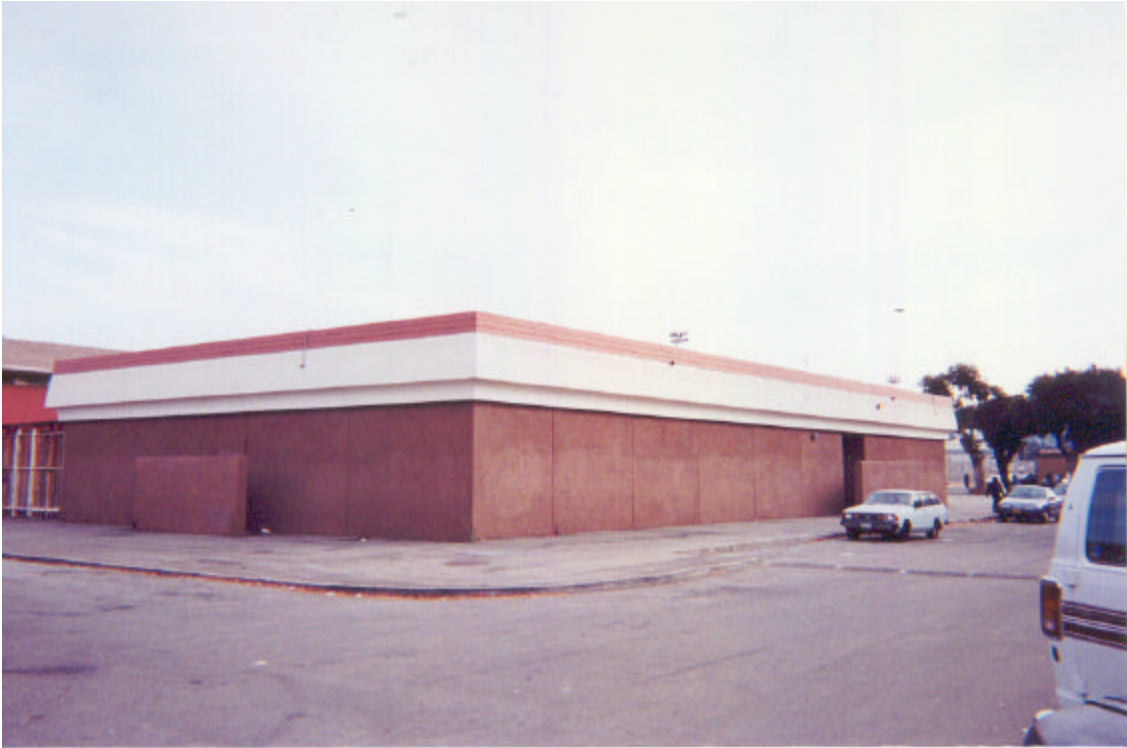
Unit E is the newer gymnasium building on campus. Supporting the roof, concrete frames spanning approximately 80 feet are exposed from the main gym below. Similar to the common area at Unit D, the hard ceiling is located at the structure level. Differing from the brick veneer of Unit D, the exterior of the new gymnasium has a stucco finish along. However, both buildings have the same exterior soffit at the roof level. Extensive lengths of wall indicate that the structure has adequate strength to resist lateral seismic loads. Unit E is shown in figures 17, 18, 19 and 20.

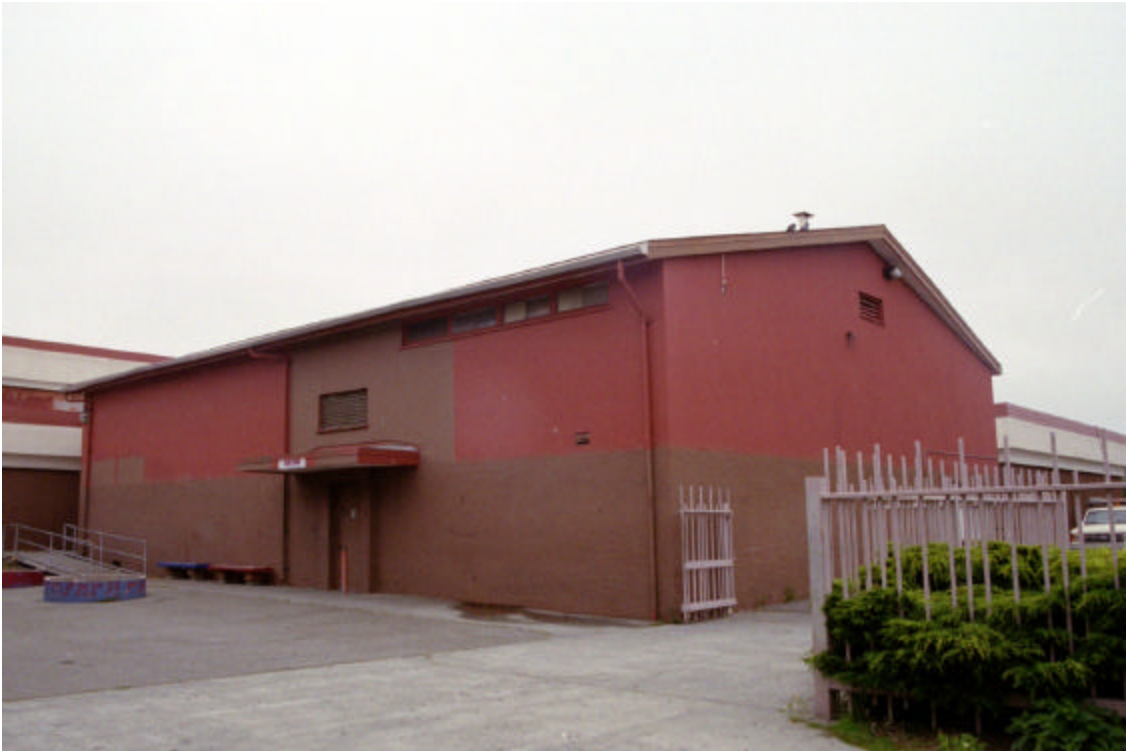
Figure 21: Music Building (Unit F), exterior northwest corner

The music building located in Unit F appears that it may have been built by tilt-up construction. However, given its exterior stucco finish and similar appearance to the adjacent Unit E, it is possible that it may be wood framed structure. The main band room has a high acoustical tile ceiling, while the rear portion of the building has a mezzanine level that is used for storage.

Some high windows were observed near the roof level, but the large amount of solid wall suggests that the building has sufficient shear wall strength. Unit F is shown in figure 21.

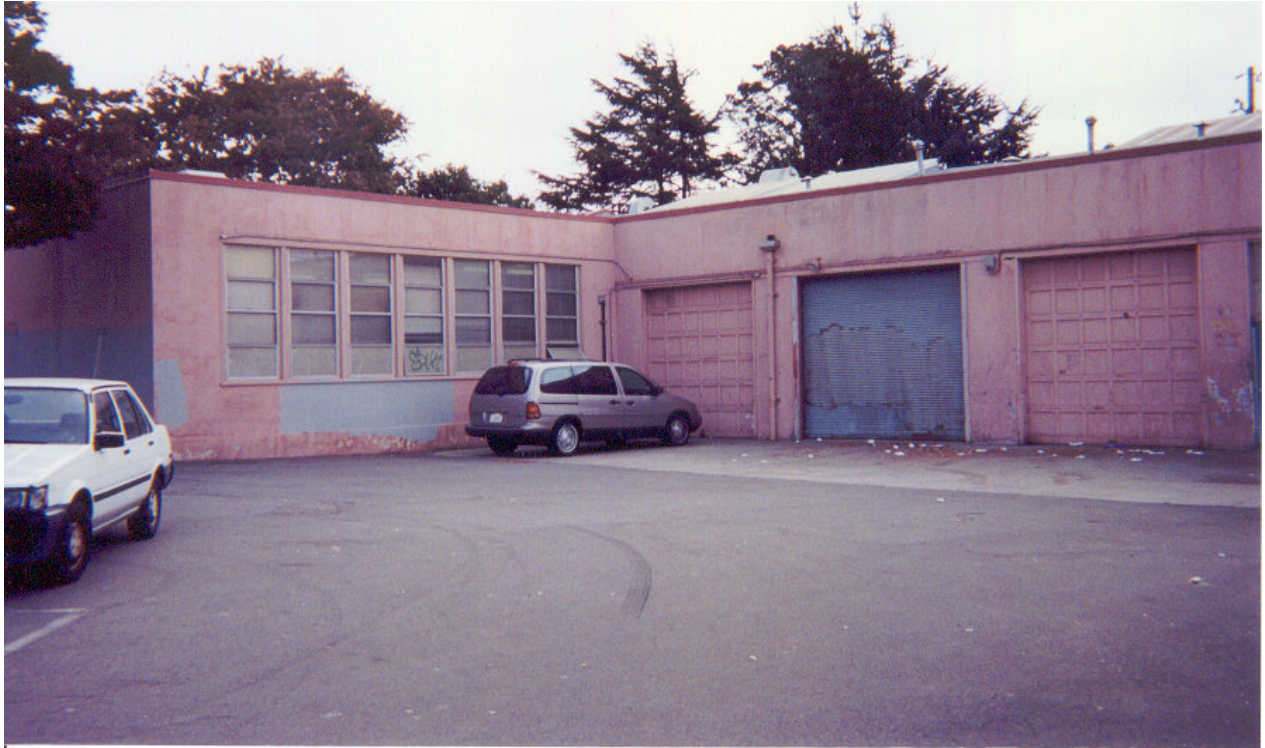
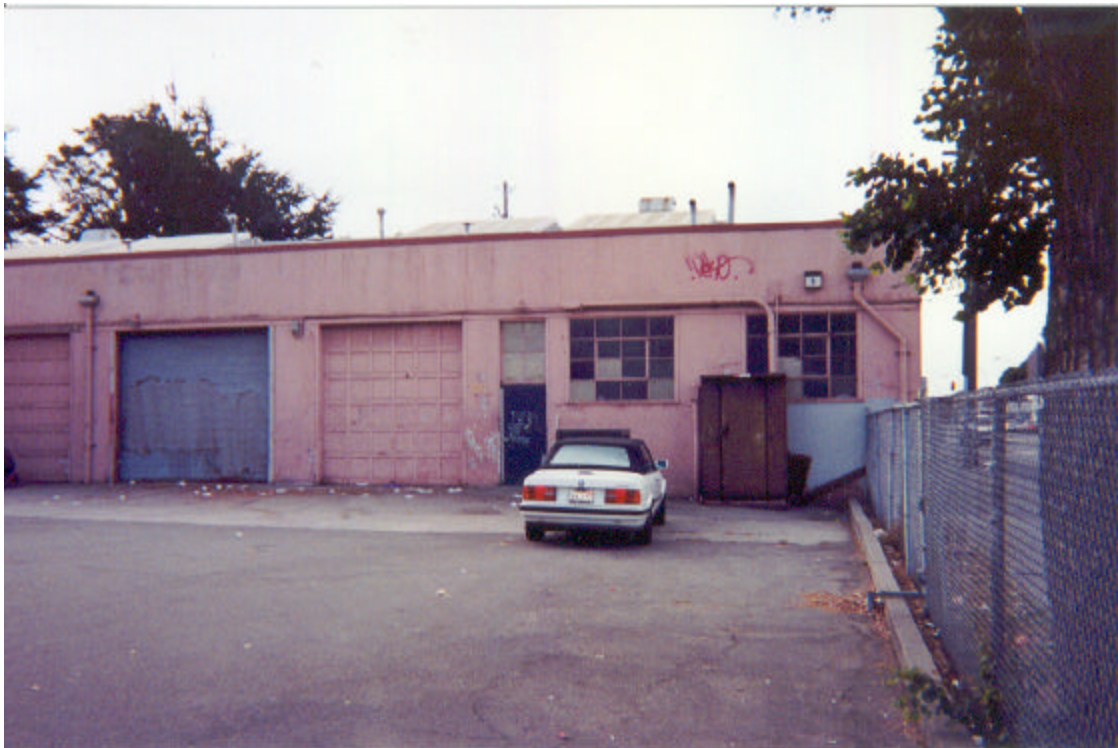
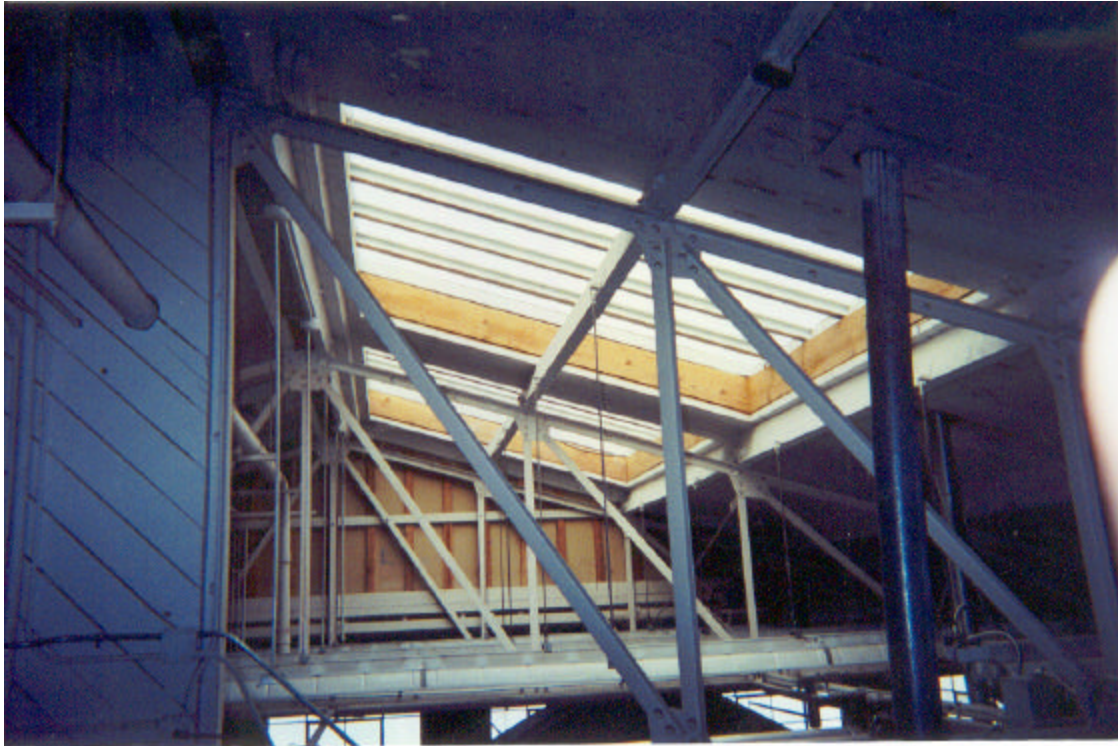
The shop building, Unit A, is a one story building that is isolated from the rest of the campus at the opposite end of the parking lot. According to one teacher, this building was originally an independent print shop that was acquired by the campus at some point. This information in combination with the fact that original construction drawings were unable to be located either by the district or the Division of the State Architect (DSA) suggests that this building may have never received DSA approval. If this is in fact the case, it is likely that DSA will require a mandatory seismic upgrade (per the provisions of the 2001 California Building Code) of the structure. The requirements of this type of upgrade would exceed both in scope and cost, the remediation procedures recommended by this report. The structure is observed to be of very old construction that uses a hybrid framing system. The roof is framed with riveted roof trusses that support wood beams. The diaphragm is composed of a combination of straight sheathing and steel tension rods that are located at the bottom chord of the steel trusses and span in the weak direction of the straight sheathing. The minimal strength of these two diaphragm systems appears to be inadequate in comparison to the expected seismic forces, and constitutes a life safety hazard. The roof is punctured with many openings, including a large skylight. Some of the building's interior walls are unfinished revealing diagonal sheathing; however, these walls are not connected to the tension rods for the transfer of seismic forces. The exterior walls have a stucco finish, and have extensive window and garage door openings. Due to the large number of openings, the walls appear to have inadequate strength to resist the expected seismic forces, and consequently a life safety hazard is perceived. Unit A is shown in figures 22, 23, and 24.

Item	Building Structural Deficiencies
1.	Unit A: Walls with extensive window openings are likely to lack adequate shear strength to resist the prescribed seismic forces.

2.	Unit A: Horizontal truss composed of steel tension rods and straight sheathed diaphragms are likely to lack adequate strength to resist the expected seismic forces.

Item	Recommended Remediation	Priority	Drawing Number
1.	Provide new plywood sheathing at existing wood stud walls with new hold-down anchors into foundation.	1.0	N.A.

2.	Remove existing straight sheathing and provide new plywood sheathing at roof with nailing into existing framing.	1.0	N.A.
3.	Provide new concrete wall in-fill at existing window locations with dowels into the existing masonry wall.	1.0	1, 2
