STRUCTURAL EVALUATION OF
RICHMOND HIGH SCHOOL
WEST CONTRA COSTA UNIFIED SCHOOL DISTRICT
(WCCUSD)

WLC Architects
Kaiser Building
1300 Potrero Avenue
Richmond, CA 94804

DASSE Design, Inc.
33 New Montgomery Street #850
San Francisco, CA 94105
(415) 243-8400

October 17, 2002

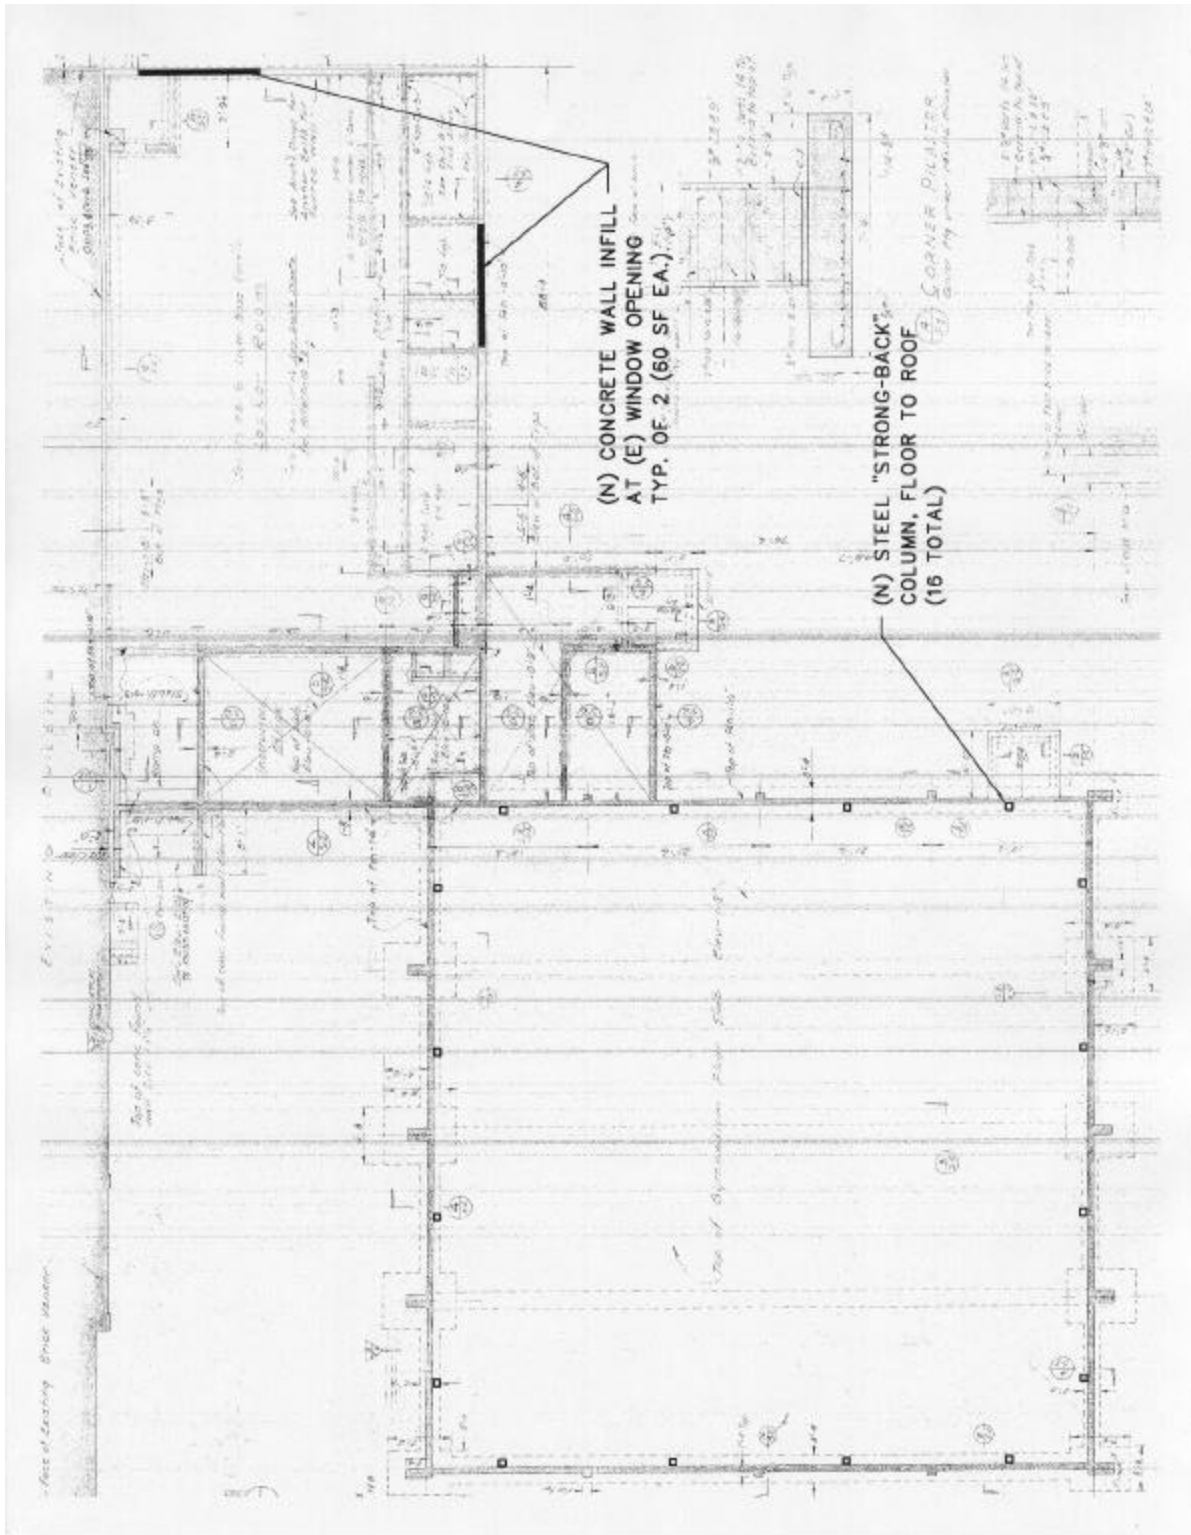
Drawing 1: Old Gymnasium Building (Unit B), Foundation Plan

3.	Unit B: Masonry walls with extensive window openings lack adequate shear strength to resist the prescribed seismic forces.
4.	Unit B: Masonry wall anchorage connection lacks adequate strength to transfer the expected out-of-plane seismic forces.

2.	Remove existing straight sheathing and provide new plywood sheathing at roof with nailing into existing framing.	1.0	N.A.
3.	Provide new concrete wall in-fill at existing window locations with dowels into the existing masonry wall.	1.0	1, 2

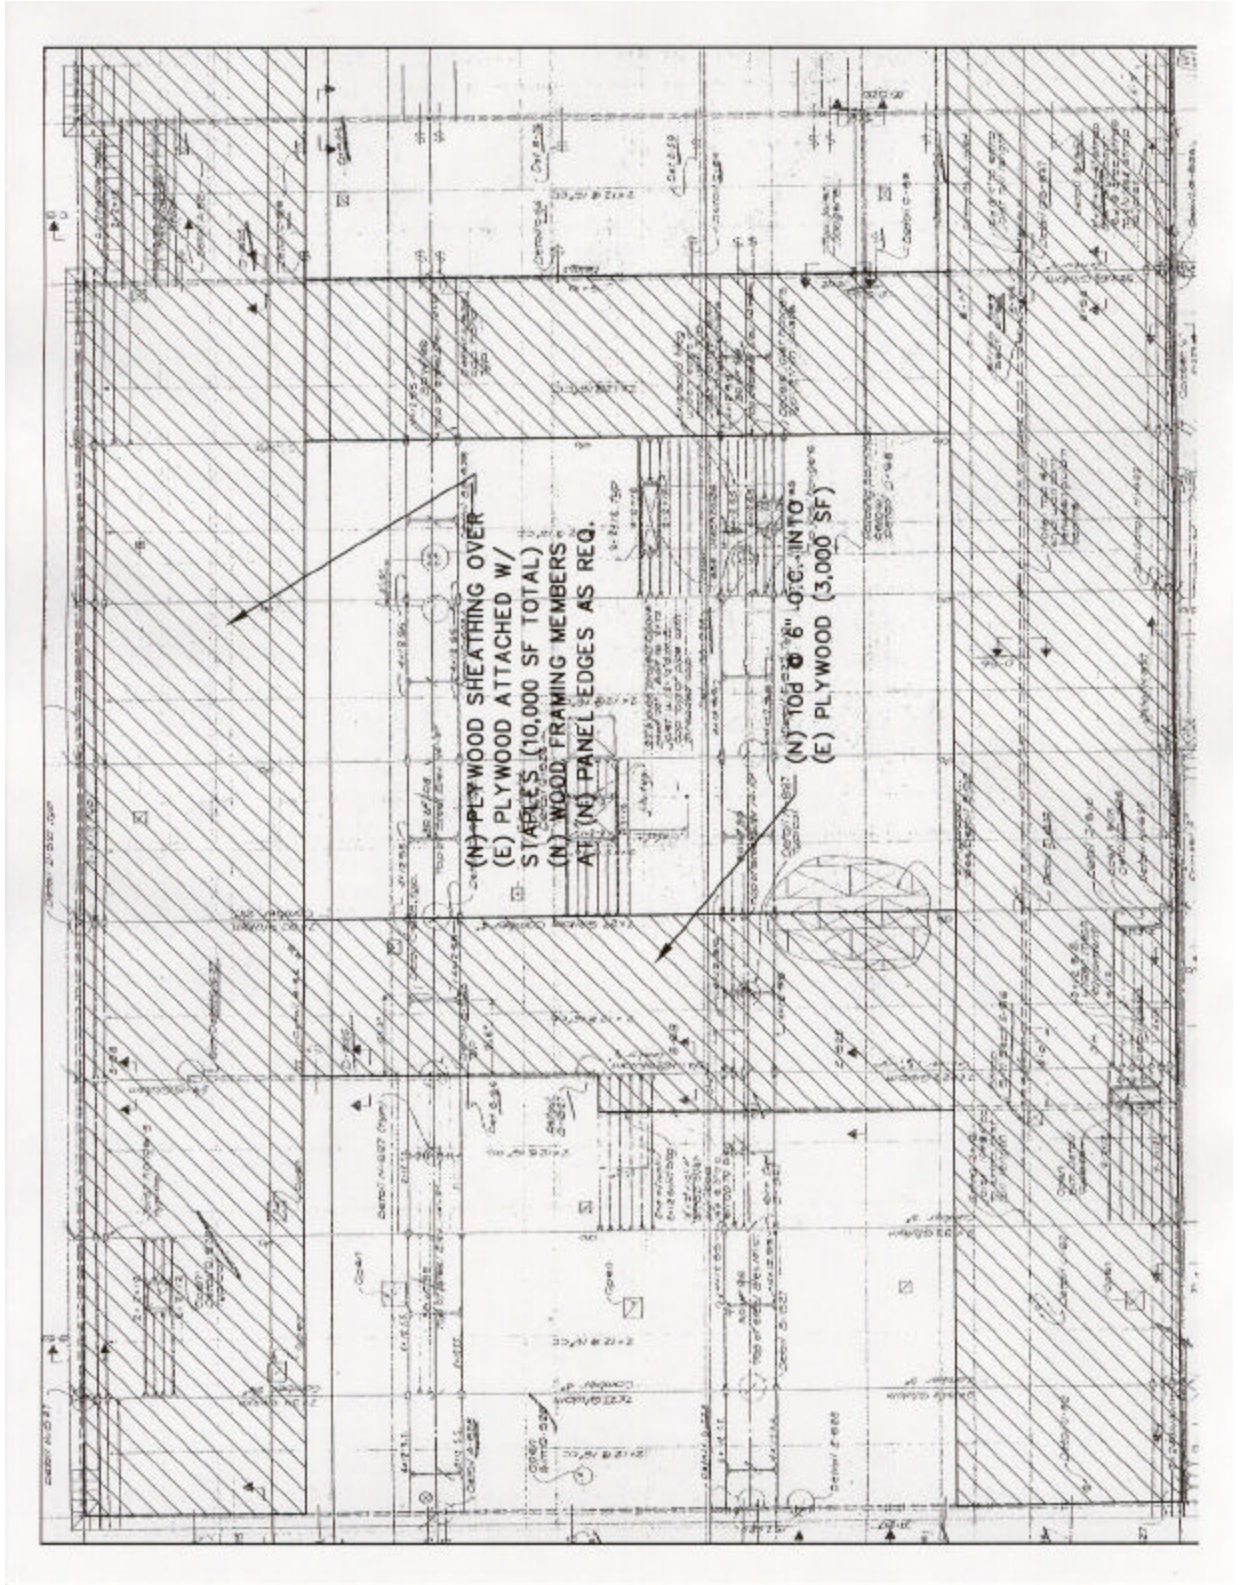
Drawing 7: Classroom Building 100 (Unit D), Roof Framing Plan

9.	Unit D, 100/200: Plywood sheathed walls lack adequate shear strength to resist the expected seismic forces.
10.	Unit D, 100/200: Plywood sheathed diaphragm lacks adequate shear strength to resist the expected seismic forces.

10.	Provide new diaphragm nailing at existing plywood panel	2.5	7, 8

Item	Recommended Remediation	Priority	Drawing Number
	edges (transverse). Provide new plywood sheathing over existing attached with staples. Provide new framing members at new panel edges as required (longitudinal).
