STRUCTURAL EVALUATION OF

CASTRO ELEMENTARY SCHOOL

WEST CONTRA COSTA UNIFIED SCHOOL DISTRICT
(WCCUSD)

April 30, 2002

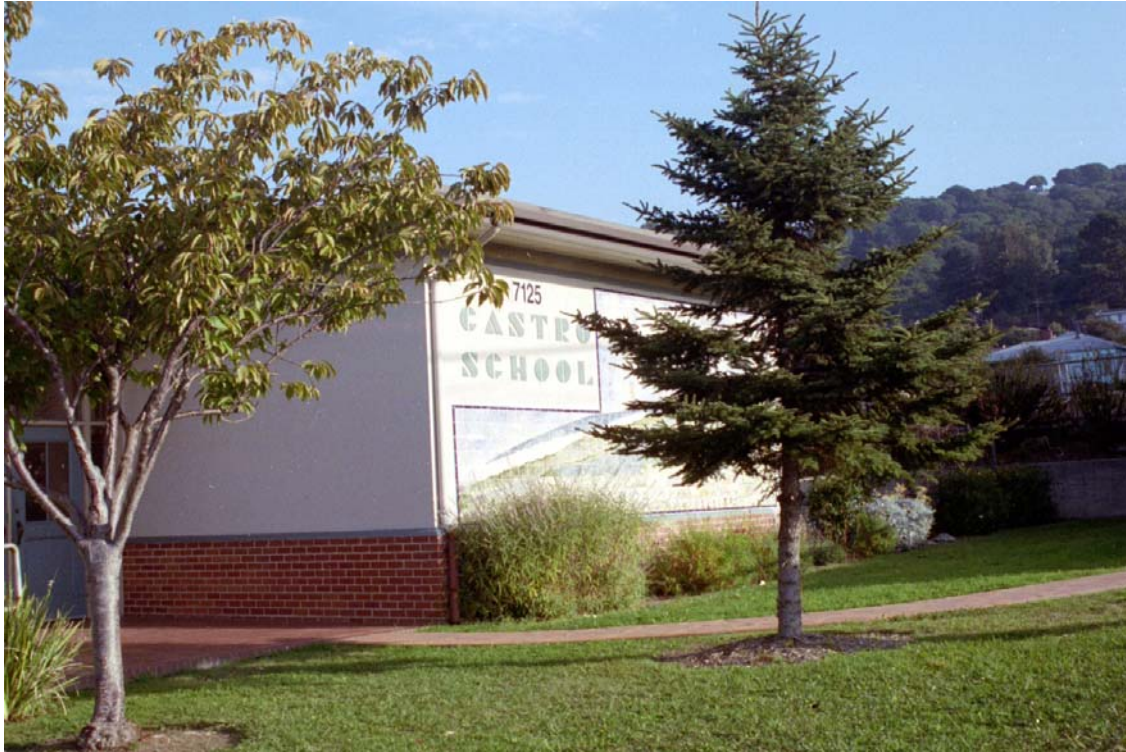
Figure 2: Unit A (main classroom building), entrance

The main classroom building (Unit A) is built into a hillside such that it is partially a two-story structure (see figures 2, 3, 4, and 10). An exterior brick veneer occurs at the lower level, while the exterior finish of the main level is a wainscot brick veneer with stucco above. At the classrooms, the exterior walls are continuous window walls (see figure 3), while the typical corridor walls have a plaster finish. In the basement, a leaking retaining wall was observed, the cause of which should be investigated further. Near the center of the building a brick chimney extends above the roof. Located at the lower end of the campus, the second classroom building (Unit B), which houses the kindergarten classrooms, is a wood-framed single story building (see figures 8 and 9). This structure also has extensive window walls. Around a large skylight over the hallway cracks in the ceiling were observed, indicating that this building is pulling apart. The multipurpose building (Unit C) is another single story, wood framed building (see figures 6 and 7). This structure differs from the others on the campus because it is framed with a series of glue-laminated, 3-pinned arches spaced at 4'-0" on center (see figure 7). The other building of Unit C is the classroom building, which was constructed very similarly to the main classroom building. These two buildings of Unit C are connected by a covered walkway. The roof of this walkway structure is sheathed with straight board sheathing, and is supported by the adjacent buildings. Because the covered walkway is connected to two different structures, it has the potential to pull apart and lose gravity support if the buildings experience opposing displacements during a seismic event. This constitutes a life safety hazard. Additionally, electrical conduit was found to be running along the covered walkways between multiple buildings. Due to the inability of the hard conduit to withstand these differential movements, this is also identified as a life safety hazard. The two portable buildings located at the east side of the playground area appear to have been built on intermittent foundations. This type of discontinuous foundation does not provide for the transfer of lateral loads, and its vulnerability to a toppling type failure is a life safety hazard. At its rear longitudinal wall, the northernmost of these two structures has a continuous window wall, which appears to have insufficient shear strength constituting a life safety hazard.

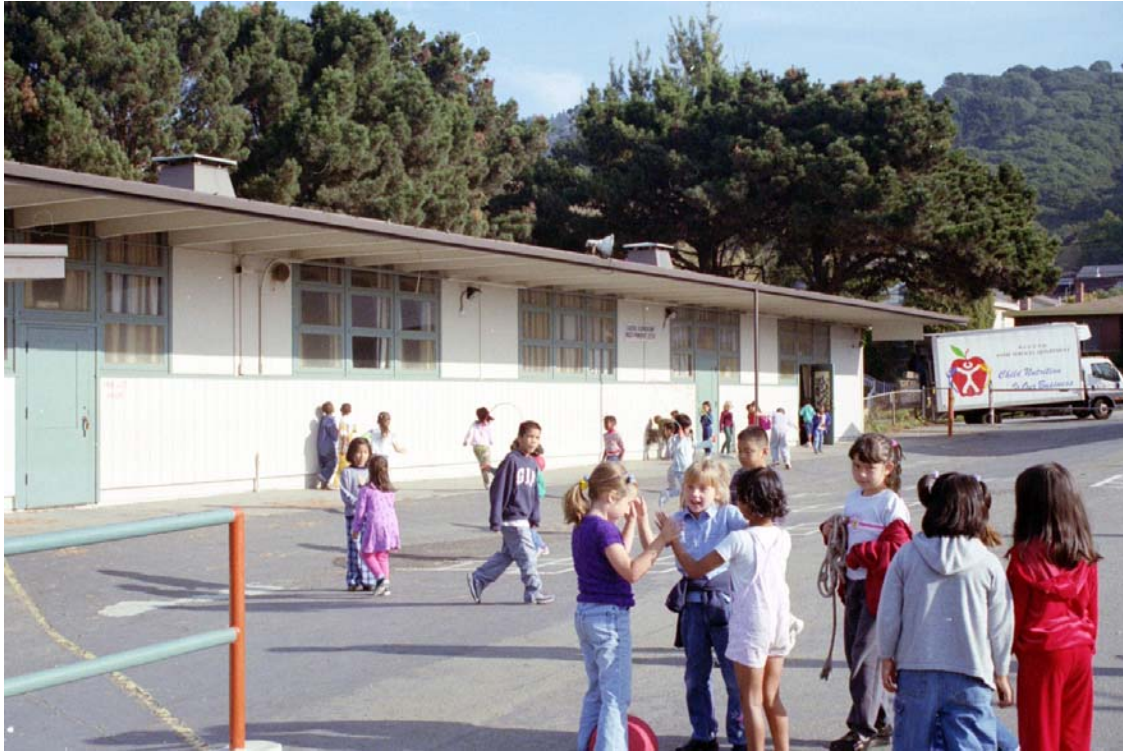
Figure 6: Unit C (multipurpose building), south face

6.	Unit B (classroom building): Positive connection of shear walls to foundation is lacking at some locations.
7.	Unit C (multipurpose building): Existing wood shear panels are discontinuous between the roof and foundation levels.

6.	Provide new holdown anchors into existing foundation at lacking locations.	1.5	N/A
7.	Provide new plywood sheathing at longitudinal walls between window locations.	1.1	6

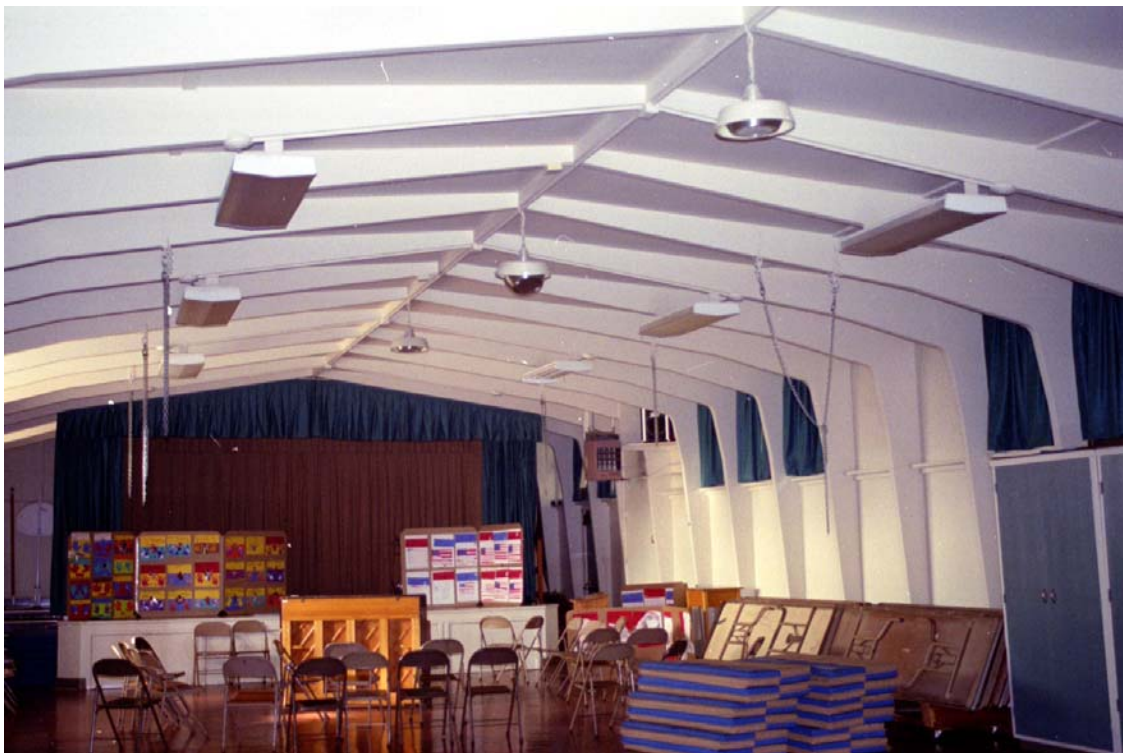
Figure 7: Unit C (multipurpose building), interior

The multipurpose building of Unit C has a framing system unique to the other buildings found on this campus. A series of 3-pinned arches constructed out of glue laminated timbers support a panelized roof system (figure 7). The glue-lam arches are spaced at 4'-0" and span the 30'-0" width of the building. The roof diaphragm is composed of 1/2" plywood with intermediate stiffener members. The walls between the glue-lam arches are framed with intermediate horizontal wood members. Diagonally sheathed (1x6) shear panels are intended to resist lateral forces in the longitudinal direction, while lateral forces in the transverse direction are resisted by the glue-lam arches and end shear walls. The longitudinal shear panels do not extend to the roof level, but instead rely on weak axis bending of the glue-lam arches to transfer forces from the roof to the sheathed wall below the windows, which is an inadvisable system. The transverse shear walls have few openings, and the large number of arches provides a redundancy that is advantageous in resisting seismic forces. However, the arches lack a positive tie at the center hinge and have an undefined foundation connection, both of which are important for the resistance of lateral seismic loads. Continuity for the transfer of chord and collector forces is provided through a wood screw splice. Reinforced concrete strip footings with a 1'-2" width support the entire structure. A positive connection between this foundation and the wood shear walls for the purpose of resisting uplift forces does not exist, but this is not deemed critical given the shear wall lengths and tributary gravity loads. The discontinuous longitudinal shear walls and the lack of continuity tie at the glue-lam arch are identified as a life safety issues at the multipurpose building. The existing roof of the multipurpose building at Unit C is about 19 years old and appears to need replacement.

8.	Unit C (multipurpose building): Positive tie across three-hinged arch is lacking. Foundation connection of three-hinged arch is unclear.
9.	Unit C (classroom building): Strength of 1x6 wood “let-in braces” is inadequate to resist prescribed forces.

8.	Provide new strap across center of each glue-lam arch. Investigate the existing foundation connection of the glue-lam arches to determine if strengthening of connection is required.	1.2	7

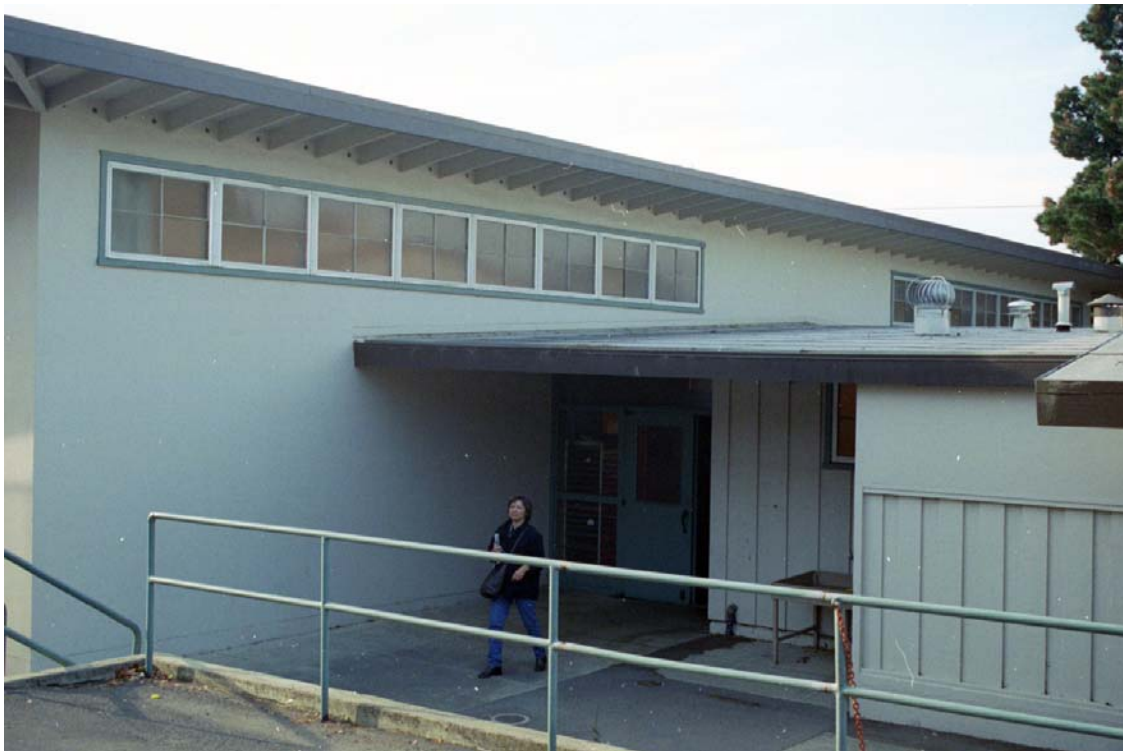
Figure 9: Unit B (classroom building), west face

Unit B, the classroom building, is a traditionally framed wood structure. Roof joists (2x14 and 2x16 spaced at 24" on center, typical) span between 2x6 wood stud, bearing walls. The roof is sheathed with 3/8" and 1/2" plywood and is discontinuous across 3 different levels (figure 9). At this discontinuity the lower roof framing is susceptible to ripping away from the supporting bearing wall due to differential displacements. Around the hallway skylight, the framing does not provide a continuous diaphragm tie at the ridge. This lack of continuity has resulted in the ceiling cracking observed and poses a concern, as the diaphragm is likely to pull apart in a seismic event. The structure resists seismic loads through both exterior and interior wood shear walls that are sheathed with 3/8" plywood. Some of the exterior walls are window walls or have clerestory windows (figures 8 and 9), but sufficient shear resistance is provided by the plywood shear walls at most locations. Double top plates with well nailed splice connections provide continuity for the transfer of chord and collector forces. At a couple of interior shear walls the shear strength is deficient, and at one critical wall an adequate collector member is not provided. The building is founded on reinforced concrete strip footings varying in width from 1'-0" to 2'-4". A positive tie down connection between this foundation and the wood shear walls for the purpose of resisting uplift forces is provided at the most critical locations, but not at all necessary locations. The local deficiencies in diaphragm discontinuities, shear wall strength, continuity of collector members, and foundation tie downs represent life safety concerns at Unit B. The existing roof of the classroom building, Unit B, is about 19 years old and appears to need replacement.

2.	Unit A (main classroom building): Strength of chord/collector splices is inadequate to resist prescribed forces.
3.	Unit B (classroom building): Plywood diaphragm is discontinuous at a common bearing wall with no provision to accommodate differential movement. Plywood diaphragm is discontinuous at the ridge around the large skylight opening.

2.	Provide new strapping at inadequate locations.	1.5	N/A
3.	Provide new post and beam support at lower roof framing at discontinuous location. Provide new strapping across ridge.	1.5	9
