STRUCTURAL EVALUATION OF
DOWNER ELEMENTARY SCHOOL
WEST CONTRA COSTA UNIFIED SCHOOL DISTRICT
(WCCUSD)

WLC Architects
Kaiser Building
1300 Potrero Avenue
Richmond, CA 94804

DASSE Design, Inc.
33 New Montgomery Street #850
San Francisco, CA 94105
(415) 243-8400

APRIL 30, 2002

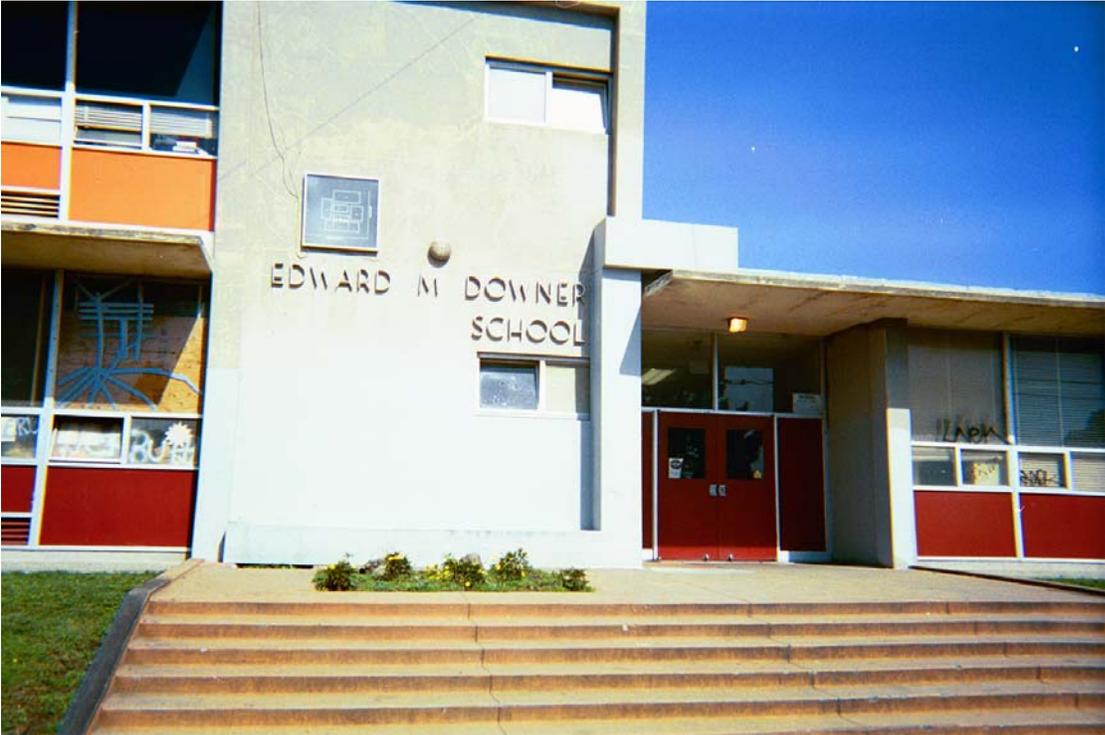
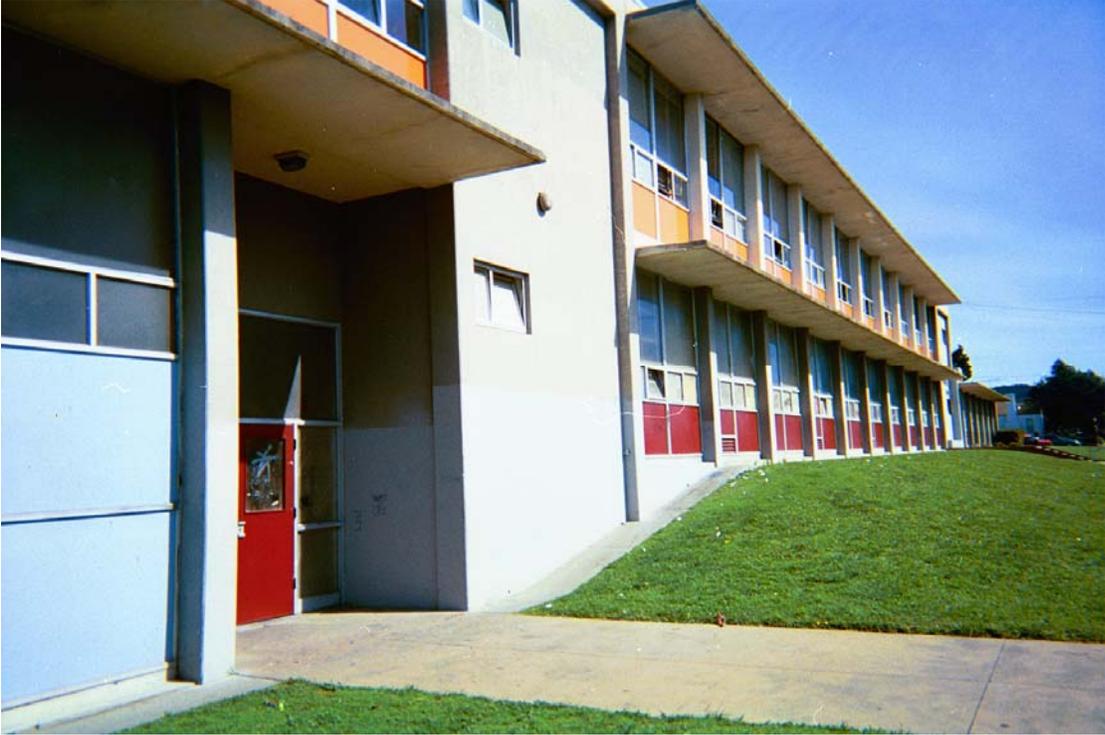
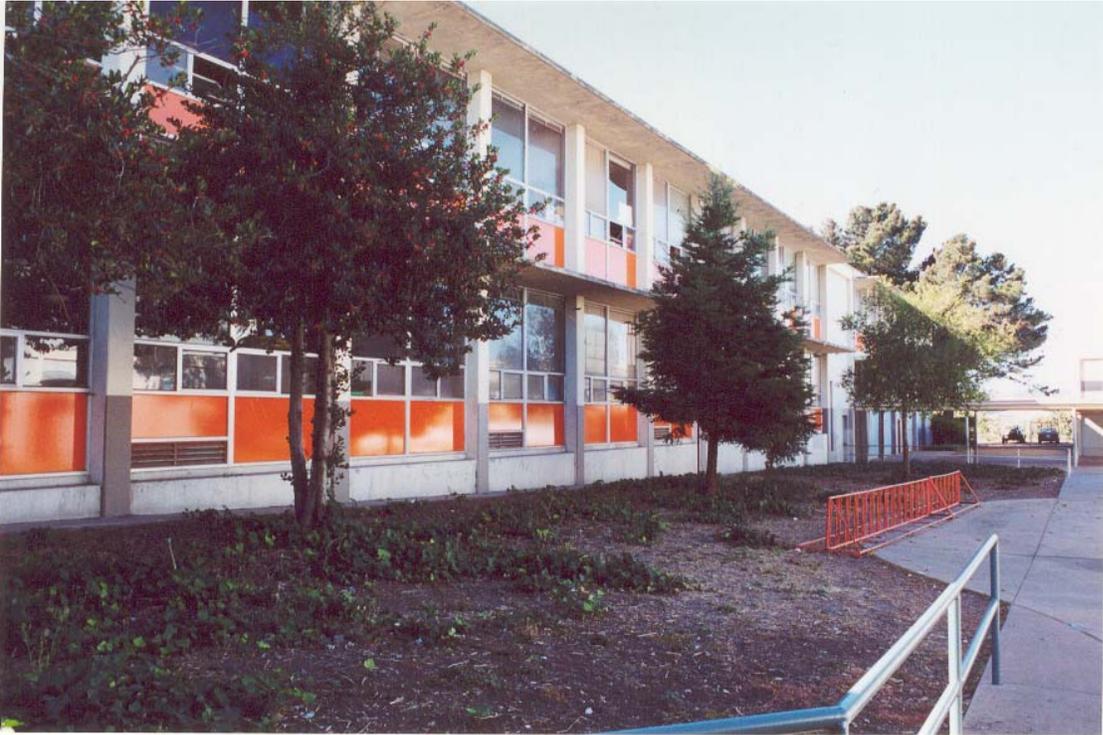
The main classroom building is a two-story concrete structure (Figures 2, 3, & 4). The North and South faces of the building have multiple large window openings with concrete columns in between. The east and west faces have long segment of shear wall. Some cracks were observed over the classroom doors.

Figure 2: Front Entrance

Figure 3: South Side of Classroom Building

Figure 4: North Side of Classroom Building

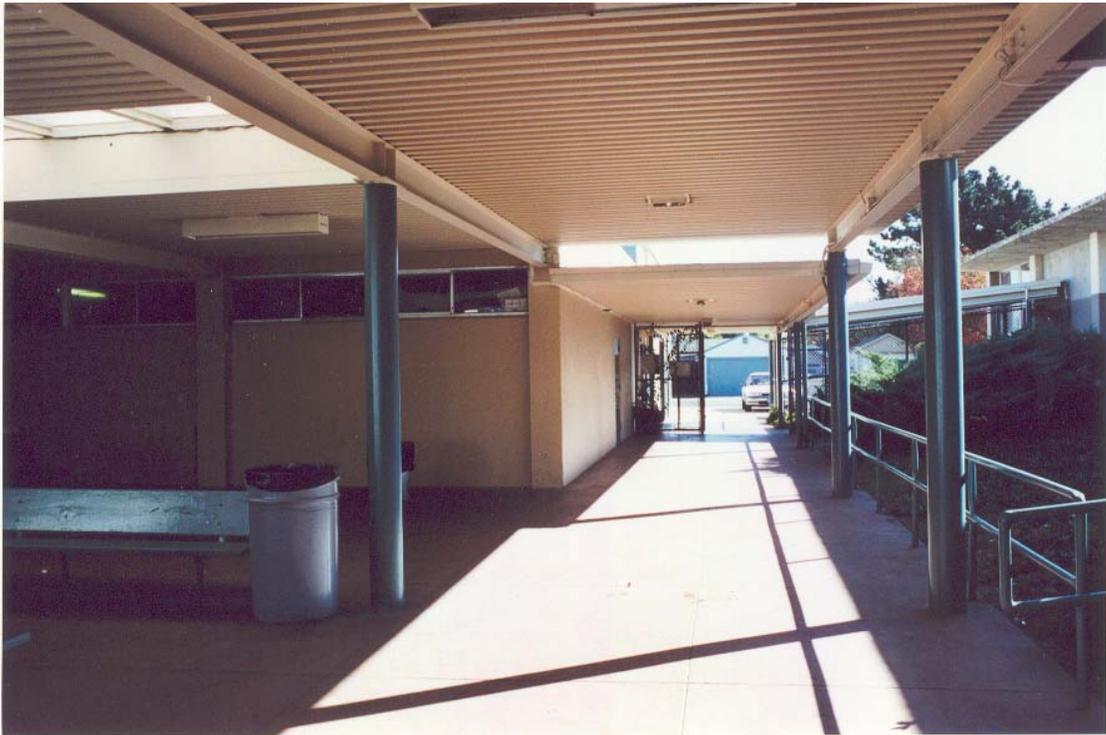
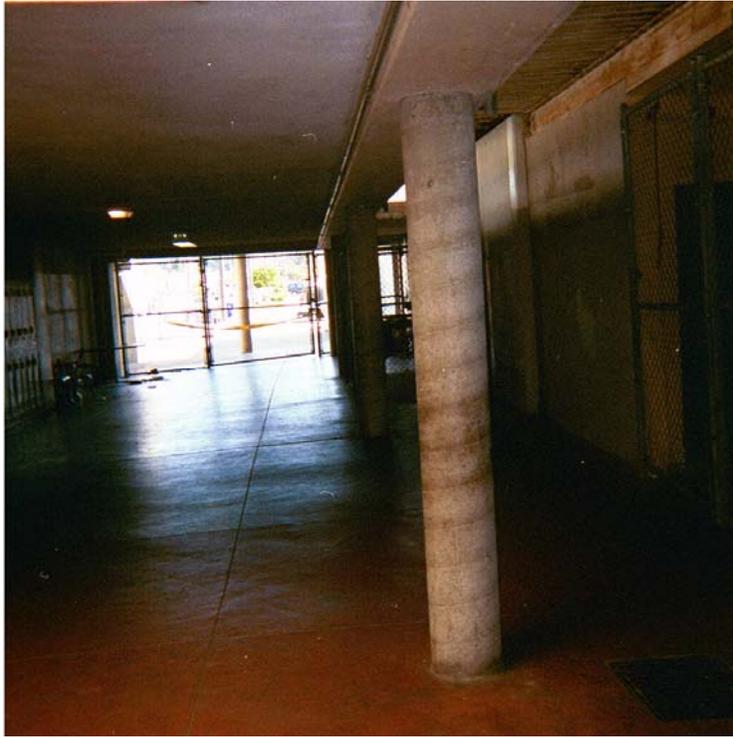
There are numerous covered walkways (Figures 6, 8, & 12) connecting the several buildings, some of which appear to be in good repair. The covered walkways near Unit B, show signs of rust on the steel and rot on the wood. In addition there was extensive rusting in covered walkway next to the Gymnasium.

Figure 6: Covered Walkway

Figure 12: Covered Walkway Adjacent to Cafeteria.

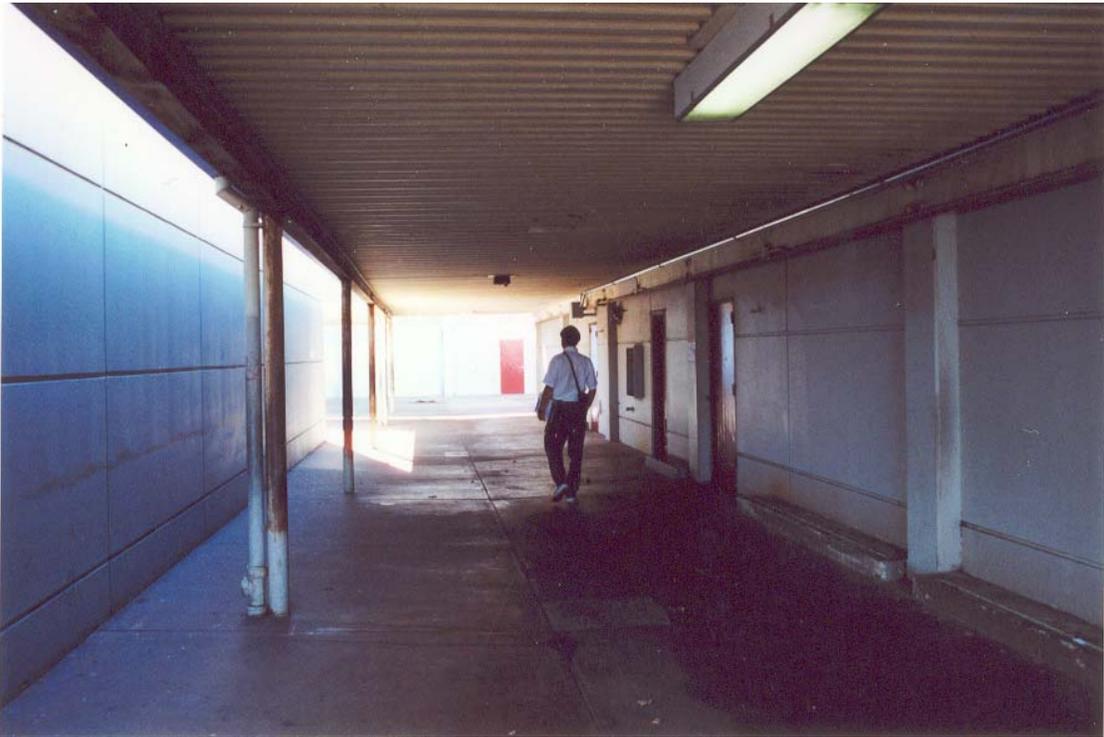
Figure 8: Covered Walkway Adjacent to Unit D

Item	Recommended Remediation	Priority	Figure Number
1.	Strengthen diaphragm and wall ties of Unit B	1.0	N/A
2.	Reinforce the braced frame in Unit B	1.0	N/A
3.	Strengthen diaphragm and wall ties of the Cafeteria.	1.0	N/A
4.	Provide lateral bracing of covered walkway between Units A and B.	1.9	8
5.	Remove decay and rust on the covered walkway near Unit B,	2.0	8

repair members and paint the members.		
6.	Brace the Mezzanine in Unit B	1.2	N/A
7.	Repair rusted metal deck and protect by painting.	2.5	13

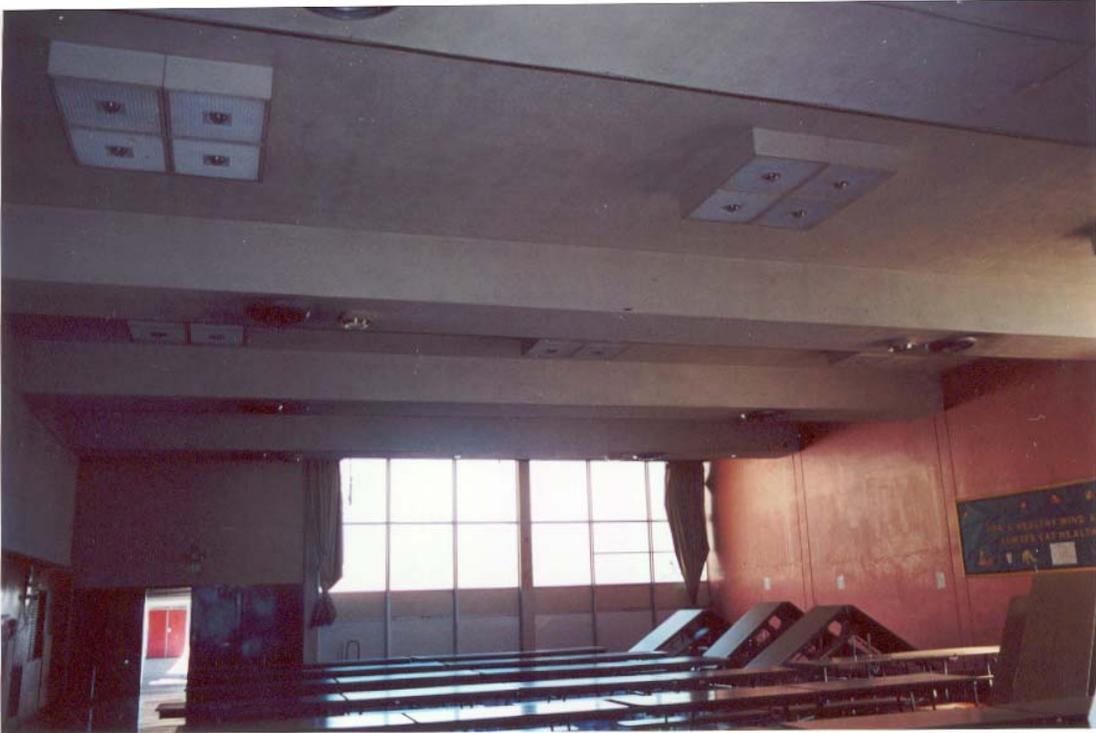
The Cafeteria Building (Figure 9) has concrete walls with some openings. The concrete roof beams were boxed out, and thus were not visible.

Figure 9: Cafeteria Building

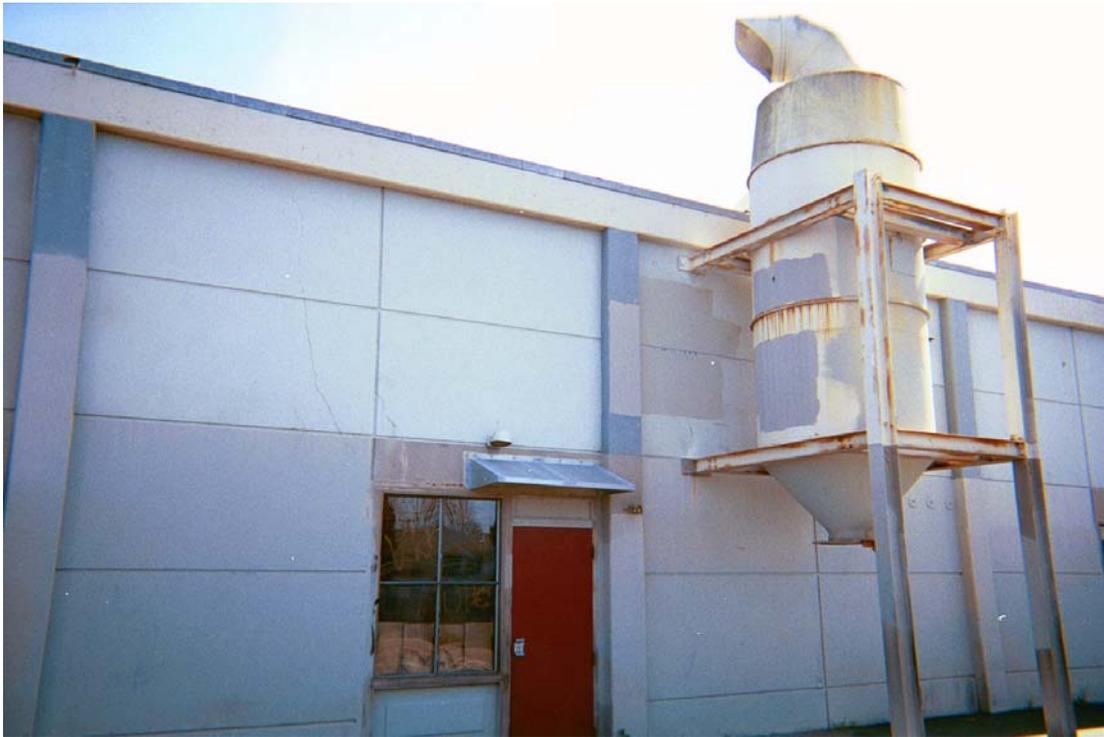
of the connections between the wood beams and exterior wall is in bad shape. Some cracks were observed in one of the wall panels on the West elevation (Figure 10). There does not appear to be ties between the concrete walls and wood roof.

Figure 10: West Wall of Unit B

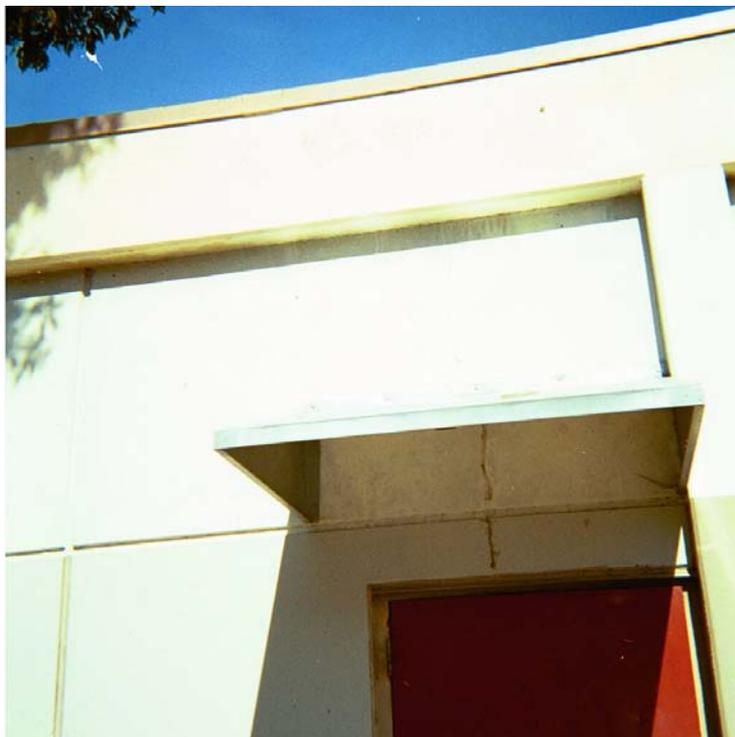
Unit D is a one story cast-in-place concrete building. A crack was observed over one of the doors on the South wall (Figure 11).

Figure 11: South Wall Unit D

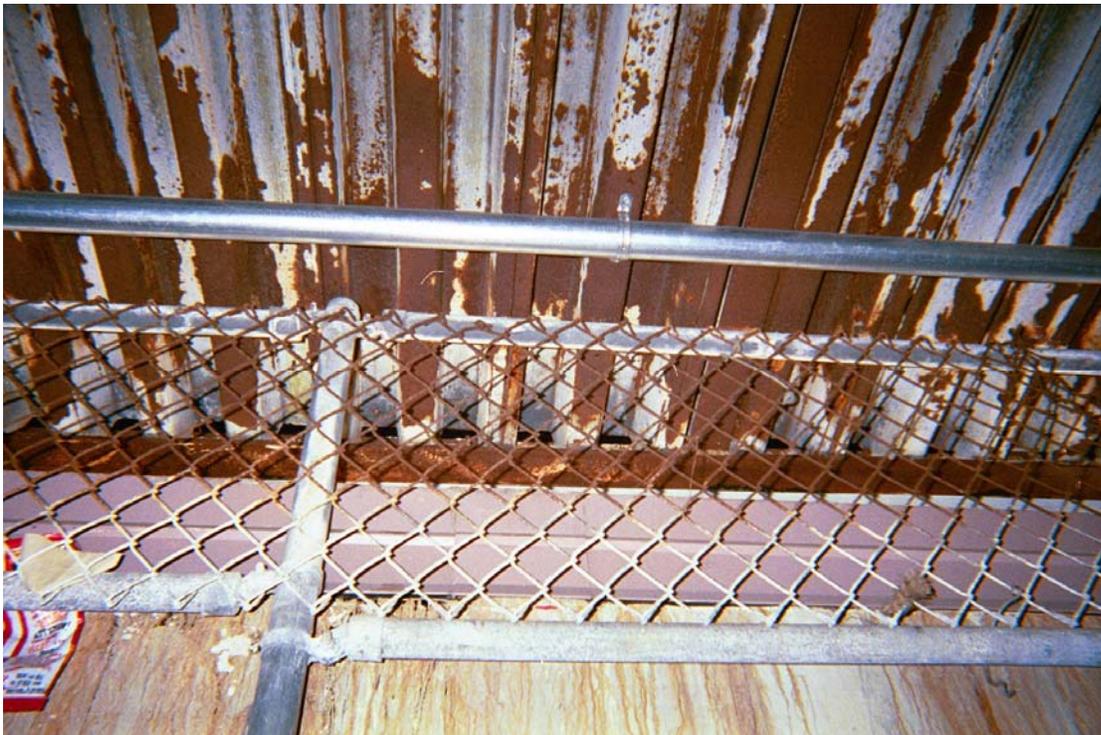
Figure 13: Metal roof adjacent to Cafeteria.
