STRUCTURAL EVALUATION OF  
ELLERHORST ELEMENTARY SCHOOL  
WEST CONTRA COSTA UNIFIED SCHOOL DISTRICT  
(WCCUSD)

DASSE Design, Inc.  
33 New Montgomery Street #850  
San Francisco, CA 94105  
(415) 243-8400

April 30, 2002

DASSE Design Project No. 01B300

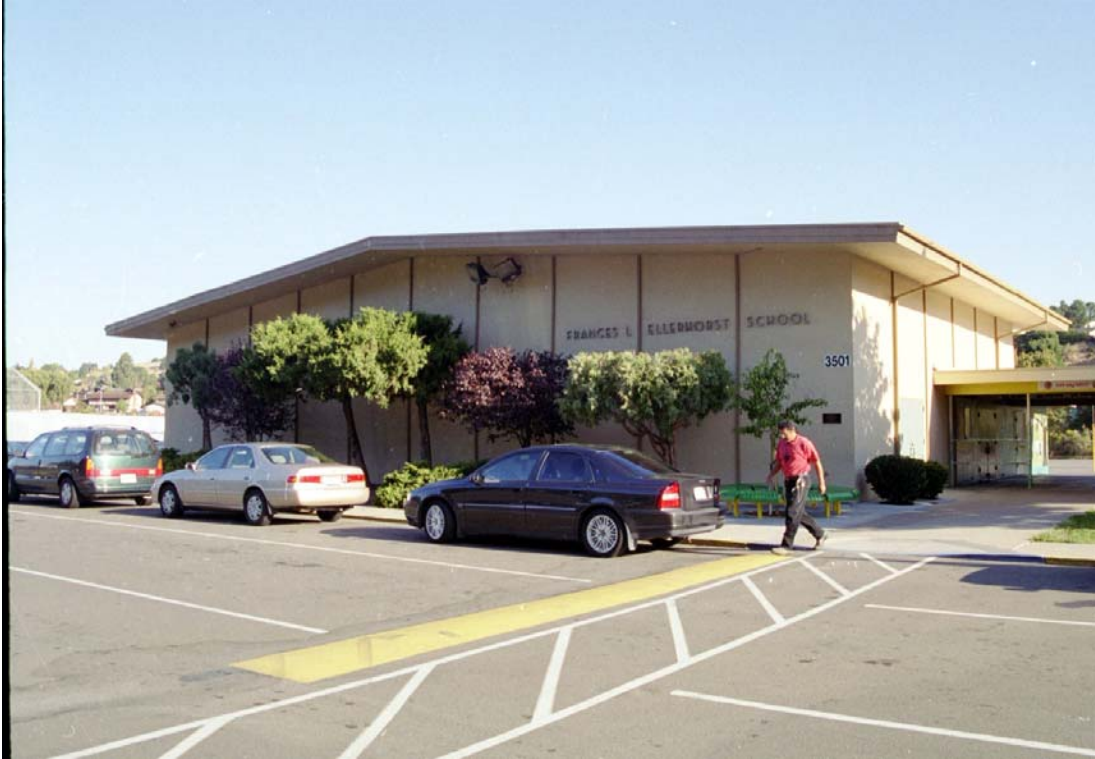
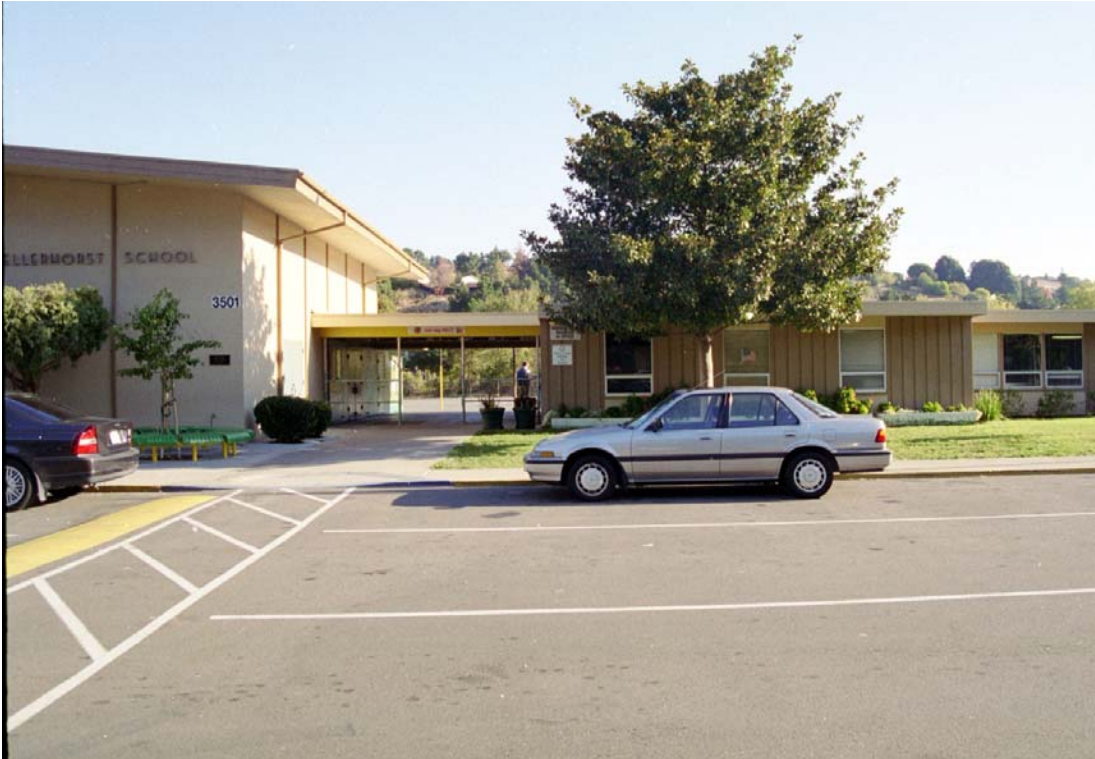
The Multi-purpose Building (figures 2 & 3) is wood framed building with exposed glued-laminated wood roof beams spaced approximately 20' on center. Checks and splits (figure 8) were noticed in both the sides and the bottoms of these beams. The exterior walls of the Multi-purpose Building is covered with cement plaster.

The lateral system of the Multi-purpose building consists of an unblocked plywood diaphragm that transfers the lateral forces to the perimeter walls, which act as shear walls. The perimeter shear walls have both plywood sheathing and cement plaster to help resist the forces. No holdowns were installed at the ends of the shear walls which limits their capacity.

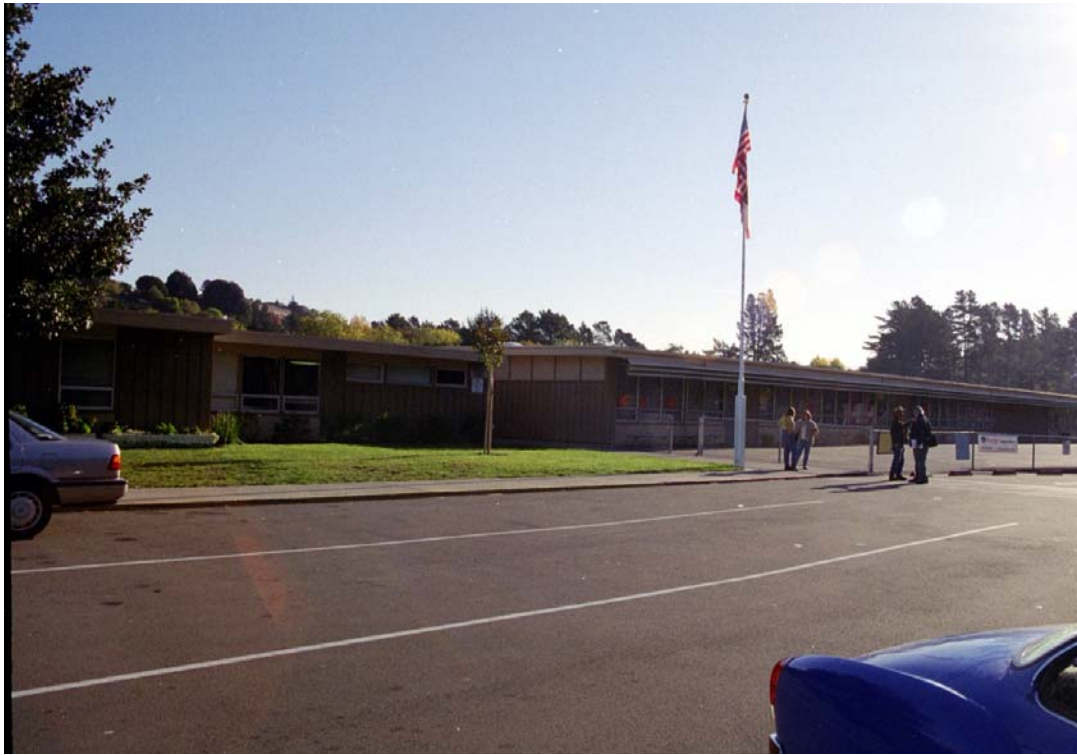
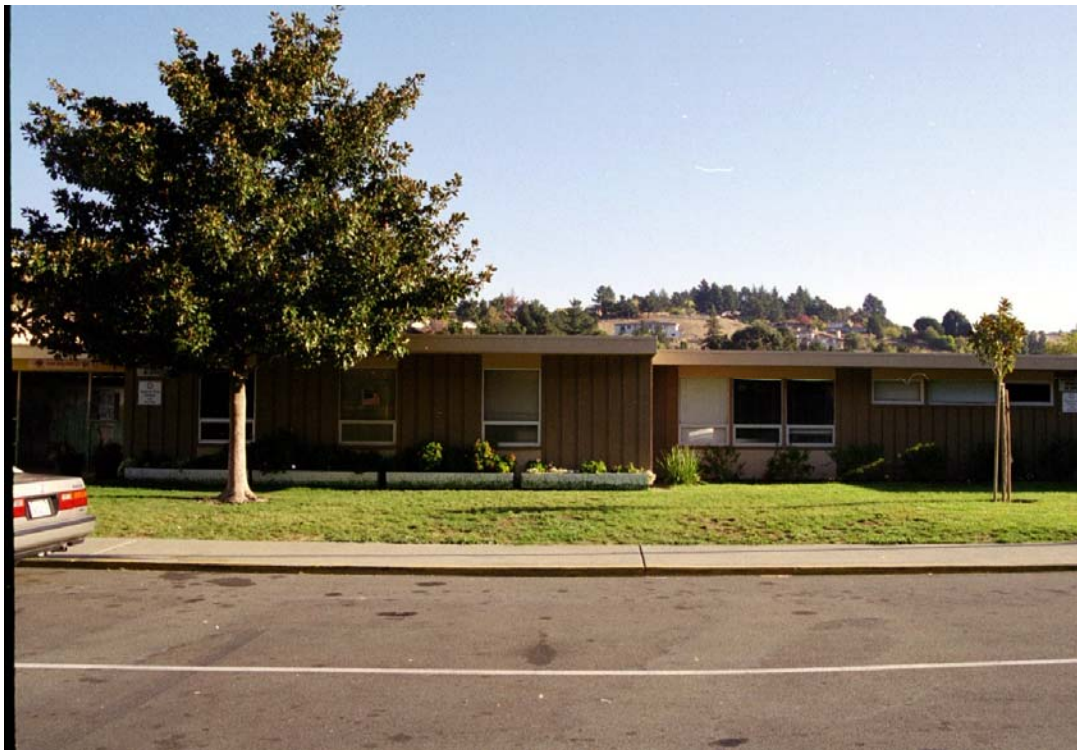
The Administration Building (figures 4 & 5) and the classroom buildings (figures 4 & 7) are constructed of light frame wood construction with wood joists spanning to beams and posts, or walls which are then supported by spread footings. In the original classroom building the roof joists span between the exterior walls and the interior corridor. In the new classroom building the roof joists span parallel to the interior corridors and are supported by either transverse walls or transverse steel beams. The floors of all of the classroom buildings consist of concrete slabs on grade.

The lateral forces from the classroom buildings are distributed to the shear walls by means of the plywood roof diaphragms. The lateral forces are transferred from the roof diaphragm to the foundation by means of plywood shear walls. The exterior and the transverse walls have 3/8" plywood sheathed shear walls. The photos (figure 6) show plywood on the interior corridors but the structural drawings do not reflect this plywood thus raising a question as to size of the plywood and the adequacy of the nailing. The lack of adequate shear walls on the interior corridors and the lack of blocking in the roof plywood diaphragm raises concerns regarding the adequacy of the roof diaphragm.

There are fewer holdowns installed at the ends of the shear walls than would be adequate.

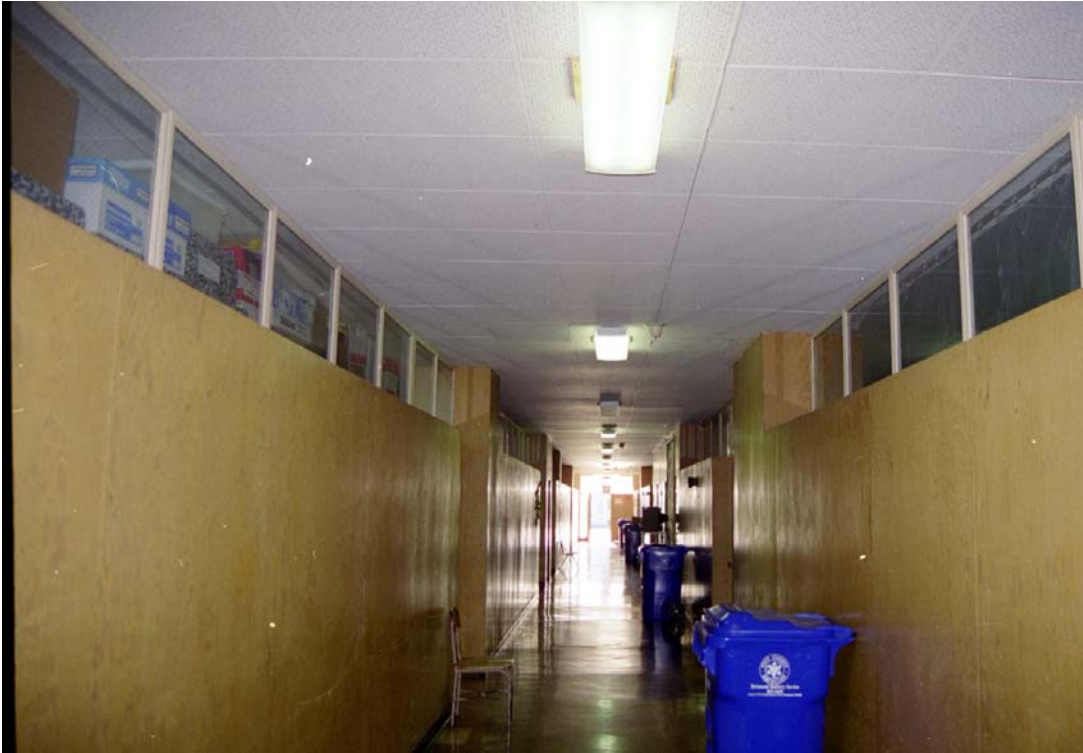
Figure 6: Classroom Building – Interior Corridor

The Administrative and classroom buildings are one story wood buildings with wood siding. The exterior walls of the classrooms have numerous windows and as a result need additional shear walls. Similarly the high windows on either side of the interior corridor create a situation where the interior walls are not effective in resisting earthquake loads. The ceilings in the corridors and classrooms are of acoustical tile.

Item	Building Structural Deficiencies
1.	Exterior longitudinal walls of classrooms have numerous window openings resulting in an inadequate shear wall capacity.
2.	The interior longitudinal corridor walls do not have a mechanism to transfer roof diaphragm forces to the shear walls due to continuous slit windows in the wall.
3.	The multi-purpose building roof glulam beams have longitudinal cracks at the side and bottom of the beams.
4.	The front wall of the Multi-Purpose Building is overstressed due to lateral forces.
5.	The slab on grade in the Administrative Building has big cracks at the intersection between the new and old slab.
6.	Covered walkways are connected to more than one building and will suffer damage in an earthquake.
7.	Electrical conduit runs in the covered walkways and thus could break in an earthquake as the buildings move.

Item	Recommended Remediation	Priority	Figure Number
1.	Increase the length of the longitudinal shear walls. Provide new collectors and holdowns	1.2	7
2.	Increase the length of the longitudinal shear walls by filling in some of the slit windows. Provide new collectors and holdowns	1.2	6
