STRUCTURAL EVALUATION OF  
FAIRMONT ELEMENTARY SCHOOL  
WEST CONTRA COSTA UNIFIED SCHOOL DISTRICT  
(WCCUSD)

WLC Architects  
Kaiser Building  
1300 Potrero Avenue  
Richmond, CA 94804

DASSE Design, Inc.  
33 New Montgomery Street #850  
San Francisco, CA 94105  
(415) 243-8400

April 30, 2002

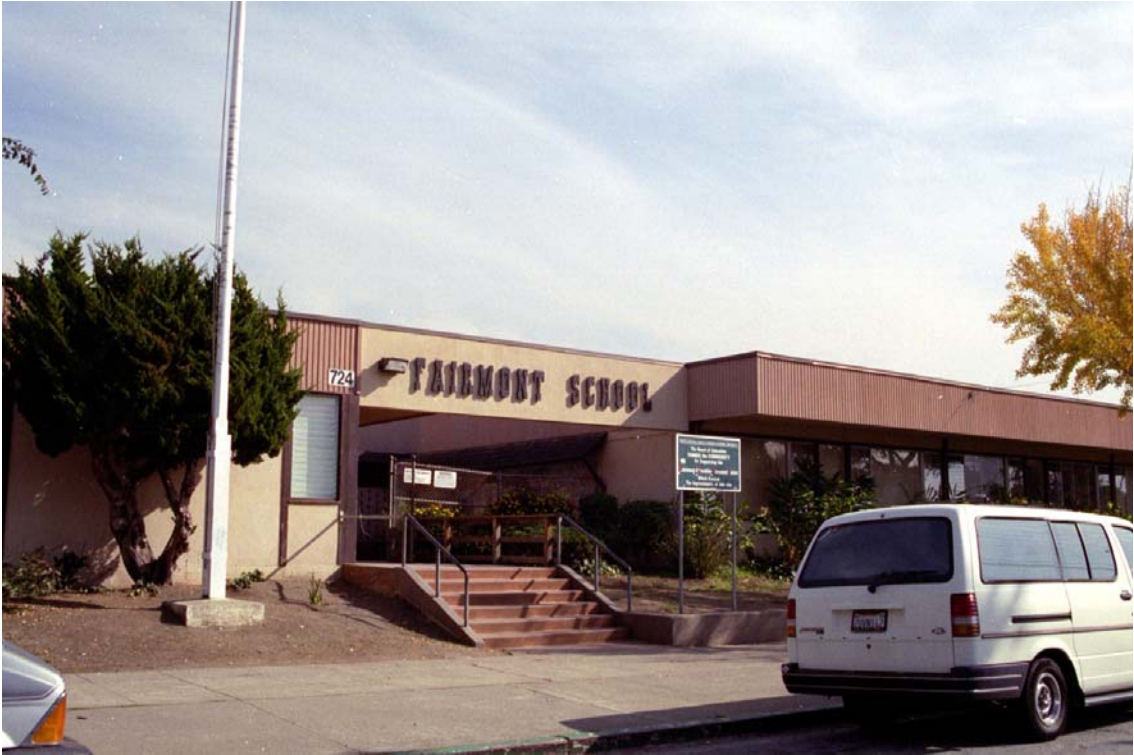
Figure 2: Front Entrance

The classroom buildings labeled unit 'A' and 'B' (see figure 1), have continuous windows on the west exterior longitudinal walls (see figures 2, 7 & 8). The east exterior longitudinal walls of units 'A' and 'B' also have numerous window openings (see figure 6). There are skylights in the corridor of classroom units 'A' and 'B' (see figure 9). These skylights extend partially into the classrooms and can be seen from inside the classrooms. Some water leakage was noticed in the

Item	Building Structural Deficiencies
1.	At the main classroom buildings units ‘A’ and ‘B’, the west and the north portion of exterior longitudinal walls have excessive window openings resulting in inadequate length of shear wall. Therefore, the shear walls along the interior corridors carry the majority of the seismic force and may be overstressed.
2.	Covered walkway running west to east and connecting classroom building unit ‘A’ and multi purpose building lacks bracing in longitudinal direction and transverse directions to resist seismic forces.
3.	The exterior longitudinal walls of administration building has numerous window

Item	Recommended Remediation	Priority	Figure Number
1.	In fill some windows at exterior with new plywood shear wall. Provide new collector elements and holdowns as required.	1.9	2, 7 & 8
2.	Provide lateral bracing in the longitudinal direction to resist lateral loads.	1.9	4
3.	In-fill some window openings with new plywood shear wall. Provide collector elements and holdowns as required.	1.5	N/A
4.	In-fill some window openings with new plywood shear wall. Provide collector elements and holdowns as required	1.5	5

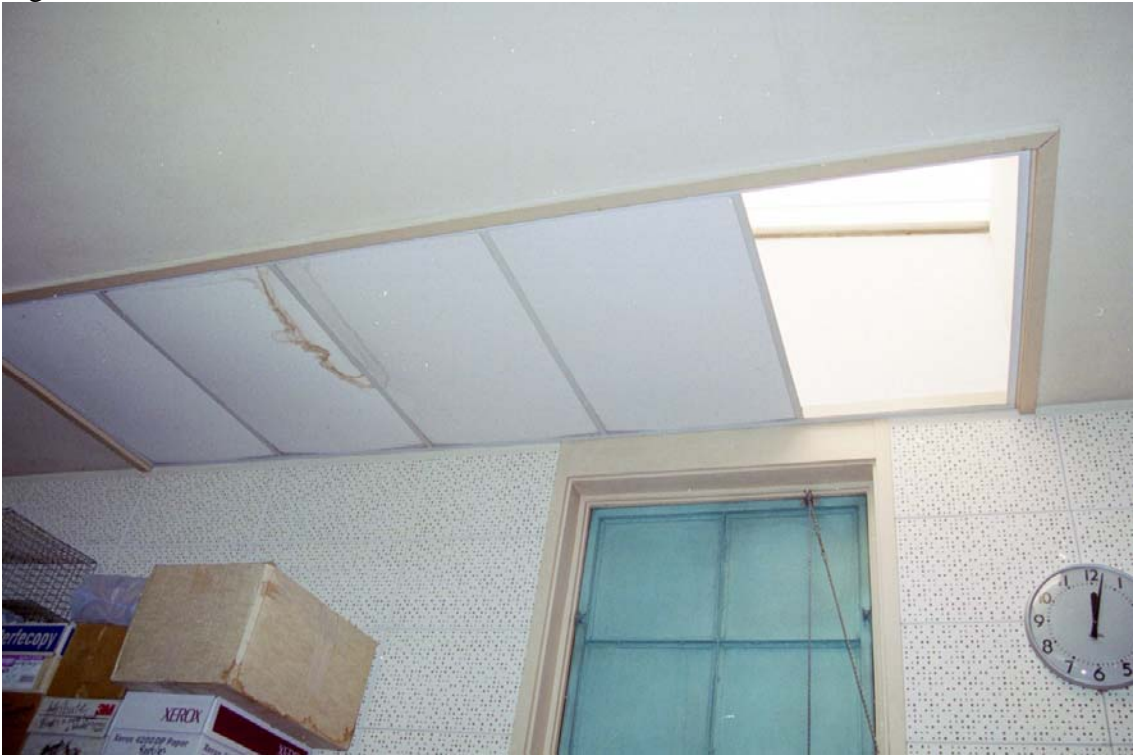
ceiling covering the skylight inside the classroom (see figure 3). Classroom and office rooms have plaster ceilings.

Figure 3: Skylight inside classroom with water leakage

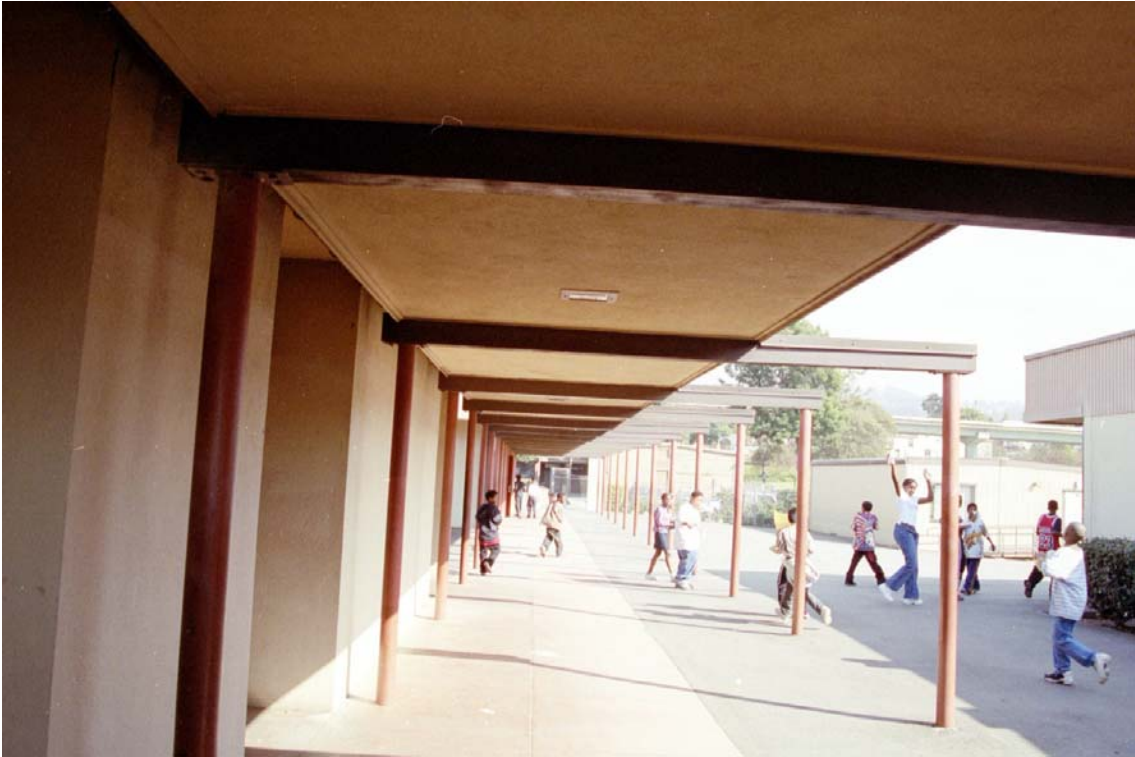
The covered walkway framing has ½" plywood roof with 2x8 members at 16" on center (in longitudinal direction with 10'-6" span), supported on 6x8 members spanning 12' and are supported on 4" diameter pipe column at 10'-6" on center. Covered walkways adjacent to unit 'B' (in east-west direction) is not attached to the buildings. Pipe columns supporting the covered walkway is connected to an unreinforced 18" diameter by 4' long drilled pier with 4-1/2" diameter by 10" long anchor bolts with a 8" square base plate (5/8" thick). Seismic force in the transverse direction of covered walkways are resisted by the 4" diameter pipe columns through cantilever action as there are no lateral frame in transverse direction. The foundation system described above does not provide fixity at the base required for cantilever action and hence lateral bracing is required in transverse direction. Similarly, lateral bracing is required in longitudinal direction also for reasons described above.

Figure 4: Covered Walkway (Not attached to the classroom building on left)

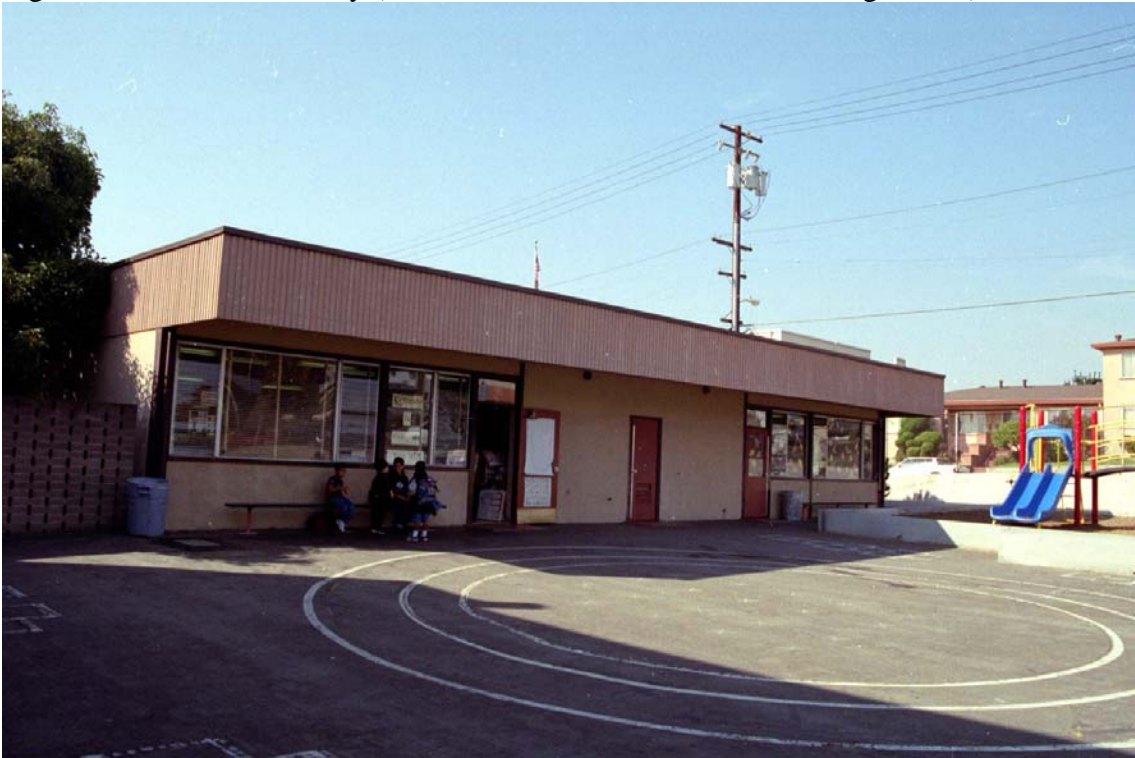
The exterior longitudinal walls of administration building has excessive openings on south side and lot of window openings in the north side. The kindergarten building has excessive openings on both the east and west exterior walls. This indicates inadequate length of shear walls to resist lateral loads in both administration and kindergarten building.

openings in north and south walls, resulting in inadequate length of shear walls.
4.	The exterior longitudinal walls of kindergarten building has excessive window openings in east and west walls resulting in inadequate length of shear walls.

Figure 5: East wall of Kindergarten Building

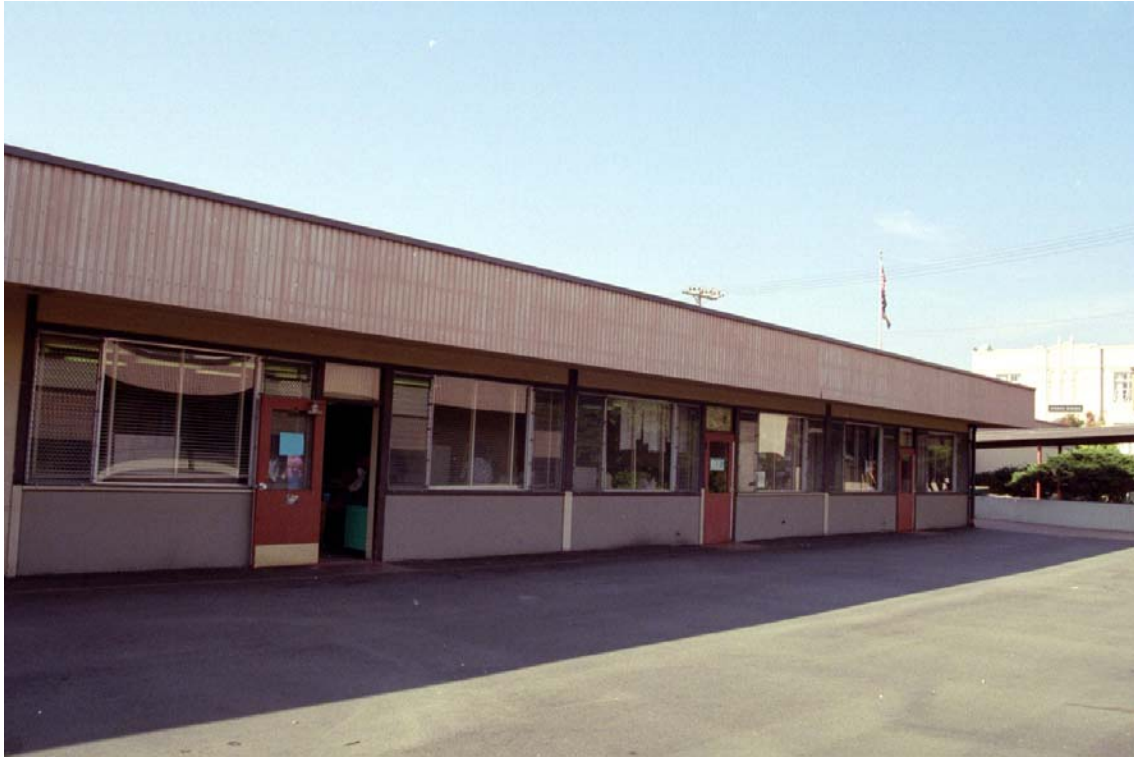
Figure 6: East wall of Classroom building (unit 'B')

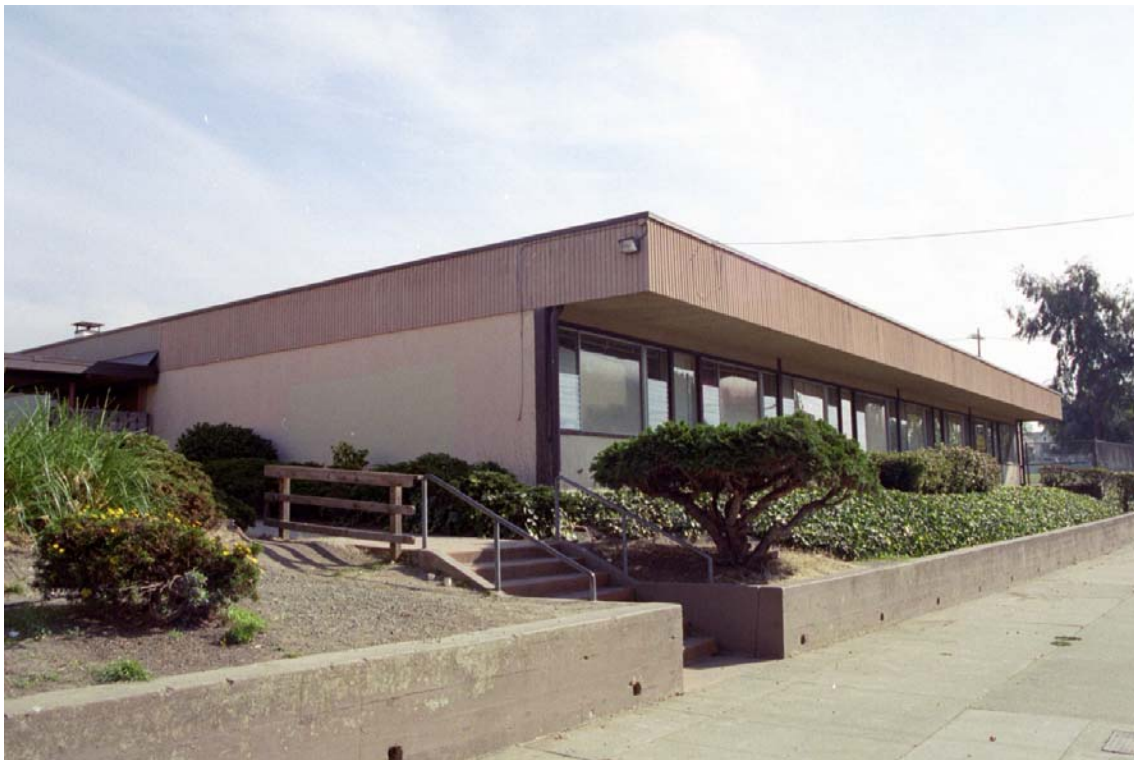
Figure 7: Exterior Longitudinal (west) wall (unit 'A')

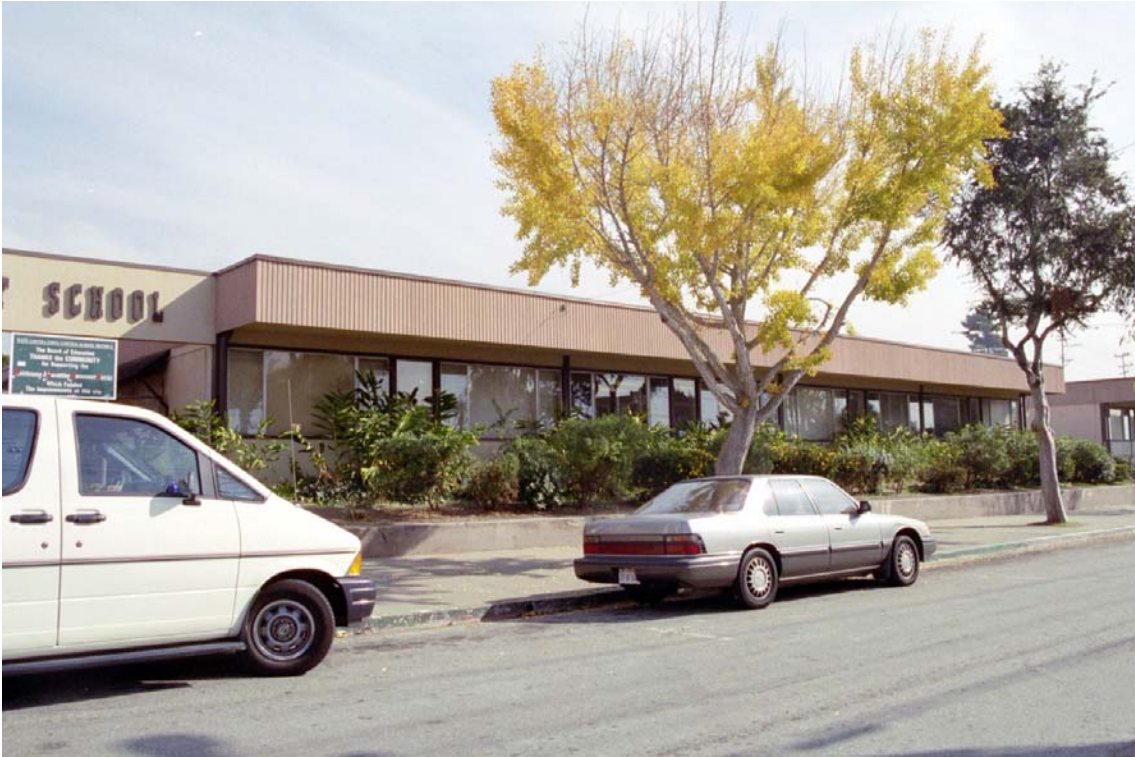
Figure 8: Exterior Longitudinal (west) wall (unit 'B')

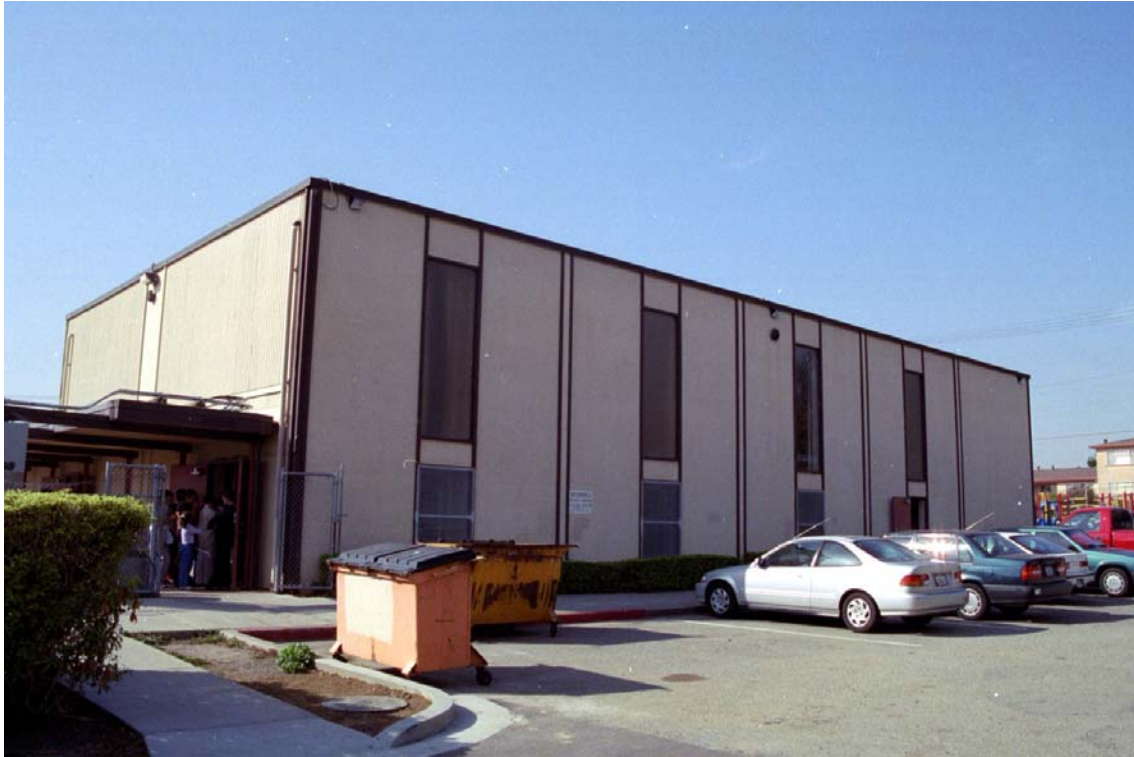
The multi-purpose room (unit 'C'), has a low one story activities and service area on the west side with a covered walkway in front and on the south side. There are narrow and tall windows on the east side of this building (see figure 10). There is a covered walkway connecting the multi-purpose room and the kindergarten room with 4 inch diameter pipe column and wood framing.

Figure 10: East wall of Multi Purpose Building

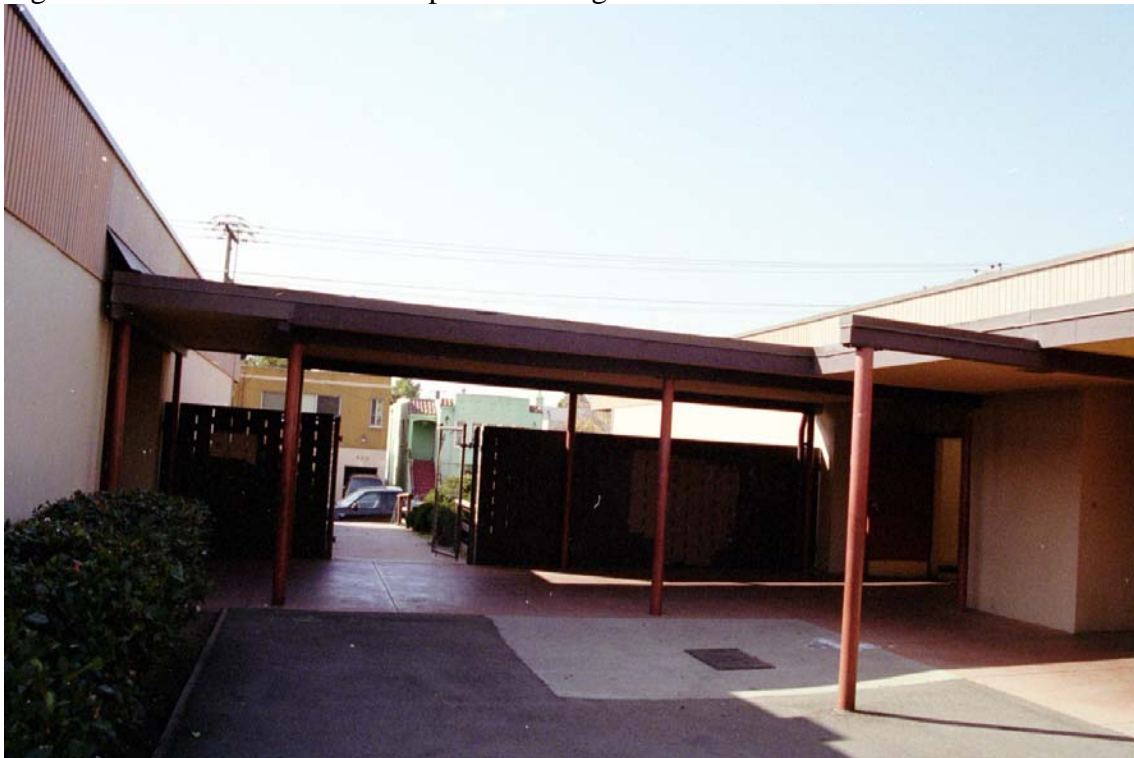
There are covered walkways connecting different units. The covered walkway between the units 'A' and 'B' is disconnected at the unit 'A' side (see figure 11). All covered walkways are supported in pipe columns and have wood framing with straight sheathing, and all of them have plaster ceiling (see figure 12).

Figure 11: Covered Walkway between units 'B' and 'A' (seismic gap at the left)

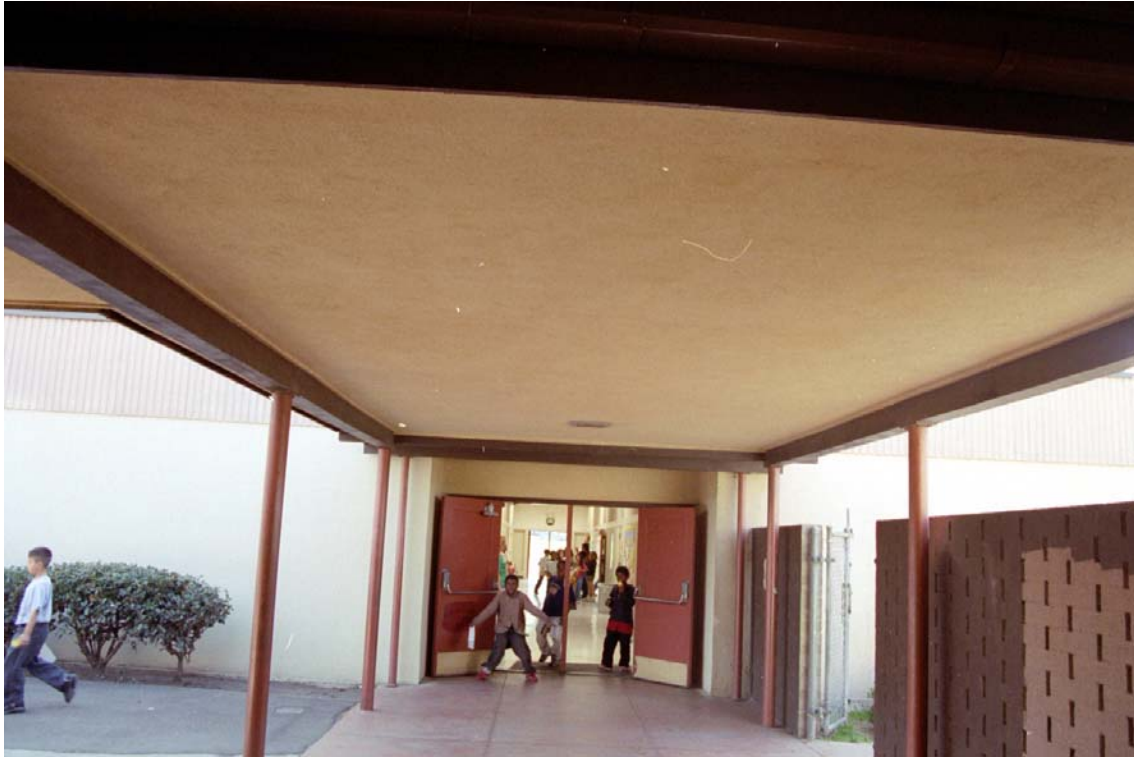
Figure 12: Covered Walkway between units 'B' and 'A' with plaster ceiling
