STRUCTURAL EVALUATION OF
GRANT ELEMENTARY SCHOOL
WEST CONTRA COSTA UNIFIED SCHOOL DISTRICT
(WCCUSD)

DASSE Design, Inc.
33 New Montgomery Street #850
San Francisco, CA 94105
(415) 243-8400

April 30, 2002

DASSE Design Project No. 01B300

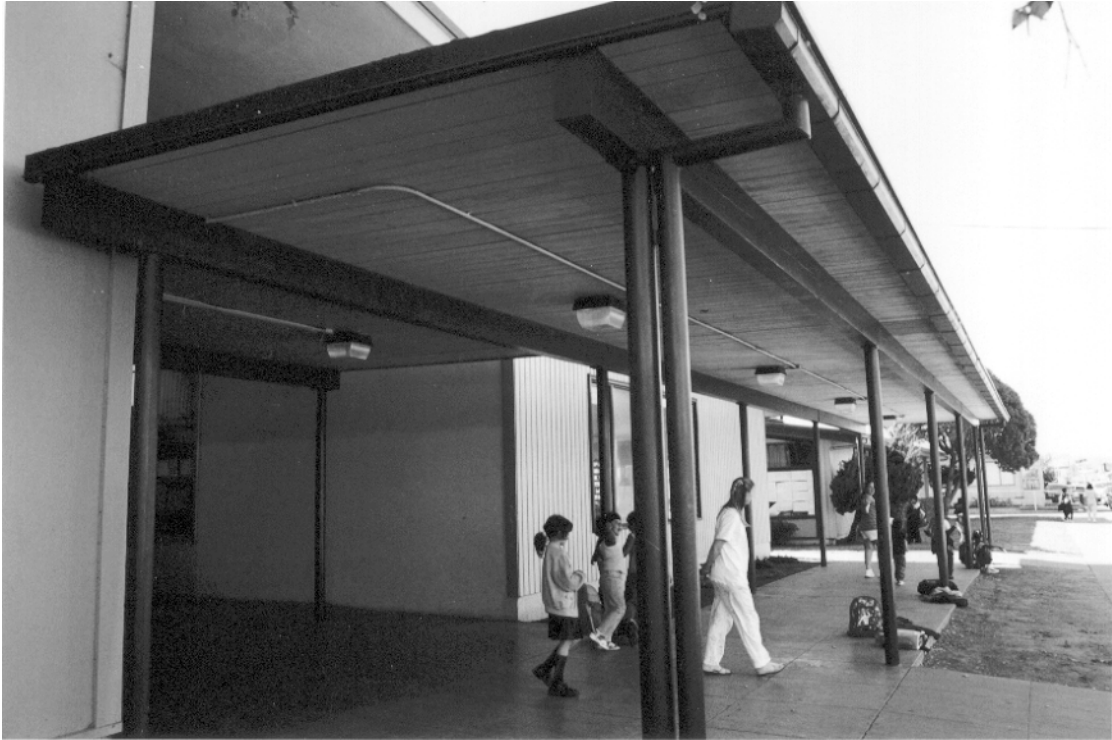
Figure 6: Covered Walkway

The covered walkways consist of 1x6 straight sheathing with wood beams and steel pipe columns. There is a need for lateral bracing since the covered walkway is not tied to the building (Figure 6).

Item	Building Structural Deficiencies
1.	Covered walkways have a lack of lateral bracing.
2.	Water damage to ceiling adjacent skylight in classroom corridor.
3.	Incinerator chimney is not braced at the roof. This could lead to damage in an earthquake.
4.	Kindergarten Building lacks sufficient seismic capacity in the longitudinal direction.
5.	Electrical rigid conduit runs between roofs of portable classrooms thus creating a potential life safety hazard when buildings move during an earthquake.
6.	The portable classrooms rest directly on the ground or on wood pads that rest on the ground. This has resulted in rot in the wood in contact with the ground.

Item	Recommended Remediation	Priority	Figure Number
1.	Add lateral bracing to the existing covered walkways.	1.9	6,7
2.	Repair the roofing and replace any damaged wood in the roof.	1.9	8
3.	Brace incinerator chimney at roof of classroom building or remove incinerator.	2.0	N/A
4.	At the Kindergarten Building, add additional length of shear walls in the longitudinal direction. Provide holdowns and collectors as required.	1.5	N/A
5.	Re-route electrical conduit or install flexible connections to enable the portable classrooms to move without damaging the conduit.	1.9	9
6.	Repair the wood members of the portable classrooms that have rot and support the structure on a raised concrete foundation.	1.9	10

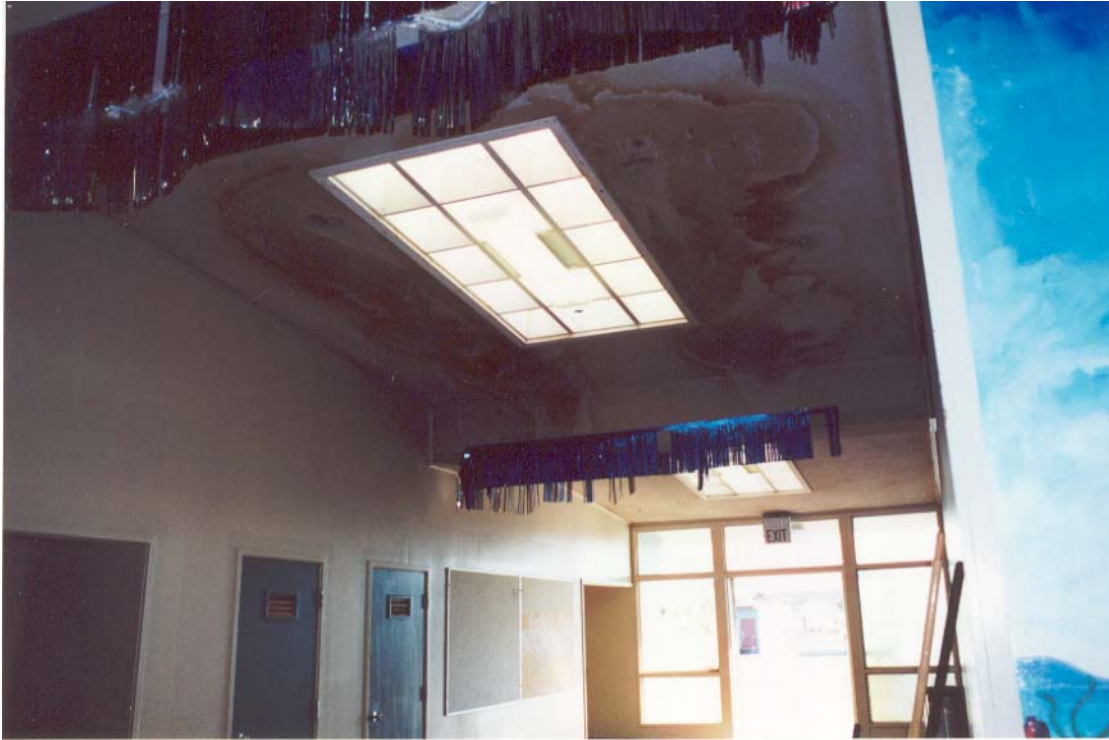
There is water damage to the ceiling around one of the skylights in the classroom building corridor (Figure 8) which indicates that there is a failure of the roofing system and the likely existence of rot in the roof framing.

Figure 8: Water Damage at Skylight Over Classroom Corridor.

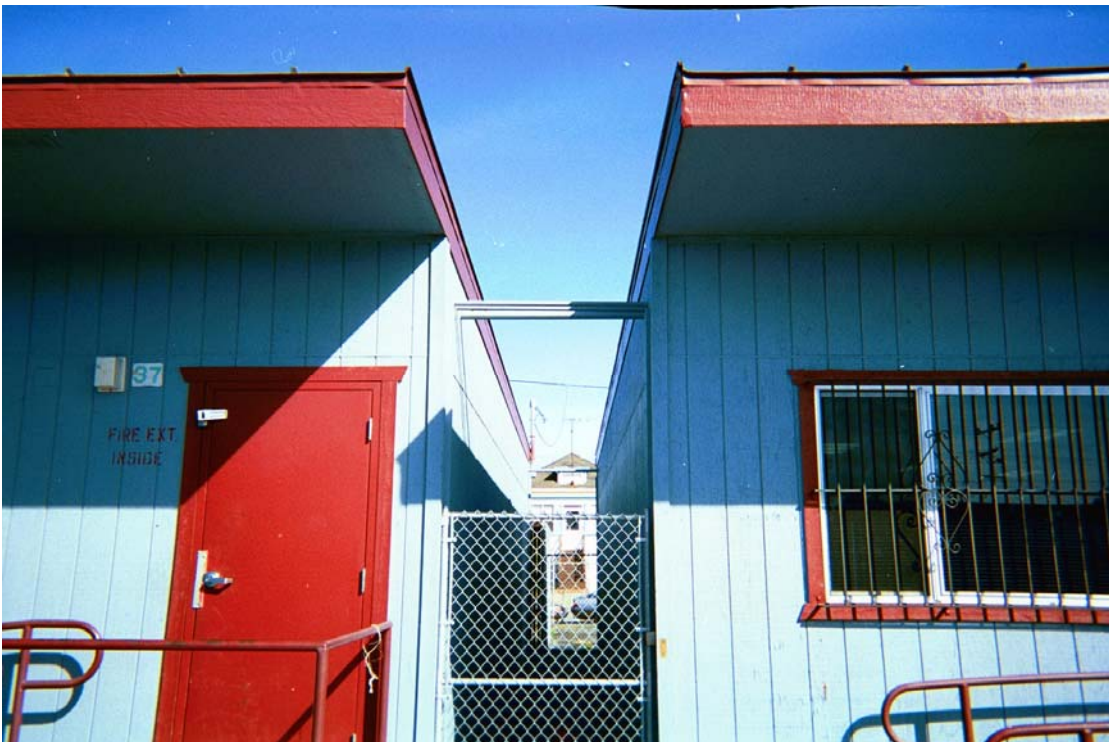
There are a number of portable classrooms on the campus. Typically the base of the portable classrooms directly on the ground or on wood pads (Figures 10&11) which has resulted in decay of the wood in close contact with the ground (Figure 10). In many instances rigid electrical conduit was observed to run between portable classrooms (Figure 9) thus creating a potential life safety hazard during an earthquake when the buildings tend to move apart.

Figure 9: Conduits Between Portable Buildings.

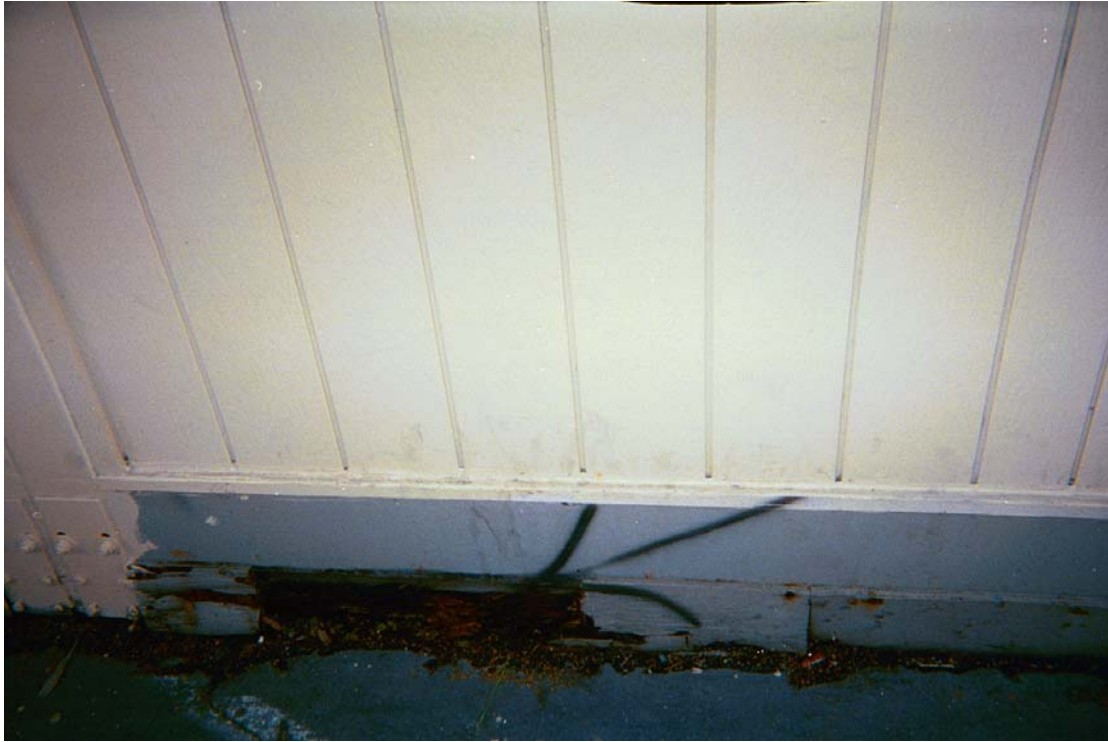
Figure 10: Decay at Base of Portable Building.
