STRUCTURAL EVALUATION OF
HARBOUR WAY ACADEMY
WEST CONTRA COSTA UNIFIED SCHOOL DISTRICT
(WCCUSD)

April 30, 2002
DASSE Design Project No. 01B300

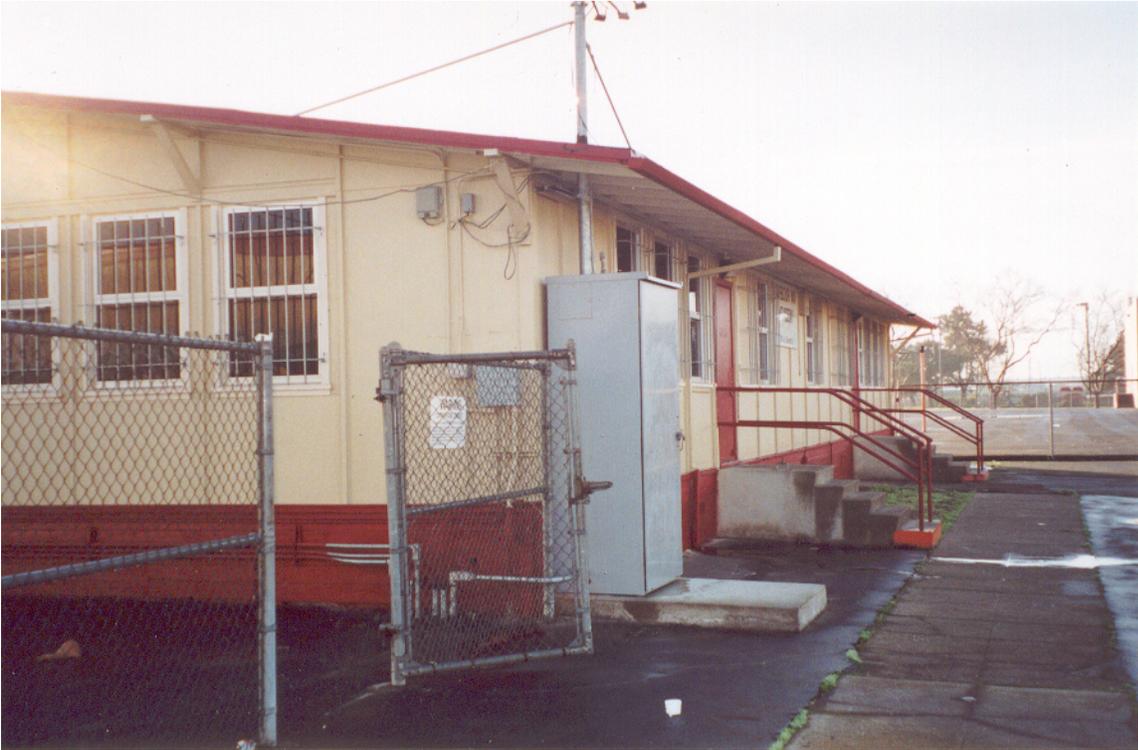
Figure 2: Front and Side of Main Building

The main building is a one-story portable wood-framed structure with wood siding (see figures 2-5). There are multiple window openings on all four sides of the building. At the front face of the building, some of the windows have been infilled with plywood (see figure 3). This connection of this plywood infill to the building does not appear to be intended to adequately transfer seismic forces. The building sits on a short cripple wall that appears to have straight sheathing and will not be adequate to laterally support the building, the result of which could be that the building could fall off of its foundation. The building has built-up roofing and an acoustical tile ceiling (see figure 6). The ceiling in some portions of the main building is sagging noticeably.

Item	Building Structural Deficiencies
1.	At the main building cripple wall, the connection of building to foundation may be inadequate. Straight sheathing is inadequate to brace the cripple wall laterally.

Item	Recommended Remediation	Priority	Figure Number
1.	Verify existing conditions. Provide new sill bolts and plywood sheathing at cripple walls.	1.2	2, 4, 5

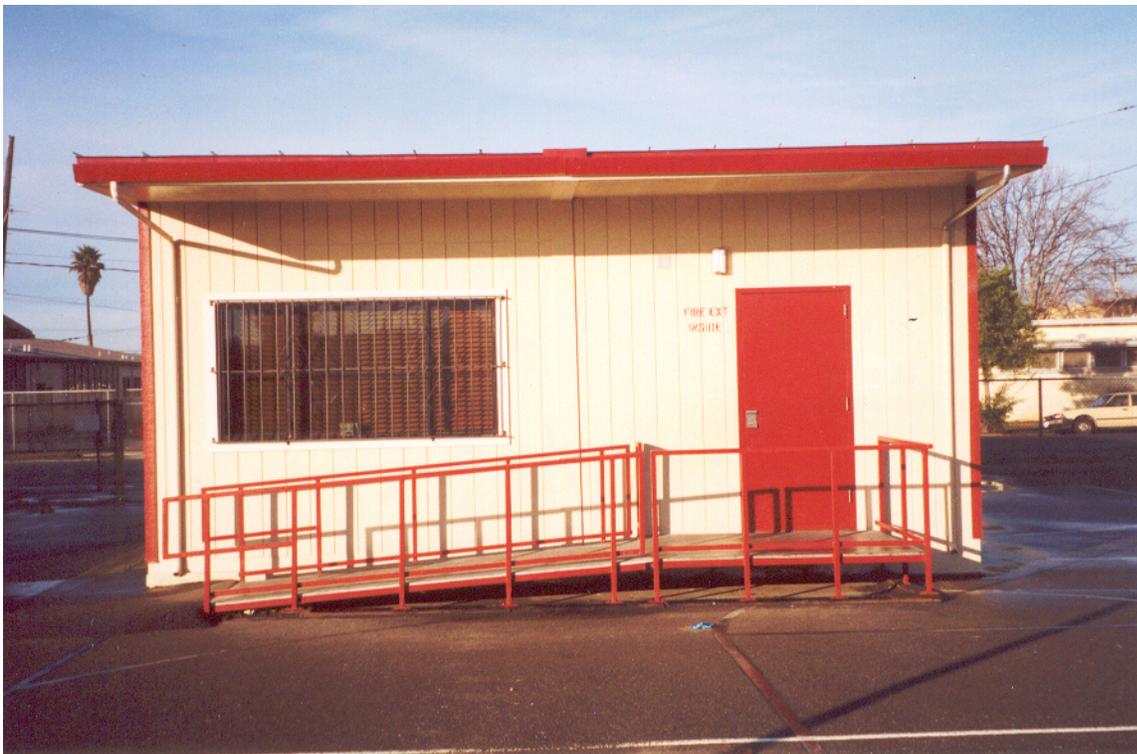
Figure 7: Front of Classroom Portable

The classroom portable is framed with sheet metal joists and studs. At the exterior of the building, there is metal roofing and T1-11 siding. The longitudinal walls do not have any openings. The openings in the transverse end walls do not appear to be excessive. There is a suspended T-bar ceiling throughout the interior.
