STRUCTURAL EVALUATION OF
HERCULES ELEMENTARY SCHOOL
WEST CONTRA COSTA UNIFIED SCHOOL DISTRICT
(WCCUSD)

WLC Architects
Kaiser Building
1300 Potrero Avenue
Richmond, CA 94804

DASSE Design, Inc.
33 New Montgomery Street #850
San Francisco, CA 94105
(415) 243-8400

April 30, 2002

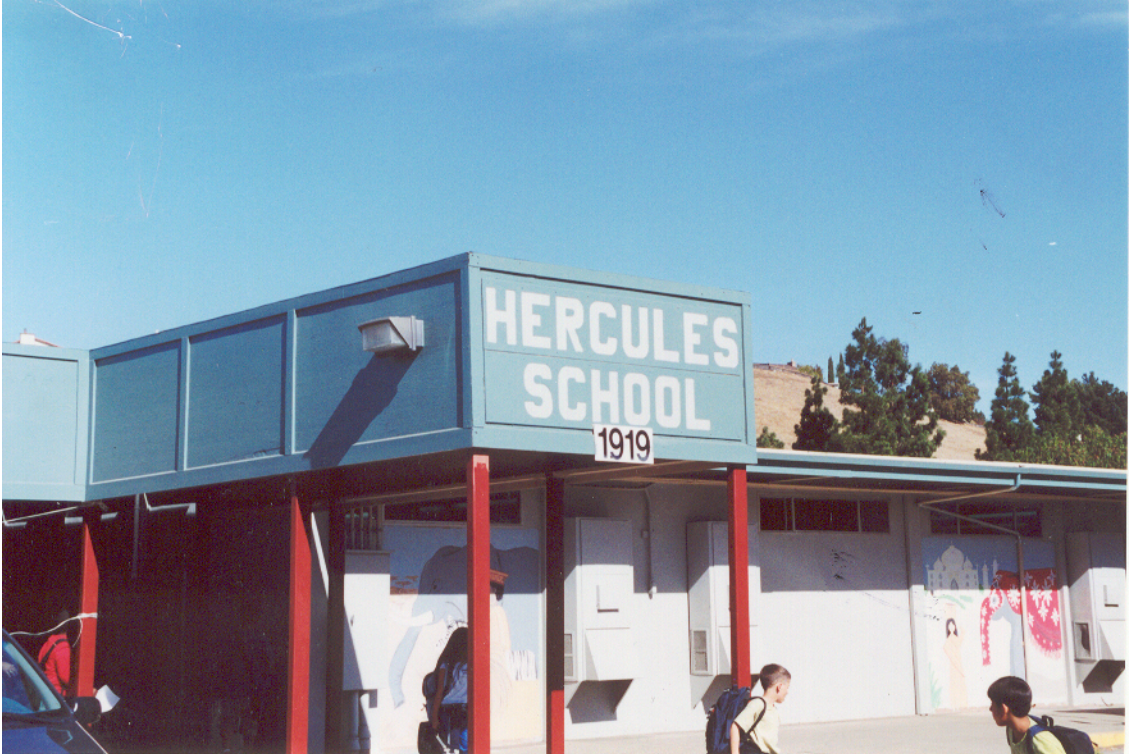
Figure 2: Main Entrance

2.	The Administration building (room numbers 19 to 23) has numerous opening on the west transverse wall resulting inadequate length of shear wall.
3.	In Administration building, connection of portable units to foundation appears to be inadequate to resist seismic uplift forces.

Item	Recommended Remediation	Priority	Figure Number
1.	Fill in some windows with new plywood and framing. Provide new collectors.	1.3	3
2.	Fill in some windows with new plywood and framing. Provide new collectors	1.3	2 & 4
3.	Provide new holdowns to resist seismic uplift forces.	1.2	N/A
4.	Fill in some windows with new plywood and framing. Provide new collectors.	1.3	N/A
5.	Provide new holdowns to resist seismic uplift forces.	1.2	N/A
6.	Fill in some windows with new plywood and framing. Provide new collectors.	1.3	5
7.	Remove rust by treating the steel beam with Navel Jelly.	2.2	N/A

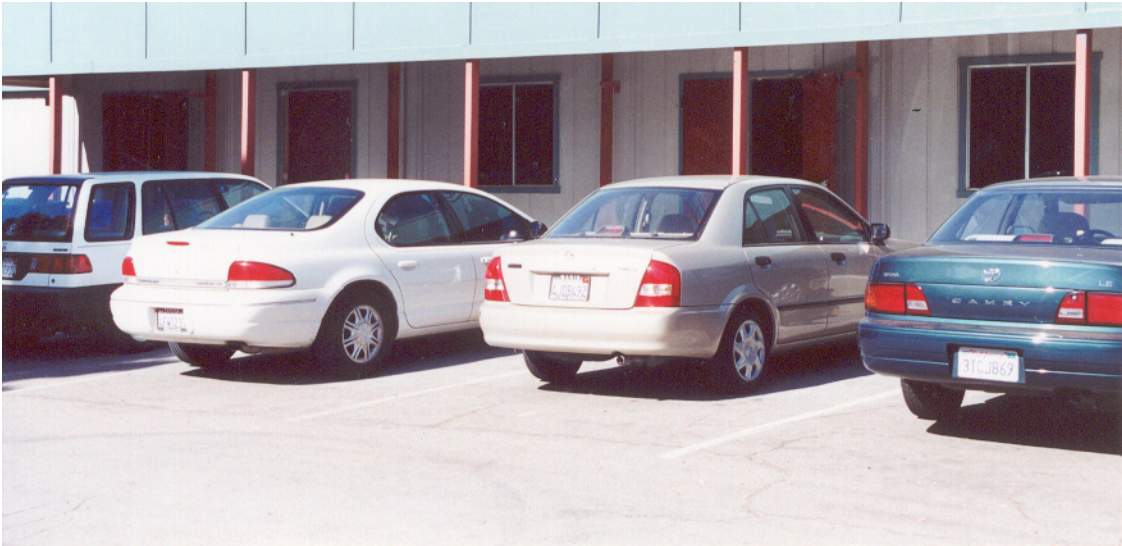
Figure 3: South wall of Administrative Building

feet long modular units. The roof has plywood sheathing and the exterior wall has plywood fascia finish. The south longitudinal wall of administration building has numerous window openings (see figure 3) resulting in inadequate length of shear wall to resist seismic forces in the longitudinal direction. North longitudinal wall has fewer window openings. The west transverse wall has numerous window openings resulting in inadequate length of shear wall to resist seismic forces in the transverse direction. East transverse wall has fewer window openings. The interior of the building has a suspended T-bar ceiling. There is a covered walkway (running north to south), between the administration building and the classroom building.

Item	Building Structural Deficiencies
1.	The Administration building (room numbers 19 to 23) has numerous opening on the south longitudinal wall resulting inadequate length of shear wall.

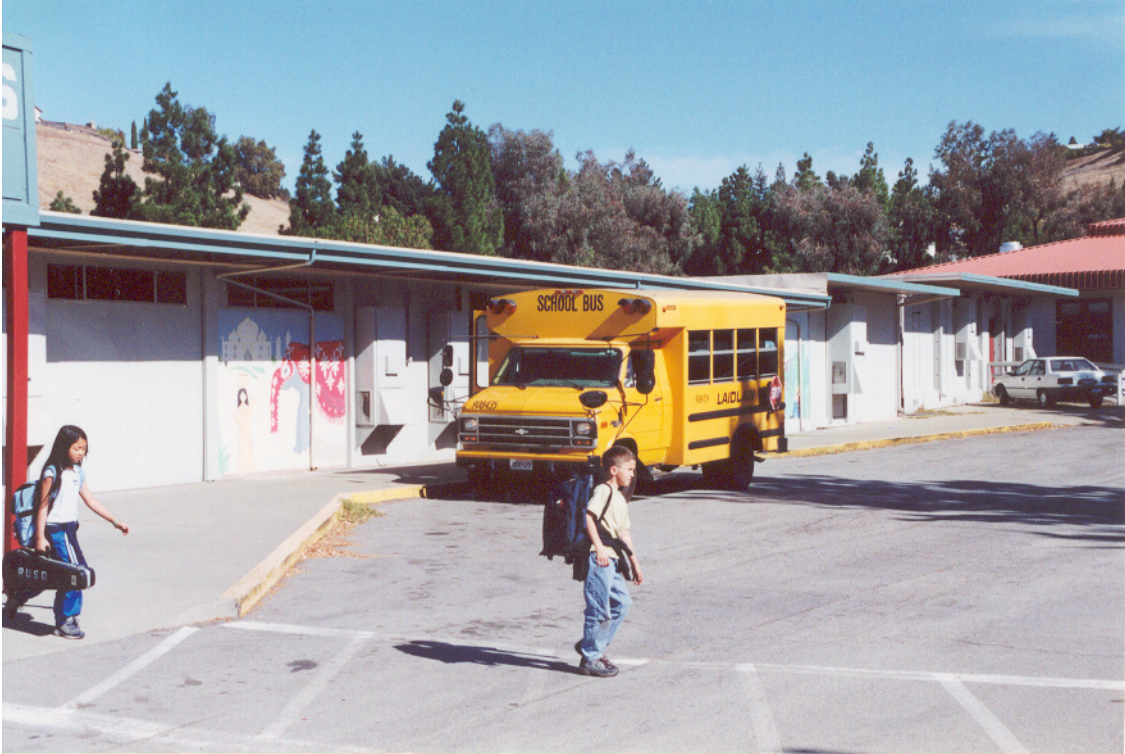
Figure 4: South Wall of Original Classroom buildings

The original classroom buildings (built in 1966 & 1967) have numerous openings (long and narrow slit window) on the south longitudinal wall (see figures 1 & 4). This results in a lack of mechanism to transfer seismic forces from the roof diaphragm to the longitudinal shear wall. Some of the roof steel beams were rusting. There are two window openings and a big door opening at the front of these portable units (see figure 5) resulting in inadequate length of shear wall to resist seismic forces. There is 5 feet roof overhang on front and rear side of the portable units.

4.	Front longitudinal walls of the original (1966/1967) classroom portables have numerous long and narrow slit-window opening. Due to these openings, the diaphragm forces cannot be transferred to the shear wall below at these locations resulting in inadequate length of shear wall.

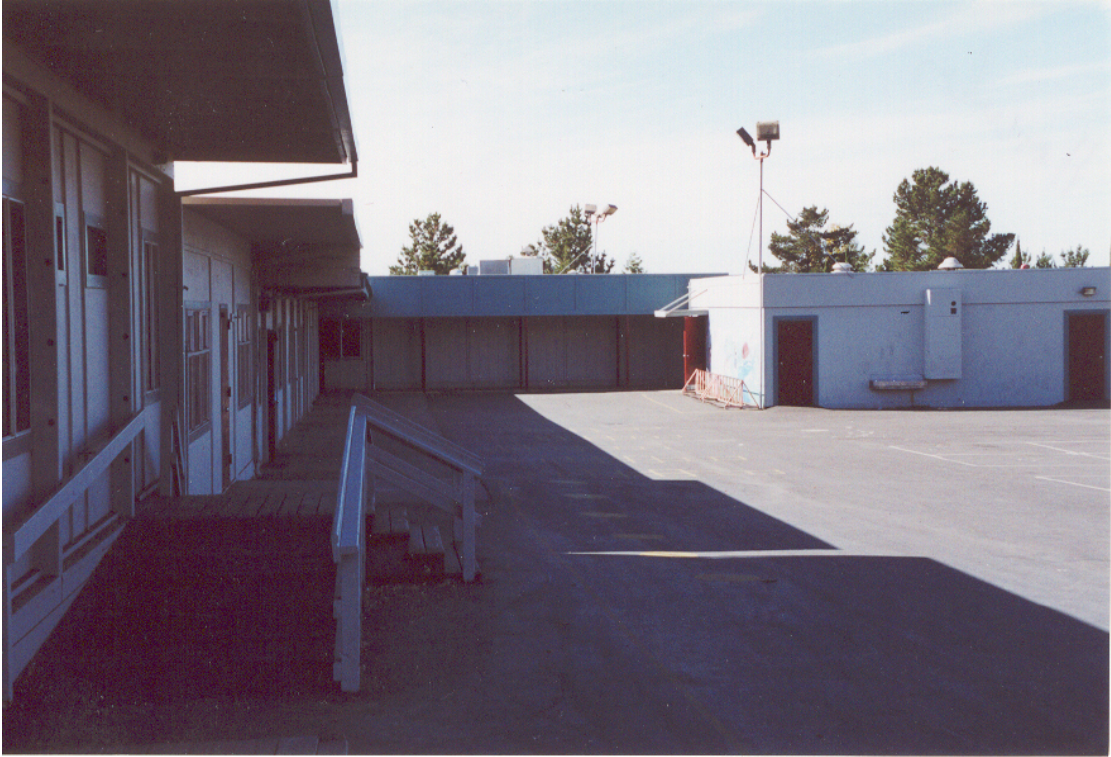
Figure 5: North Wall of Original Classroom building (Room numbers 1 through 4)

5.	In original (1966/1967) classroom portables, connection of portable units to foundation appears to be inadequate to resist seismic uplift forces.
6.	Numerous openings at the front wall of original classroom portables resulting in inadequate length of shear wall to resist seismic forces.
