STRUCTURAL EVALUATION OF
KENSINGTON ELEMENTARY SCHOOL
WEST CONTRA COSTA UNIFIED SCHOOL DISTRICT
(WCCUSD)

DASSE Design, Inc.
33 New Montgomery Street #850
San Francisco, CA 94105
(415) 243-8400

April 30, 2002

DASSE Design Project No. 01B300

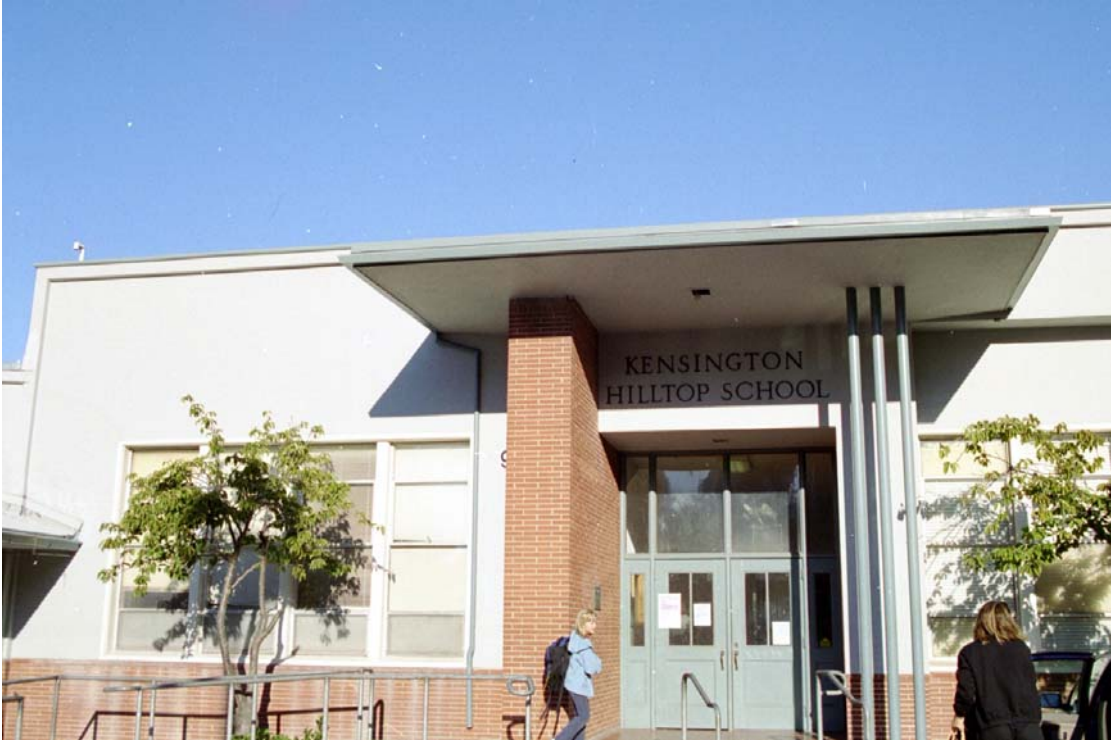
The school is one story with stucco exterior with brick wainscots. The front of the Administration building (figures 2, 5, & 6) is characterized by tall CMU pilasters, tall pipe columns and a minimum of shear walls. The Classrooms were characterized by clerestory windows (figure 4) on the west side and extensive glazing on the east face (figure 3) resulting in minimal lateral resistance in the longitudinal direction. The front wall adjacent to the multi-purpose room had extensive glazing with a 4 foot high brick wall (figure 6). In the absence of structural drawings it is not clear what is the mechanism for resisting out of plane loads.

3.	Lack of sufficient lateral bracing of the front entrance of the Main Building.
4.	The brick wall, between front entrance and the Cafetorium, supporting windows may be unstable.

Figure 2: Front Entrance

Item	Recommended Remediation	Priority	Figure Number
1.	Fill in some existing classroom windows with new plywood shear walls and provide new collectors and holdowns as required.	1.1	3
2.	Add plywood shear walls at several classroom clerestory windows and provide new collectors and holdowns as required.	1.0	4
3.	Add new lateral bracing of the front entrance of the Main Building.	1.8	5
4.	Provide continuous columns from floor to roof at the tall windows adjacent to the Cafetorium Building.	1.8	6

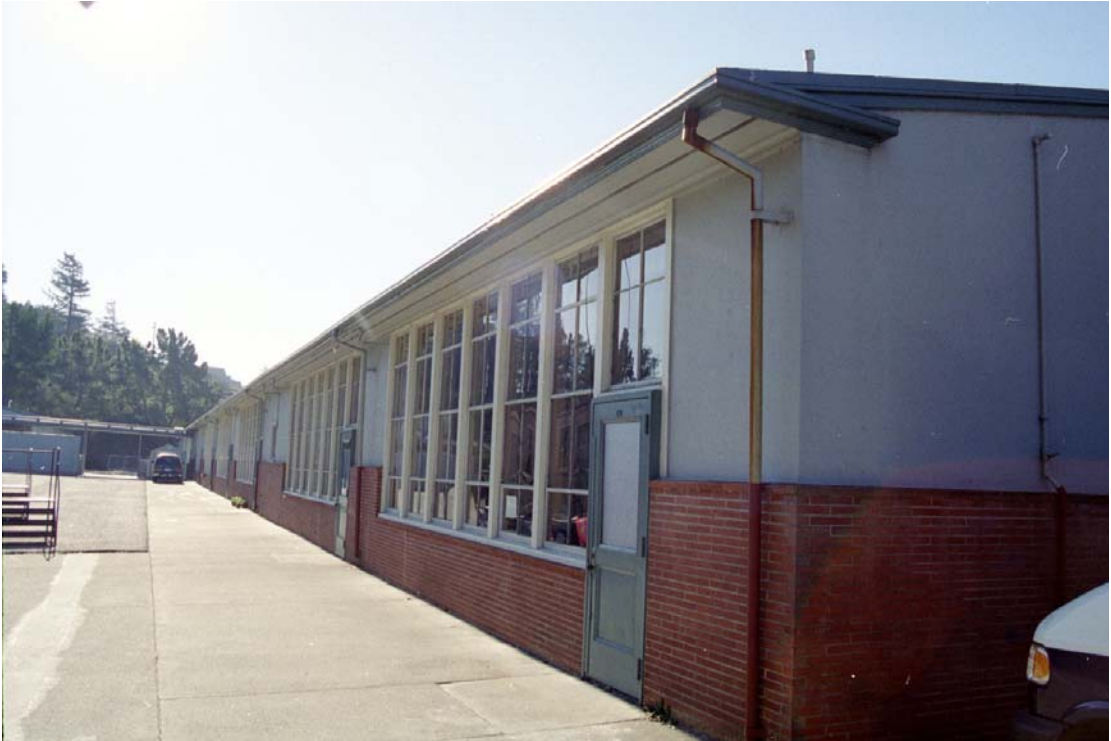
Item	Building Structural Deficiencies
1.	Lack of shear walls in the east longitudinal walls of the classrooms due to numerous window openings.
2.	Lack of shear walls in the west longitudinal classroom walls due to clerestory windows.

Figure 3: Classrooms East longitudinal Walls

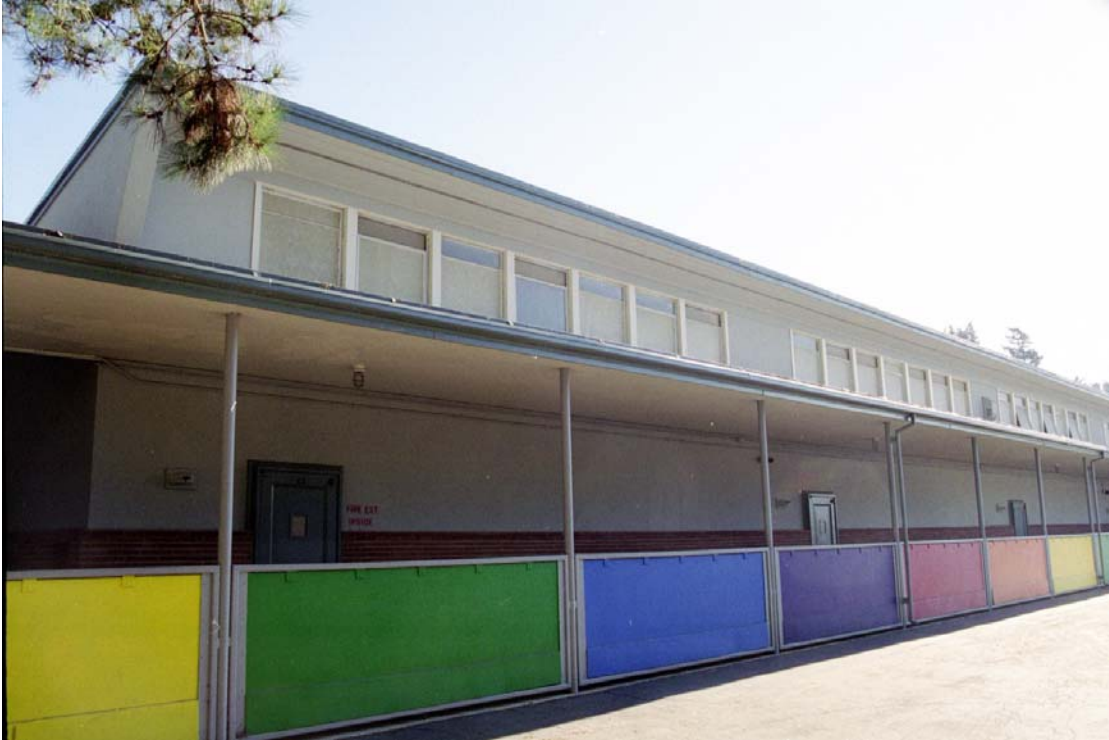
Figure 4: Classrooms with Clearstory Windows, West Longitudinal Walls

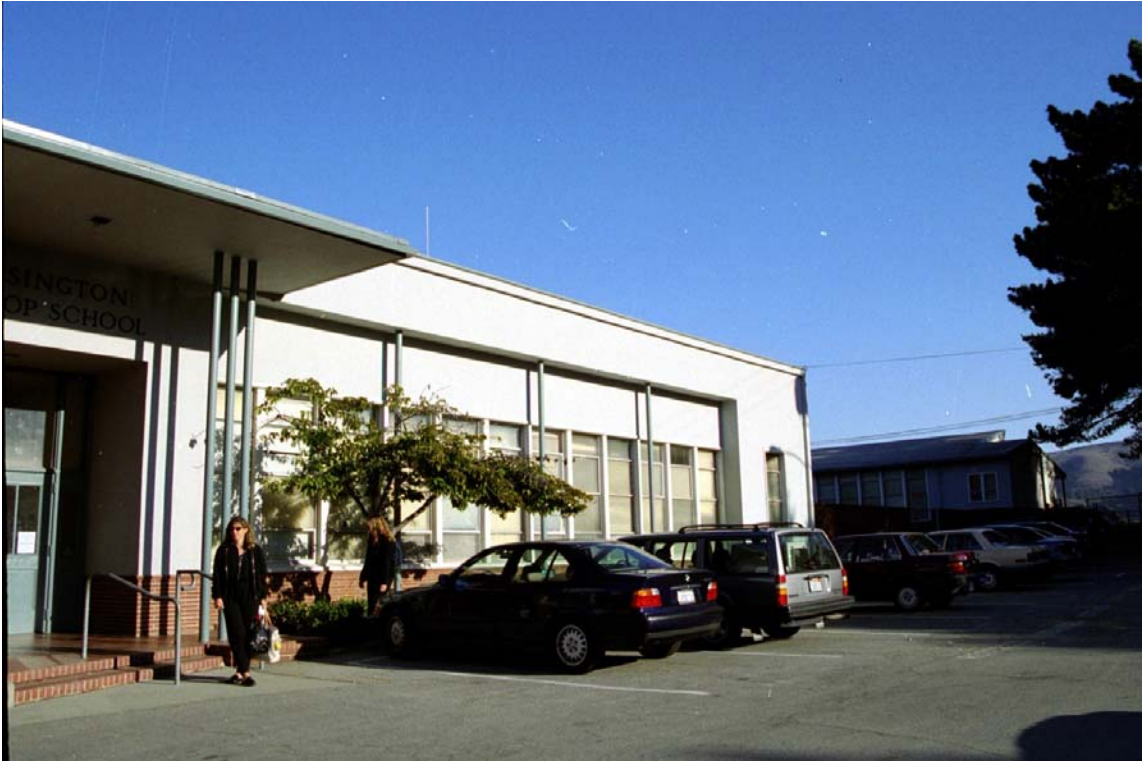
Figure 5: Main Building Front Entrance.

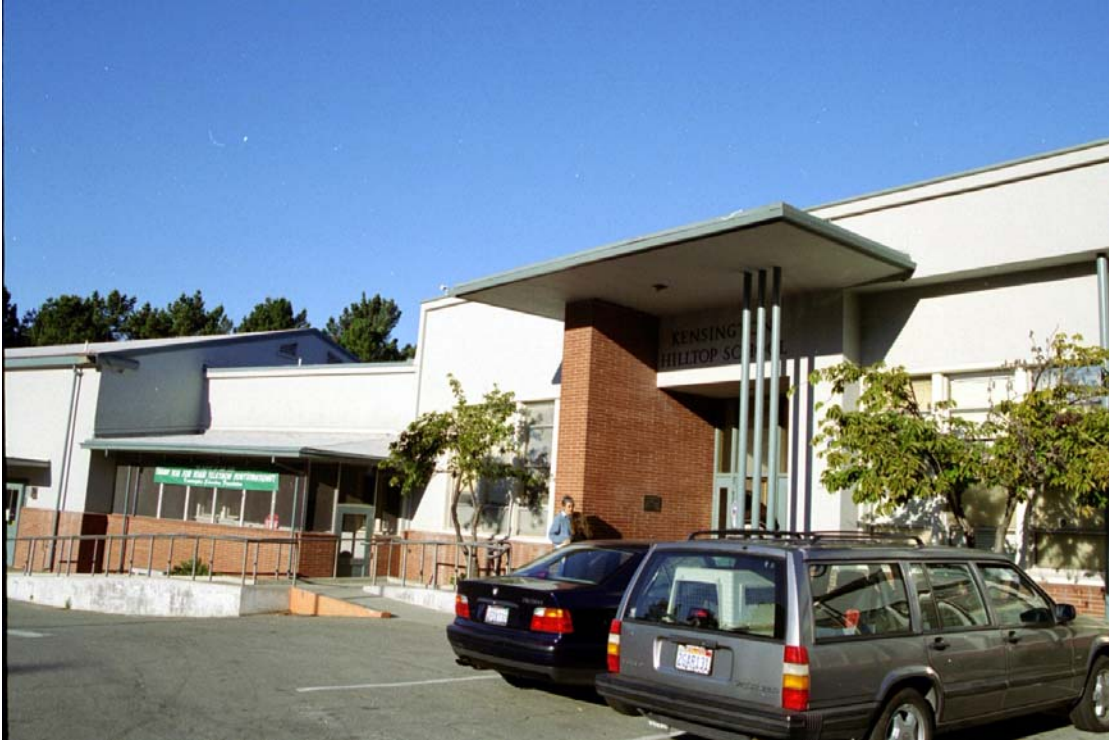
Figure 6: Main Building Front Entrance

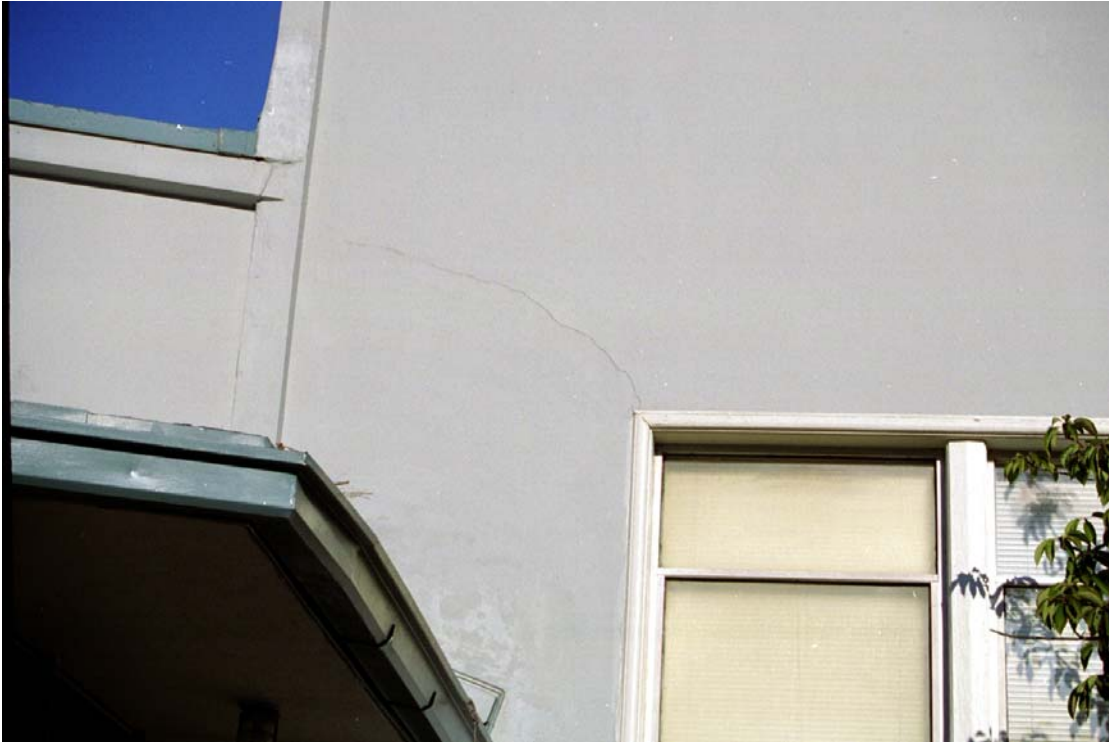
The multi-purpose room is of wood construction with stucco finishes both exterior and interior and has big exterior windows on either side. Cracks were observed in the back wall of the multi-purpose room, above windows (figure 7).

5.	Stucco cracks on the main building, may lead to rot and deterioration of the wall.
6.	Brick in the main building above the northwest exterior corridor openings and around columns may present a falling hazard.

Figure 7: Main Building – Plaster Cracks

5.	Fix the cracks in the stucco.	3.0	7
6.	Verify if it is brick wall or brick veneer and if it is veneer, remove brick veneer in the Main building corridor.	1.9	8
7.	Add new seismic joints at covered walkways along with necessary additional lateral and gravity supports. Where conduit crosses the seismic joints provide flexible connections.	1.9	9
8.	Remove selected decorative panels in front of classroom doors.	2.0	4
9.	At the kindergarten classroom building soffit, replace the damaged wood and paint to prevent further decay.	3.0	N/A
10.	Ensure that the portable buildings are adequately anchored to their footings.	2.0	N/A

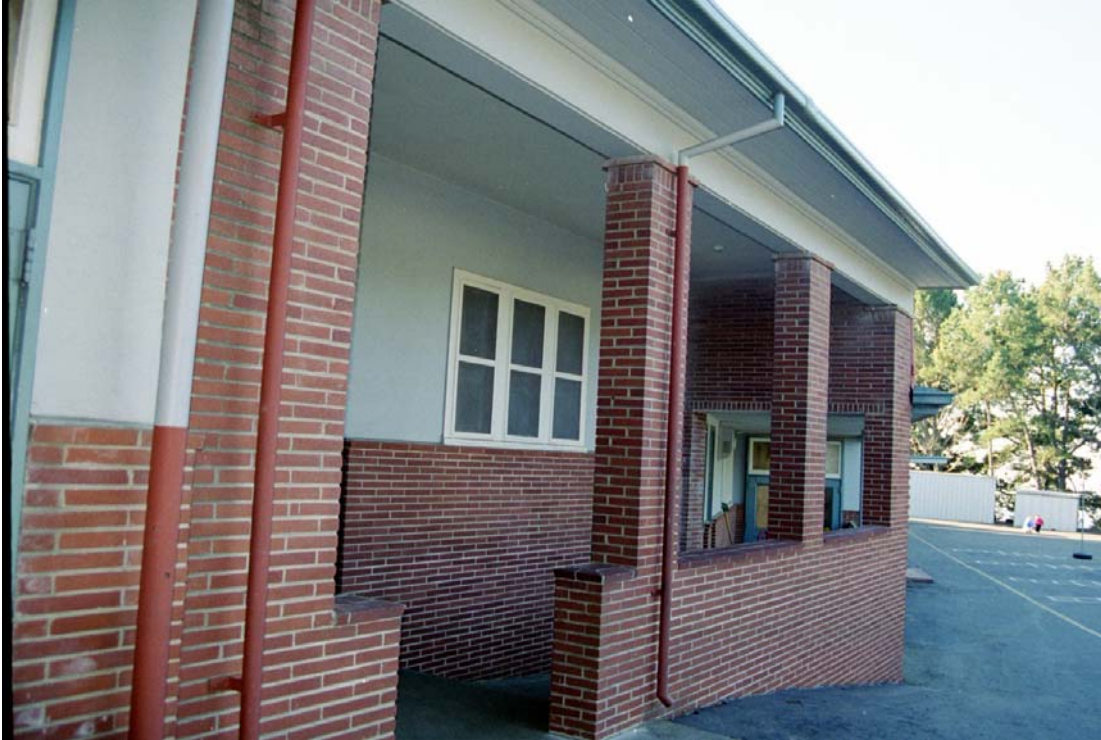
The exterior corridor at the rear of the administration building has a brick finish on the columns and walls (figure 8).

Figure 8: Main Building Northwest Exterior Corridor

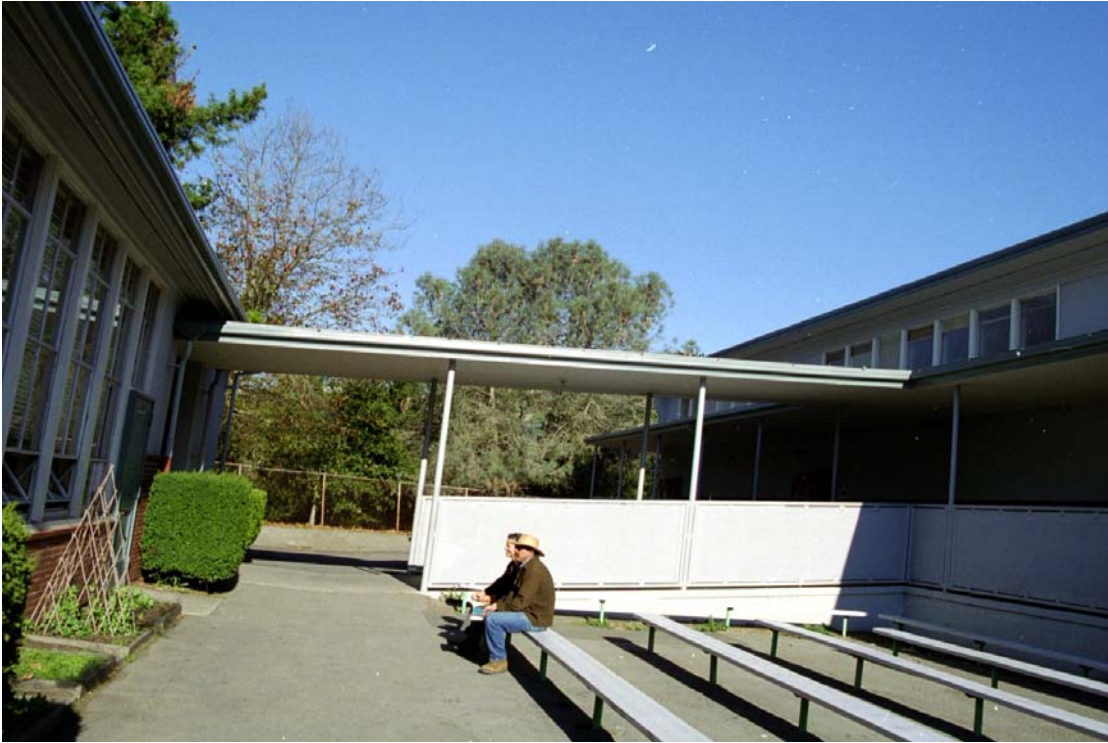
Connecting the classrooms are covered walkways with plaster ceilings that are supported by 3" diameter pipe columns. The walkways are connected at both ends to the adjacent building and depend on their connection to the adjacent buildings for lateral resistance (figure 9).

The covered walkways that run between the several wings are supported by exterior stud walls. They do not have their own independent lateral force resisting systems, and there is no seismic joint between them and the wings they connect.

7.	The covered walkways between the buildings may suffer damage and collapse as a result of being connected to more than one building. In addition the electrical conduit supported by these walkways may become damaged creating a potential life safety hazard.

Figure 9: Covered Walkway Between Buildings
