STRUCTURAL EVALUATION OF  
MARTIN LUTHER KING JR. ELEMENTARY SCHOOL  
WEST CONTRA COSTA UNIFIED SCHOOL DISTRICT  
(WCCUSD)

WLC Architects  
Kaiser Building  
1300 Potrero Avenue  
Richmond, CA 94804

DASSE Design, Inc.  
33 New Montgomery Street #850  
San Francisco, CA 94105  
(415) 243-8400

April 30, 2002

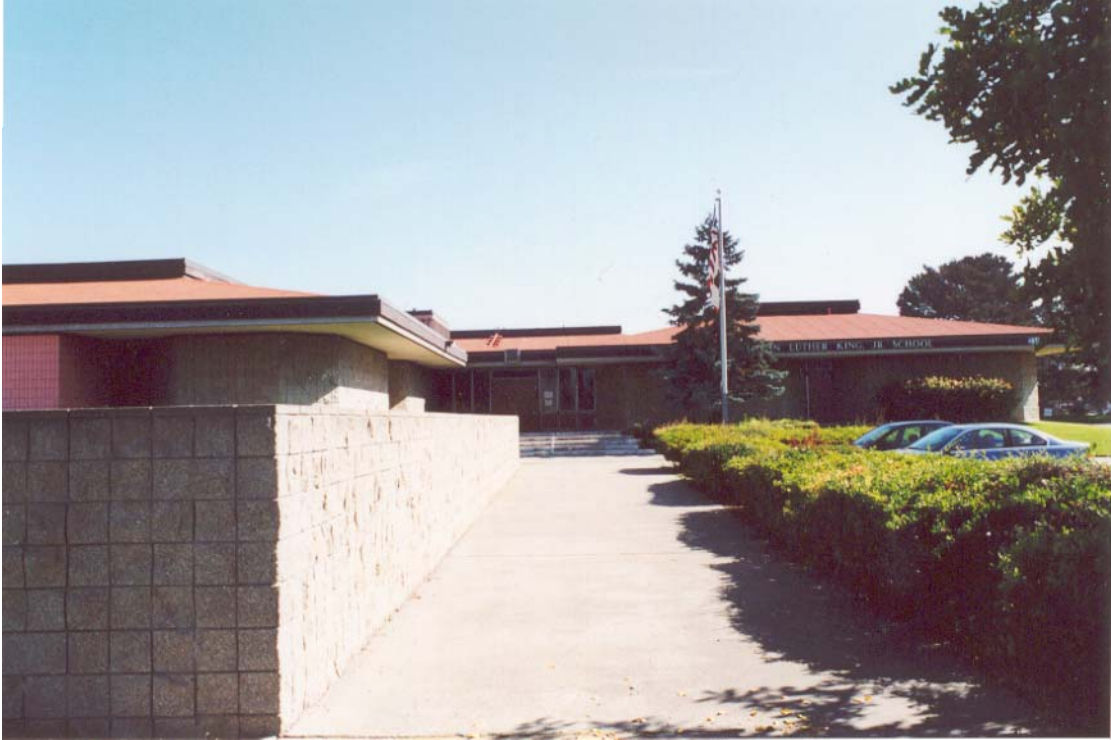
Figure 2: School Entrance

The 1968 Main Building (figures 2 & 3) is a two story split level structure and is organized as a collection of pods around courtyards (figure 4) exterior walls are predominately constructed of 8x8 stacked bond split face masonry. Some of the masonry walls from the lower level are extended above the floor to act as guard rails for the upper level balconies (figure 5). There appears to be an adequate length of shear wall but given the vintage of the construction there are concerns about the adequacy of the anchorage of the wood floors and roofs to the masonry walls.

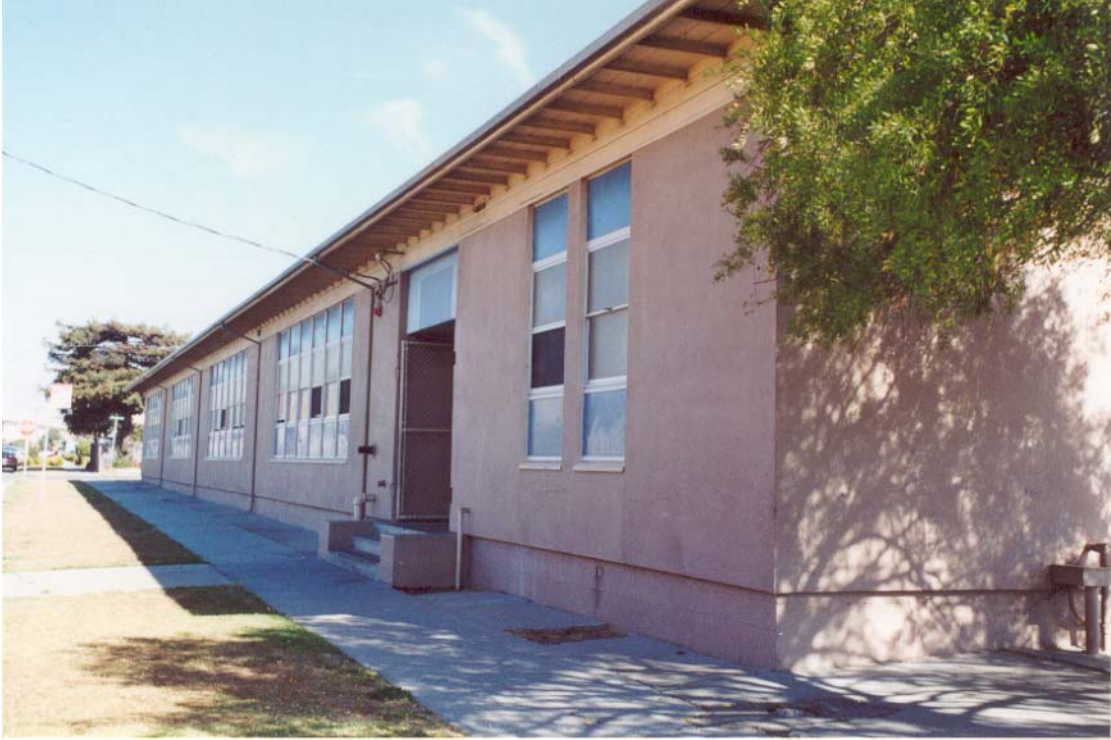
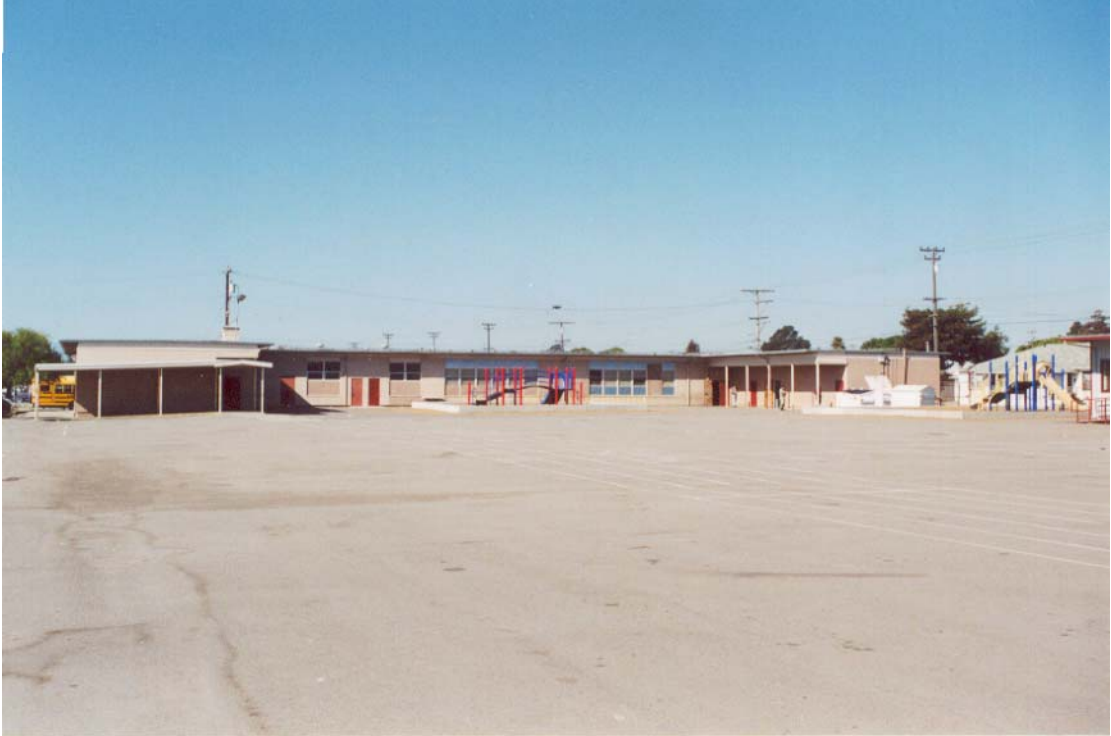
The 1944 Classroom Building is one story and of wood construction with a stucco exterior (figures 6, 7 & 8). The exterior classroom walls have window walls, which limit their ability to resist seismic loads.

Item	Building Structural Deficiencies
1.	In the 1944 classroom building the large expanses of window walls, and the limited extent of diagonal sheathing on corridor walls results in a lack of adequate shear strength.
2.	There is a lack of bracing of the covered walkway adjacent to the 1944 building.
3.	In the 1968 building there is a concern about the anchorage of the masonry walls to the roof and floor diaphragms.
4.	The handicap ramp at the Community Room has holes and is deteriorated.
5.	Community room has a lot of window openings in the longitudinal walls resulting in inadequate length of shear wall.
6.	In the Community room building, 3 hinged arch ridge connection is possibly inadequate to transfer seismic axial forces.

Item	Recommended Remediation	Priority	Figure Number
1.	Reinforce longitudinal walls by adding plywood shear wall panels. Provide collectors and holdowns as required.	1.5	6 & 7
2.	Provide seismic bracing of the covered walkways.	1.9	8 & 9

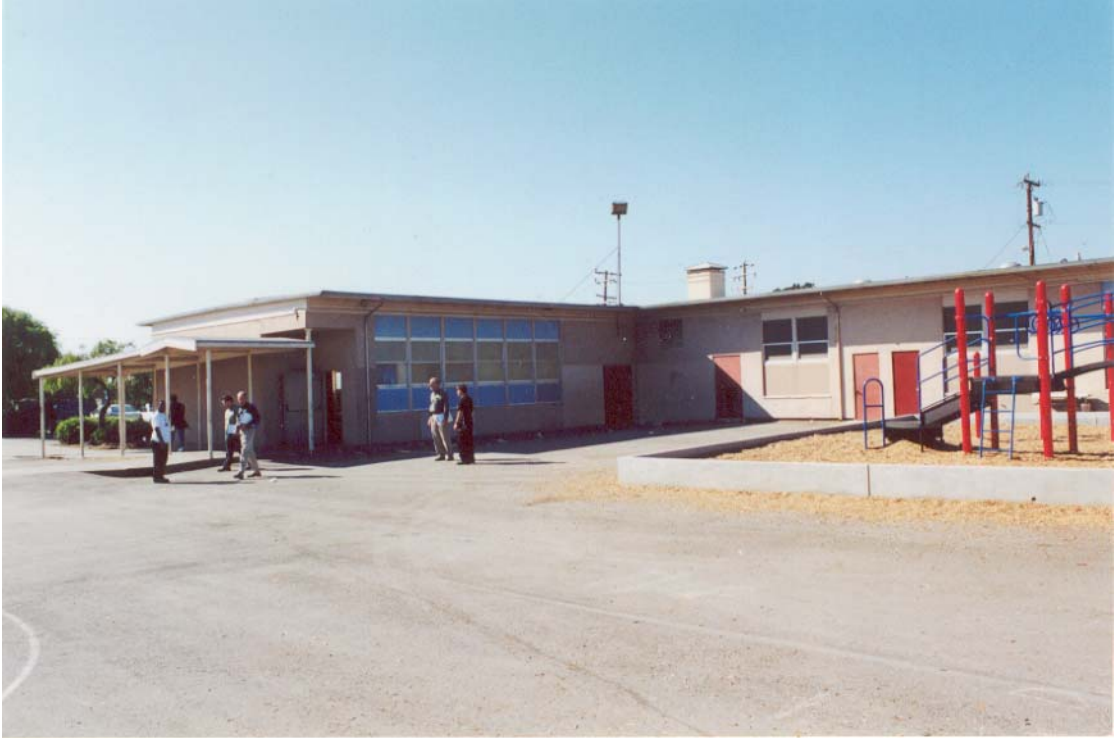
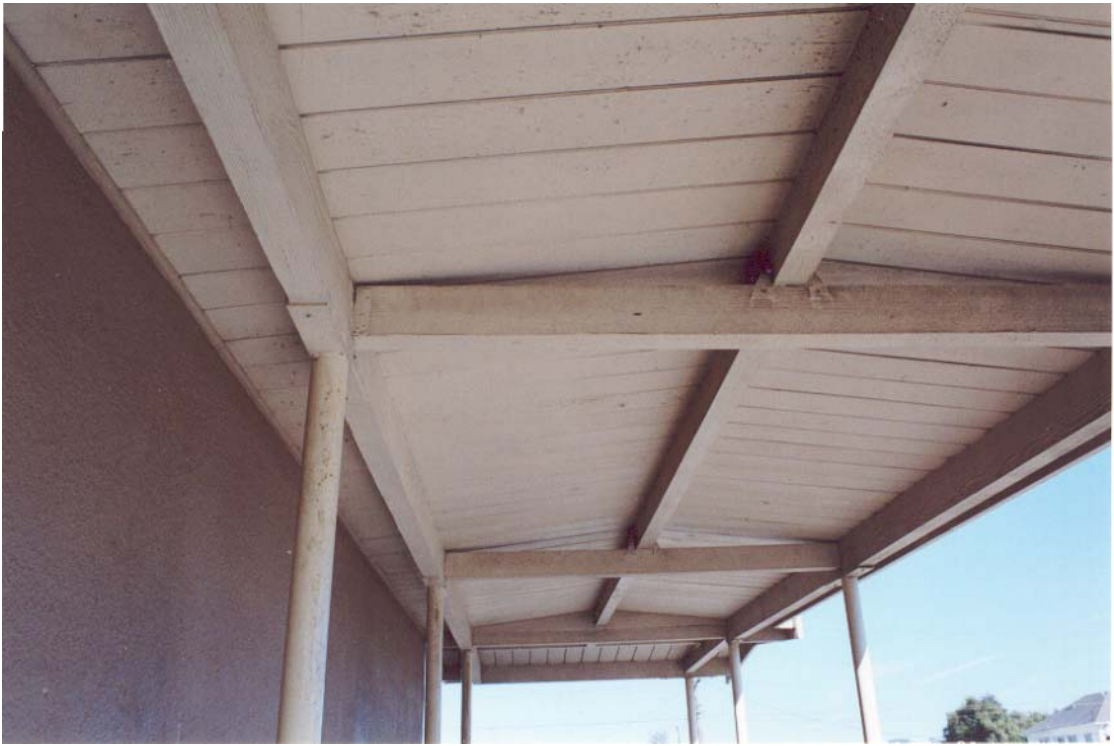
At the 1944 classroom building the covered walkways do not appear to be well anchored to the building and thus there is a concern that they will pull away and become a life-safety falling hazard (figures 8 & 9).

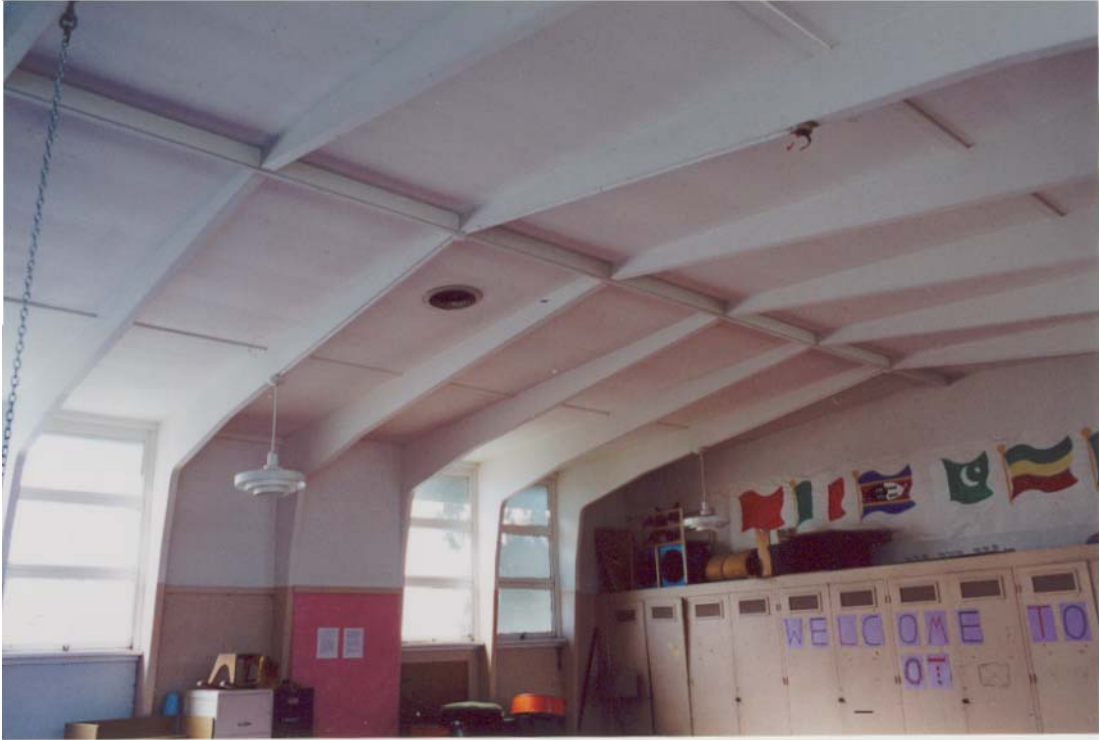
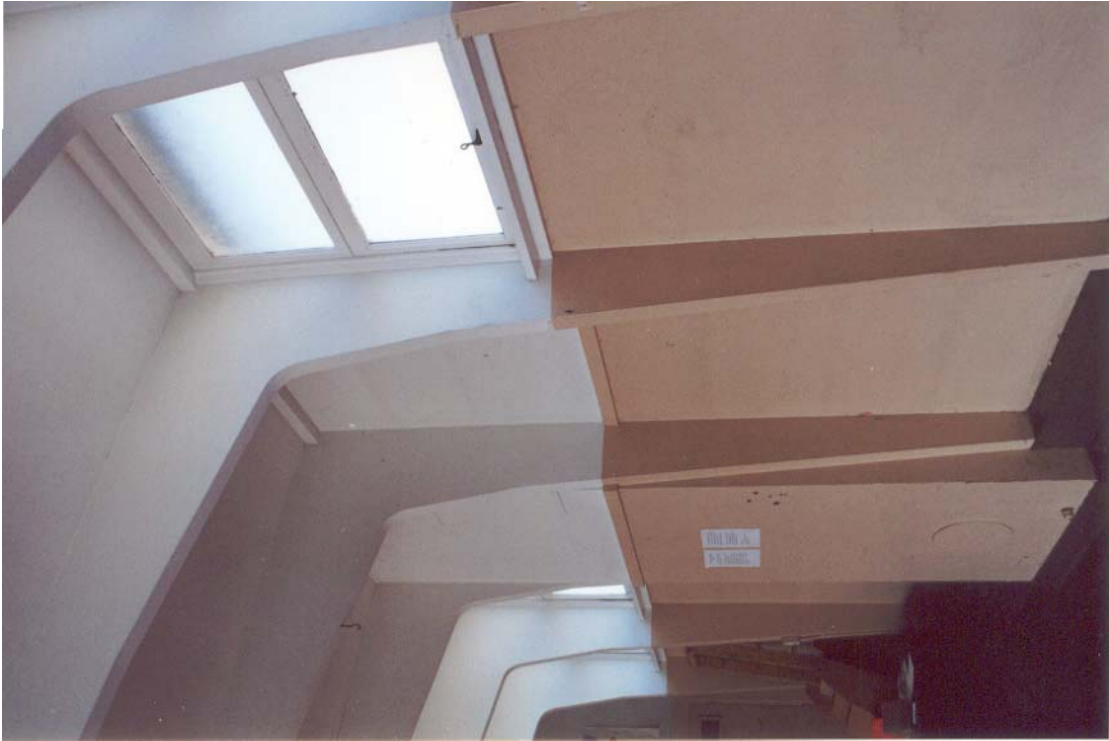
The Community Room is a separate building of indeterminate age. The structure consists of 3 hinged arches at 4'-0" o.c. with a lot of windows on the longitudinal sides (figures 10 & 11). The 3 hinged arch is constructed of 3-1/2" glu-lam arches.

3.	Investigate the adequacy of the anchorage of the masonry walls to the wood diaphragm and provide additional bracing if necessary.	1.5	5
4.	Repair handicap ramp at the Community Room.	1.0	N/A
5.	Replace some of the existing windows on the longitudinal walls with plywood shear wall panels. Provide collectors and holdowns as required.	1.5	N/A
6.	Analyze three hinged arch and reinforce connection as required.	1.5	N/A
