STRUCTURAL EVALUATION OF
MONTALVIN ELEMENTARY SCHOOL
WEST CONTRA COSTA UNIFIED SCHOOL DISTRICT
(WCCUSD)

April 30 2002

DASSE Design Project No. 01B300

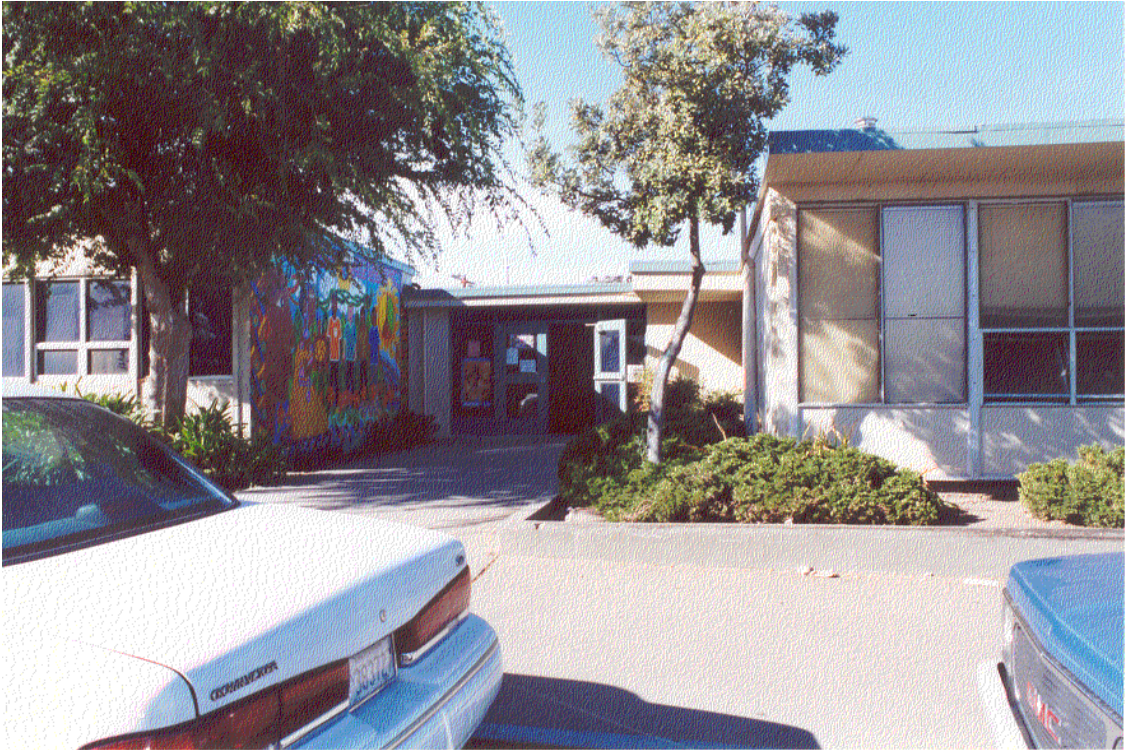
Figure 2: Main Entrance

The administration building, which dates back to the original campus construction, appears to be of a hybrid of steel/wood framing. Wood planks span 6'-0" to steel beams spanning in the transverse direction of the building. While the building has significant solid walls on three sides, the long window wall at the building's front has minimal strength to resist seismic forces, resulting in a life safety hazard. Built along with the classroom additions, the library building is also a traditional wood-framed building with wood joists spanning between wood stud bearing walls. Lastly, the campus contains some miscellaneous covered walkways, which are supported by multiple buildings. This condition, including the hard conduits that occur at the covered walkway structures, represents a life safety hazard due to the inability of the system to withstand the potential differential movements of the adjacent buildings. It should also be noted that while waterproofing issues are beyond the scope of this evaluation, the users of the campus have expressed concern over water leakage in both the multipurpose and classroom buildings.

Construction drawings for the administration building are not available for review at this time (see figure 2). The existing roof of the administration building was not evaluated in the "Measure M" roofing report provided by the Garland Company Inc.

Similar to the classroom additions, the library building is a wood-framed structure with 2x12 joists at 24" on center supported by 2x6 stud bearing walls (see figure 2). The roof is sheathed with 1/2" plywood with a maximum 49'-0" diaphragm span. Plywood (3/8") shear walls are provided to resist seismic forces. Significant lengths of shear wall occur in the transverse direction and at the west wall, but due to a long window wall the shorter length of shear wall at the east side of the building is likely to be inadequate. Continuity for the transfer of chord and collector forces is provided by double top plates with nailed splices, but the strength of these splices is minimal and likely to be inadequate to resist the required seismic forces at the longitudinal walls. Reinforced concrete strip footings make up the foundation system of the building. While tie down connections are provided at some of the existing shear wall locations, this type of positive connection to the foundation is likely to be needed at the other shear wall locations as well. The life safety hazards identified at the library building include the inadequate shear wall and collector splice strength at the longitudinal walls, and a lack of uplift connection at the shear wall locations. The existing roof of the library building was not evaluated in the "Measure M" roofing report provided by the Garland Company Inc.

6.	Remove some windows and replace with new stud framing and plywood sheathing. Provide holddown anchors and collectors as required.	1.1	2
7.	Remove some windows and replace with new stud framing and plywood sheathing.	1.1	N/A

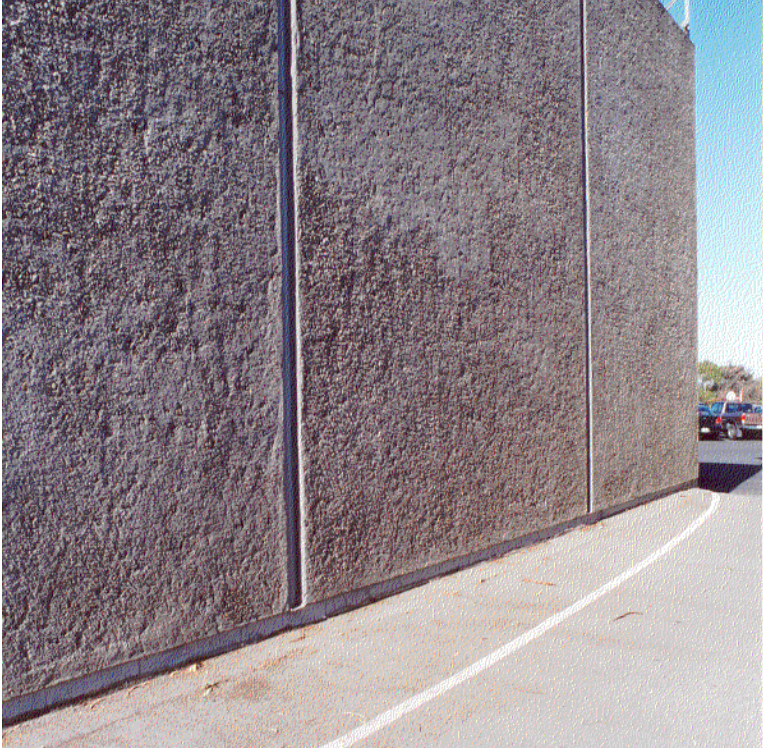
Figure 3: Multipurpose Building, east face

The multipurpose building is a single story structure with transverse beams spanning the 45’-0” width of the building. The concrete walls indicate that the building was constructed by the tilt-up method, and it is anticipated that the roof is wood-framed, although this cannot be verified visually due to the acoustical tile ceiling. It is also expected that the anchorage of these concrete walls to the wood roof diaphragm is inadequate and poses a life safety hazard. A large

settlement cracked in the slab on grade was observed running across the width of the building, and foundation cracks were apparent at the building's exterior (see figure 3), which should be investigated by geotechnical engineer. On the west side of the building, the kitchen area has a lower roof diaphragm, where the out of plane anchorage of the concrete walls should also be addressed.

Construction drawings for the multipurpose building are not available for review at this time (see figure 3). The existing roof of the multipurpose building was not evaluated in the "Measure M" roofing report provided by the Garland Company Inc.

Item	Recommended Remediation	Priority	Figure Number
1.	Provide new out-of-plane anchorage connection and continuity ties in roof diaphragm.	1.0	N/A
2.	Provide new out-of-plane anchorage connection and continuity ties in roof diaphragm.	1.0	N/A

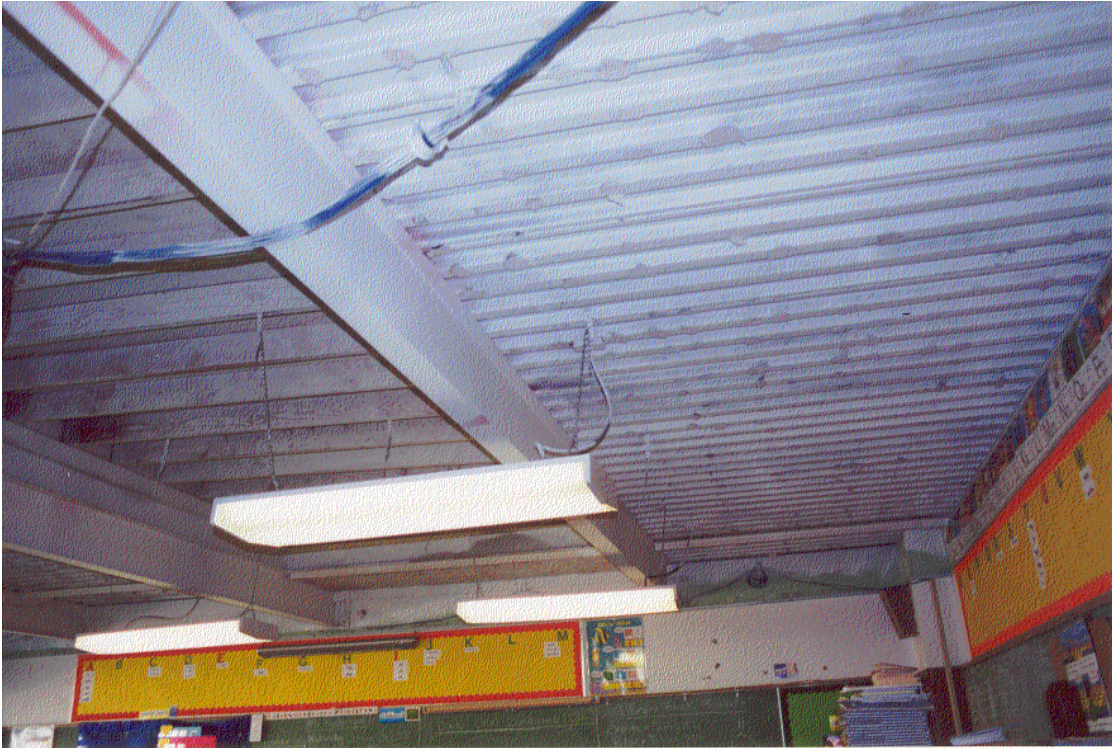
Figure 4: Classroom Building, interior of classroom

Because the ceiling has been removed from the single story classroom buildings, the steel roof beams are observed spanning the longitudinal length of the classrooms and supporting a metal deck roof that spans in the transverse direction of the building (see figure 4). The steel beams are supported throughout the structure by intermediate concrete walls between the classrooms. The outside longitudinal walls at the classrooms are metal deck walls (exposed to the exterior) with stiffeners spaced at 6'-0" on center between windows, and the corridor walls are concrete. While the steel beams act as struts to support the transverse walls under out of plane loading, the corridor walls do not appear to have adequate anchorage. This deficiency in out of plane wall anchorage constitutes a life safety hazard. Each classroom also has a skylight filled with wood framing. The additions to the classroom buildings are traditional wood-framed structures (see figure 5). Hard conduits were observed running across the transition between the original classroom building and its addition without provision for the differential displacement of the two structures. This also represents a life safety concern.

Construction drawings for the original classroom buildings are not available for review at this time (see figures 4, 6, 7, and 9). The existing roofs of the classroom buildings were not evaluated in the "Measure M" roofing report provided by the Garland Company Inc.

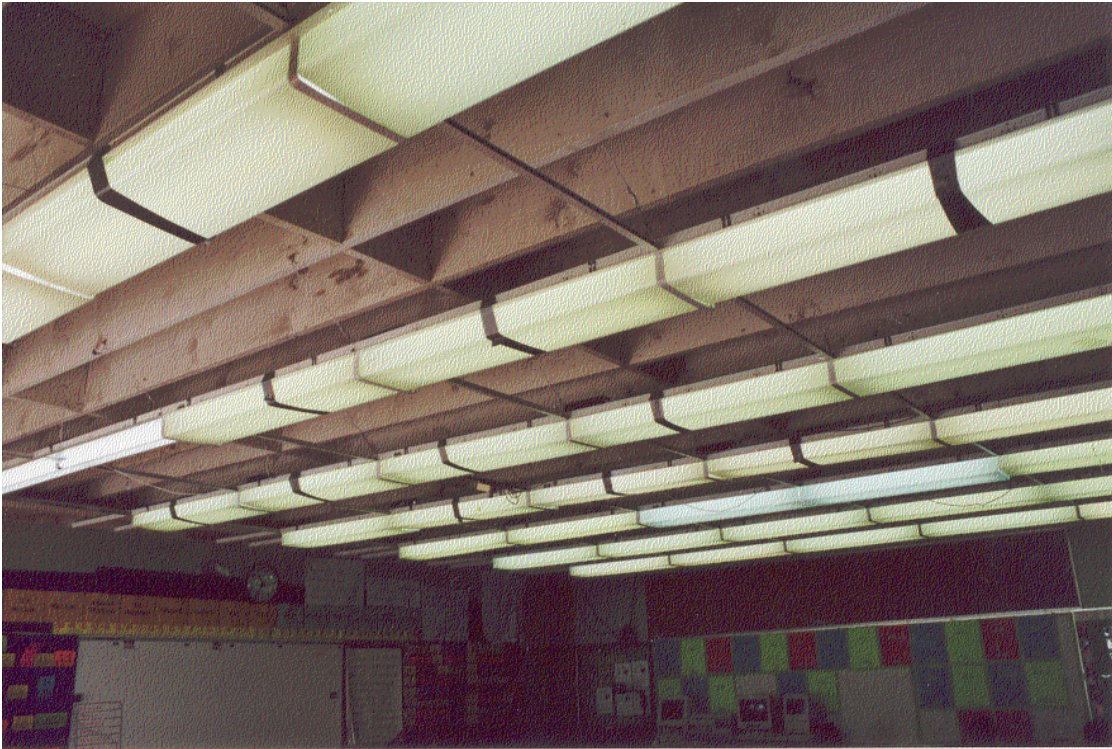
Figure 5: Classroom Building Addition, interior of classroom

The wood-framed additions to the classroom buildings are separate structures with a 1½" seismic separation from the original structure (see figures 5, 6, 8, and 9). Given the stiffness of these two shear wall structures this separation is expected to be adequate to prevent pounding of the two

buildings, but the prevention of this pounding action should be a primary design consideration in the implementation of the rehabilitation measures recommended below. At the classroom additions the roofs are framed with typical 2x14 joists spaced at 16" on center, sheathed with 1/2" plywood, and supported by 2x6 stud bearing walls. Substantial lengths of plywood (3/8") shear walls resist seismic loads at each side except the window walls at the north and south ends of the additions (figures 6 and 8). While shorter shear panels do exist at these walls it is likely that more of the wall will need to be sheathed in order to provide adequate resistance to seismic loads. Double top plates with nailed splice connections provide continuity for the transfer of chord and collector forces, but the strength of these splices is minimal and likely to be inadequate to resist the required seismic forces at the north and south window walls. These buildings are founded on reinforced concrete strip footings of a typical 1'-2" width. For the resistance of uplift forces, foundation tie downs have been provided only at the short shear walls. A positive connection may be necessary at the other wall locations as well. The life safety hazards identified at the classroom building additions include the inadequate shear wall and collector splice strength at the window walls, and a lack of uplift connection at the shear wall locations. The existing roofs of the classroom building additions were not evaluated in the "Measure M" roofing report provided by the Garland Company Inc.
