STRUCTURAL EVALUATION OF
SEAVIEW ELEMENTARY SCHOOL
WEST CONTRA COSTA UNIFIED SCHOOL DISTRICT
(WCCUSD)

DASSE Design, Inc.
33 New Montgomery Street #850
San Francisco, CA 94105
(415) 243-8400

April 30, 2002

DASSE Design Project No. 01B300

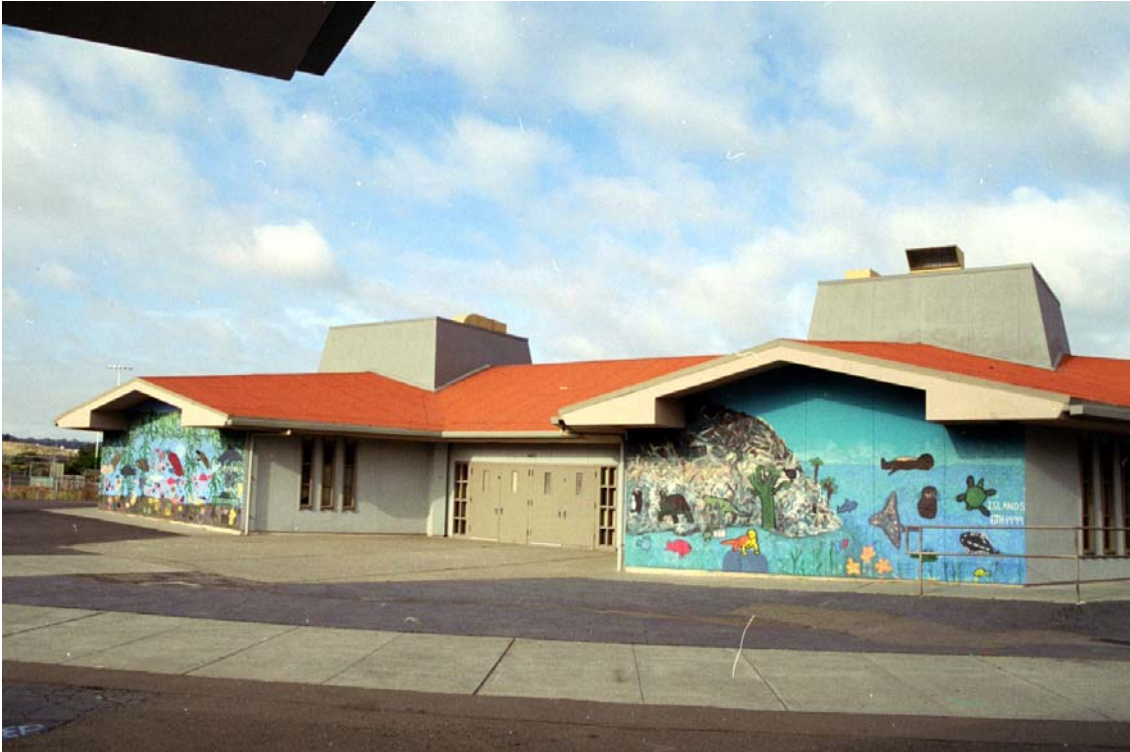
Figure 4: Classroom Building, Unit B, east face

The single story classroom buildings have a plan arrangement of two pods or clusters of classrooms that are symmetrical about a central space (see figures 4, 5, 6, and 7). These buildings have wood framed walls with an exterior stucco finish. The interior ceilings are a mix of suspended T-bar with panels and acoustical tile attached to the structure. Substantial lengths of solid walls were observed in these structures. Similar to the repeated classroom building, the administration building has wood framed walls, finished with stucco, and with significant solid lengths (see figures 2 and 3). The oldest of the portable buildings, the cafeteria, has steel roof beams in which significant rusting was observed (see figures 8 and 9). Deterioration of this type is deemed a life safety hazard. Elsewhere among the portable structures, hard electrical conduits were found passing from structure to structure without provision for the possible differential movement of these buildings. This, too, constitutes a life safety hazard.

The classroom buildings of Units B and C are symmetrical, single story buildings (see figures 4, 5, 6, and 7). The pod-type classroom configuration of these buildings in plan results in some walls skewed relative to the orthogonal directions. The structure is framed with 2x12 roof joists at 24" on center that are supported by wood bearing walls and four 3-pinned steel arches. Plywood sheathing (1/2") covers the roof framing to provide a continuous roof diaphragm across some significant spans (up to 57'-6"). Lateral forces are resisted primarily by plywood shear walls, most of which occur at the exterior walls. There appears to be a substantial length of shear wall in both directions. It is also noted that the 3-pinned arches will provide a secondary lateral force resisting system. While double top plates are provided at the top of the wood framed walls, the splice connection has minimal capacity and is identified as a life safety concern. Additionally, collector elements are not detailed for the interior shear walls. The building's foundation system consists of typical 1'-2" wide reinforced concrete spread footings with grade beams used to tie the arch bases together. A positive connection between this foundation and the wood shear walls for the purpose of resisting uplift forces has not been provided, which constitutes another life safety hazard. The existing roofs of the classroom buildings, Unit B and C, are about 3 to 5 years old and appear to be in acceptable condition.

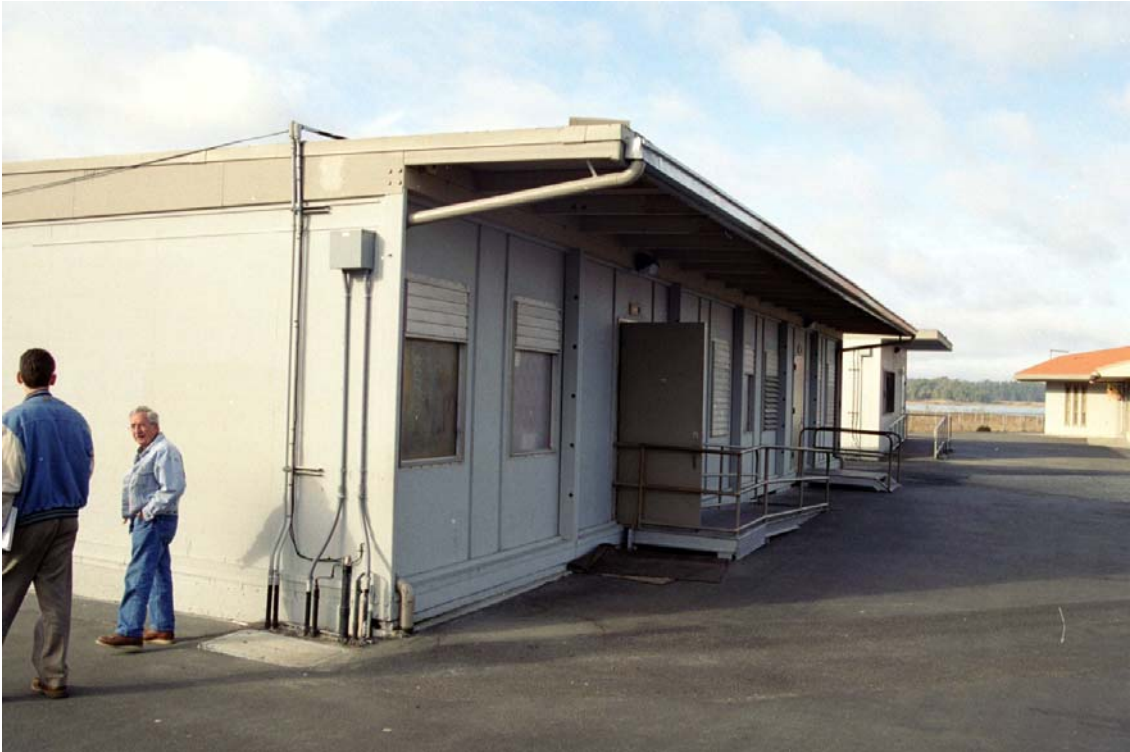
Figure 8: Portable Buildings, north face

Item	Building Structural Deficiencies
1.	Unit A, B, & C: Strength of chord/collector elements is likely to be inadequate to resist prescribed forces. Continuity of chord/collector elements is lacking at some shear wall locations.
2.	Unit A, B, & C: Positive connection of shear walls to foundation is lacking.
3.	Cafeteria/Kitchen Portable: Rusting observed at steel roof beams
4.	Portable Buildings: Electrical conduits are connected to adjacent buildings with no provision to accommodate differential movement.

Item	Recommended Remediation	Priority	Figure Number
1.	Provide new strapping and blocking at inadequate locations.	1.5	N/A
2.	Provide new holdown anchors into existing foundation.	1.5	N/A
3.	Remove existing cafeteria portable building	1.0	8, 9
4.	Provide new flexible electrical conduits between portable buildings,	1.9	N/A

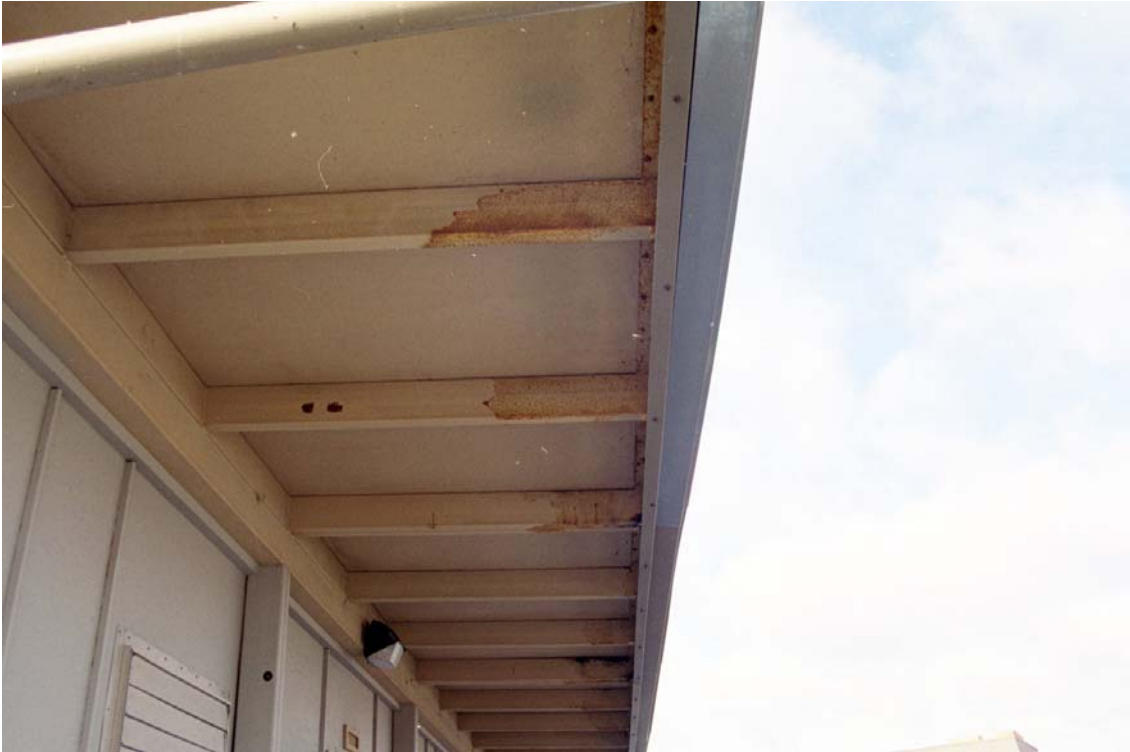
Figure 9: Cafeteria Portable, rusted roof beams
