STRUCTURAL EVALUATION OF
STEWART ELEMENTARY SCHOOL
WEST CONTRA COSTA UNIFIED SCHOOL DISTRICT
(WCCUSD)

April 30, 2002

DASSE Design Project No. 01B300

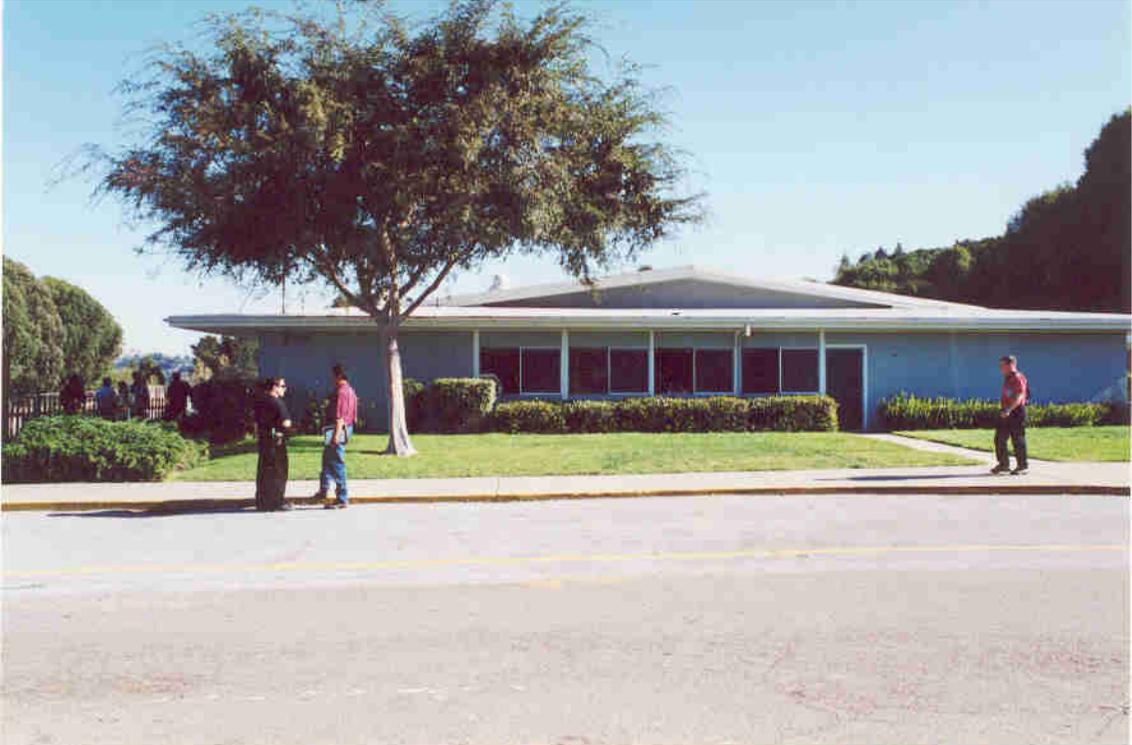
Figure 2: North-west Elevation Looking at School Offices

The main classroom buildings are one-story wood framed buildings with very slightly sloping roofs (see figures 2 and 4). The buildings are built as long classroom buildings with a central corridor and with window walls to the exterior. During the site visit, access into a ceiling space above a corridor revealed that the corridor walls and roof employed plywood sheathing and the corridor walls framed directly up to the roof framing.

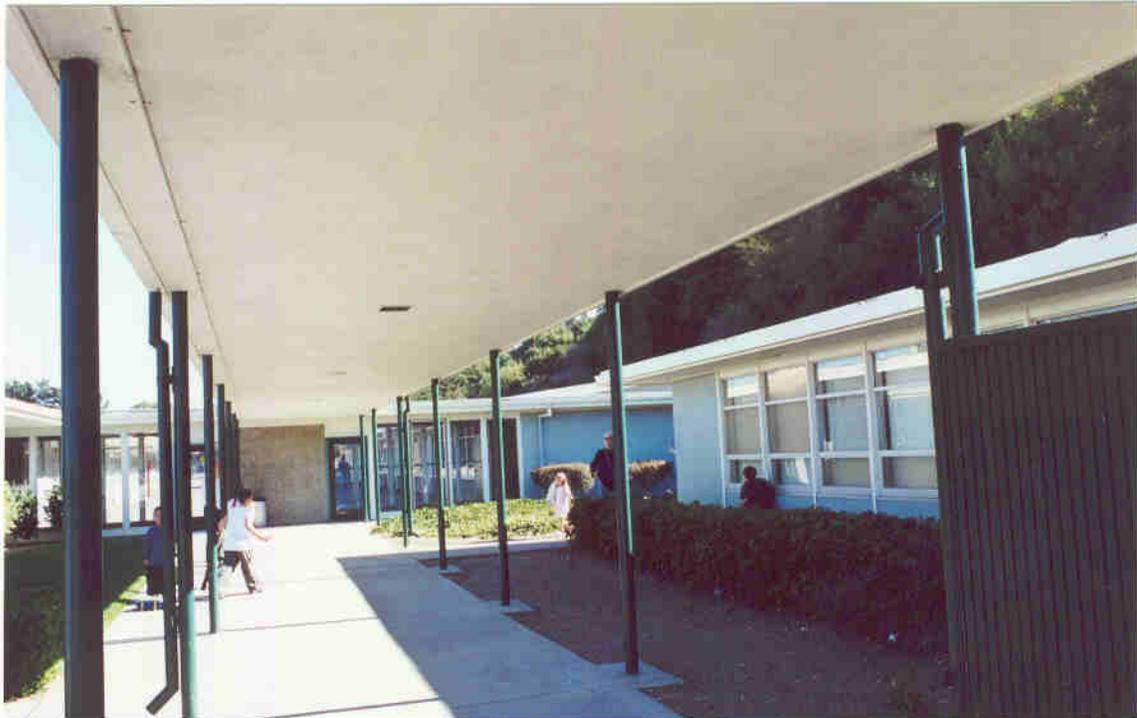
Figure 6: Covered Walkway between Multi-purpose Room and Main Classroom Buildings

columns supported on square footings with slab-on-grade to tie individual footings together. The roof framing employs longitudinal 6x8 beams with transverse spanning 2x8 roof joists on 24 inch centers. The Covered Walkway roof sheathing is ½ inch plywood. The pipe column attachment to the longitudinal girders is a flat plate with two lag bolts, and to the footings is a base plate with 4 anchor bolts. The absence of a cantilevered column lateral force resisting system or a roof level moment frame system indicates that this covered walkway is vulnerable to seismic load resistance and is a falling hazard if it were subjected to strong earthquake ground shaking.

Item	Building Structural Deficiencies
1.	The covered walkways employ pipe columns without cantilever moment connections at the foundation level or moment connections at the roof level. The lateral stability of the covered walkway between the Multi-purpose Building and the Main Classroom Building is not adequate and poses a falling hazard if it were subjected to large seismic ground motions.

Item	Recommended Remediation	Priority	Figure Number
1.	Recommend adding steel frames to provide increased lateral stability for covered walkway.	1.9	6
