STRUCTURAL EVALUATION OF  
TRANSITION LEARNING CENTER  
WEST CONTRA COSTA UNIFIED SCHOOL DISTRICT  
(WCCUSD)

April 30, 2002

DASSE Design Project No. 01B300

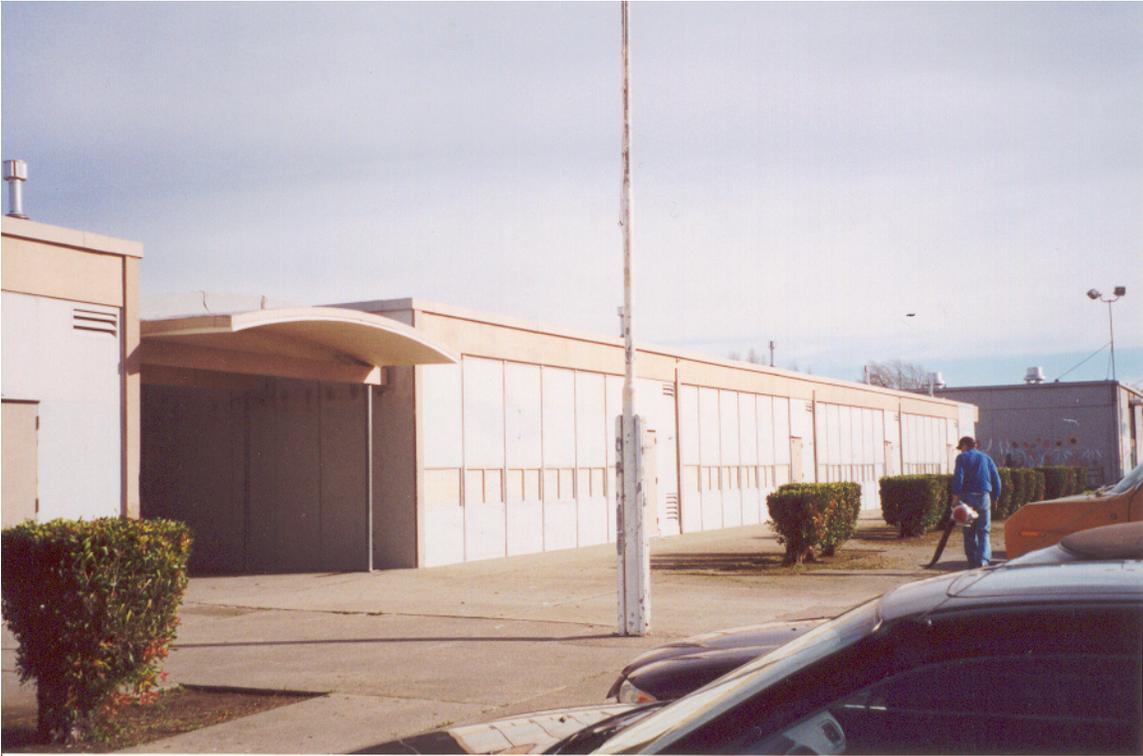
Figure 2: South Longitudinal Wall of Main Building (East Half)

Item	Building Structural Deficiencies
1.	The exterior longitudinal walls of the main building have window walls. Therefore, the shear walls along the interior corridors carry the majority of the seismic force and may be overstressed.

Item	Recommended Remediation	Priority	Figure Number
1.	Infill some windows at exterior with shear wall. Provide new collector elements and holdowns as required..	1.1	2, 7
2.	Strengthen collectors, add straps on roof at corners of openings.	1.5	N/A
3.	Provide straps above the roof sheathing and new clip angles from blocking to shear walls.	1.3	6
4.	Infill some windows at exterior with shear wall. Provide new collector elements and holdowns as required.	1.2	6

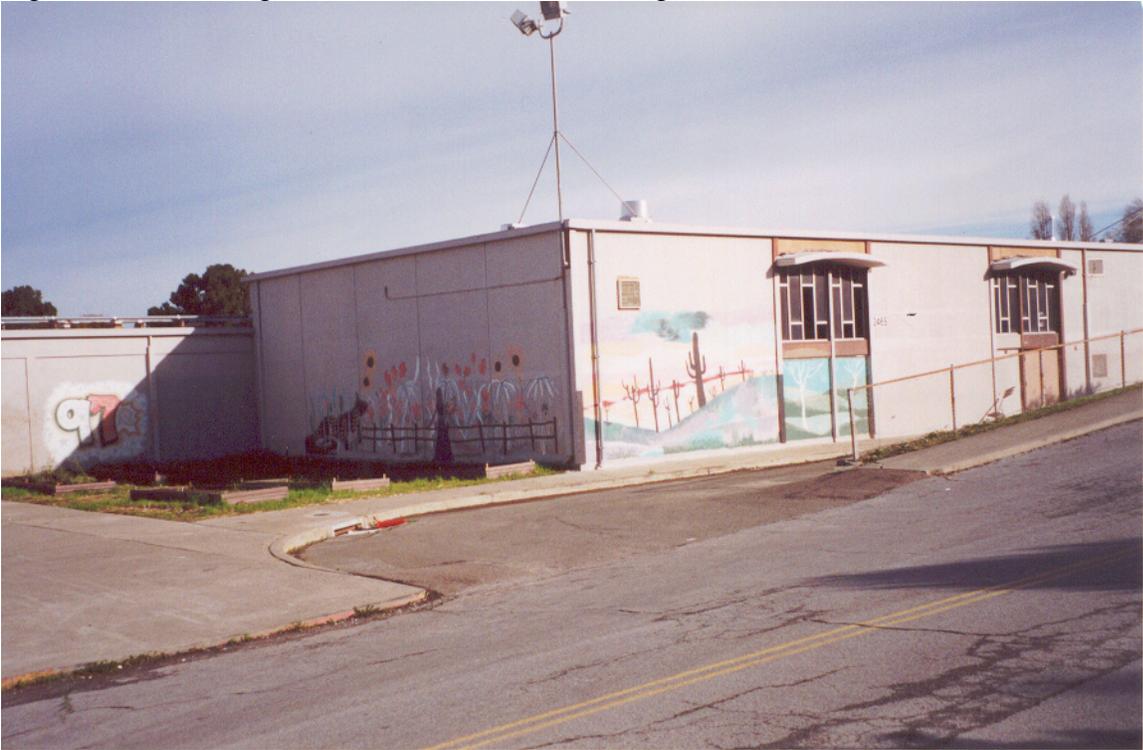
Figure 3: South Face of Multi-Purpose Building

5.	The corridor between the main building and multi-purpose building does not appear to be attached to the main building. There is a seismic joint at that end of the corridor. The corridor structure has no lateral support in the transverse direction at one end, and therefore may experience large deflections and potential partial collapse.

6.	At the high roof of the multi-purpose building, the chord splices at the longitudinal walls may be overstressed.
7.	At the multi-purpose building, there may be a displacement incompatibility where the east end wall of the kitchen area frames into the north wall of the multi-purpose room area. This may result in localized damage to the walls.

5.	Provide a new frame for independent lateral support in the transverse direction.	1.5	3, 6, 16
6.	Provide new straps above roof sheathing at chords	1.5	3, 5
7.	Strengthen existing connection of low roof into the wall of the multi-purpose room.	1.8	4
8.	Provide knee bracing at frame at the front of the entrance canopy.	2.2	15
9.	Relocate conduit or install flexible connections to accommodate movement.	1.9	14

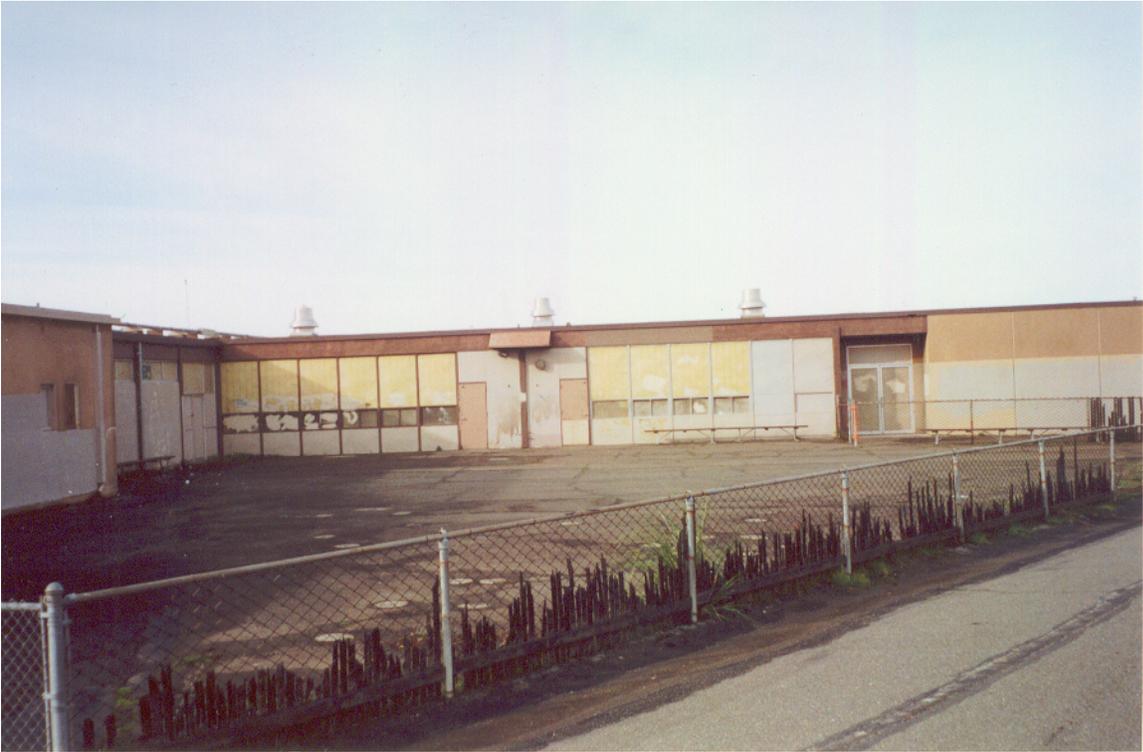
Figure 6: East Face of Main Building

3.	The collector at the east wall of the main building may be overstressed.
4.	The corridor between the main building and multi-purpose building lacks shear panels on the north wall.

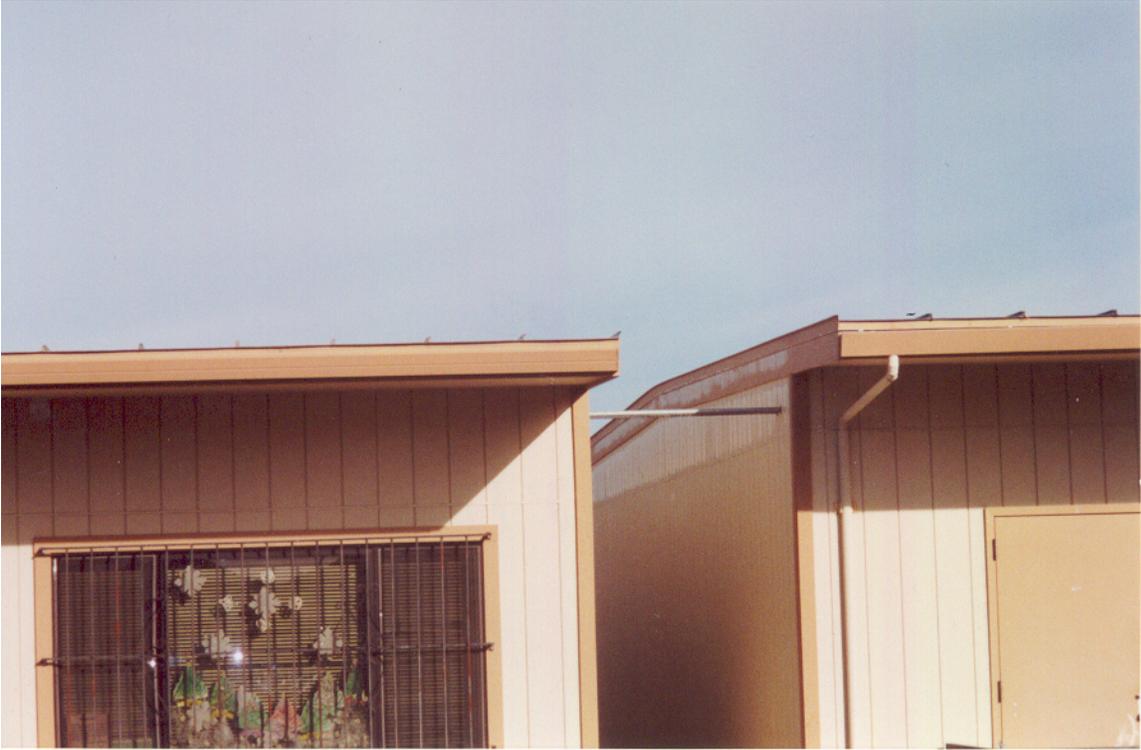
Figure 14: Conduit Running between Portable Classrooms

8.	The entrance canopy appears to lack adequate lateral support. The canopy may partially tear away from the main building during an earthquake event.
9.	There is electrical conduit running between the portables near the roof level that does not have flexible connections. As the buildings move independently, the conduit may get damaged and is a life-safety hazard.
