STRUCTURAL EVALUATION OF

VERDE ELEMENTARY SCHOOL

WEST CONTRA COSTA UNIFIED SCHOOL DISTRICT
(WCCUSD)

April 30, 2002

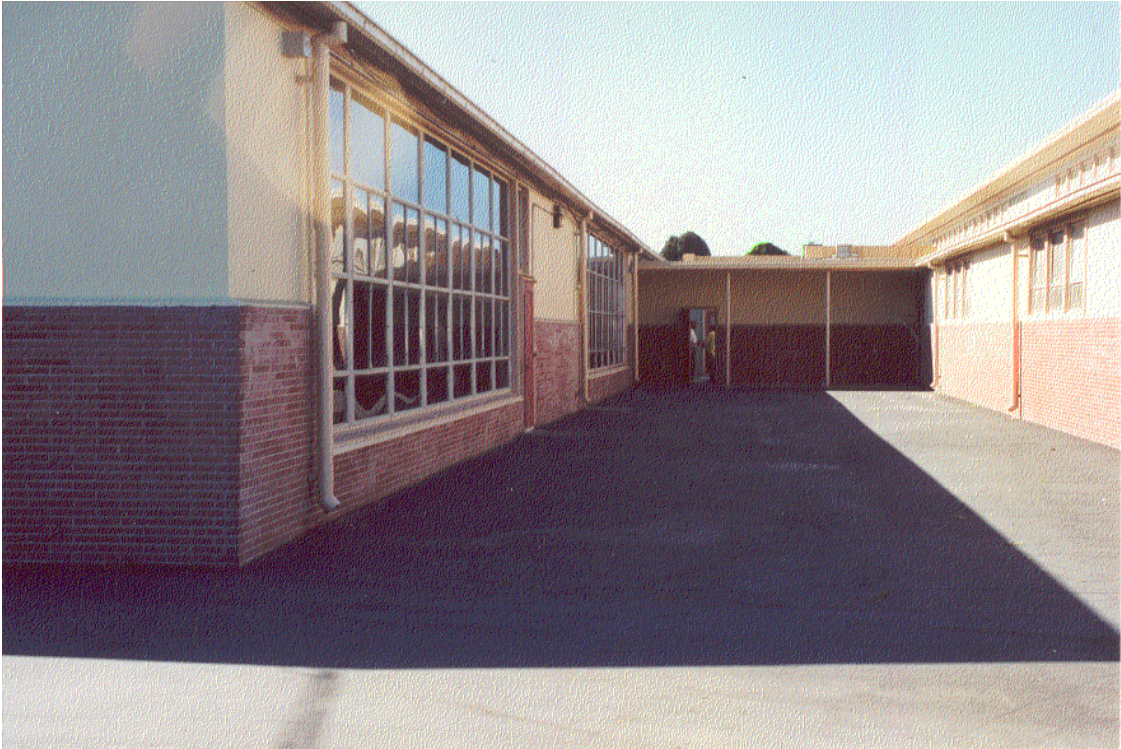
Figure 3: Unit D (classroom buildings) east face

Unit D was originally constructed as two separate classroom buildings, but with the addition of the library the two structures were combined into one. The resultant structure has a plan geometry with severe re-entrant corners, and the diaphragm does not have a continuous tie at these locations. The original classroom buildings were framed with wood trusses built from 2x8 and 2x10 members and spaced at 24" on center. These trusses span transversely between wood-framed bearing walls and are covered with diagonal sheathing. The central library portion of Unit D is framed with 2x8 joists at 24" on center carried by W14 and W18 steel beams and girders. The roof here is sheathed with 1/2" plywood. The combined structure resists seismic loads through the original diagonally sheathed wood shear walls and plywood shear walls added during the addition. The addition of the library included the removal of some walls previously used to resist seismic forces. This removal was compensated for by the addition of plywood sheathing to the remaining portions of wall. Along with the minimal longitudinal shear walls, these reduced transverse shear walls are vulnerable to seismic loading. Continuity of the chord/collector elements is provided through a variety of means including double top plates at the transverse walls and spliced headers in the longitudinal direction. The capacities of these chord/collector splices are inadequate at some locations. The building foundation is composed of reinforced concrete spread footings from both construction phases ranging in width from 11" to 3'-0". Some of the shear walls are anchored to these footings, but this type of positive connection is lacking at other locations. The life safety hazards identified in Unit D are the re-entrant corners, inadequate shear wall length, and inadequate collector strength. The existing roof of Unit D is about 3 years old and appears to be in acceptable condition.

4.	Replace existing diagonal sheathing with new plywood sheathing at inadequate locations and/or remove some windows and replace with new stud framing and plywood sheathing. Provide new holddowns as required.	1.1	3, 4, 5, 6

5.	Provide new strapping and blocking at inadequate locations.	1.5	N/A
6.	Provide new continuous ties with new joists, strapping, and blocking.	1.5	3
7.	Replace existing diagonal sheathing with new plywood sheathing at inadequate locations and/or remove some windows and replace with new stud framing and plywood sheathing. Provide new collectors and holddowns as required.	1.1	7

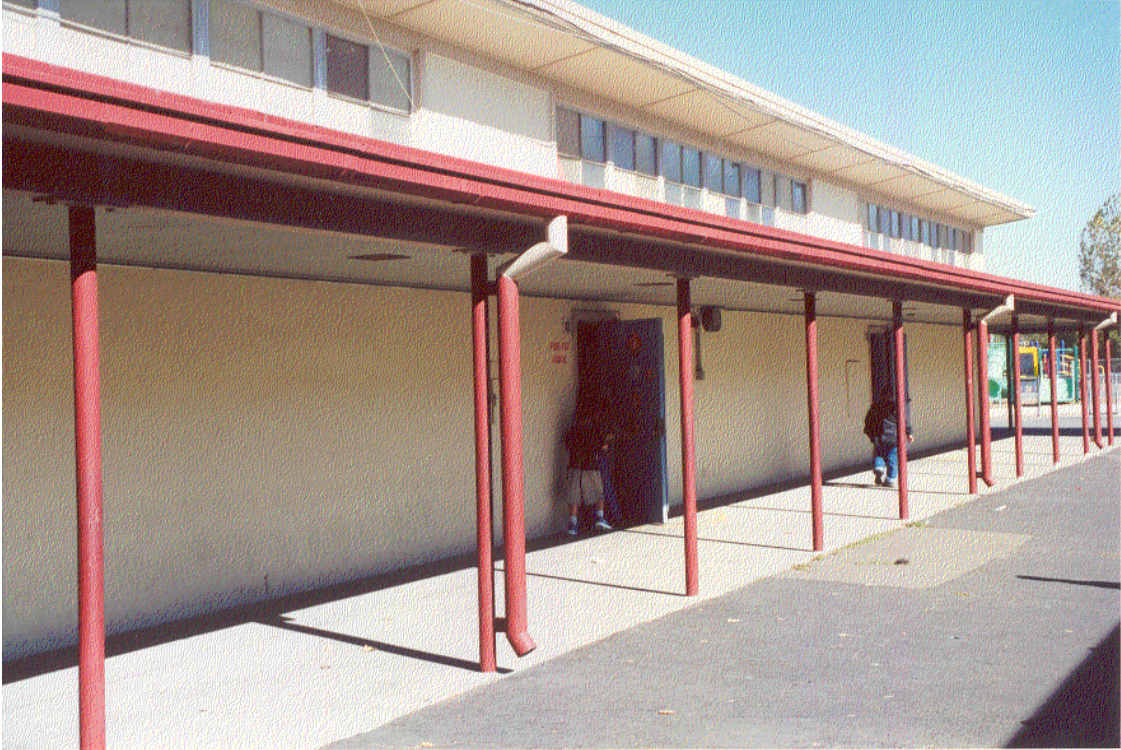
Figure 5: Unit C (classroom building) south face

Unit C is a single story classroom building, also wood-framed with a stucco exterior (figures 5 and 6). A covered walkway runs the entire length of the building on the south side, and the north wall is a window wall. The lack of shear wall resistance due to these windows constitutes a life safety hazard. The classroom buildings of Unit D are very similar wood-framed structures (figures 3, 4, 8, and 9). The exterior walls and interior corridors are finished with a brick veneer up to five feet tall, and stucco above. Similar to Unit C, the north walls of the classrooms are window walls creating a life safety hazard. Unit D also includes the library addition, which ties the classroom wings into one structure.

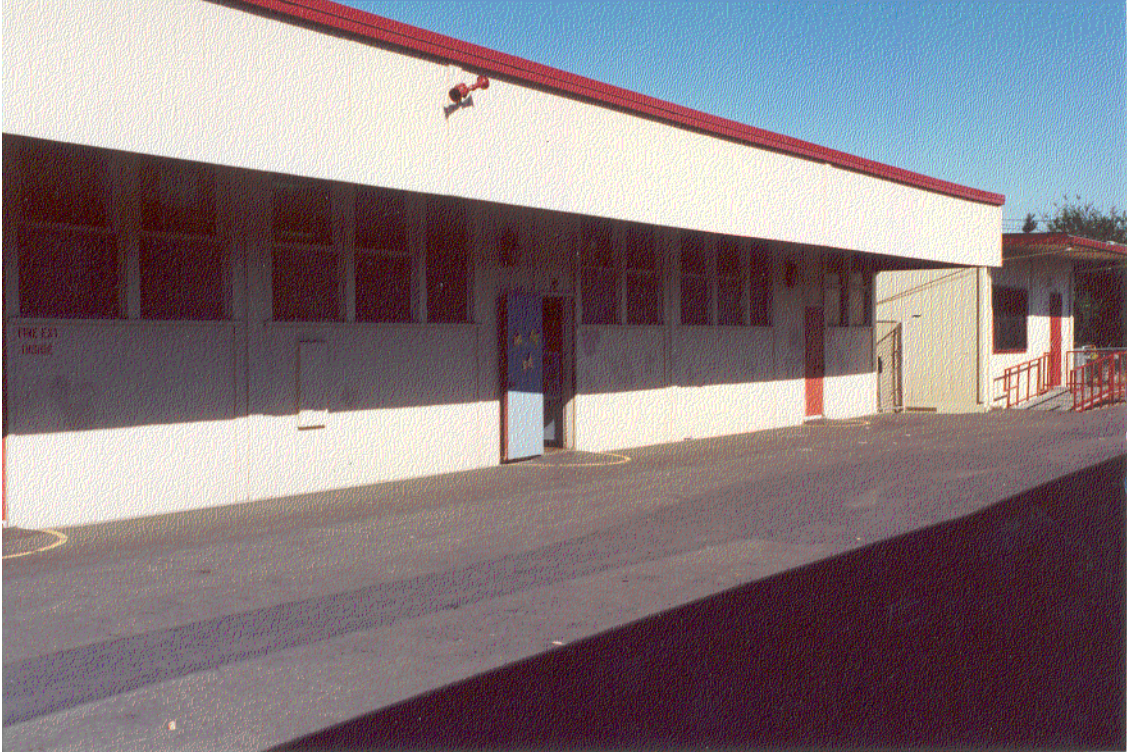
Figure 7: Unit E (classroom building) south face

The final classroom building, Unit E, was built as a modular-type structure with vertically ribbed plywood siding. The large extent of window openings in the longitudinal walls represents a life safety hazard. This building's foundation system consists of an intermittent foundation typical of portable construction. The inability of this foundation system to transfer seismic loads creates a life safety hazard. At the long classroom buildings and connecting the various buildings, covered walkways are framed with wood beams and steel pipe columns, and are supported by multiple structures. The inability of this system to withstand differential displacements of the buildings to which it is tied represents a life safety hazard. Electrical conduit was found to be running along the covered walkways and between multiple buildings. Similarly, the inability of this conduit to withstand these differential movements, this is also identified as a life safety hazard.

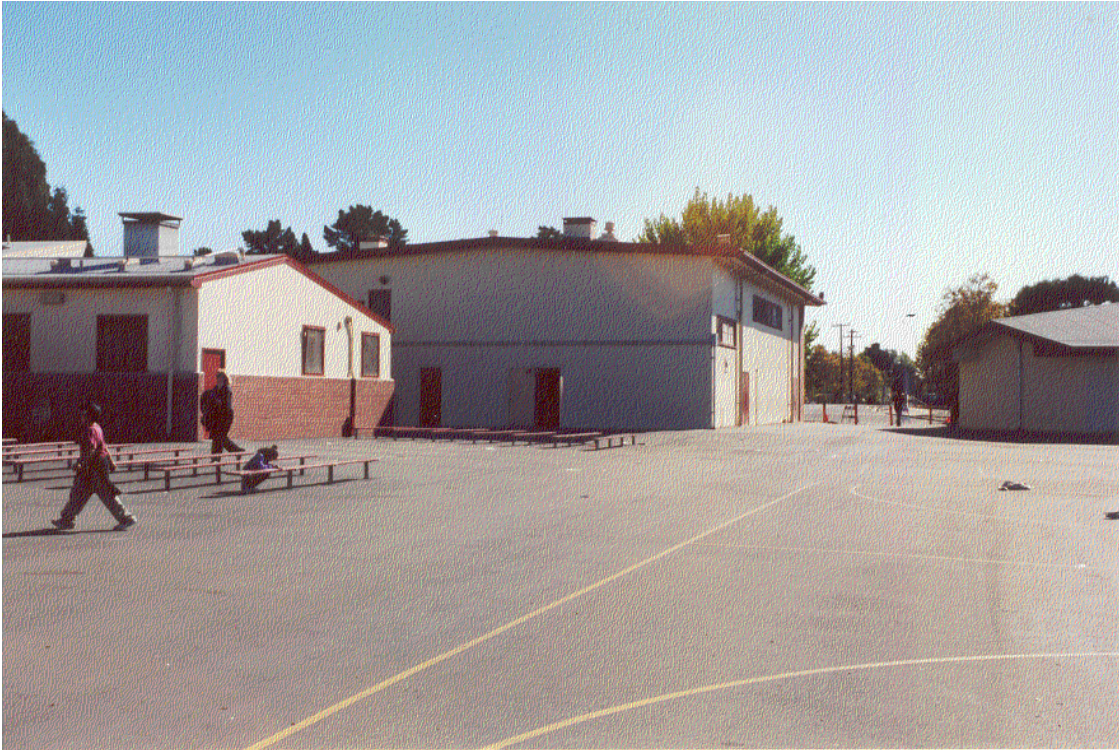
Figure 10: Unit B (multipurpose building) north face

The Unit A pod classroom building is a wood-framed structure with stucco exterior wall finishes (figure 11). The single story building is built on a slab on grade with spread footings. A built-up asphalt roof is used. The single story Unit B houses the multipurpose room and administrative offices (figures 2 and 10). It is a wood-framed building that includes roof trusses. Most of the building's exterior is stucco, but there are significant portions of brick veneer at the front of the building, including ground to roof veneer in some locations and a 20 foot tall brick pier at the entry canopy. Multiple windows and other wall openings limit the seismic shear strength of the building in the longitudinal direction to the extent that a life safety hazard is observed.

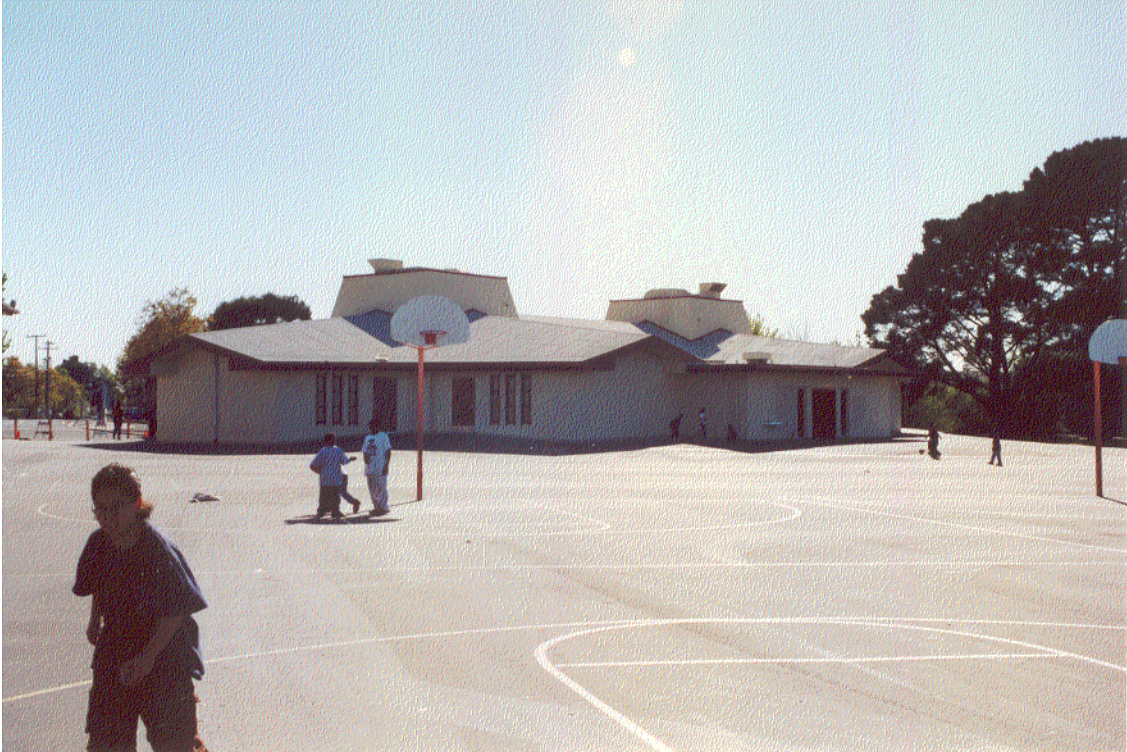
Figure 11: Unit A (classroom building) north face

Units A is a symmetrical, single story pod building (see figure 11). The pod-type classroom configuration of these buildings in plan results in some walls skewed relative to the orthogonal directions. The structure is framed with 2x12 roof joists at 24" on center that are supported by wood bearing walls and four 3-pinned steel arches. Plywood sheathing (1/2") covers the roof framing to provide a continuous roof diaphragm across some significant spans (up to 57'-6"). Lateral forces are resisted primarily by plywood shear walls, most of which occur at the exterior walls. There appears to be a substantial length of shear wall in both directions. It is also noted that the 3-pinned arches will provide a secondary lateral force resisting system. While double top

plates are provided at the top of the wood framed walls, the splice connection is deficient for the prescribed forces. Additionally, collector elements are not detailed for the interior shear walls. The building is founded on a typical 1'-2" wide reinforced concrete spread footings with grade beams used to tie the arch bases together. A positive connection between this foundation and the wood shear walls for the purpose of resisting uplift forces has not been provided. The life safety hazards identified at Unit A are the inadequate collector strength and the lack of shear wall tie downs. The existing roof of Unit A is about 5 years old and appears to be in acceptable condition.
